Experimental Research on Glass-Polycarbonate Beams

Bernhard Weller, Kristina Härth

*Technische Universität Dresden, Institute of Building Construction, Germany,
www.bauko.bau.tu-dresden.de*

A research project at the Institute of Building Construction explores composite beams made of glass and transparent polycarbonate. These beams consist of one inner polycarbonate sheet and two outer panes of glass and are bonded by a transparent adhesive. Several experimental tests demonstrated that the glass-polycarbonate beams can behave in a ductile manner when the load-bearing capacity is exceeded. Furthermore, a high residual load-bearing capacity after complete glass-breakage exists. On the contrary, typical laminated glass beams fail in cases of complete glass breakage despite the PVB-foil used. Tests with the composite beams made of glass and polycarbonate were carried out with varying cross-sections, glass types and loadings. Moreover, the different elongations due to temperature were investigated in climate tests.

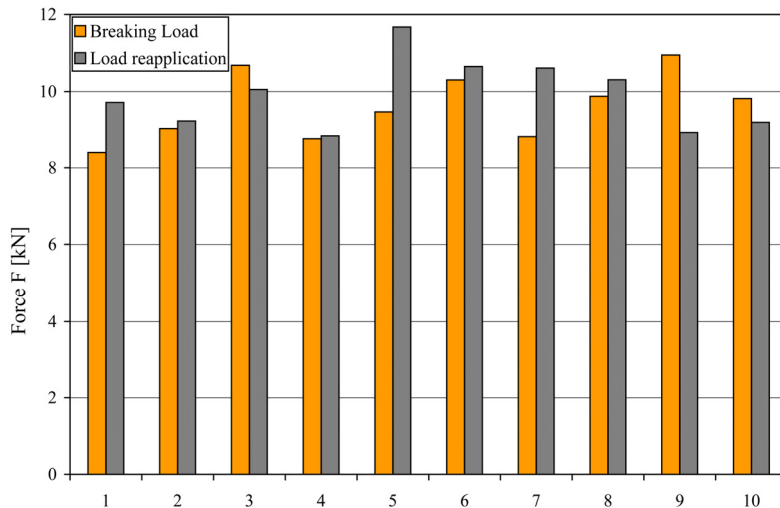
Figure 3: Breaking load and load reapplication of glass-polycarbonate beams.

A series of ten composite beams was manufactured to check the residual load-bearing capacity of glass-polycarbonate beams in principal. These beams consist of two outer panes of annealed glass with a thickness of 6 mm each and one inner sheet of polycarbonate with a thickness of 4 mm. As with the laminated glass beams, the specimens with a height of 150 mm were loaded in a four point bending test until glass breakage which occurred again nearly simultaneously in both glass panes. Unlike the laminated glass beams, the beams made of annealed glass and polycarbonate had an excellent post-breakage behaviour. The residual load-bearing capacity was in all beams almost as high as the breaking load or even more (Figure 3). The positive results of those preliminary tests were the base for further tests with varying parameters.

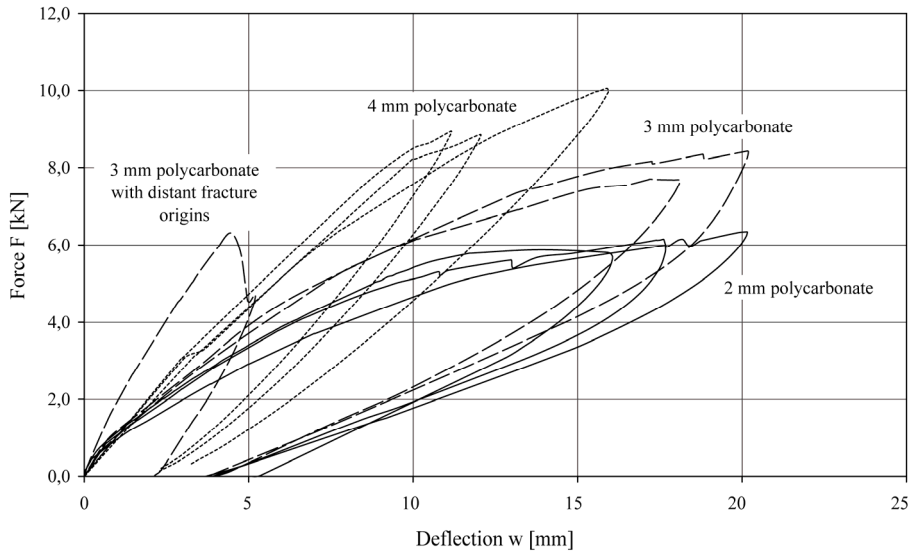
Figure 5: Load-deflection curves of composite beams with polycarbonate thicknesses of 4, 3 and 2 mm.

After complete glass breakage, the glass-polycarbonate beams were reloaded to check the post-breakage behaviour. These tests showed that, on the one hand, the residual load-bearing capacity decreases with decreasing polycarbonate thickness, but, on the other, the participation of the broken glass in the load transfer and therefore, the fracture origins and the fracture pattern of the two glass panes play an important role. When the two glass panes broke independently of each other in two test runs and, furthermore, the fracture origins were distant from each other, the residual load-bearing capacity increased even more. Figure 5 shows load-deflection curves of completely broken composite beams with 4, 3 and 2 mm polycarbonate thicknesses. One beam with a polycarbonate thickness of 3 mm had very distant fracture origins in the two glass panes. This increased the residual load-bearing capacity considerably.
