Ties That Bind: The Emergence of Iron Tie Rod Reinforcement in Load Bearing Masonry Buildings of Charleston, S.C.

A Thesis
Presented to
the Graduate Schools of
Clemson University and the College of Charleston

In Partial Fulfillment
of the Requirements for the Degree
Masters of Science
Historic Preservation

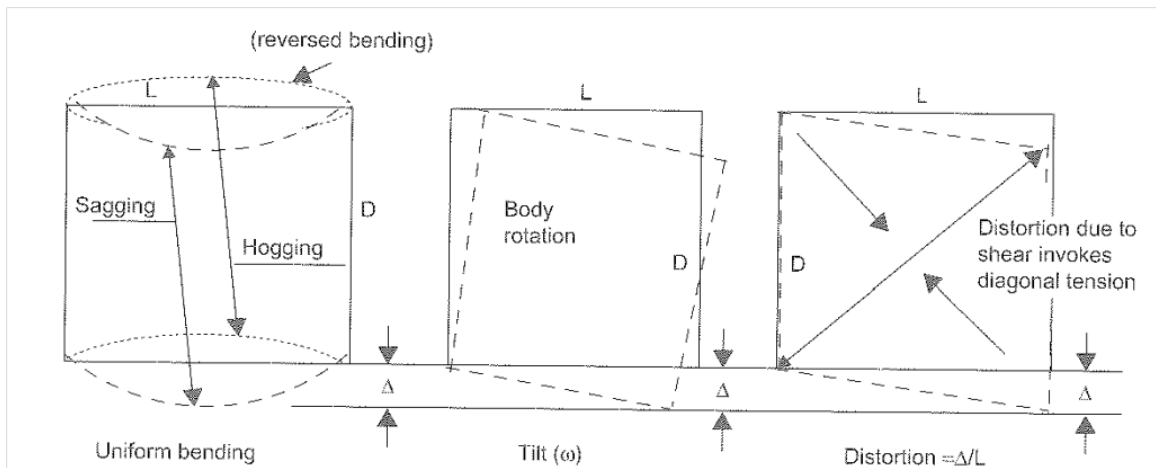
Figure 2.1: Customary definitions of building settlement (Source: Forsyth, Michael, ed. *Structures and Construction in Historic Building Conservation*. Oxford: Blackwell Publishing, 2007).

Apart from questions of appearance, masonry is seldom remarked on unless it fails, usually with the surprise appearance of cracks, which quite often signal a problem with the foundation itself or settlement of the entire structure. Settlement usually refers to movement of the finished building structure. Differential settlement is movement that causes the structure to change shape, and therefore introduces new strains within the building. Figure 2.1 illustrates the three customary forms of differential settlement, though a building will usually be subjected to a combination of all of these. Under uniform bending by sagging (or reverse bending), the façade of a load bearing masonry structure goes into bending like a simple beam. If excessive, hair line cracking will typically emerge above the damp-proof course. Tilting occurs when the

entire structure or façade rotates within the same plane. Although ground settlement is typically present, it might not always introduce torsion stresses if it settles evenly without deformation of the building. Therefore, a wall panel can tilt without showing evidence of strain or cracking. Deformation due to shear is effectively illustrated as a distorted parallelogram shape. Shear forces are the source for diagonal tension; therefore, diagonal cracking develops within the masonry walls at right angles to the direction of the tension stress¹.

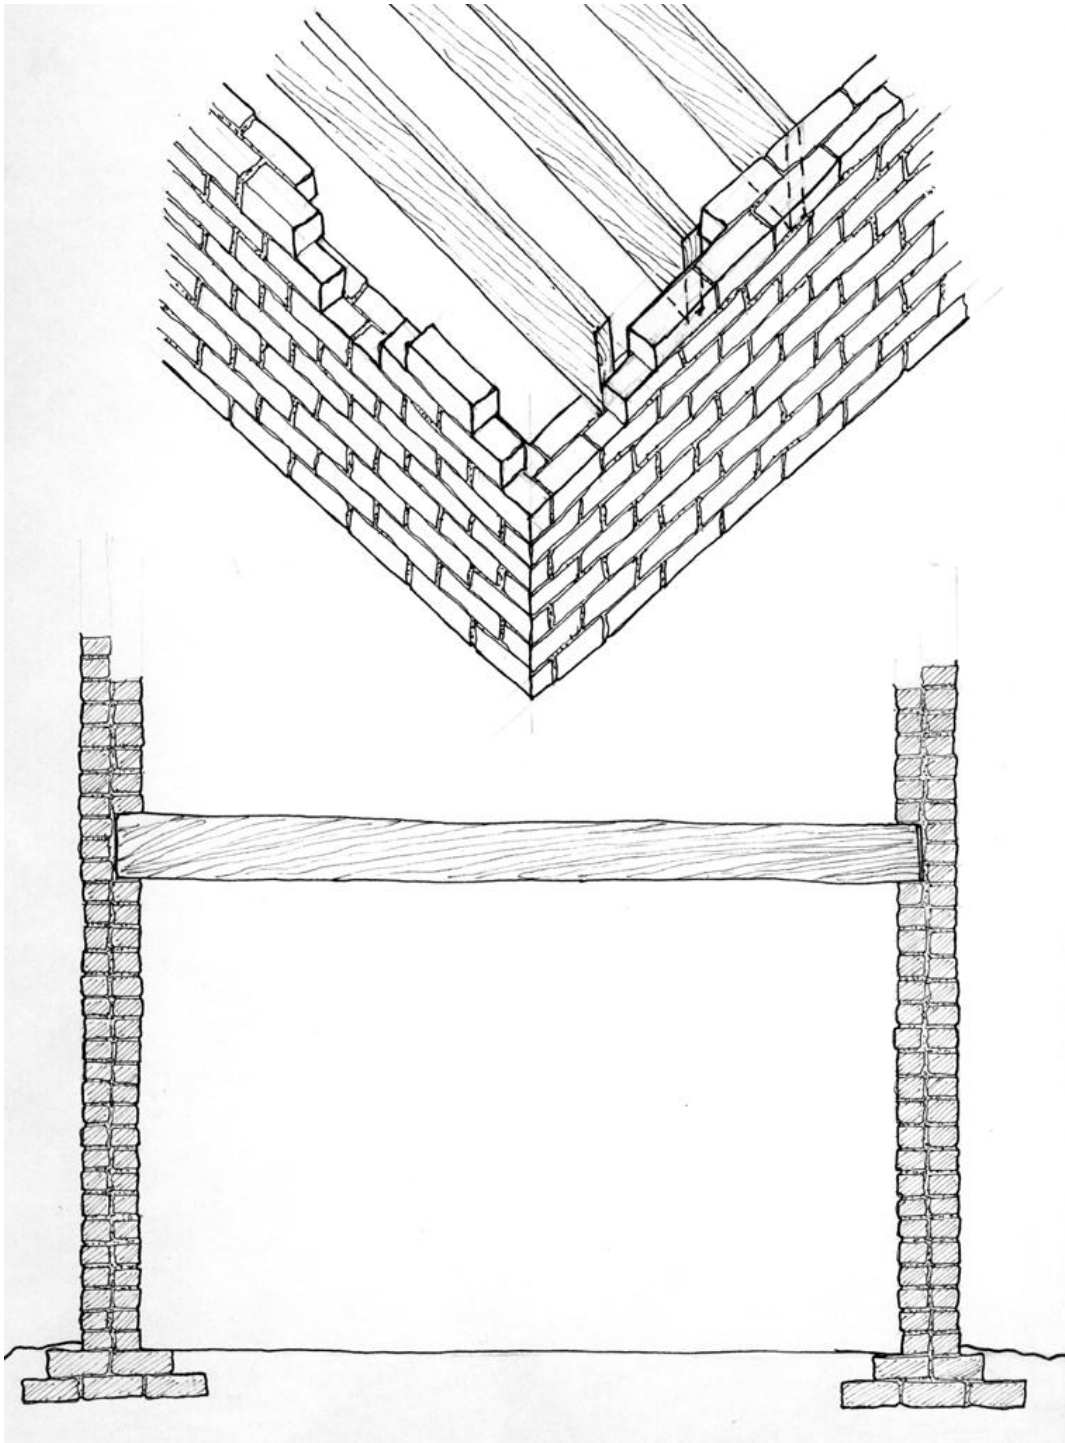
Figure 2.2: Sketch: inadequate wall restraint in load bearing masonry construction (Sketch by author).

Perhaps the most common reason for the failure of load bearing masonry walls is the lack of restraint as a result of the inadequate structural design of LBM buildings in the 18th and 19th centuries. Lateral restraint is fundamental to prevent buckling - the tendency of the wall system to suddenly bow outwards - but also to prevent the wall from completely falling away from the frame. Lateral restraint is often provided by floor and roof framing members spanning onto the wall; their weight, and the floor or roof acting as a stiff horizontal 'plate', are adequate to hold the wall in place at floor level. However, any load bearing masonry structure with a timber frame has two opposite walls supporting floor joists spanning between them, but the other two walls run parallel with the joist system, providing no restraint for the walls (see figure 2.2). If such an external wall has no ties into the adjacent construction, the building will

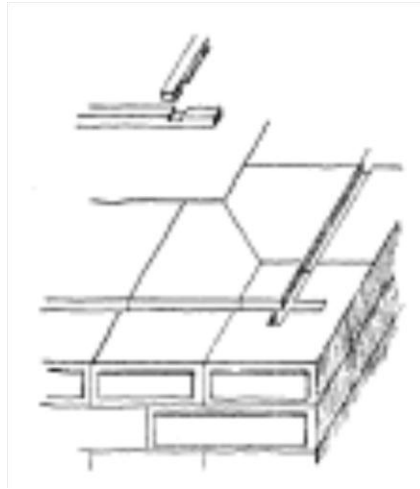
Figure 2.3: Foundation of Theban Treasury at Delphi. (Source: Dinsmoor, *“Structural Iron in Greek Architecture”*, 149)

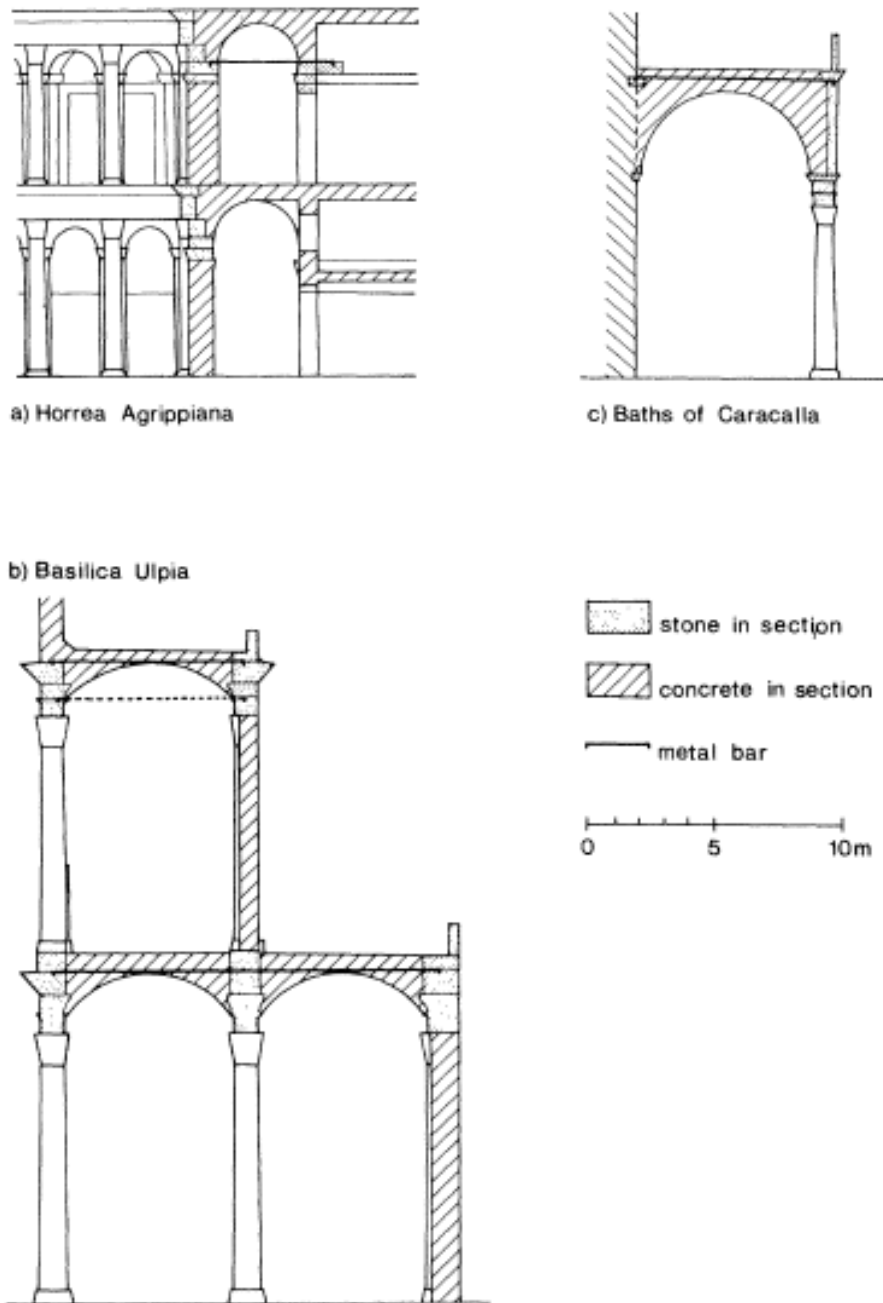
Figure 2.4: Early Greek & Roman methods of iron reinforcement; iron reinforcement was used in structures such as the Basilica Ulpia and Baths of Caracalla. (Source: Delaine, "Structural Experimentation",

Although iron ties were used to reinforce foundations and the span of architraves above columns in Greek architecture, the Romans set the initial precedent for the use of iron tie bars across barrel-vaulted spaces⁷. Perhaps the earliest example is in the upper floor arcades of the Augustan Horrea Agrippiana in Rome. Evidenced by cuttings in the upper surface of several Travertine blocks at the top of the arcade piers, iron tie bars (roughly 6-10cm in cross section) spanned the passage at the level of the springing of the vaults (see figure 2.4a). In the Basilica Ulpia, iron bars were attached to the entablature blocks over both sets of columns and passed through the crown of the barrel vault (see figure 2.4b). Slight evidence has also been found for exposed tie bars at the level of the architrave cornice in the upper level. Similar to Basilica Ulpia, a concealed system was utilized in the colonnades of the Baths of Caracalla. However, here, one of the ties was anchored to the outer wall by means of stone blocks embedded in the concrete (see figure 2.4c) – an indication that the development of iron reinforcement was progressive, one innovation inspiring another.

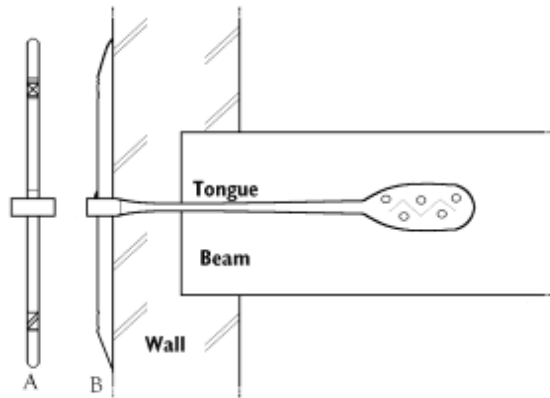
Figure 2.5: Elevation (A) and section (B) of a Dutch short wall anchor. (Source: Reynolds, *Transmission and Recall*, PhD diss.)

On occasion, tie rods and bars do not span the full distance of the building, connecting opposite walls. In fact, tie rods were commonly threaded through an exterior masonry wall and then bolted or hooked onto an interior framing member, sometimes just eight to ten feet into the structure. This type of reinforcement is also sometimes referred to as a 'stay' (see again figure 2.5).

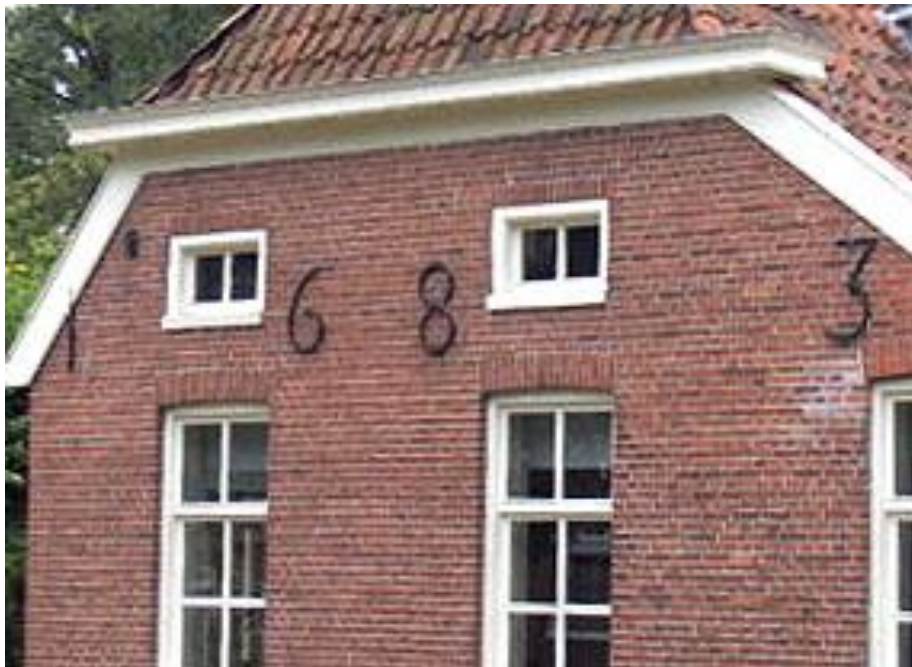
Figure 2.6: Dutch short wall anchors with decorative exterior attachments revealing the date of construction in Great Yarmouth, Norfolk. (Source: Reynolds, *Transmission and Recall*, PhD diss.)

exterior attachments became decorative and could be formed into the initials of the builder/owners, merchants' marks, even the date of construction (see figure 2.6).

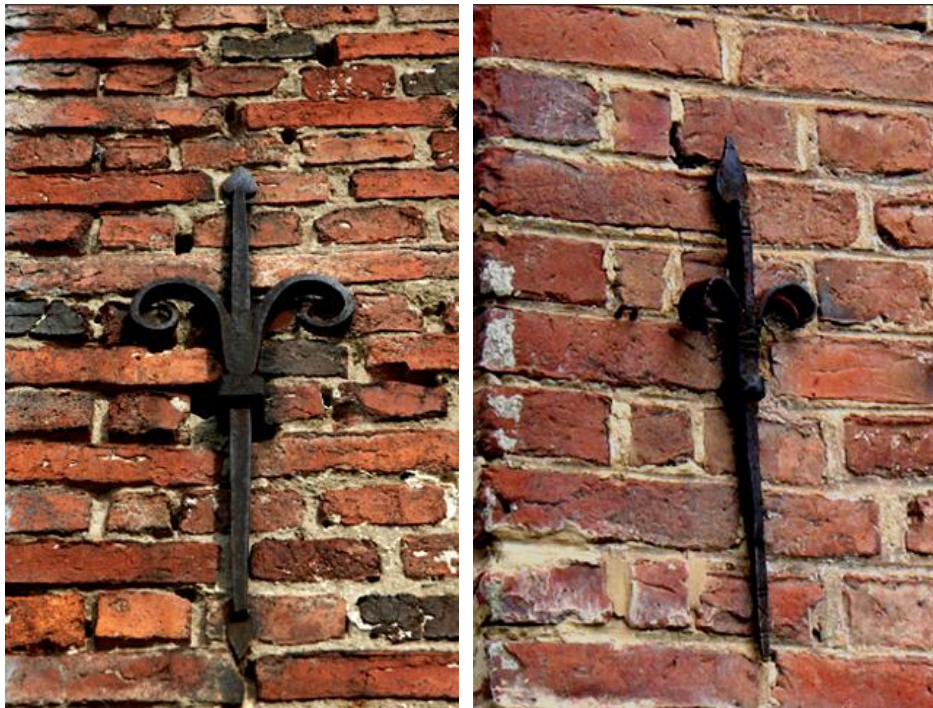
Figure 2.7: Dutch inspired wall anchors: Left: Van Hoesen House (1740) & Right: Pieter Winne House (1720). (Source: *Van Hoesen House Historical Commission*, <http://www.vanhoesenhouse.org>)

The Hudson Valley region of present-day New York abounded with these Dutch settler houses, most of which exhibited such wall anchors, generally of the fleur-de-lis design like the ones at the Pieter Winne house (1720) and the Van Hoesen house (1740) in Claverack Township, NY (see figure 2.7). In other cases, these anchors were numerals announcing the date when the house was built, or letters indicating the owner's initials like those on the old Salisbury House in Leeds, NY (see figure 2.8)¹⁷.

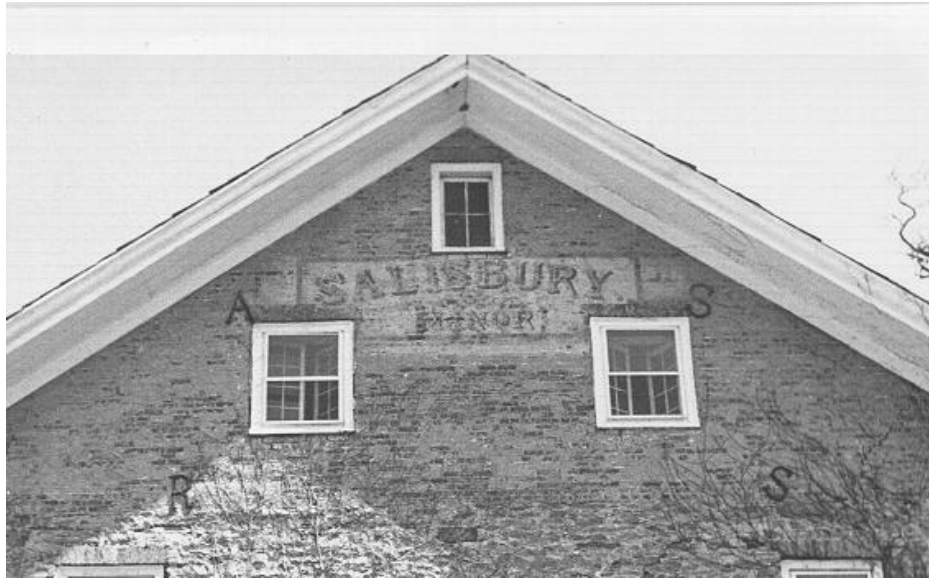
Figure 2.8: Wall anchors in the form of owner's initials on the old Salisbury House in Leeds, NY (Source: *National Register of Historic Places: Salisbury Manor*, <http://www.oprhp.state.ny.us>).

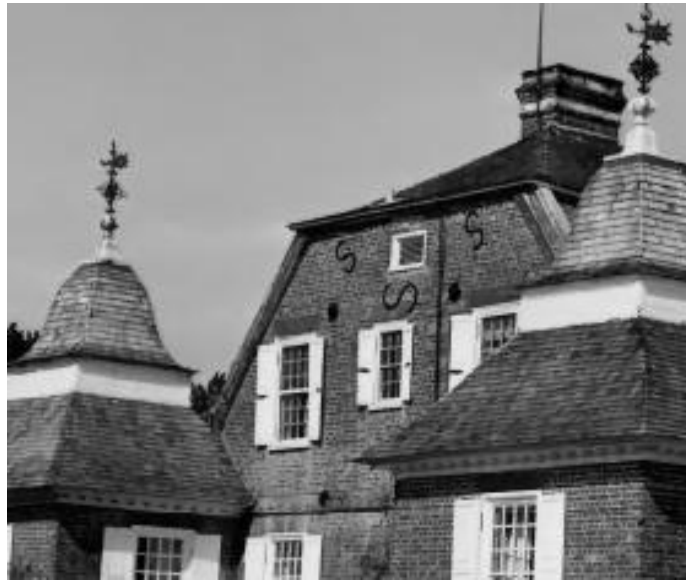
Figure 2.9: 'S' type wall anchor plates at Mulberry Plantation (1714), Berkeley County, SC (Source: "Mulberry Plantation, Berkeley County SC", National Register Properties in South Carolina, <http://www.nationalregister.sc.gov>).

In the southern colonies, the 'S' type is the most common type of early wall anchor plates found in various forms, a form which also has English prototypes. This type of stay is of almost infinite variety in Charleston and was a favorite with the smiths in nearly all of the colonies from the Carolinas to Canada¹⁸. In Berkeley County, SC just outside of Charleston, Mulberry Plantation has possibly some of the earliest forms of iron ties in the lowcountry. The house was built circa 1714 in the Jacobean baroque style with 'S' type anchors in the upper brick gable (see figure 2.9)¹⁹. Although the precise date of installation of the wall anchors at Mulberry is not known, or whether or not they were installed during initial construction, the form and style of the 'S' shaped plates could certainly be of an early 18th century origin. Figure 2.10 shows a 'butterfly' shape wall anchor on an 18th century structure at 91 Exchange Street in Charleston. This pattern and other similar forms can be found on other houses in New England and Canada that date to roughly 1745-1750²⁰.

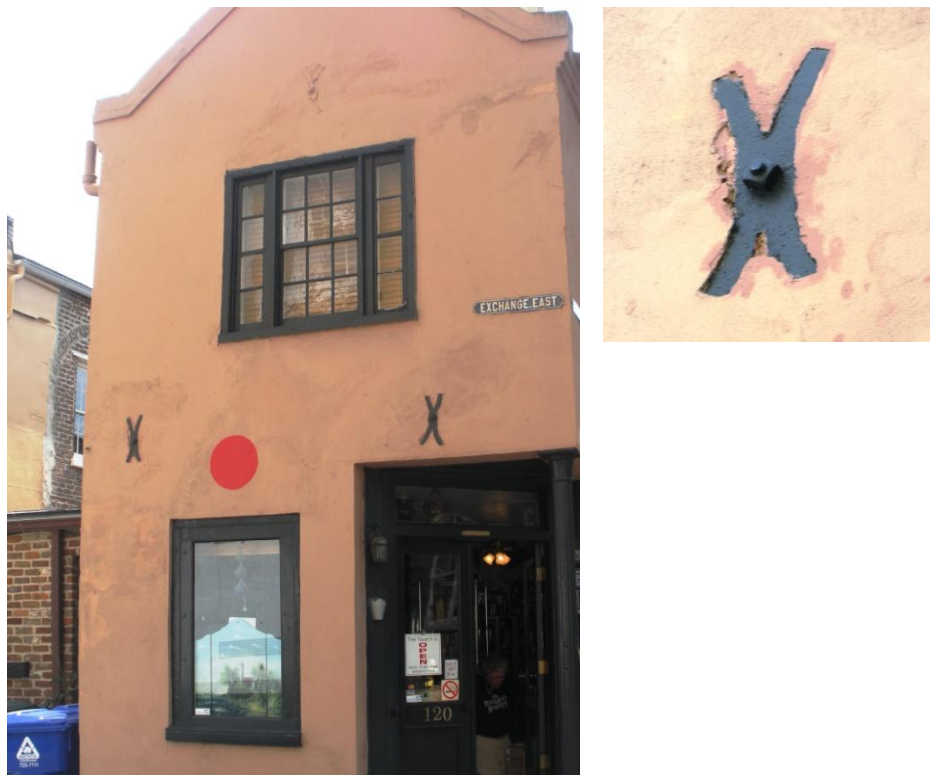
Figure 2.10: An early 'butterfly'-shaped wall anchor on an 18th century structure at 91 Exchange Street, Charleston, SC (Photos taken by author)

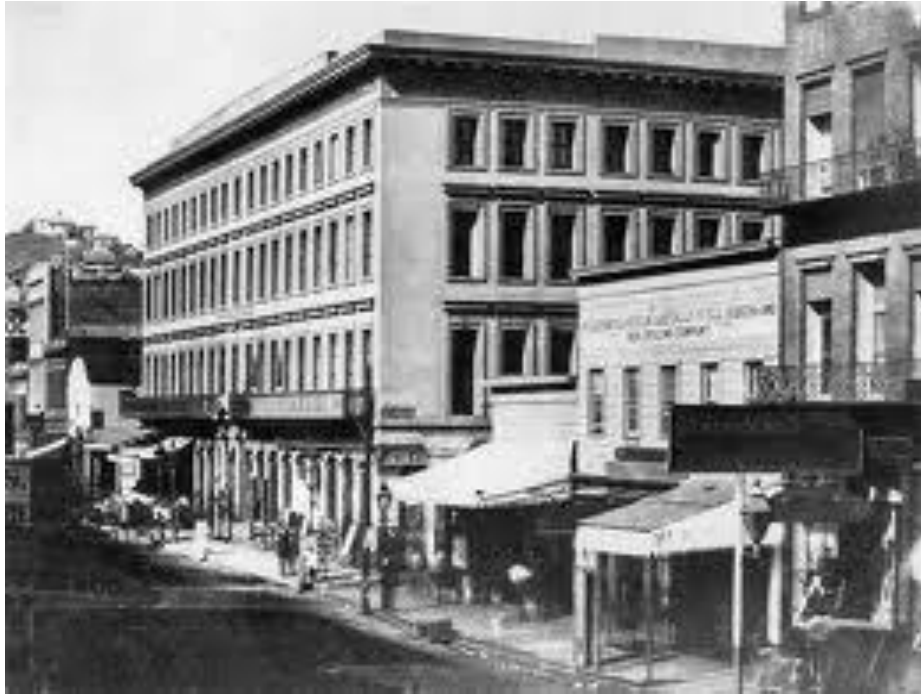
Figure 2.12: The Montgomery Block in San Francisco, CA, erected with iron reinforcement probably designed to resist earthquakes and settlement. (Source: *Tobriner, Bracing for Disaster*, 17)

Wrought iron continued as the structural material for carrying tensile loads. With recent advances in iron production methods, tie rods could be rolled directly from flat bar. The rolling process produced a rod with excellent longitudinal strength, which could easily be worked to form a flattened end that could then be drilled to receive a pin. Such rods were frequently used as components in 19th century 'composite' structures, such as trusses, trussed beams, and timber partitions as well as in direct applications like wall tie rods²². With the exception of a few rare 18th century examples, the application of full-length, wall-to-wall iron tie rods first appeared in America on a regular basis in the 1800s. In New York and Chicago, rods were patented and advertised for frequent use in controlling uneven settling (see figure 2.11). Some even make the claim that these rods became a standard practice in all construction in the 19th century²³. In San Francisco, architects and engineers appear to have maximized cross-structure tie-rods for earthquake-resistant purposes, specifying tie rods in both new designs and retrofits. In 1853, Gordon Cummings, an English architect, was commissioned to build a massive brick structure at Montgomery and Washington streets, known as the Montgomery Block (see figure 2.12). The symmetrical building's design featured innovative structural features. The building contract

stated that “transverse and longitudinal rods of iron will run through each wall and also through partitions ... and every 8th joist will have an iron anchor.” The bills for iron confirm the building was tied by a quantity of iron rods, bars, and anchors per the original design²⁴. The use of these reinforcing devices illustrates a growing understanding of the threat of lateral bending and possible collapse of masonry walls.

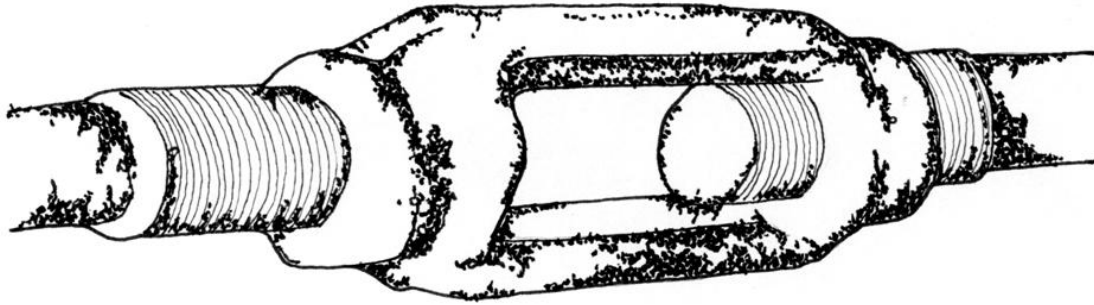
Figure 2.13: Sketch: Turnbuckle center attachment detail (*Sketch by author, not to scale*).

In some instances, tie rods and bars are used to connect two opposite masonry walls, spanning the full-length of the building, and to arrest their relative movement. Historically, the installation of these full-length tie rods or bars typically involved inserting two separate ties through the opposite walls and then joining them (usually at the center point), where adjustments can be made to “tighten” the building. At their center connection point, rods and bars were either screwed into turnbuckles or toggles (see figure 2.13), or hooked together end-to-end (see figure 2.14).

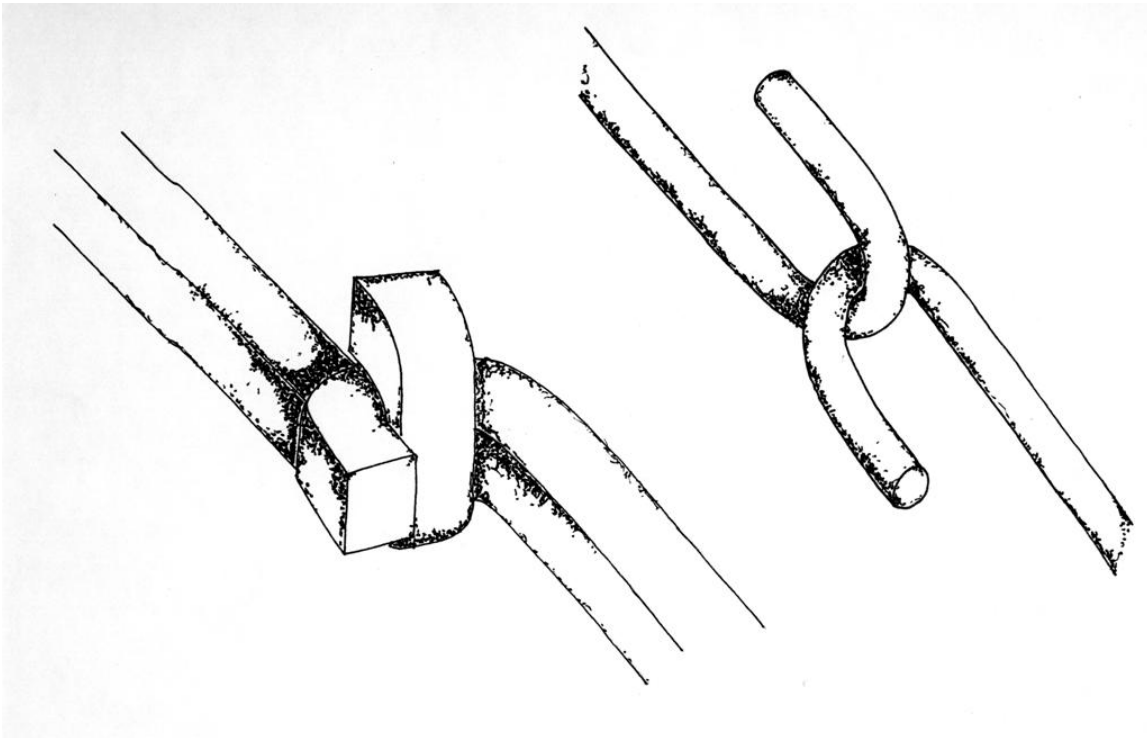
Figure 2.14: Sketch: Hooked center attachment detail (*Sketch by author, not to scale*).

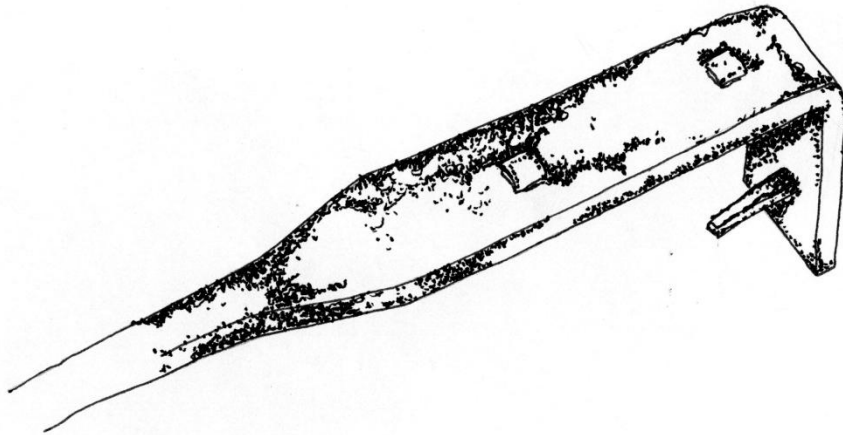
Figure 2.15: Sketch: Bent, nailed end connection (*Sketch by author, not to scale*).

Tie rods and bars are anchored at their ends to the exterior structure in a number of ways. Most commonly, attachment methods include nailed or stapled terminals if concealed within the structural frame (see figure 2.15), or their threaded ends are passed through an exterior plate and secured with nuts or bolts on the exterior of the masonry wall. These exterior plates are commonly called a number of terms including: gib plate, anchor plate, bearing plate, and/or patress plate.

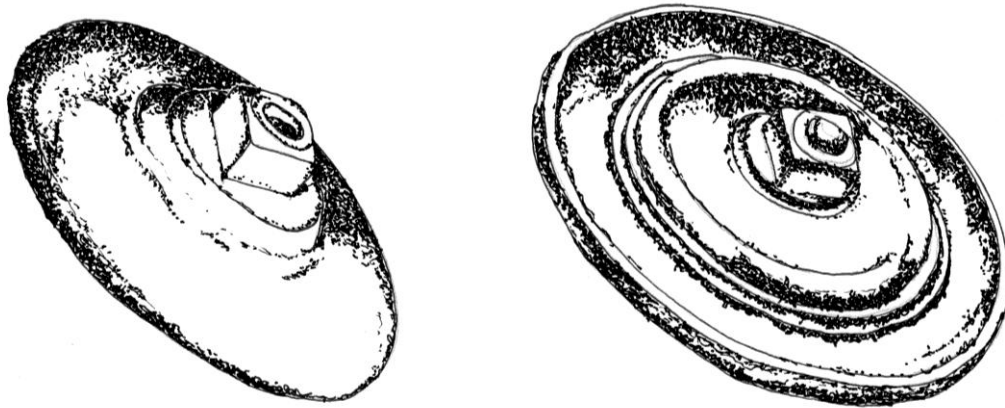
Figure 2.18: Circular anchor plates; (L) flat, plain profile; (R) decorative, moulded profile. (Sketch by author, not to scale).

The exterior anchor plates used to secure the outside ends occur in countless shapes and sizes. The illustrations in Figures 2.16 and 2.17 were done in 1928 by Albert Sonn for his book *Early American Wrought Iron*²⁷, and demonstrate some of the earliest, European-inspired types of plates found in America. Circular bearing plates grew in popularity in the 19th century, and truly proliferated in the Charleston area after the earthquake of 1886. These round plates are also sometimes called bosses (see figure 2.18). Additional photographic documentation of common anchor plate types observed throughout Charleston can be found in the *Survey Findings* section of Chapter Three.

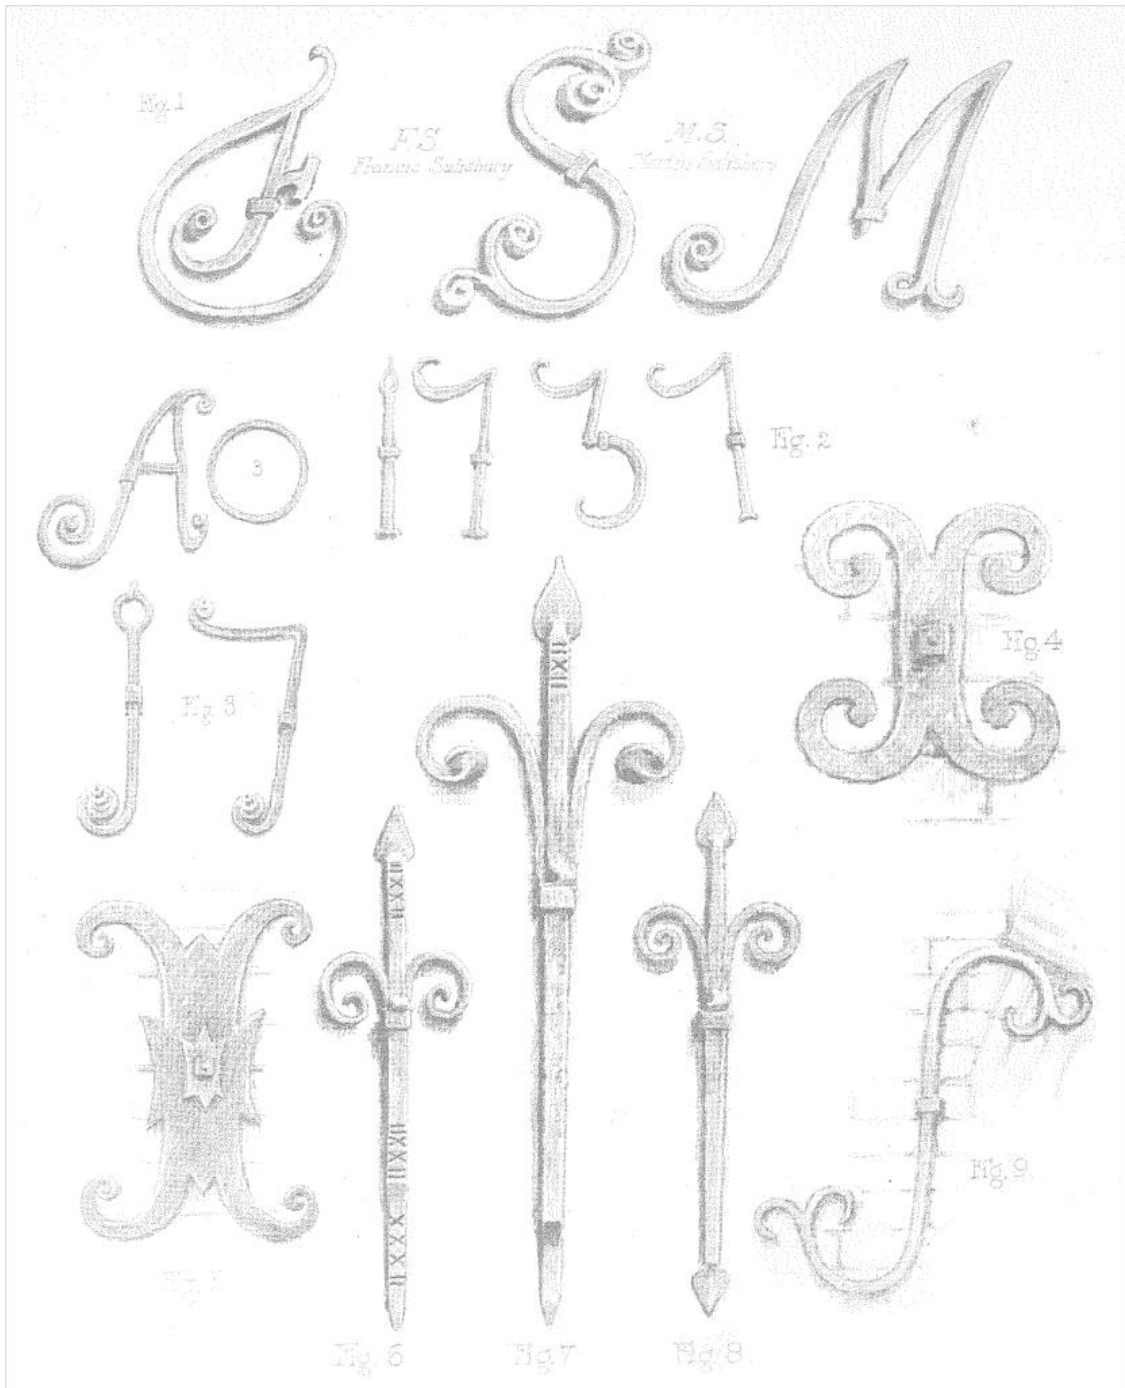
Figure 2.16: Plate 256 in Sonn's *Early American Wrought Iron* (Source: Sonn, *Early American Wrought Iron*, 111)

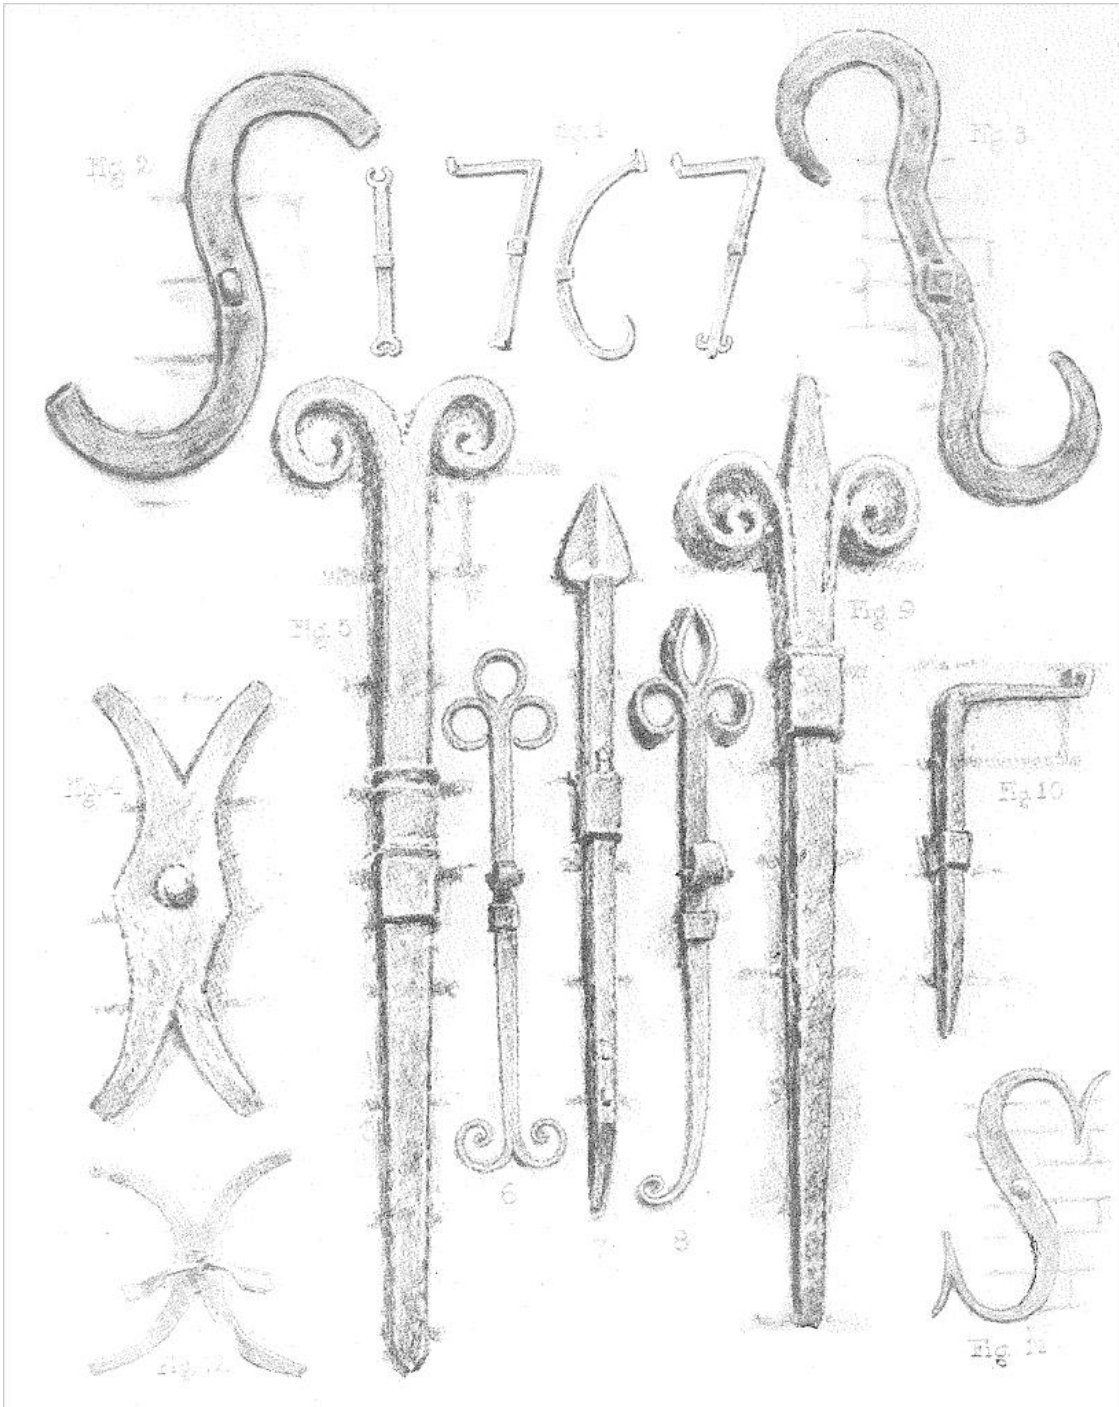
Figure 2.17: Plate 255 in Sonn's *Early American Wrought Iron* (Source: Sonn, *Early American Wrought Iron*, 109)

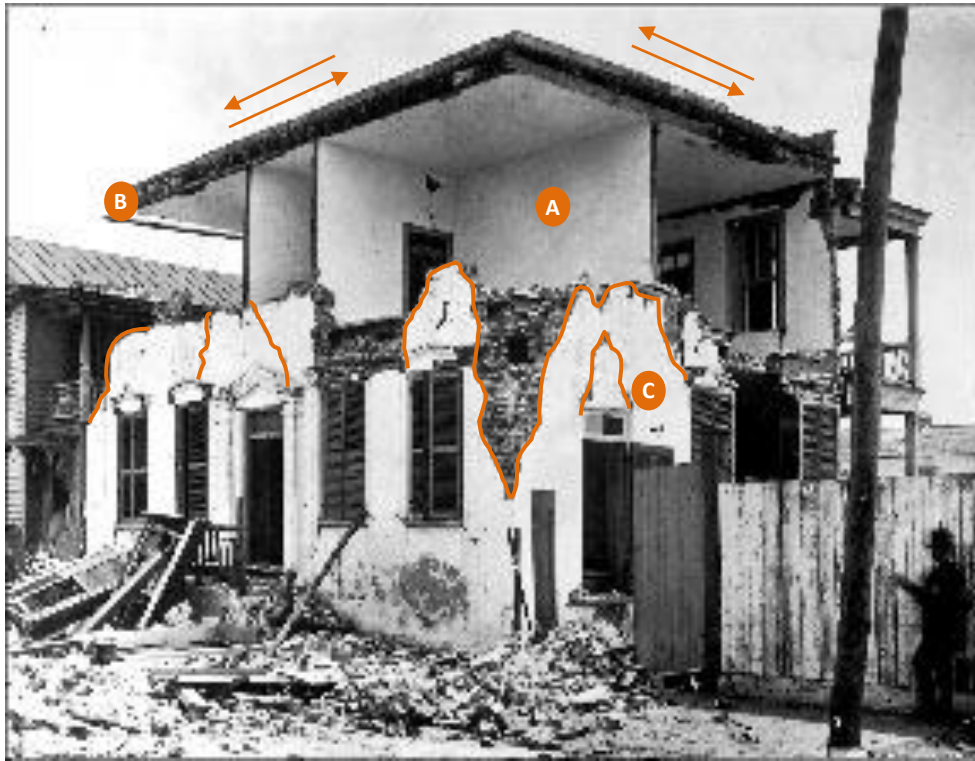
Figure 3.1: Masonry buildings in earthquakes: 157 Tradd Street, Charleston, immediately after the earthquake of 1886. The wooden interior walls (A) moved back and forth on both the ground floor and the second floor. The exterior walls shook, and the diaphragms (B) transferred the load to the exterior walls. However, the whole interior assembly of floors and partitions was more flexible than the brittle exterior walls. In some areas, the walls resisted the shear forces and then broke along the diagonal. The shear cracks are highlighted. Torsion, or the direction of the movement, might explain why the end walls (C) collapsed. (Photo Source: <http://earthquake.usgs.gov>; diagramming by author)

the horizontal, lateral forces are the most dangerous in earthquakes. Shear forces, which tend to distort the shapes of walls, occur when lateral forces push a wall along its length. Lateral forces are transferred from the ground through shear walls (typically interior, wood-frame partition walls) to diaphragms (exterior masonry walls), and then back to the ground again. If a brick wall is pushed sideways via lateral forces, it will resist until the bond breaks between the masonry units, or the masonry itself breaks. A diagonal crack or sometimes an X-shaped crack, called a shear crack, will appear³². This is most commonly seen above and below window or door openings in the spandrel wall (see figure 3.1).

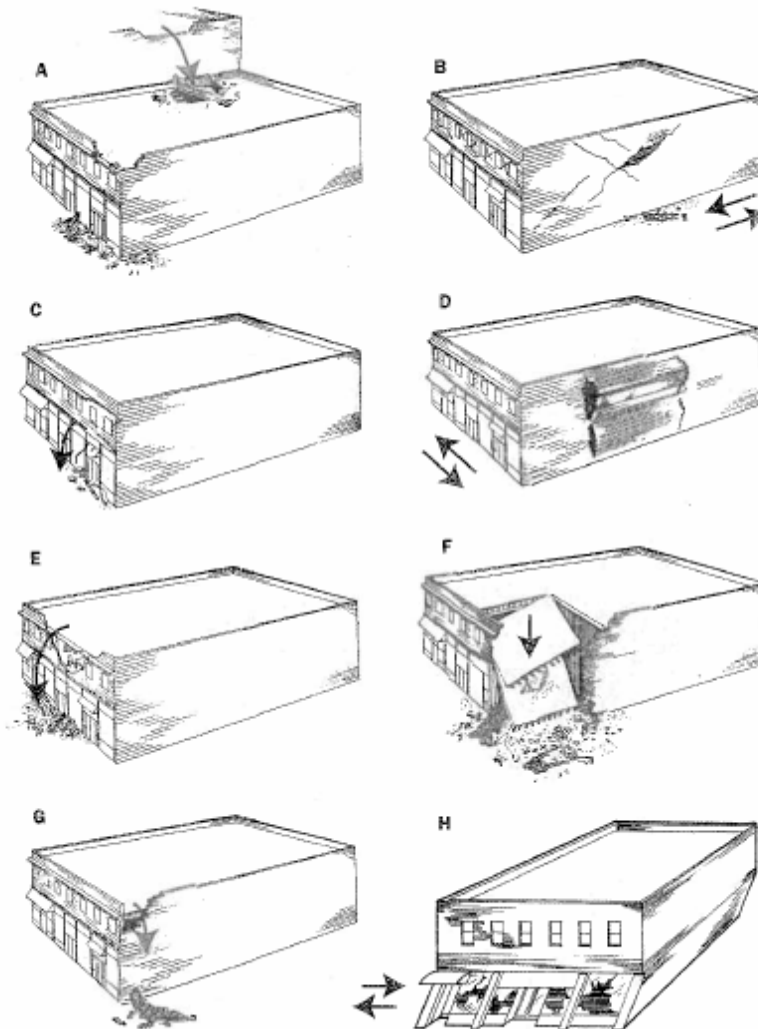
Figure 3.2: The vulnerability of load bearing masonry structures in earthquakes:

- A. Parapet and fire-wall failure
- B. In-plane wall failure resulting in diagonal shear cracks
- C. Nonstructural falling hazards
- D. Wall failure in bending between partition walls, or floors and roof
- E. Façade failure
- F. Roof and/or floor collapse
- G. Wall failure
- H. Soft-story failure

Reasons for the known poor performance of load bearing masonry structures in past earthquakes are the inherent brittleness, lack of tensile strength, and lack of ductility of the materials – that is, a lack of properties given to reinforced masonry by reinforcing³³. The wider the brick wall in relation to its height, the fewer the openings, and the better the masonry bonding, the more it can resist shear. However, even on an extensive uninterrupted masonry wall, earthquake forces are problematic. The heavier the wall, the greater the inertial forces an earthquake will create within it. Thus, instead of bending to dissipate energy, a heavy, brittle, stiff masonry wall will crack, or the walls may rupture and collapse. Additionally, parapets and gable ends tend to disconnect from the building and fall outward, creating a hazard for people below and sometimes causing the building to collapse. Shockwaves can also reduce the bearing capacity of soils beneath the building in a process known as “liquefaction”, in which the soil behaves structurally like a liquid. Any weight resting on this soil sinks into the ground, causing structural deformations resulting from settlement³⁴. Figure 3.2 illustrates the ways in which unreinforced, load-bearing masonry can fail in the event of an earthquake.

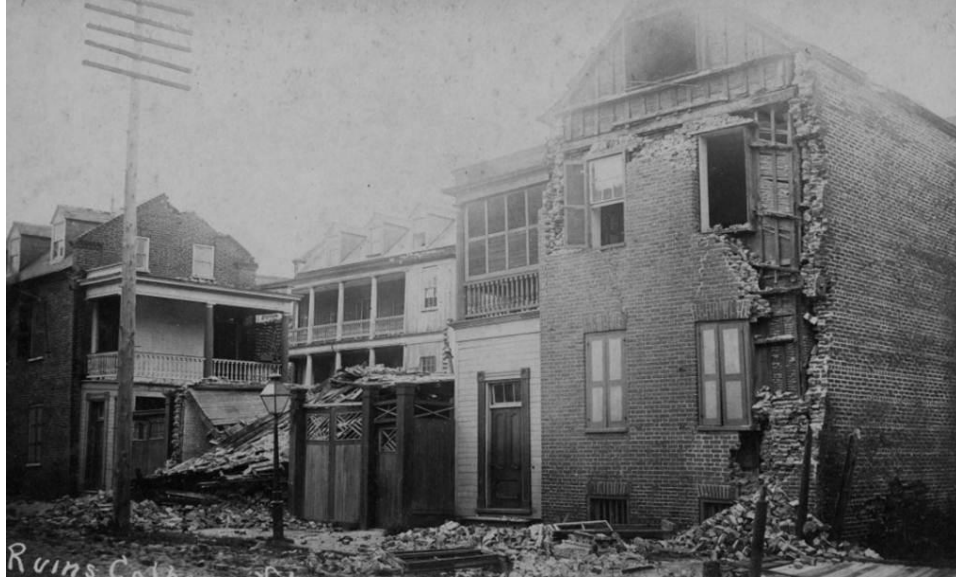
Figure 3.3: Cook's Earthquake Views of Charleston and Vicinity: "Calhoun Street" (Source: Charleston Museum Earthquake Photographs, Digital Collection, www.lowcountrydigital.library.cofc.edu)

“There was not a building in the city which had wholly escaped injury ... There was not a brick or stone building which was not more or less cracked ... The bricks had ‘worked’ in the embedding mortar and the mortar was disintegrated. The foundations were found to be badly shaken and their solidity was greatly impaired. Many buildings had suffered horizontal displacement; vertical supports were out of plumb, floors out of level, joints parted in the wood work, beams and joists badly wrenched and in some cases dislodged from their sockets.”³⁶ (See figures 3.3 and 3.4).

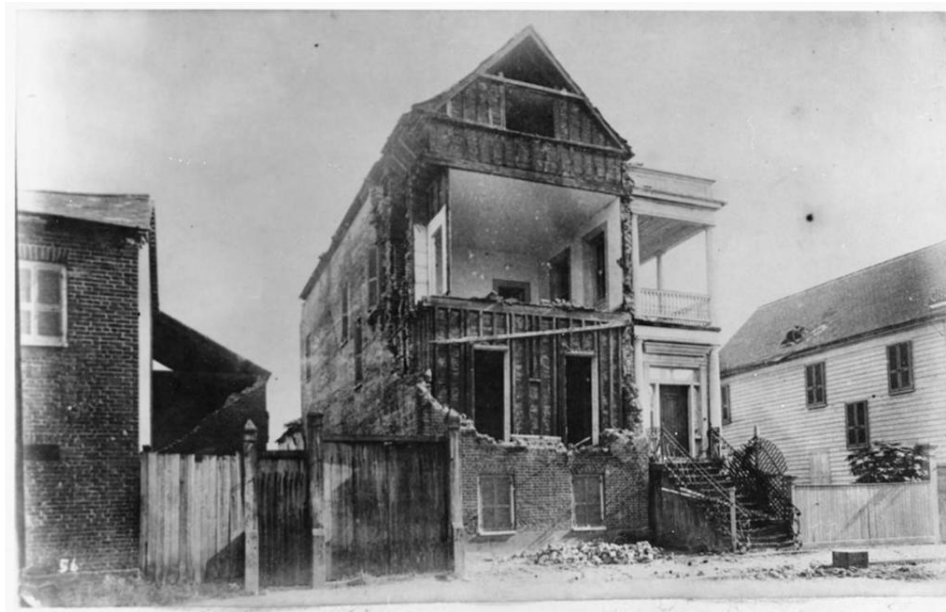
Figure 3.4: Cook's Earthquake Views of Charleston and Vicinity: "Wentworth Street" (Source: Charleston Museum Earthquake Photographs, Digital Collection, www.lowcountrydigital.library.cofc.edu)

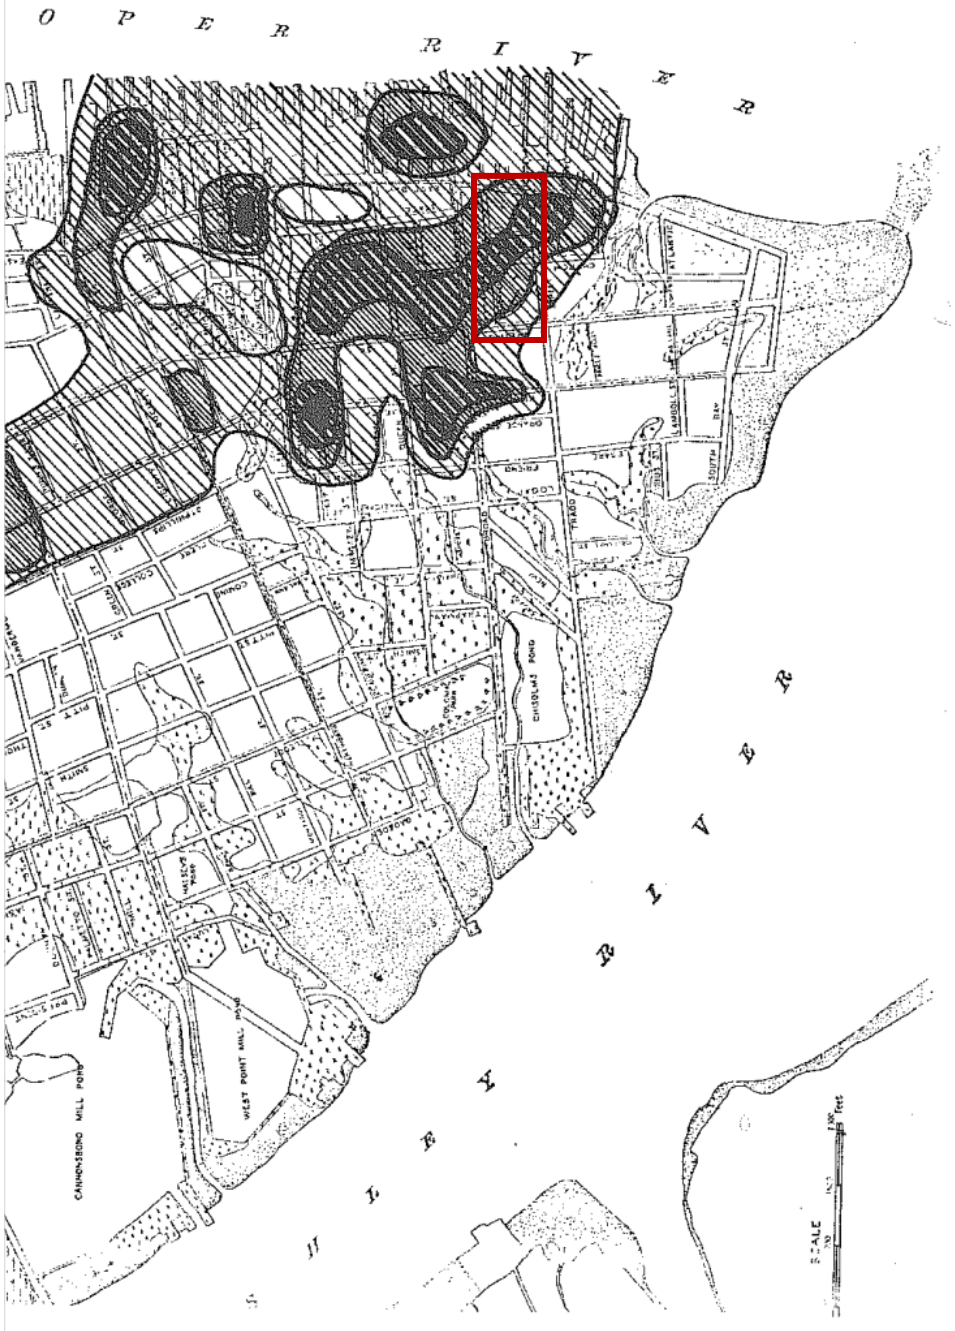
Figure 3.6: Earthquake Damage Distribution map (1983) created by the Citadel Department of Engineering; survey area indicated by red outline. (Source: Printed in Robert Stockton, *The Great Shock: The Effects of the 1886 Earthquake on the Built Environment of Charleston, South Carolina*, (Easley: Southern Historical Press, 1986))

The general area to be surveyed in this study was initially narrowed down using the Earthquake Damage Distribution map (see figure 3.6) created for a Site Period study conducted by the Citadel Department of Engineering. In 1983, a specific study of site periods as they relate to earthquake vulnerability was undertaken at the Citadel. As a component of this study, 3,888 buildings from the Parkins & Stewart earthquake damage assessment report were analyzed on a block by block basis. The study computed and quantified several items including destruction to masonry buildings categorized by degree of damage, the damage percentage of the walls in each orientation (north, south, east, and west), and an overall building rating computed using area and volume as weighing factors. Subsequently, the average building rating by block was plotted on a map of the city to establish the distribution of damage⁴⁶.

The Citadel's Earthquake Damage Distribution map confirms other post-earthquake reports from the 19th century and their findings: some of the heaviest damage occurred in areas on made ground and closest to the wharves. Thus, the specific survey area for this study is defined by that bounded on the north by Elliot Street and St. Michael's Alley, on the south by Tradd Street, on the east by East Bay Street, and on the west by Meeting Street (see figure 3.7). As seen on the Sanborn Fire Insurance Map from June 1884, the area within these boundaries is comprised of primarily masonry structures, presumably unreinforced before the earthquake.

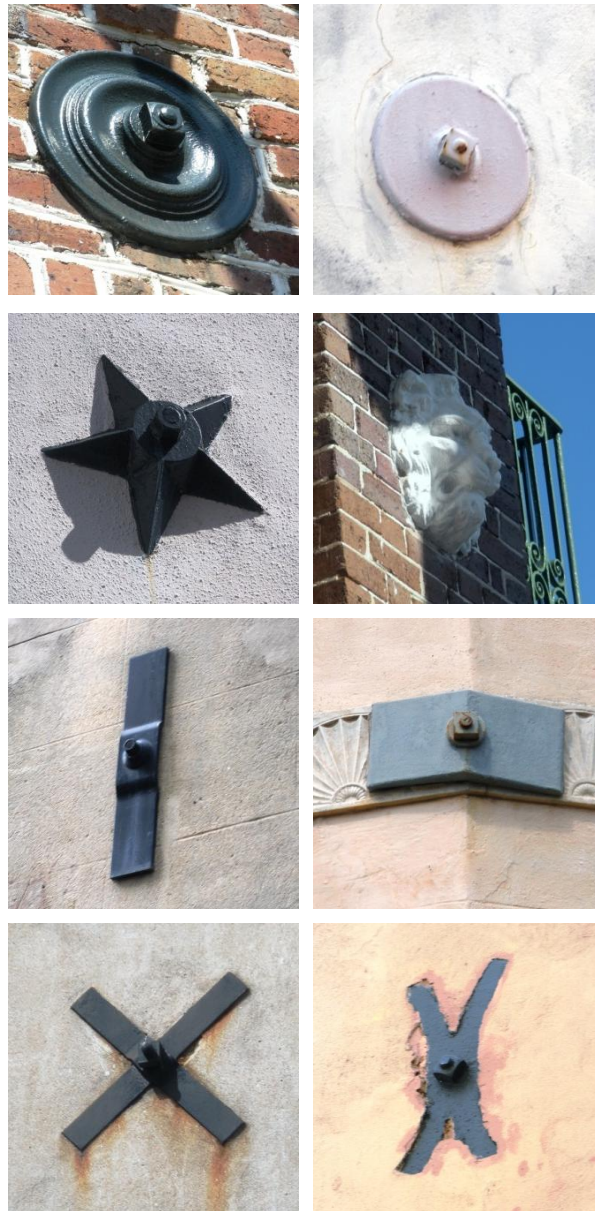
Figure 3.8: Various forms of ‘earthquake bolt’ patrix plates observed around the city of Charleston (All photos taken by author).

Top Row: 28 Tradd: Circular plate with decorative profile; 107 East Bay: circular plate with flat profile

Carolina. Visual surveillance substantiates that although earthquake bolts were cast in a variety of shapes, they were typically plain. Most common of all are the circular style: some with decorative profiles, others with completely flat in profile and devoid of decoration. In other instances, building owners chose to disguise them with cast iron decorations, such as lions' heads, or stars. The images in Figure 3.8 exemplify various types of earthquake bolts around the city of Charleston.
