Ties That Bind: The Emergence of Iron Tie Rod Reinforcement in Load Bearing Masonry Buildings of Charleston, S.C.

A Thesis
Presented to
the Graduate Schools of
Clemson University and the College of Charleston

In Partial Fulfillment
of the Requirements for the Degree
Masters of Science
Historic Preservation

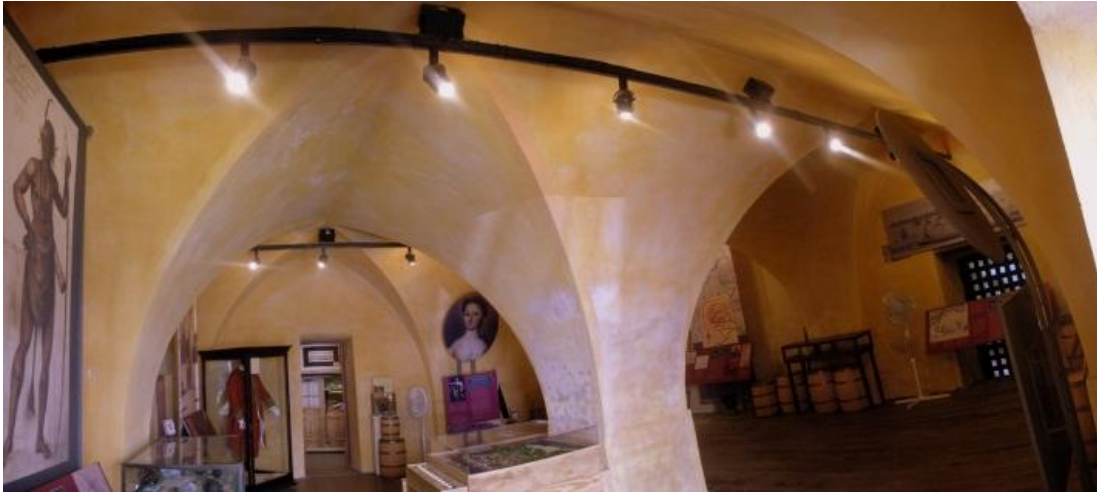
Figure 4.3: Interior panorama showing the iron tie rods exposed in the powder magazine ceiling vault. *(Photo taken by author)*

Visible on the interior are the two, full-length iron tie bars that run east-west connecting the roof gable pairs (see figures 4.2 and 4.3). The rectangular bars themselves are made of hand wrought iron, a material known and used for its tensile strength. The plates and bolts on the exterior that are used to secure the ends of the reinforcement bars are more than likely forged of wrought iron also. Later iron tie rods had plates made of cast iron, a material with greater compressive strength. The plate on the north-west gable and both plates on the eastern façade have a much more uniform visible appearance (see figure 4.4), and show evidence of several possible makers' marks. However, the plate on the south-west gable has a more uneven surface appearance, and shows evidence of severe deterioration (see figure 4.5). Perhaps this is an indication that the southwest exterior plate is an original, while the others are later replacements. However, the exact reasoning for the accelerated deterioration of this anchor plate over the others is hard to discern.

Two additional observations were made of the Powder Magazine tie bars that may also provide interesting clues to dating the bars themselves. First, on the interior of the Powder Magazine, where the bar is exposed within the ceiling vault, there is slight evidence of the hand-wrought center connection. Later tie rods that were installed throughout Charleston in the 19th

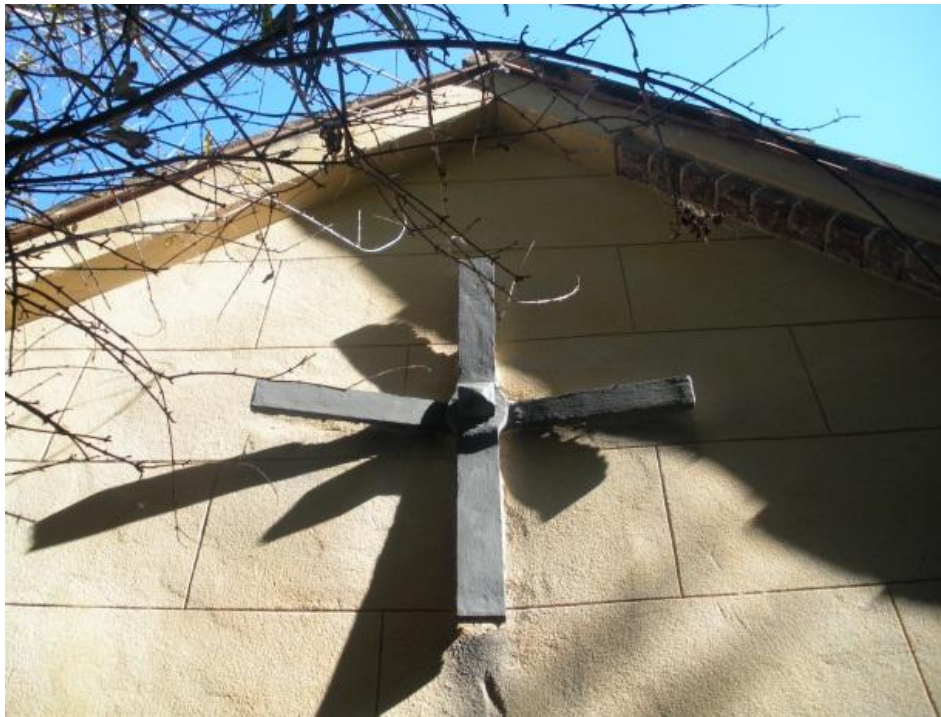
Figure 4.4: Exterior anchor plate on north-west gable. *(Photo taken by author)*

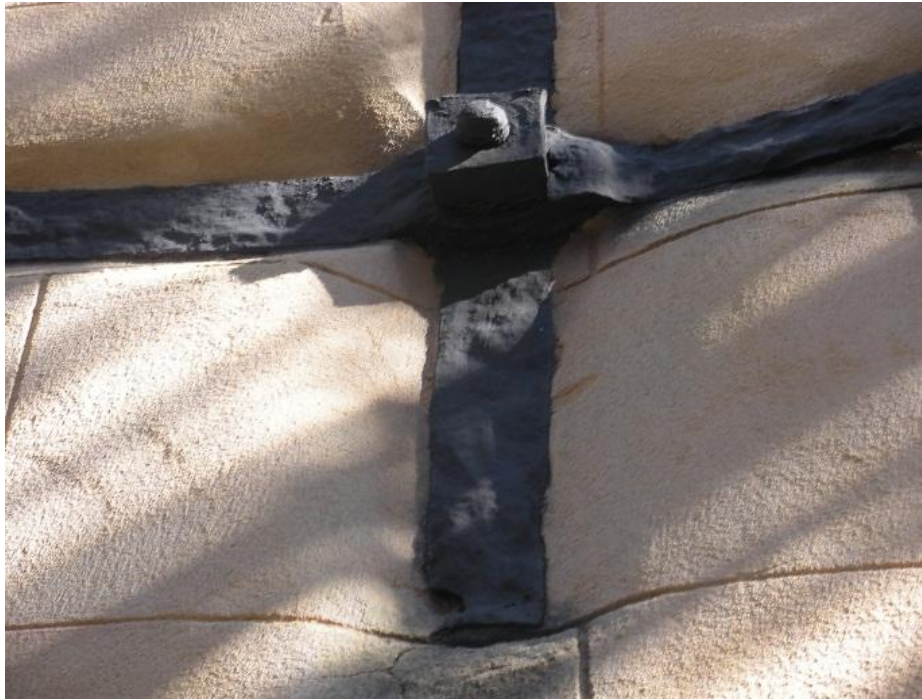
Figure 4.5: Close up photograph of the anchor plate on the south-west gable showing extreme deterioration. *(Photo taken by author)*

date of the manufacture or installation of the iron tie bars at the Old Powder Magazine is not known, but one of the large cross-shaped anchor plates appears in the 1860 Harper’s Weekly engraving, one of the earliest images of the Powder Magazine (see figure 4.6). The bars, anchor plates and bolts all have a quality that could date from the 18th or early 19th century. They could, in fact, be the unidentified solution to a 1743 warning from the Commons House “that the present Powder Magazine in Charles Town has given way on every side and is cracked in several places ... it must be secured on every side”⁵⁷. The aforementioned stamps, possible maker’s marks (see figure 4.7), which are visible on the two eastern plates and on the north-western plate, could potentially provide a clue to the origin of the tie bars. There is no visible evidence of a stamp on the south-west exterior plate, the highly deteriorated plate.

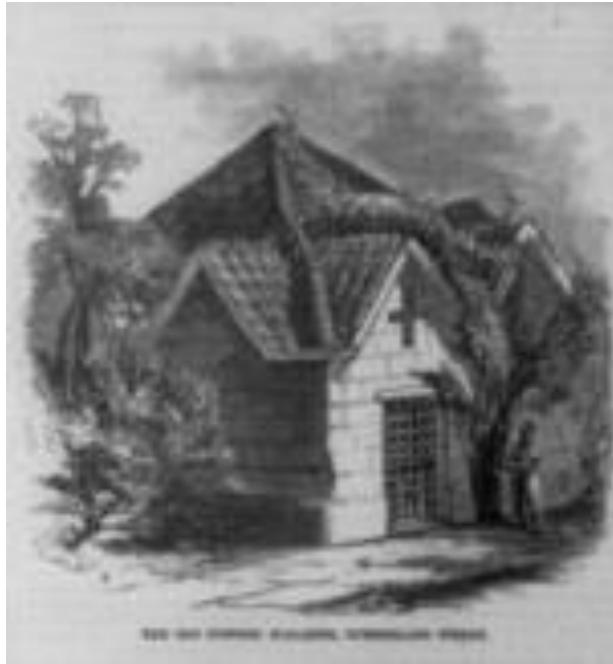
Figure 4.6: November 1860 issue of Harper's Weekly illustrating the Old Powder Magazine in Charleston with exterior tie rods visible. (Source: *Harper's Weekly*. New York, NY. 3 November 1860)

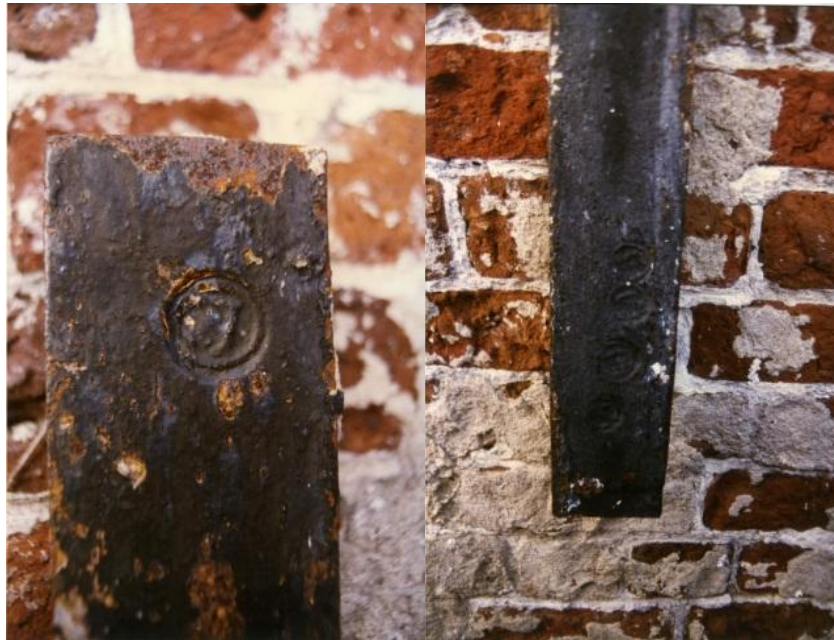
Figure 4.7: Maker's marks stamped onto the iron anchor plate arms. Images were taken during the 1996 restoration. (Photo courtesy of Richard Marks Restoration, Inc.)

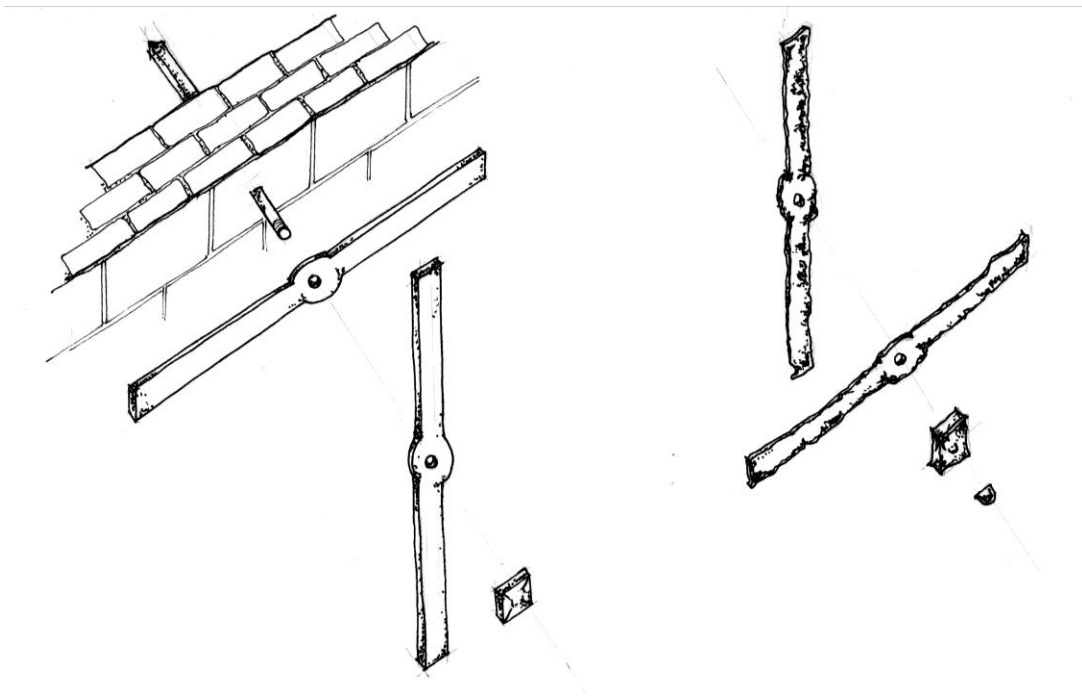
Figure 4.8: Attachment methods used on exterior anchor plates (*Sketch by author*)

century were typically rounded rolled iron bars that were extruded through opposite masonry walls and then connected in the center via a turnbuckle or hook. Second, when visually inspecting the southwestern-most anchor plate, one can see that its attachment method is different as compared to the other three plates. When looking at the southwest exterior plate, the vertical arm is threaded onto the bar first. Then the horizontal arm is threaded and followed by the very square, box-like bolt. The other three bearing plates have their horizontal arms threaded first, followed by the vertical arm and then a pyramid-capped bolt (see figure 4.8). Although the northwestern-most plate appears to have a replacement bolt cap, if all four anchor plates are of the same time period and the same building campaign, it is hard to discern why the builders would have installed one anchor plate one way and the other three plates in a different manner. The manufacture and installation techniques of the Powder Magazine tie bars may be evidence of possible earlier methods, offering further support to the theory that the southwest exterior plate is of an earlier date than the other three. Other case studies of iron tie bars installed around the lowcountry in the 18th century need to be analyzed for further comparison.

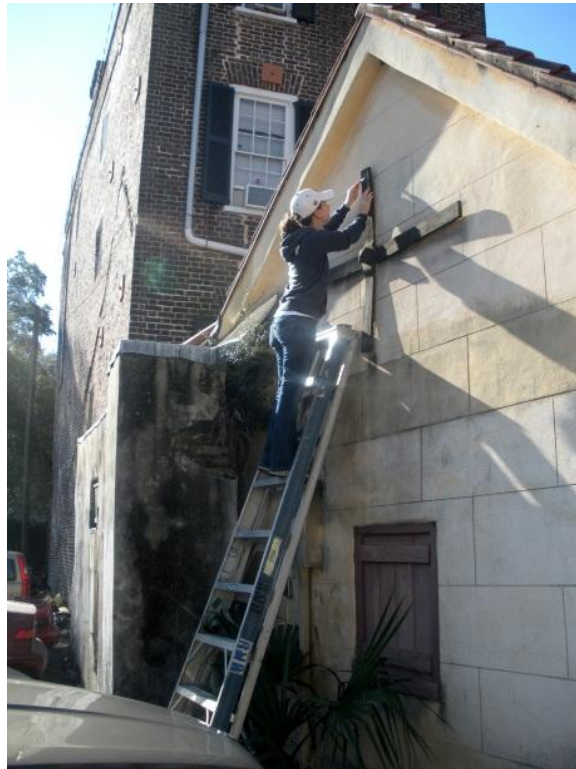
Figure 4.9: Taking a clay mold of the maker's mark on the upper arm of the south-east anchor plate. (Photo taken by student Elyse Harvey)

In an attempt to learn more about the manufacture and origin of the Old Powder Magazine tie bars, a clay mold was taken of one of the exterior plate stamps on November 29, 2011 (see figure 4.9). In preparation for the mold, the area around the chosen stamp was first cleaned of all dirt, and loose paint was removed with a wire brush and metal scraper. Paint removal was attempted with a few different techniques. First, a coat of Smart Strip⁵⁸ paint and varnish remover was brushed onto the surface (see figure 4.10). The water-based, zero-VOC paste seemed to remove the top layer of paint, but did not remove all layers. Subsequently, a layer of Strypeeze⁵⁹ paint stripper was applied to the taped off surface. The semi-paste material was easy to apply to the vertical surface and penetrated the paint layers deeper, stripping the majority of the paint with the exception of within the smaller crevices. To remove the last traces

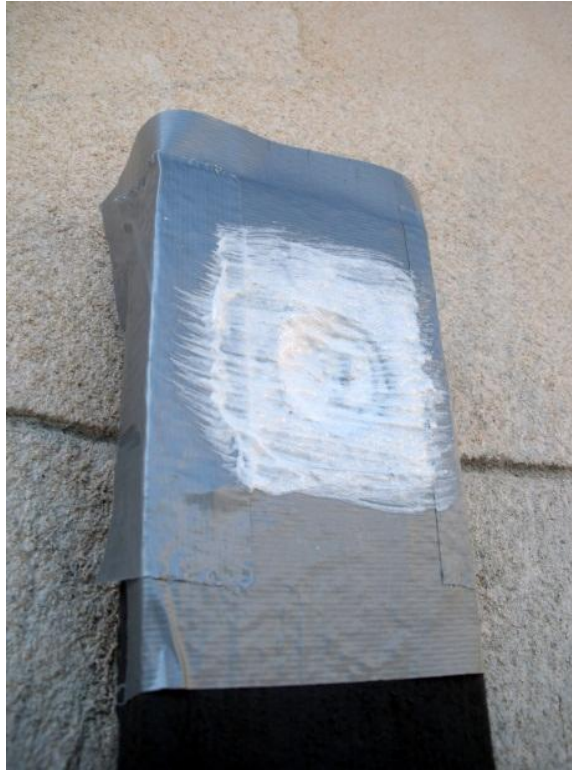
Figure 4.10: After initial cleaning and brushing, a layer of Smart Strip is applied to the area to remove top layers of paint. *(Photo taken by author)*

of paint within the stamp area, a multi-temperature heat gun was used to heat the surface and the paint scraped using metal hand tools. Using Sargent Art natural-colored modeling clay⁶⁰, a total of three clay impressions were taken of the cleaned iron surface, and then transported to the Clemson/College of Charleston graduate conservation lab at 292 Meeting Street.

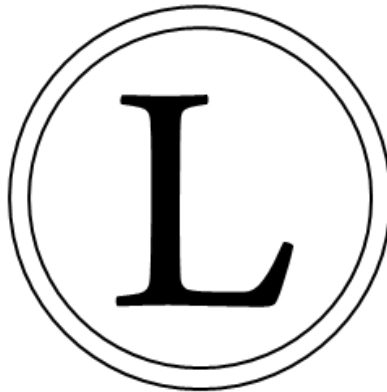
Figure 4.11: Recreation of the stamp applied to the Old Powder Magazine anchor plates (*Drawn by author*)

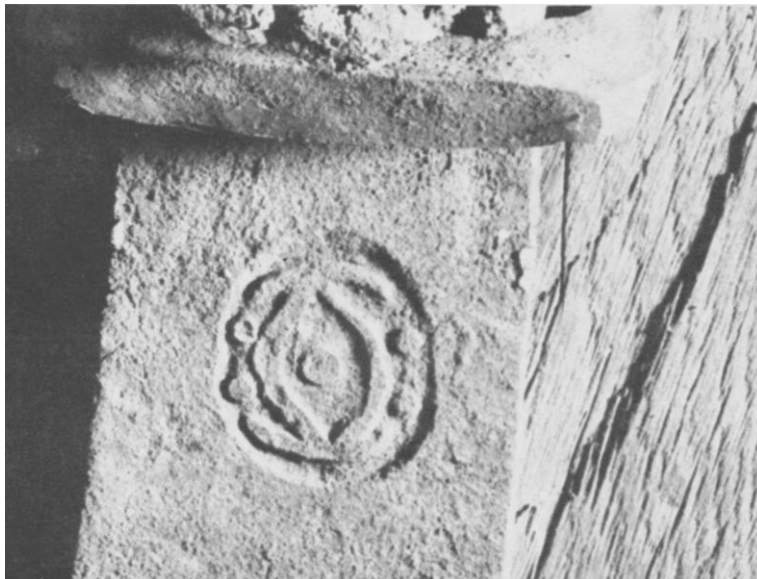
Figure 4.12: "Horseshoe" iron mark at Christ Church, Lancaster County, Virginia (1732) (Source Carlton, "Marks on the Iron Stirrups, *APT*, Vol. VII No. 1)

at Christ Church in Lancaster County, Virginia. This colonial brick church, a modified Greek cross in plan, was built in 1732 from a bequest of Colonel Robert "King" Carter of Corotoman, and has survived remarkably complete. In the roof structure, a series of iron straps band the king posts and principal rafters to the lower chords of the roof trusses. It is on these iron straps that several different impressed marks can be seen. There are six distinct marks including some with Roman lettering, specifically the letter 'K', a double 'K', and 'RP'. Others incorporate symbols such as dots, parallel, and intersecting lines (see figure 4.12)⁶⁴. A number of similar marks have also been seen stamped near the ends of wrought iron bars used as fireplace lintels in New Hampshire colonial period houses⁶⁵.

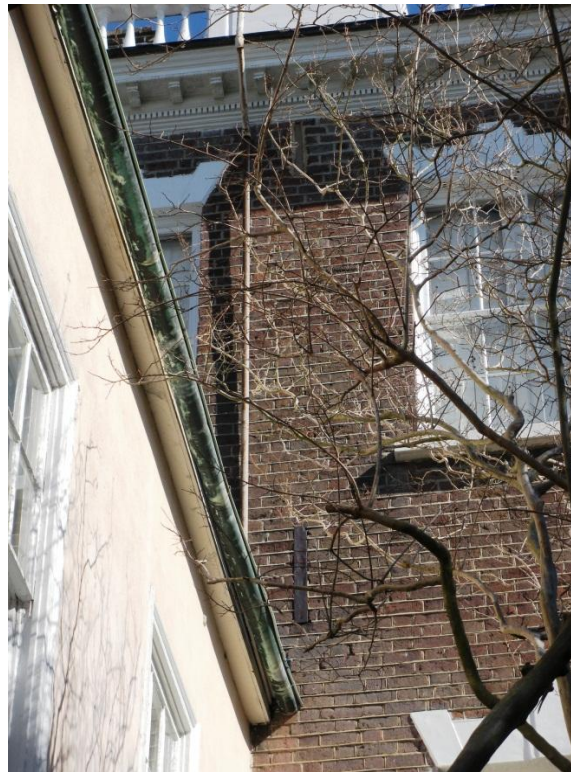
Figure 4.15: Vertical Iron straps indicate the insertion of tie rods on the rear wall of the main house following the 1811 tornado. Masonry damage just below the cornice indicates the placement of additional tie rods between the third floor and attic. (*Photo taken by author*)

Two iron plates set into the brickwork on the exterior west wall of the main house are the only readily visible evidence of a set of four iron straps that were installed after the tornado damage of 1811. The two visible plates belong to the lower pair of iron straps; the plates corresponding to the upper pair of tie rods appear to have been removed or popped away from the wall (see figure 4.15). The historic structures report completed for the Nathaniel Russell house in 1996 makes note of two areas of masonry failure at the top of the rear wall. The areas of bulged and broken brick aligned with the straps below, and led the investigative team to discover the pair of ties installed between the third floor and attic space⁷⁴. The portions of the wrought iron clamps that remain visible on the exterior today measure approximately 3-1/4 inches wide, and 30 inches long set in a vertical orientation. They are at least one inch thick and carefully cut into the brickwork to fit flush with the wall. There are no other fittings on the

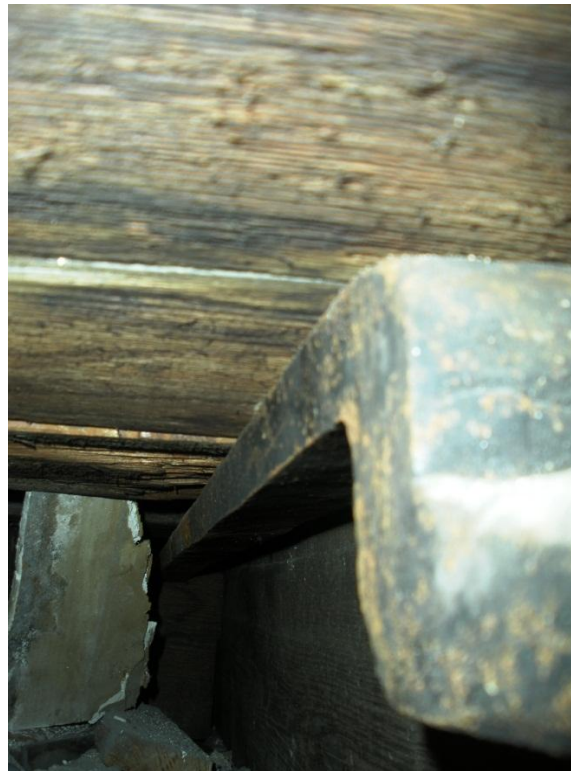
Figure 4.16: An 1811 tie rod installed to correct tornado damage projects through the attic floor in between joists. *(Photo taken by author)*

Clear evidence survives of the early 19th century reinforcement within the northwest corner of the attic of the main house. Reinforcement was accomplished by installing the wrought iron tie bars: two between the second and third floors, and two between the third floor and attic. These early tie bars are of a design easily distinguished from later work associated with the 1886 earthquake, and are visible in the attic with some investigation. Each bar appears to have L-shaped clamped ends bedded into the top of the west wall, with one leg extending vertically down into the wall, the other continuing into the attic approximately nine feet. Here, the bars are set between the joists and project through a diagonal roof beam that supports the hip rafters of the roof. Threaded on their ends, each is secured with a nut to the beam (see figures 4.16 and 4.17). Presumably, the pair directly below was finished in a similar manner and extends approximately nine feet into the house at the third floor joist level⁷⁶ (see figure 4.18).

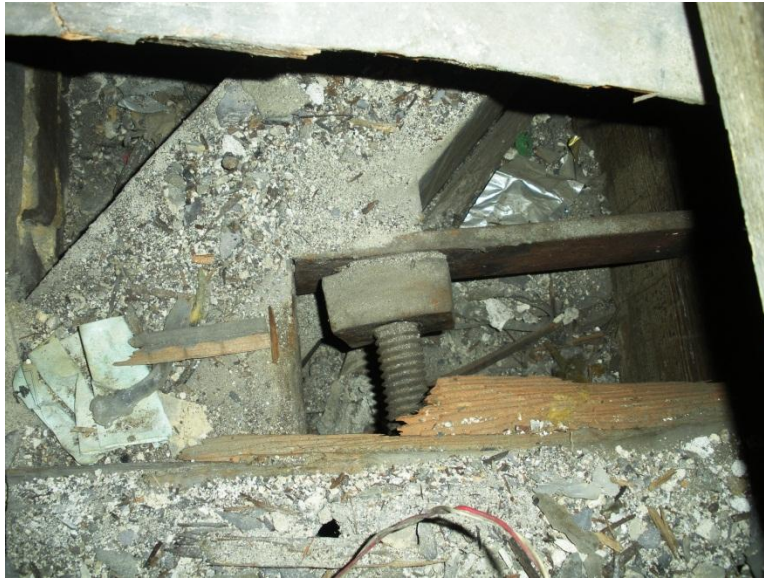
Figure 4.17: Tie rods installed in 1811 are threaded at their ends and secured to diagonal roof beams with bolts. *(Photo taken by author)*

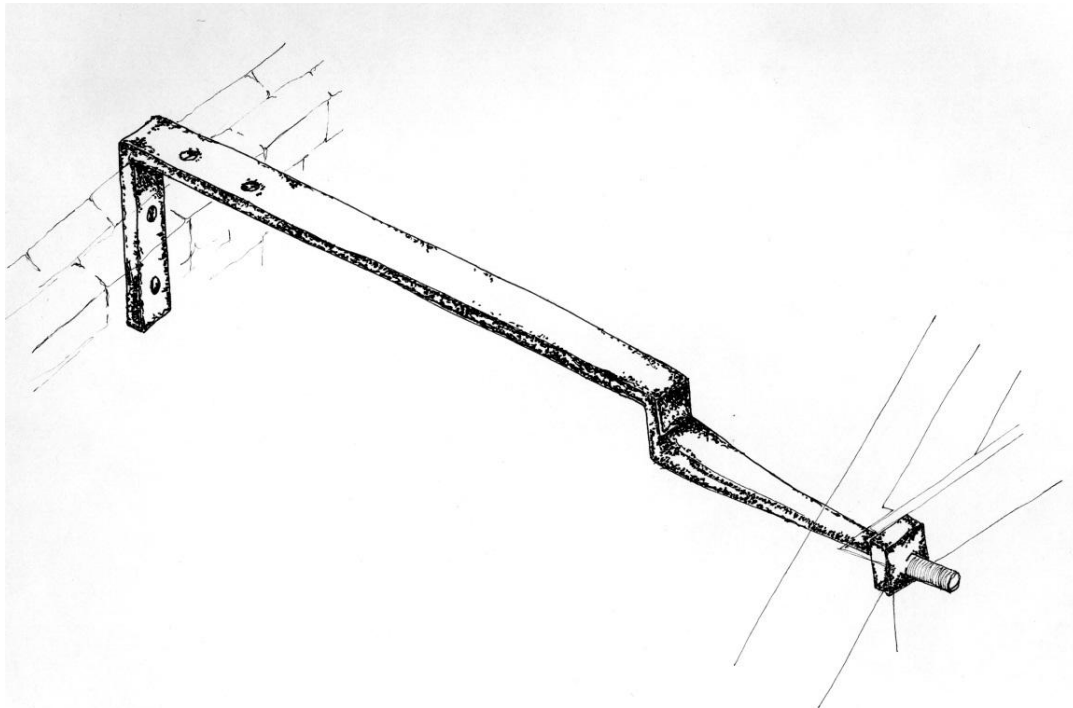
Figure 4.18: Sketch: Iron straps installed in rear wall, circa 1811. *(Sketch by author, not to scale)*

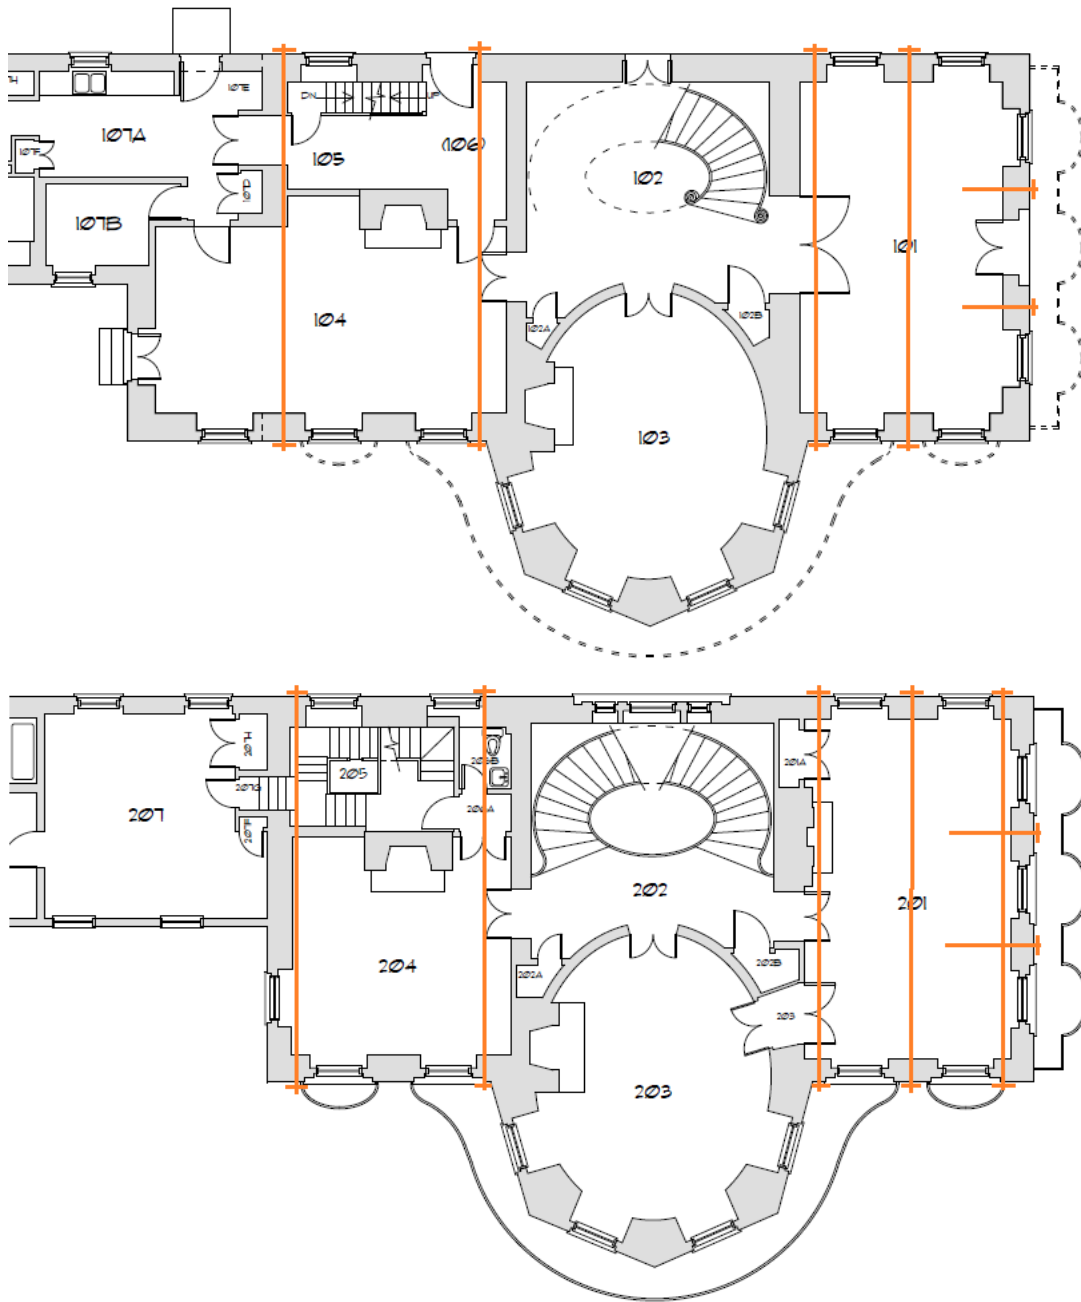
Figure 4.19: After the 1886 earthquake, the original portion of the Nathaniel Russell house had to be reinforced using full length tie rods to secure the north & south walls, and short wall anchors to secure the east (front) wall; Top: First floor plan & reinforcement diagram, Bottom: Second floor plan and reinforcement diagram. (Drawings courtesy of Historic Charleston Foundation, drawn by Glenn Keyes Architects; diagramming by author)

A second, and much more extensive, episode of reinforcement was required following the disastrous earthquake of 1886. The damage assessment that was conducted city wide noted that the east and west walls were badly cracked over the openings and the house was “badly sprung and separated”. The damages at the Russell house and its dependencies were approximated to be \$2500⁷⁷. Damage to the stable and hyphen was evidently severe. The north wall of the hyphen was completely torn down and rebuilt along with the upper west gable of the kitchen house. However, at the stable damages were allowed to go without repair and remediation was deferred. Eventually the structure was torn down around 1890⁷⁸. At the main house, earthquake damages required reinforcement of all four of the load bearing masonry walls. Iron tie rods and anchor plates were inserted into the building at the second and third floors, just below finish floor level. The front façade was reinforced by inserting two tie rods on each floor level; the north and south elevations are supported with four tie rods at the second floor and five at the third floor (see figure 4.19).

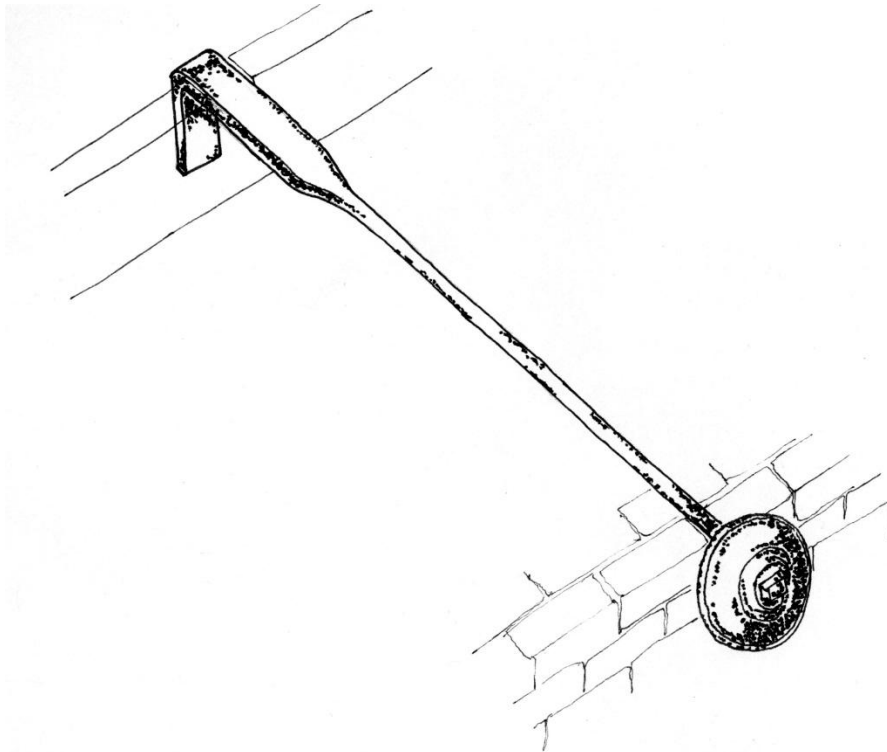
Figure 4.20: Sketch: Tie rods installed in front façade, circa 1886. *(Sketch by author, not to scale)*

According to the Historic Structures Report conducted by Ridout and Graham, the tie rods that reinforce the front façade extend only a few feet into the house. Sub-floor investigations for the report revealed that the circular tie rods are modified into rectangular section bars on the interior end. Although the end connection was not accessible during the investigation, it is probable that the bar is bent over an interior joist and nailed or bolted into place (see figure 4.20). A similar detail can be found on a vertical iron tie rod discovered in the attic of the Nathaniel Russell house, used to strengthen a roof truss. This strap is applied against a plaster and lath partition that probably dates to the 1870s; thus, the iron strap is more than likely part of the 1886 earthquake repairs as well⁷⁹.

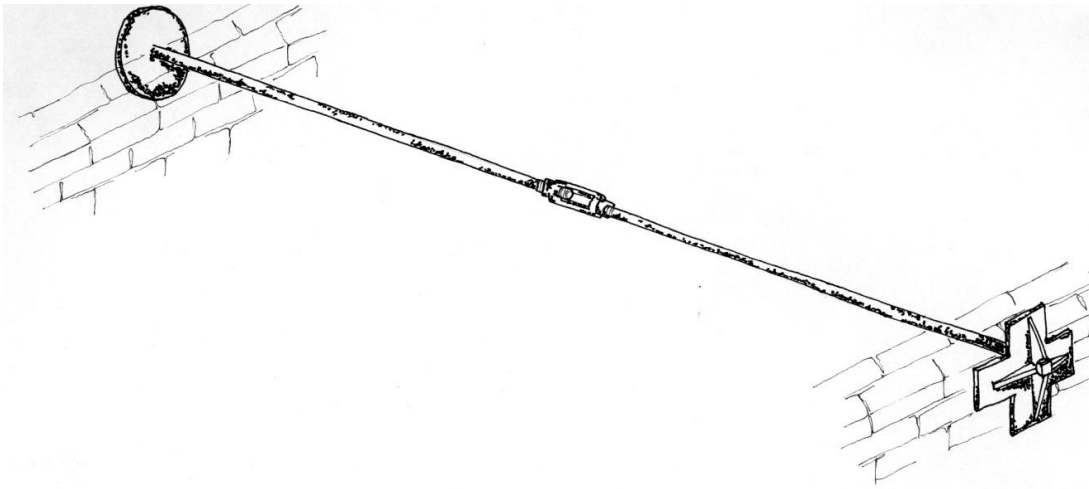
Figure 4.21: Sketch: Tie rods installed wall-to-wall to secure the north and south walls, circa 1886.
(Sketch by author, not to scale)

the load over the exterior brick wall surface. Each tie rod is joined near the mid-point and tightened by a large turnbuckle (see figure 4.21). This feature was examined by Ridout and Graham just a few inches below the floor boards in the chamber above the withdrawing room by lifting the flooring near the center of the room⁸⁰.

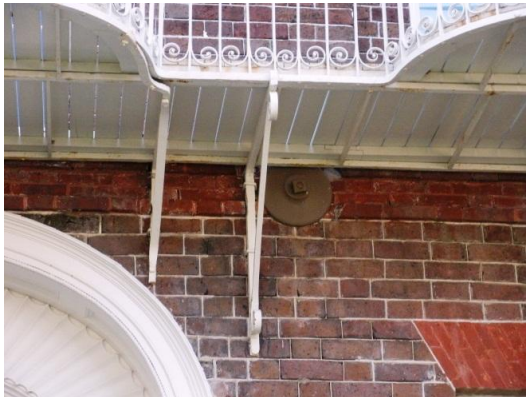
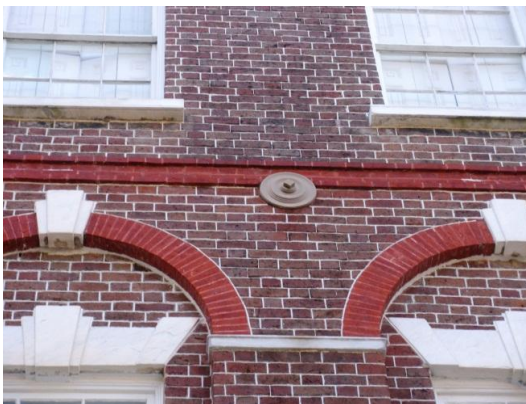
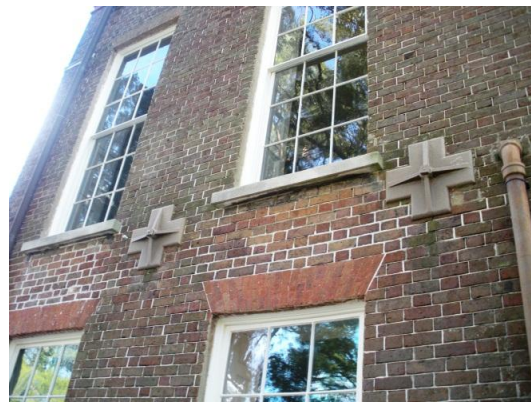
Figure 4.22: The Nathaniel Russell house features three different tie rod anchor plate forms: Top Left: Plain, circular anchor plate on the front façade. Bottom Left: Circular anchor plate with molded profile on the front façade. Right: Cruciform shaped anchor plates on the north façade.
(Photos taken by author)

The Nathaniel Russell house tie rods feature a number of cast-iron anchor plates on the exterior facades. In fact, there are 22 total plates in three varieties: circular plates with a plain, non-decorative profile, circular plates with a molded profile, and large, three-dimensional cross-shaped plates that are cast rather than cut from bar stock (see figure 4.22). There is little pattern to the location of each type of plate, and the method of attachment is the same for all three types. Therefore, it is believed that all three plate varieties are from the same period of installation. However, there does appear to be some effort to use the circular molded profile in the more visible areas of the house, with the plain round plates as a second alternative. These two types are the predominant forms in the late 19th century during earthquake repairs

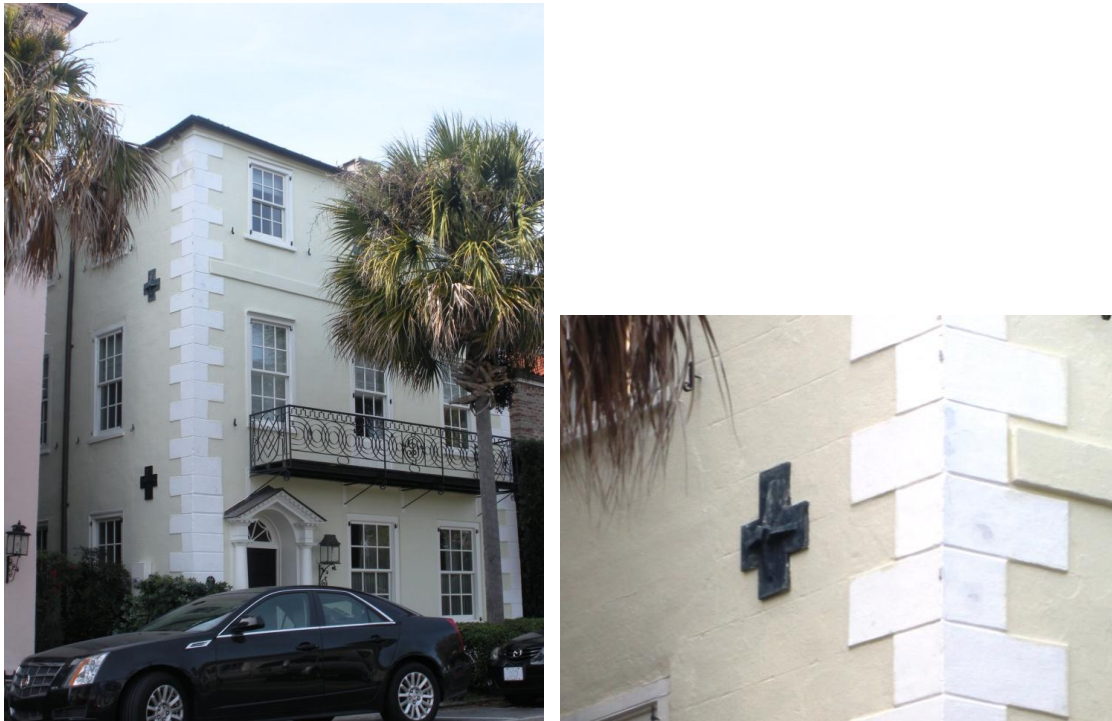
Figure 4.23: Left: Cruciform shaped anchor plates installed at 57 East Bay Street; Top: Anchor plate detail (*Photos taken by author*)

throughout the city. Use of the cruciform plates is restricted to the north façade. In the Historic Structures Report compiled by Ridout and Graham, it is stated that a search revealed no comparables for the cast cruciform model⁸¹. However, a visual search conducted during research for this thesis revealed that the same cross-shaped plates were indeed used at 57 East Bay Street, which was also badly wrecked during the earthquake with an estimated \$2,479 in damages incurred to the structure⁸² (see figure 4.23).

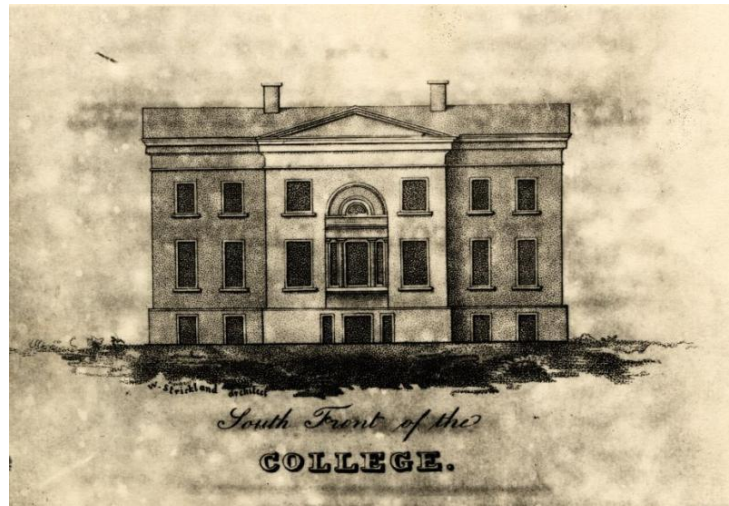
Figure 4.24: Architect William Strickland's sketch of the Main Building. This is the view of Randolph Hall when originally built, before the addition of wings and porticos. (Source: *Low Country Digital Library*; <<http://lowcountrydigital.library.cofc.edu>>)

In 1827, the architect William Strickland of Philadelphia prepared plans for the College of Charleston's first new building, known simply as the Main Building until the 1970s when it was renamed to honor College President Harrison Randolph⁸⁵. The new building was the first 19th century public building designed by an outside architect in Charleston. As a student of Benjamin Latrobe and an architect of the United States Capitol, Strickland also designed both the Second Bank of the United States and the personal residence of Langdon Cheves in Philadelphia - former College of Charleston trustee and President of the Second Bank of the United States⁸⁶. Construction of the Main Building began in 1828 and was virtually completed by March 1829. As designed, William Strickland's building is a simple rectangular, two-story brick structure over an elevated basement, with a pedimented three-bay-wide projecting central pavilion on the south (primary) façade and gable ends on the east/west sides (see figure 4.24). This original structure now forms the center section of the building on campus today. In 1840,

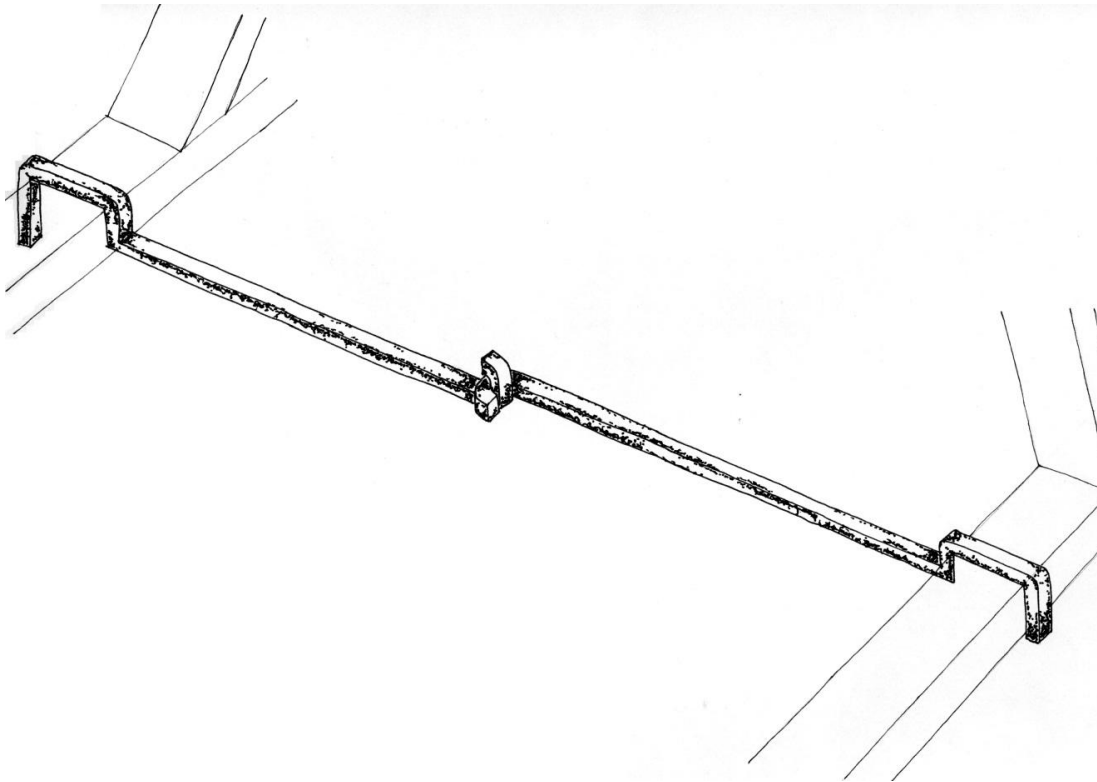
Figure 4.27: Sketch: Iron tie rods installed in the roof structure of the Main Building securing the north and south walls. (Sketch by author, not to scale)

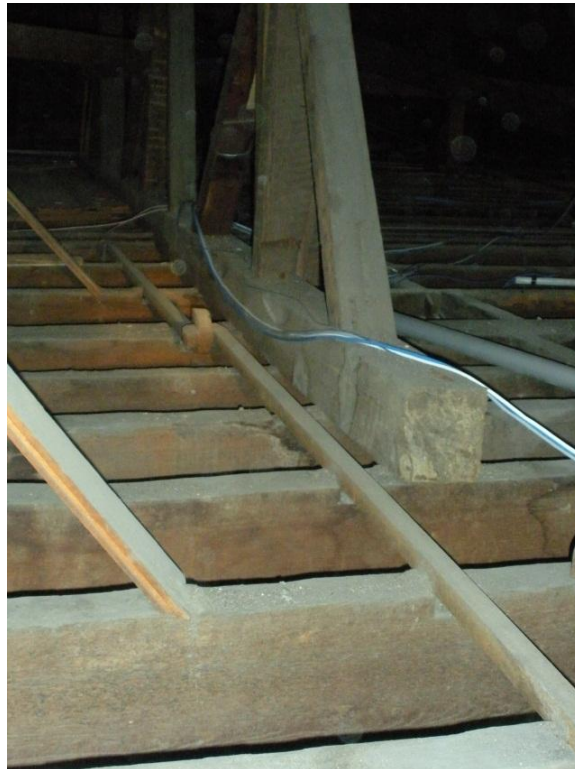
Figure 4.28: Iron tie rods installed at Randolph Hall, presumably in the mid-19th century during renovations, are cut into the roof joists and hook together in the center. (Source: Photo taken by author)

Concealed within the roof structure of the original portion of Randolph Hall, and accessible in the attic, are one pair of large wrought iron tie bars (see figure 4.28). Square in section, both bars run the full depth of the building (north to south) and are positioned to either side of the building's centerline. Unlike other iron tie rods that penetrate the outer masonry walls and are threaded to receive anchor plates, the exterior ends of the bars at Randolph Hall are strap-like and cramp down over the top of the ceiling plate timbers (see figure 4.29) to essentially pull the outer walls inward, much like the earliest tie bars in the Nathaniel Russell house that date to 1811. The extended length of these cramped L-shaped ends was indeterminable during investigation. Each tie bar is fashioned into a large hook near the mid-point, providing the connection of the north wall to the south wall (see figure 4.30).

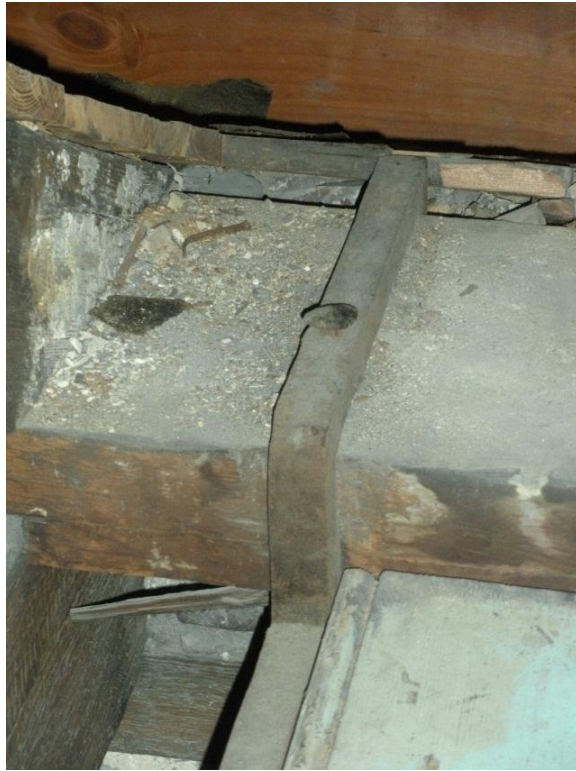
Figure 4.29: End attachment detail of the tie rod where the rectangular rod clamps over the sill plate within the roof structure. (Source: Photo taken by author)

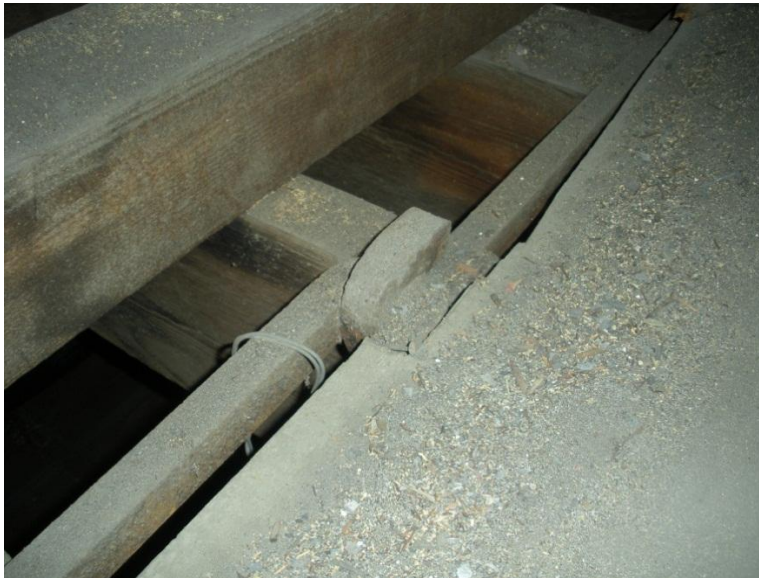
Figure 4.30: Center hook connection. (Source: Photo taken by author)

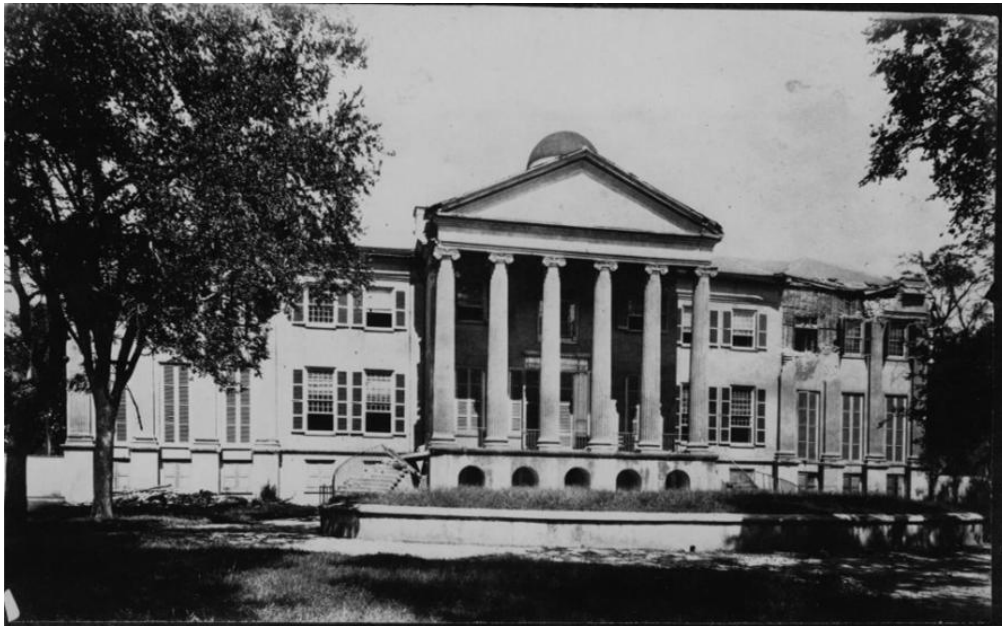
Figure 4.31: South façade of Randolph Hall after the Charleston Earthquake of 1886. Damage to east wing is visible on right. Both wings were eventually removed and reconstructed. (Source: Low Country Digital Library; <<http://lowcountrydigital.library.cofc.edu>>)

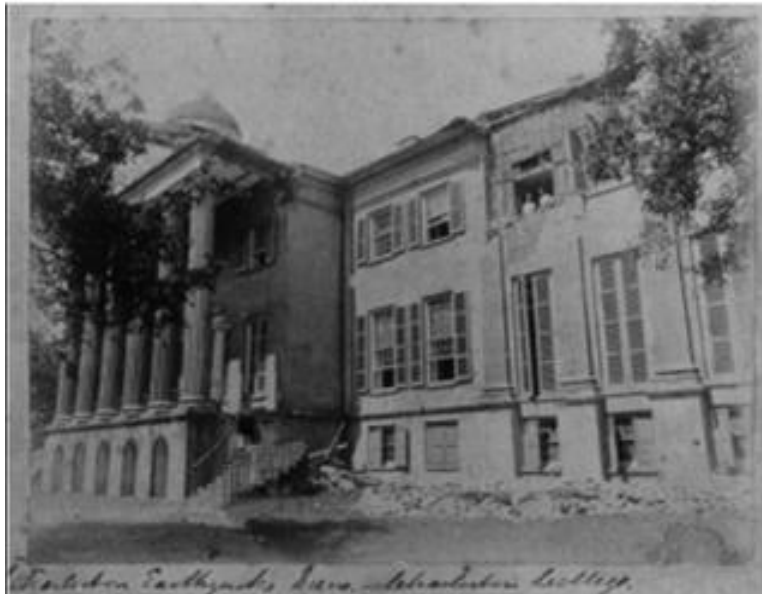
Figure 4.32: Earthquake damaged south façade of Randolph Hall. Damage to east wing is visible on right and evidence of the portico pulling away can be seen on the left. (Source: Low Country Digital Library; <<http://lowcountrydigital.library.cofc.edu>>)

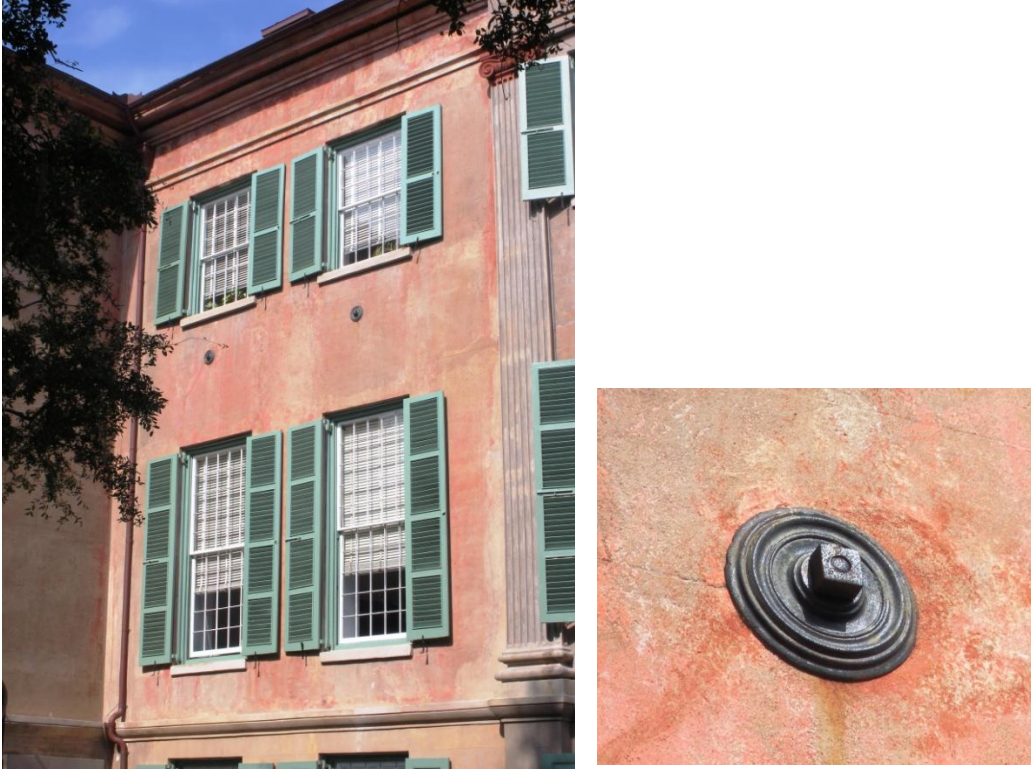
Figure 4.33: South wall of the Main Building, east of the portico showing two earthquake bolts installed between the first and second floors. Detail: Circular patterned plate with decorative, moulded profile. *(Photos taken by author)*

From both the interior and exterior, there is no visible evidence of reinforcement on the north wall of the Main Building portion of Randolph Hall. Presumably, these 'earthquake bolts' were installed and then covered by a new application of stucco during repairs. Although nothing can be seen on the north wall, on the south wall there are two circular anchor plates to either side of the portico positioned in between the first and second floor (see figure 4.33). Whether or not these reinforcement rods tie the south wall all the way into the north wall cannot be determined; however, they were certainly installed post-1886 as they appear to be missing from the photographs taken directly after the earthquake.

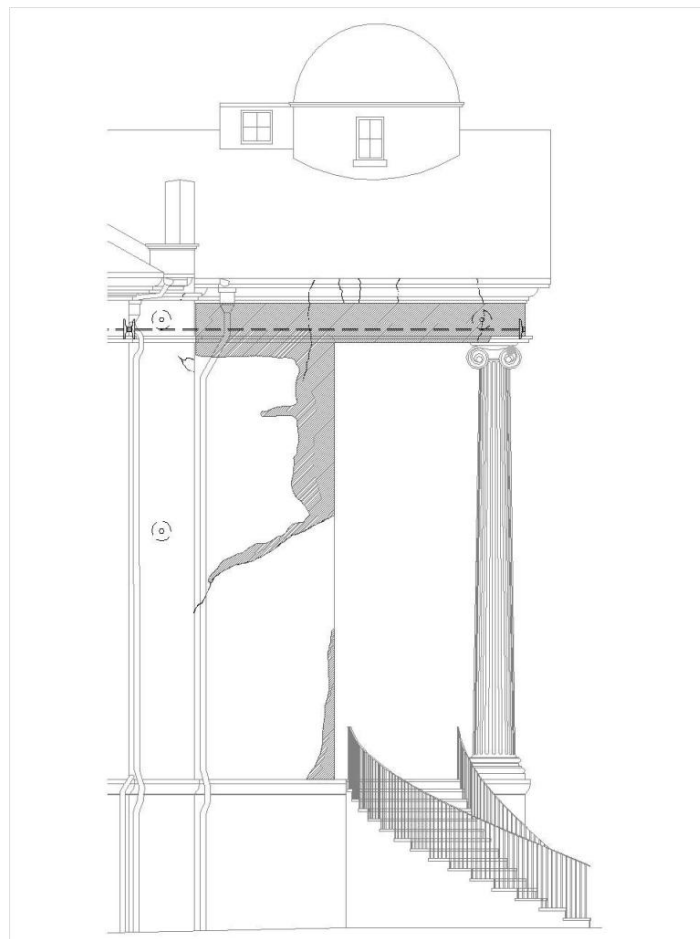
Figure 4.34: A conceptual scheme designed by structural engineers at 4SE, Inc. for securing the portico back to the main building (Source: *Cummings & McCrady, Conservation Master Plan, 19*)

Recommendation: Tie portico pediment back to the main building so that it cannot move independently of the building. A conceptual scheme is illustrated in Figure 4.34.

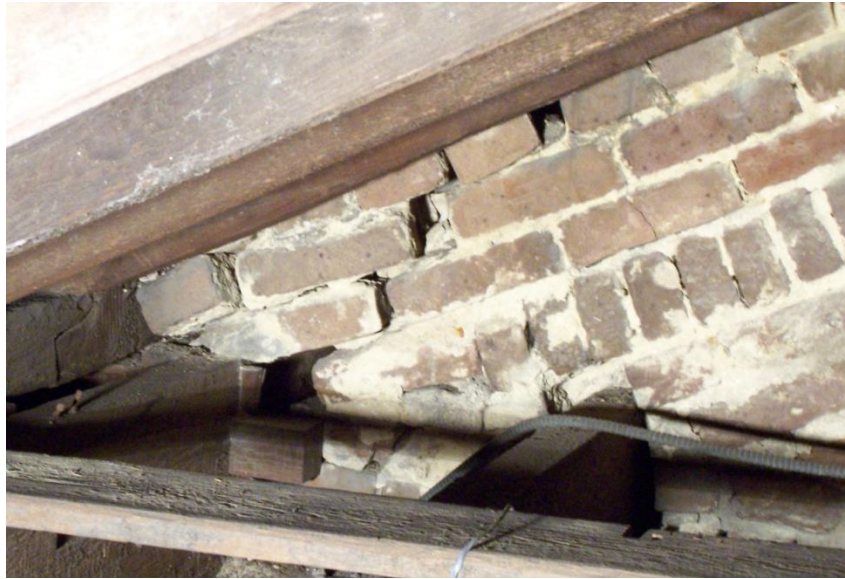
Figure 4.35: Portions of the brick portico gable at Randolph Hall , originally damaged in the 1886 earthquake, showing signs of additional movement. *(Photograph provided by 4SE, Inc.)*
