Ties That Bind: The Emergence of Iron Tie Rod Reinforcement in Load Bearing Masonry Buildings of Charleston, S.C.

A Thesis
Presented to
the Graduate Schools of
Clemson University and the College of Charleston

In Partial Fulfillment
of the Requirements for the Degree
Masters of Science
Historic Preservation

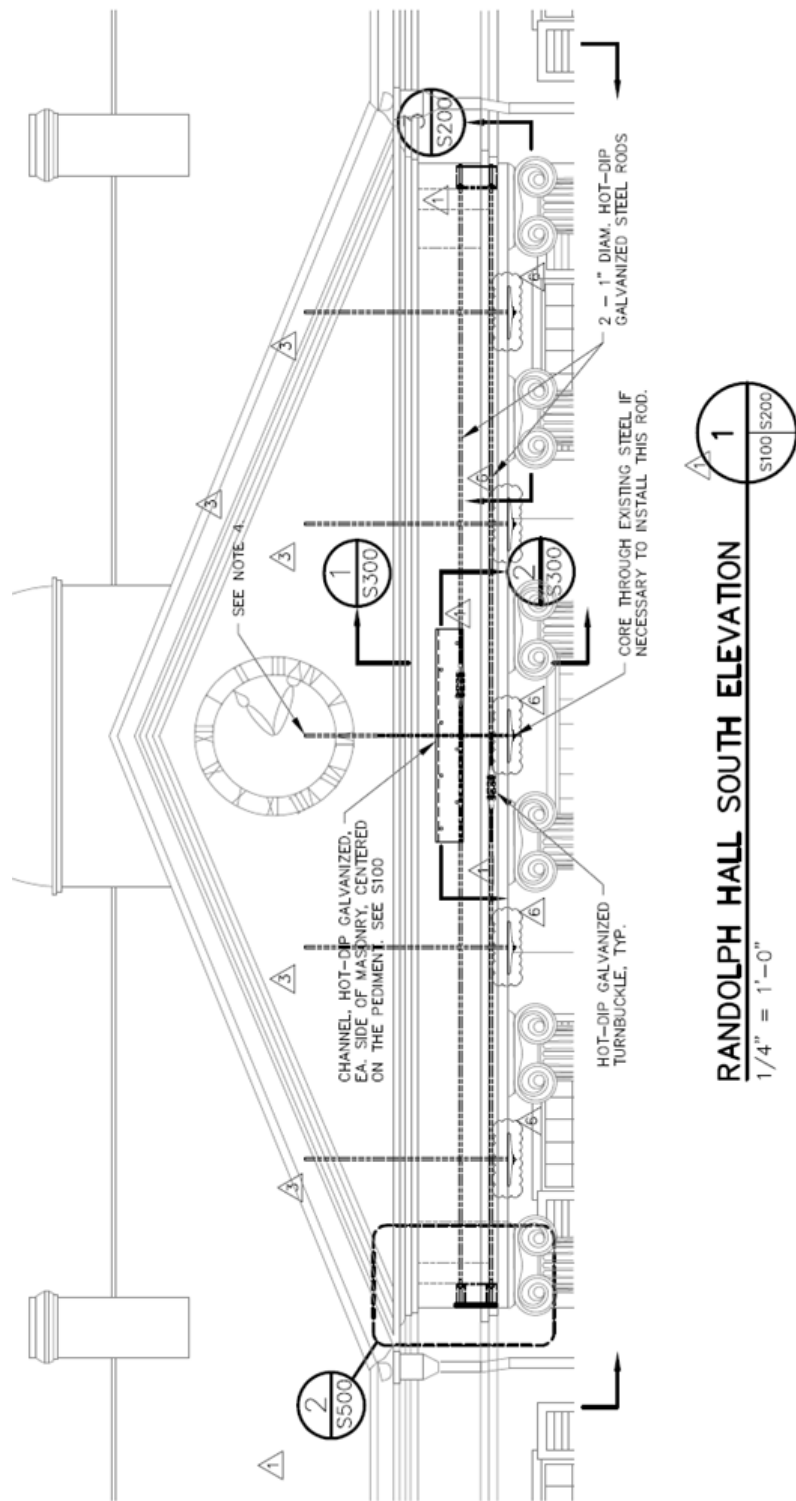
Figure 4.37: Elevation drawing showing the location of vertical tie rods installed to secure the brownstone entablature at Randolph Hall. (Drawings provided by 4SE, Inc.)

During the restoration, even further reinforcement requirements were determined for the entablature to secure the brownstone slabs that span between the columns. Unlike the horizontal reinforcement that has been addressed in all previous instances, the brownstone would require vertical tie rods to prevent the masonry from sagging further and potentially falling to the ground below. To prevent this from happening, 4SE designed a reinforcement method that involves a 1-1/8" diameter stainless steel reinforcement rod inserted vertically in

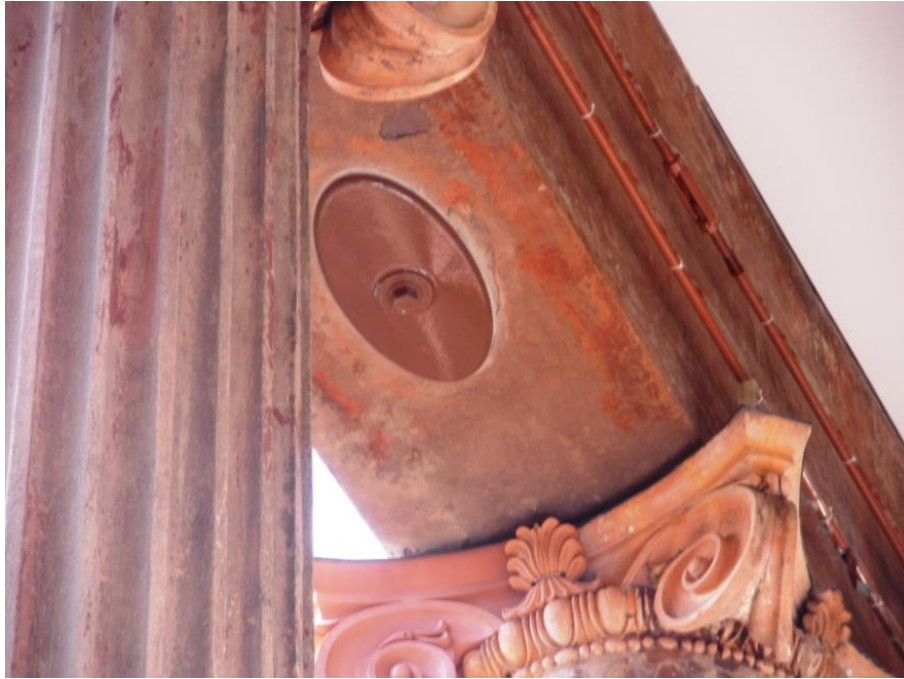
Figure 4.38: Photo showing the brownstone entablature and underneath the portico roof. The oval pattern plates can be seen securing the brownstone entablature with the tie rod and turnbuckle tying the portico side walls behind the entablature. *(Photo taken by author)*

between each column through the entablature, a total of five tie rods. Due to the unique nature of the brownstone entablature, the deformed reinforcing bar is cored through the brick gable and penetrates the masonry approximately seven to eight feet above. A concrete grout provides added security around the rod within the gable and an exterior anchor plate serves to secure the exposed end of the reinforcement. The elevation detail drawn in Figure 4.37 illustrates the location of one of these reinforcement rods within the entablature and roof gable. When standing on the portico floor and looking up, these unique 21st century applications of the tie rod can be seen adjacent to one another (see figure 4.38).

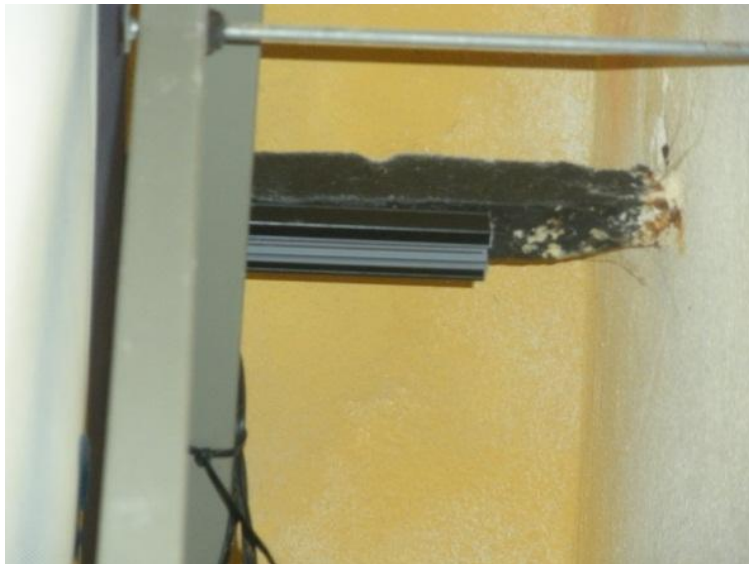
Figure 5.1: Localized corrosion where rectangular tie rod enters interior wall. (Photo taken by author)

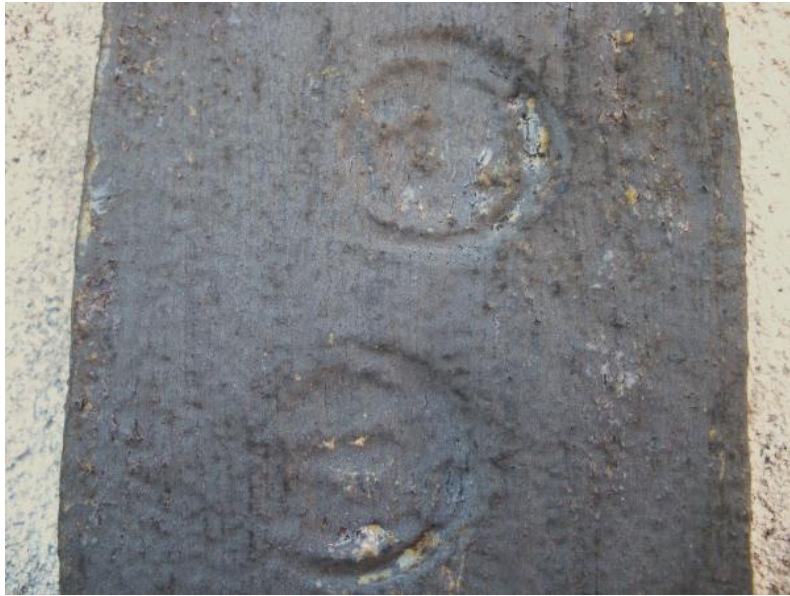
Figure 5.2: Evidence of maker's marks & paint deterioration on the northeast anchor plate arm. *(Photo taken by author)*

Another issue at the Old Powder Magazine is the high salinity. "There's so much salt in the walls, the alkalinity is tremendous,"¹⁰⁹ Keyes says. As a result, the integrity of the embedded structural iron has no doubt been compromised. The question is to what extent. The recent restoration of the brick and stucco on both the interior and exterior of the Powder Magazine has possibly hidden any previous evidence of masonry movement as primary evidence of problems beneath. However, there is some indication of corrosion and deterioration of the iron bars at the locations where they enter the interior walls (see figure 5.1). There is also visible evidence of rusting on some areas of the exterior anchor plates. The plate located within the southwest gable of the magazine shows significantly more pitting and deterioration than the other three plates (see figures 5.2 and 5.3).

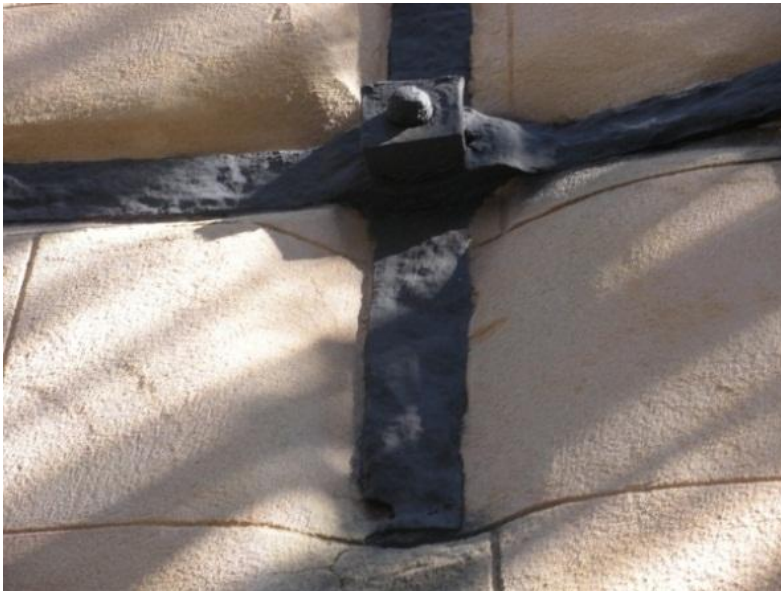
Figure 5.3: South-west anchor plate showing severe deterioration. *(Photo taken by author)*

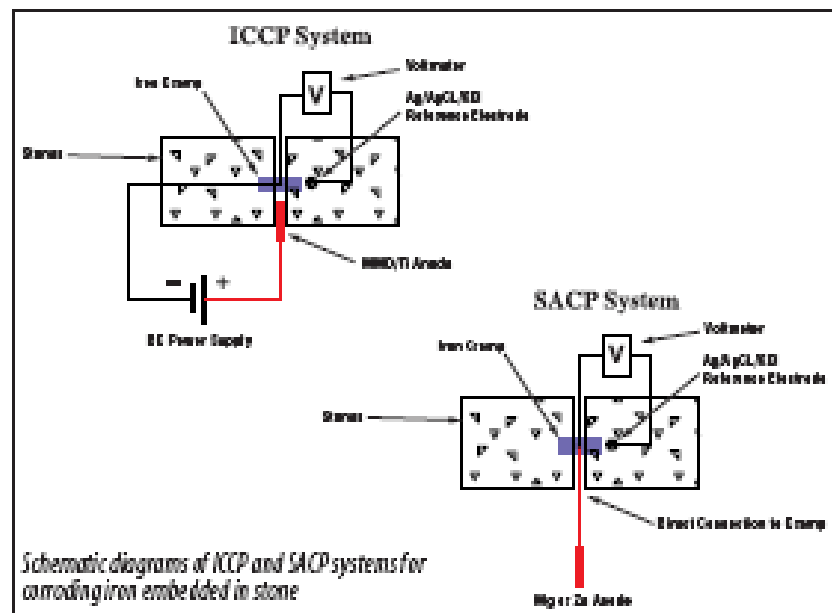
Figure 5.5: Schematic diagrams of ICCP and SACP systems for corroding iron in stone. (Source: Farrell, David and Kevin Davies. "Cathodic Protection of Iron and Steel in Heritage Buildings in the United Kingdom". *APT Bulletin* 36, 2005)

metal surface; corrosion occurs at these two anodes. Cathodic protection is used to control the corrosion of metal by making the whole metal surface the cathode of an electrochemical cell. When used to protect structural iron and steel this is achieved by applying small DC electric currents, via the building material. This supplies a constant stream of electrons to satisfy the cathodic reaction. The corrosive reaction then becomes suppressed. There are two methods of achieving this, either Sacrificial Anode Cathodic Protection (SACP) or Impressed Current Cathodic Protection (ICCP) (see figure 5.5). SACP systems use sacrificial anodes (zinc, aluminum or magnesium), which are placed in close proximity to the corroding metalwork and electrically connected to it. As the sacrificial anode corrodes, it generates a current that passes through the building material to provide protection to the embedded metalwork. The current is ionic-ally conducted by means of pore water contained within the building material. These systems are capable of protecting small metal components, such as embedded iron cramps or restraints set into walls, floors or roofs of a building. ICCP systems use transformer rectifiers, normally mains powered, to provide the DC current to the iron or steel being protected. These systems use corrosion resistant anodes, fixed close to the metalwork, to provide part of the current pathway.

ICCP systems are more complex than the SACP systems, but are suitable for providing CP to much larger areas of embedded steel such as I-beams, supports and columns. However, impressed-current cathodic protection systems are typically the most costly to install, and they require substantial ongoing monitoring and adjustment to ensure a proper voltage output over time¹²⁸.

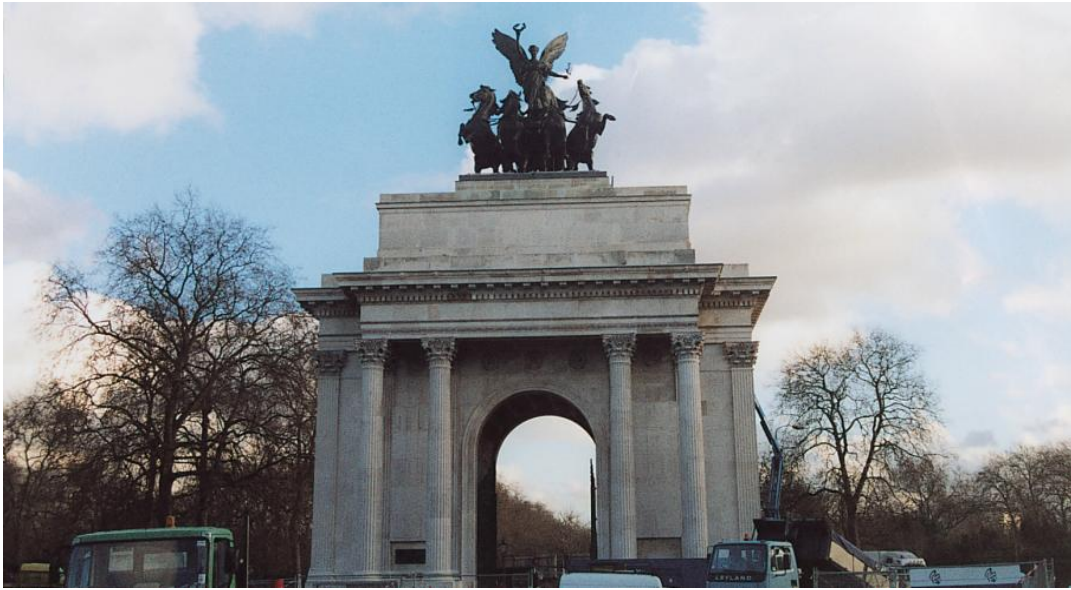
Figure 5.6: The Wellington Arch, Hyde Park, London; constructed in 1820, a recent inspection revealed significant corrosion of the steel I-beam supporting the Quadriga sculpture. (Source: Farrell and Davies. "Cathodic Protection of Iron and Steel in Heritage Buildings in the United Kingdom". *APT Bulletin* 36, 2005)

Most recently, a successful ICCP system has been installed in the Wellington Arch at Hyde Park Corner (see figure 5.6). The arch was built in the late 1820s using Portland stone and the roof slab was formed from concrete, supported by steel I-beams. The arch has recently undergone extensive renovation, including the repair of the steel and concrete structure which supports a large bronze sculpture. During an inspection it was discovered that some of the key steel I-beams in the roof had suffered significant corrosion. This was partly due to rainwater penetrating the roof structure. The worst corrosion, however, was where the beams had been in direct contact with the Portland stone (see figure 5.7). In fact, as a sedimentary rock formed in a marine environment, Portland stone may sometimes contain significant concentrations of chlorides or sulfates which, in the presence of moisture, can accelerate the corrosion process. A similar environment can be found within the Old Powder Magazine brick walls. At the Wellington Arch, English Heritage did not wish to replace the beams, as this would have been both expensive and disruptive. Thus, ultrasonic readings of the steel beams were taken, showing that their remaining thickness was sufficient to support the roof slab and sculpture, provided that ongoing corrosion could be controlled¹³¹.

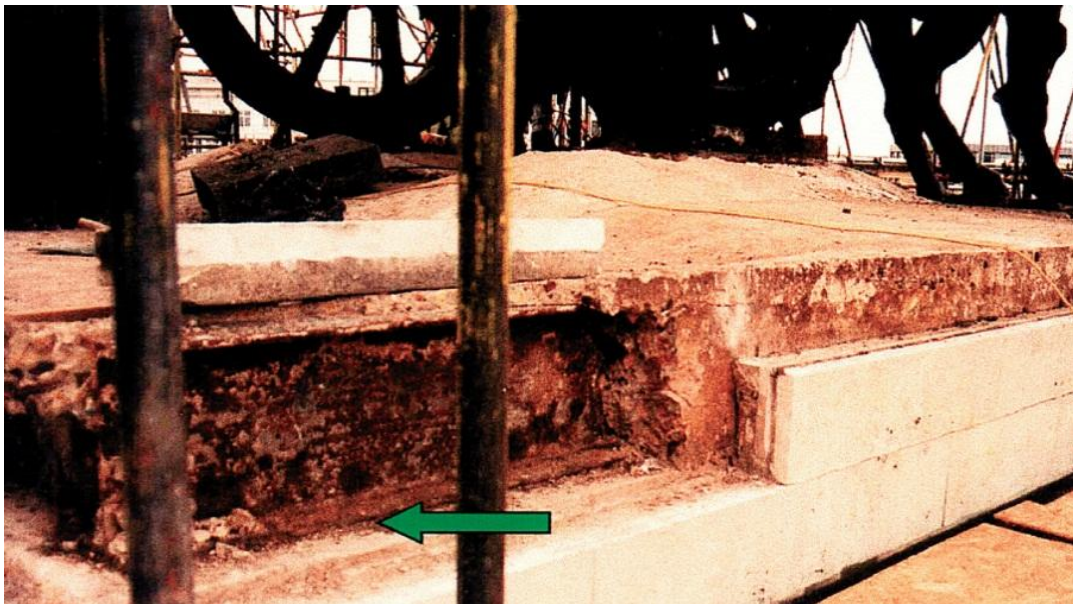
Figure 5.7: Corroded steel I-beam within the Wellington Arch; Not wanting to replace the historic steel structure, English Heritage chose to install an ICCP system to provide sufficient long-term corrosion prevention. (Source: Farrell and Davies. "Cathodic Protection of Iron and Steel in Heritage Buildings in the United Kingdom". *APT Bulletin* 36, 2005)

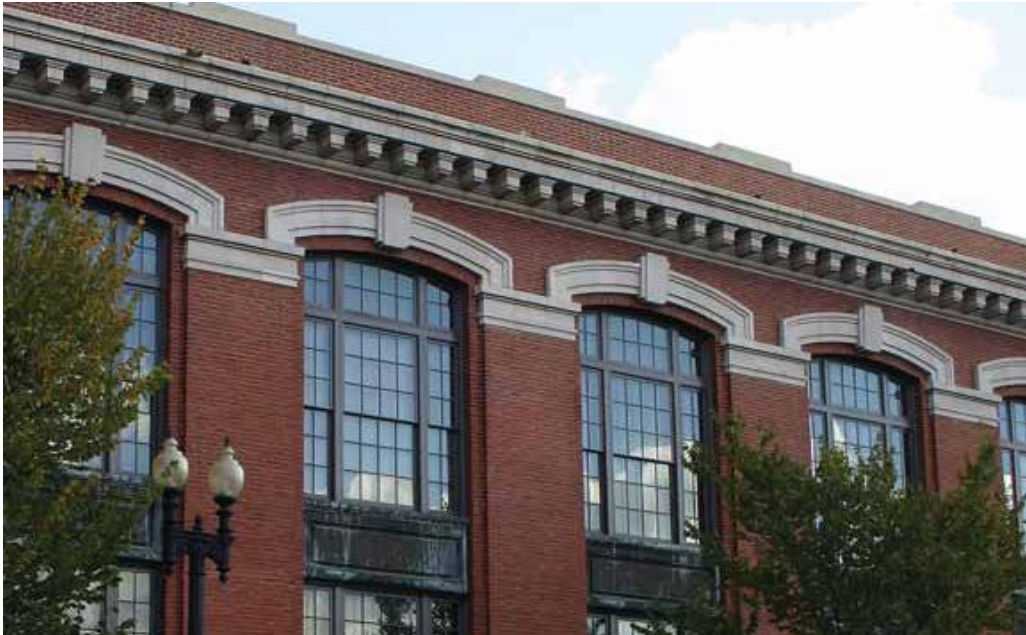
Figure 5.8: A view of the restored terra cotta cornice at the National Holocaust Museum in Washington, D.C. (Source: Kelly Page, ed., “Cathodic Protection of Historic Terra Cotta Cornice”, *Concrete Repair Bulletin* (May/June 2009): 20-23, accessed 27 January 2012, www.icri.org)

While cathodic protection as a conservation technique for heritage structures has been widely accepted in the United Kingdom, relatively few examples of the system being used in the United States exist. However, in 2005, a large scale CP installation was initiated at the National Holocaust Museum in Washington D.C., only the fourth such installation in the United States. Constructed in 1904 and located along the Mall in D.C., the building houses the administrative functions of the historic museum (see figure 5.8). The facility is a National Historic Landmark and an important destination for many. In 2005, a condition survey revealed the need for an entire exterior envelope repair, re-pointing of the brick, patching and repair of the terra cotta elements, and other elements typical of a thorough historic preservation and repair report. The report also indicated that the building's terra cotta cornice was deteriorating due to corrosion of the supporting steel elements and that the main joint above the modillions, which was cracked and open in areas, had been previously improperly repaired with a Portland cement mortar. The corrosion product was up to 0.75 inches thick, causing downward stresses and cracking on the terra-cotta modillions. Because the owners required repair options that would protect the

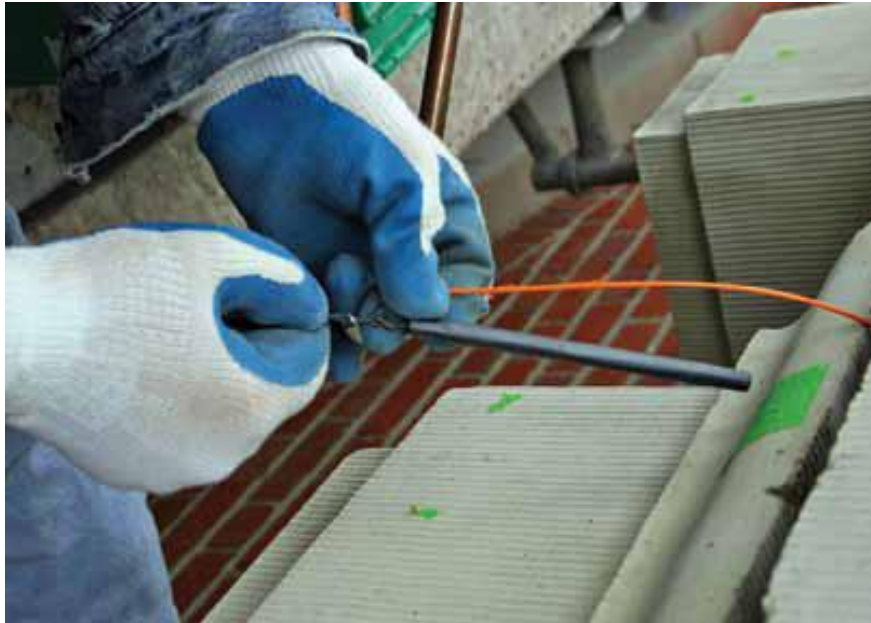
Figure 5.9: Discrete anode connected to power supply and ready for placement into mortar joint. (Source: Kelly Page, ed., "Cathodic Protection of Historic Terra Cotta Cornice", *Concrete Repair Bulletin* (May/June 2009): 20-23, accessed 27 January 2012, www.icri.org)

Contractor selection and training was a crucial because of the limited ICCP installations on historic buildings in the United States. The installation crew also was trained on project-specific procedures and quality assurance for this structure. Once the contractor began to remove the mortar joint above the modillions, anodes were inserted into areas to deliver corrosion protection. Joints were repointed as the installation was occurring, which masked all visible evidence of the system and prevented prolonged exposure to oxygen and moisture (see figures 5.9 and 5.10). The anodes were then connected to a DC power supply to deliver low-voltage electric currents. The system has been successfully monitored and running without issue since January 2007 and is controlled by a specialized control unit specially designed for steel frame corrosion in heritage buildings (see figure 5.11)¹³³. Although primarily concerned with steel corrosion, the cathodic protection system at the National Holocaust Museum

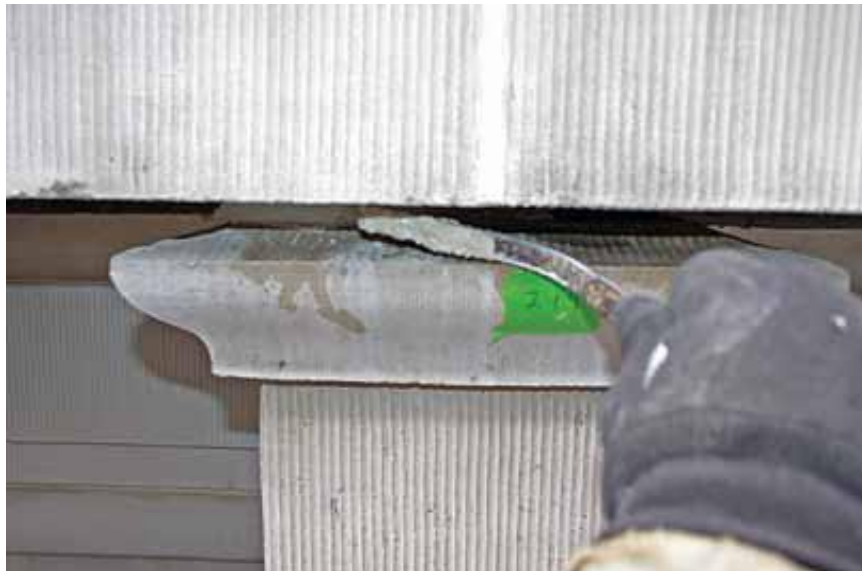
Figure 5.10: Placement of lime-based mortar after anode and reference electrode installation. (Source: Kelly Page, ed., "Cathodic Protection of Historic Terra Cotta Cornice", *Concrete Repair Bulletin* (May/June 2009): 20-23, accessed 27 January 2012, www.icri.org)

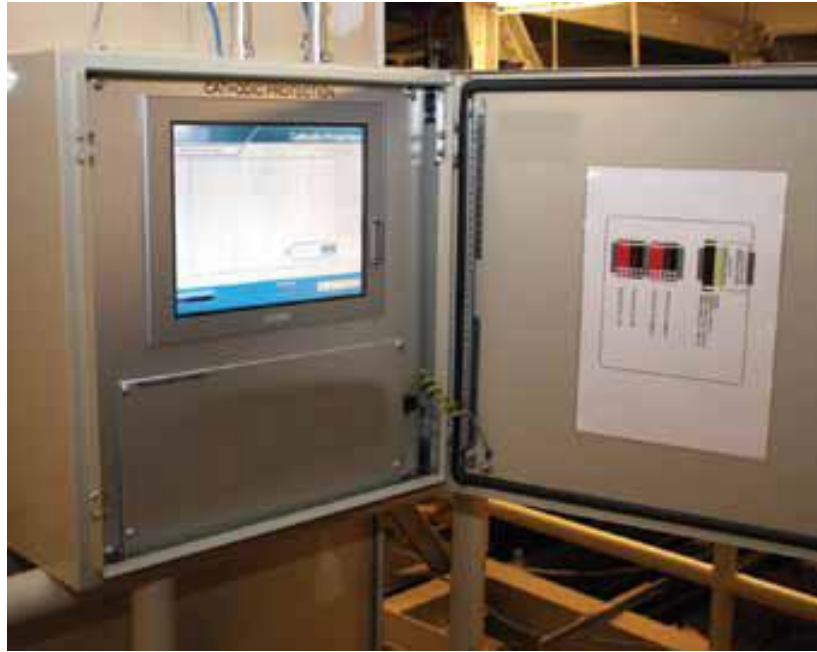
Figure 5.11: Monitoring equipment installed inside the building allows for remote monitoring and system adjustment. (Source: Kelly Page, ed., “Cathodic Protection of Historic Terra Cotta Cornice”, *Concrete Repair Bulletin* (May/June 2009): 20-23, accessed 27 January 2012, www.icri.org)

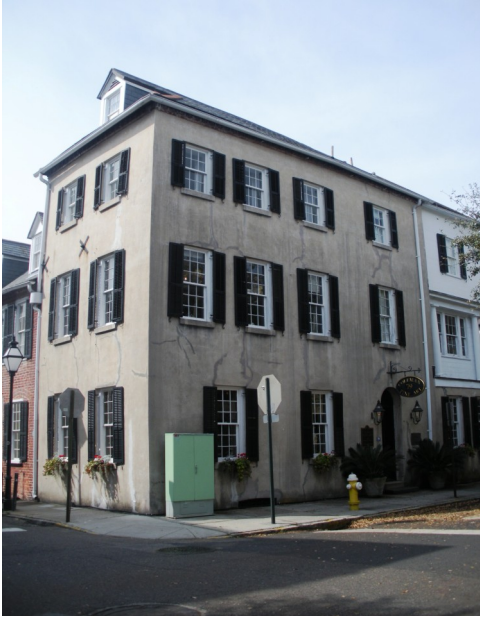
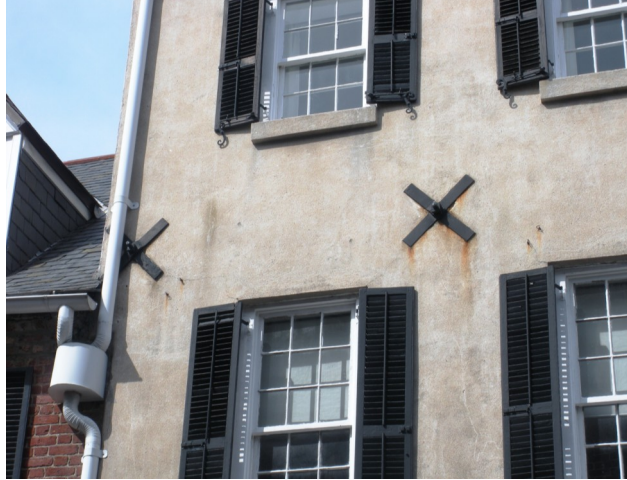
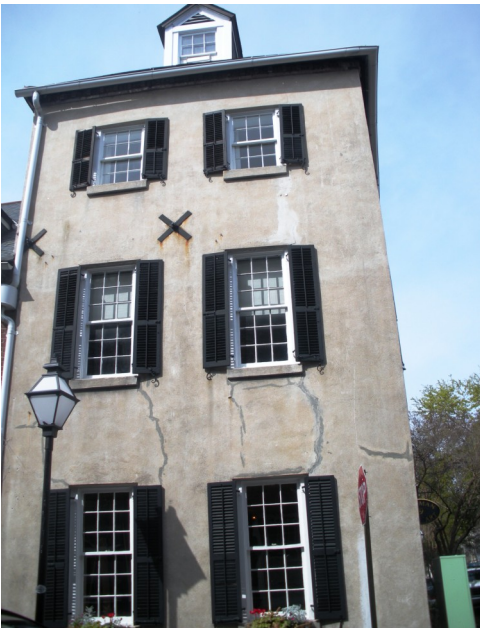
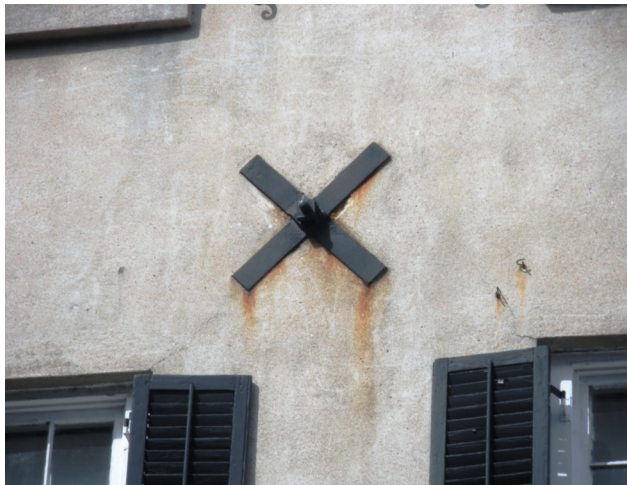
Earthquake Reinforcement Survey Form
79-81 Church Street: Photographs

The plates themselves are cross-shaped, an early form. The earthquake damage assessment indicates that the structure was already repaired before the assessors made their observations. Thus, it is difficult to determine whether these are in fact “earthquake bolts” or earlier reinforcement.

The stucco beneath the plates shows some discoloration from rust build up. The anchor plates themselves appear to be in good condition.

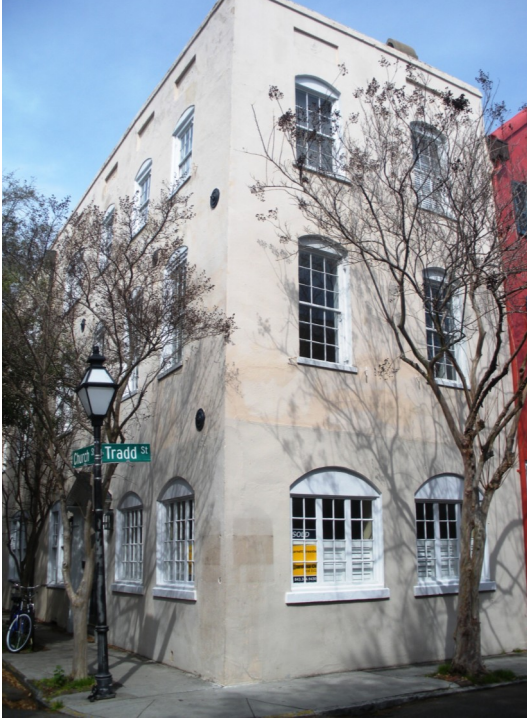
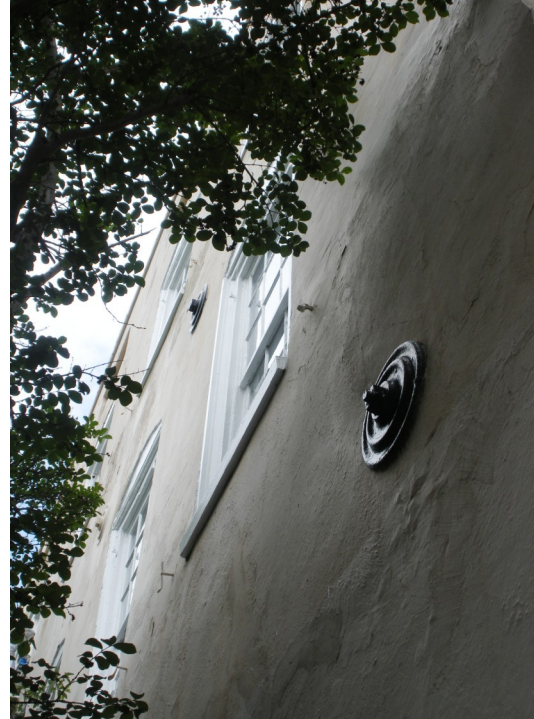
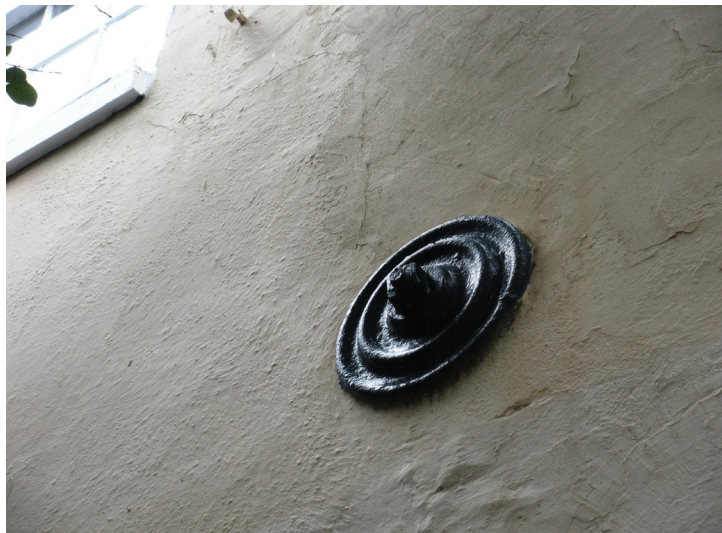
Earthquake Reinforcement Survey Form
82 Church Street: Photographs

The structure that occupies 82 Church Street exhibits five anchor plates total, all on the west façade. There is 1 plate between the first and second floors & 4 anchor plates between the second and third floors. Both the north and east façades are attached to adjacent structures and not visible, so presumably these tie rods only extend into the floor frame 2-3 joist bays. The plates themselves are all of the same shape and form, indicating they were probably all installed at the same time. The circular anchor plate with moulded profile is typical of post-1886 repair work.

The earthquake damage assessment indicates that both the west and south walls were damaged and cracked during the earthquake. As a result, anchoring was specifically recommended for the east and west walls, which appears to have been done.

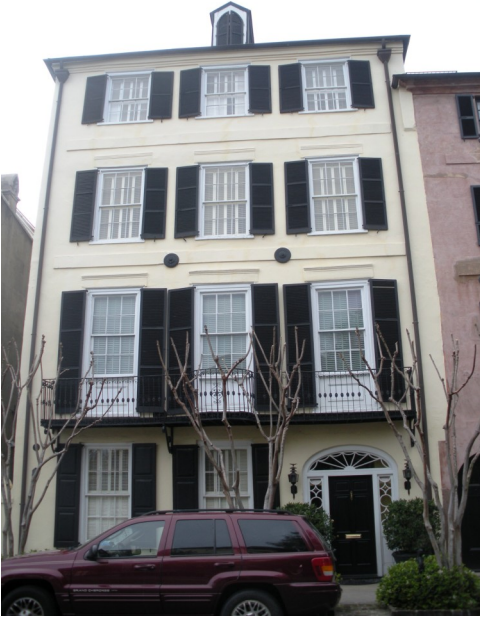
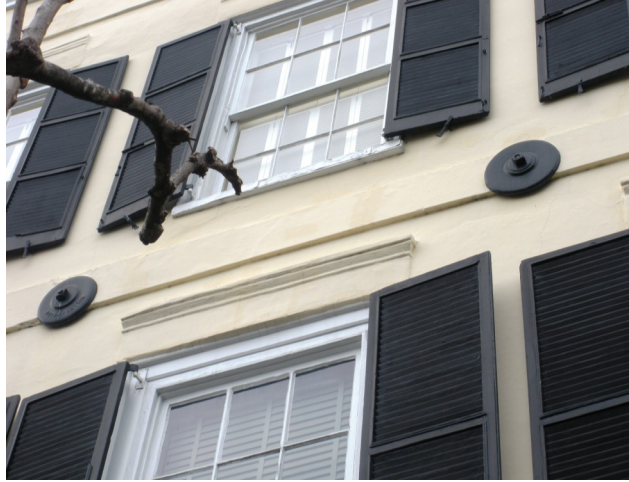
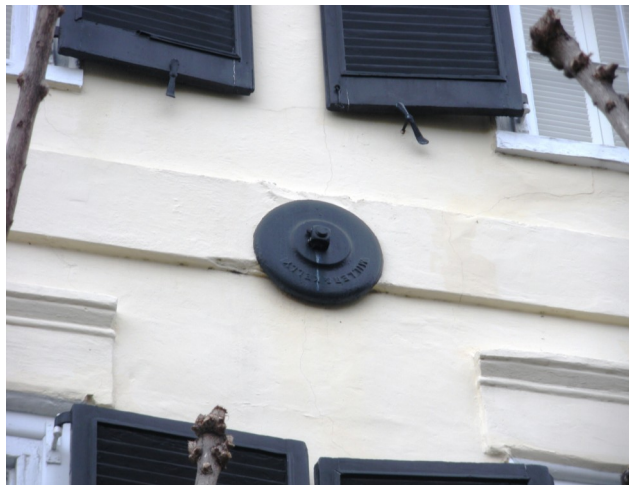
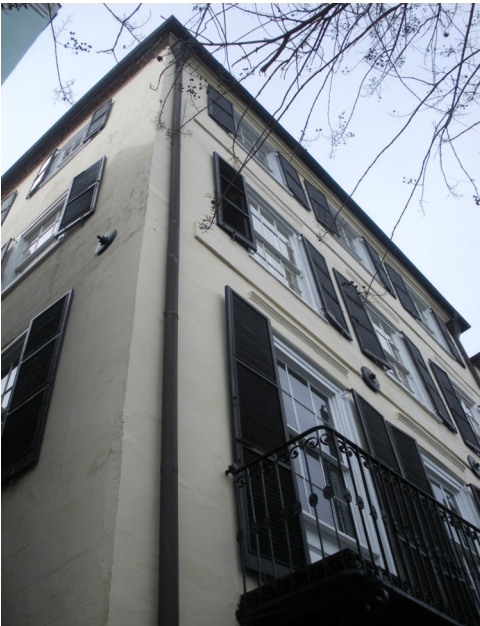
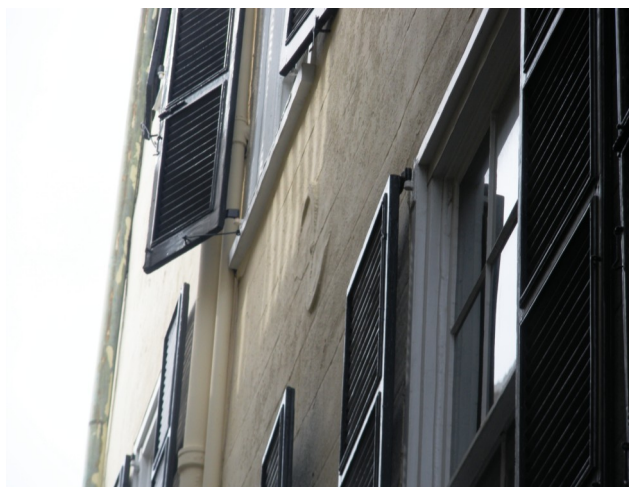
Earthquake Reinforcement Survey Form 83 East Bay Street: Photographs

Should be well anchored; rear building in good condition.

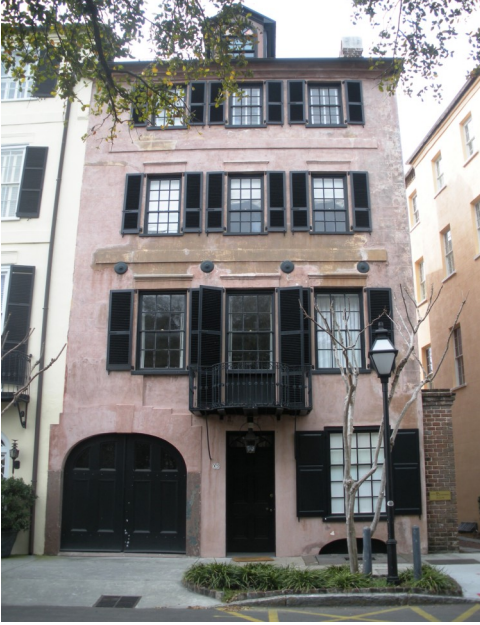
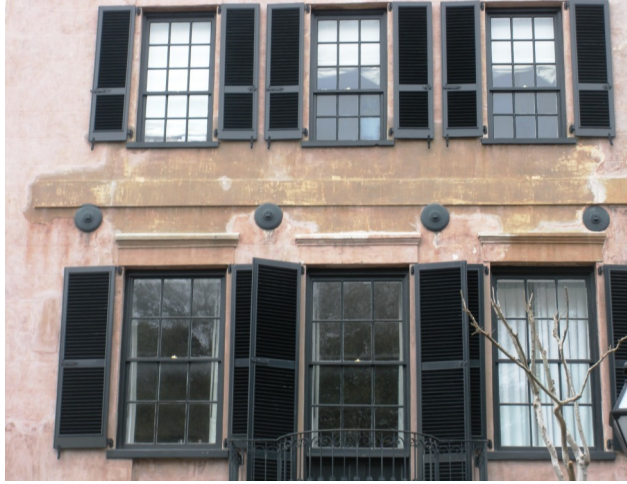
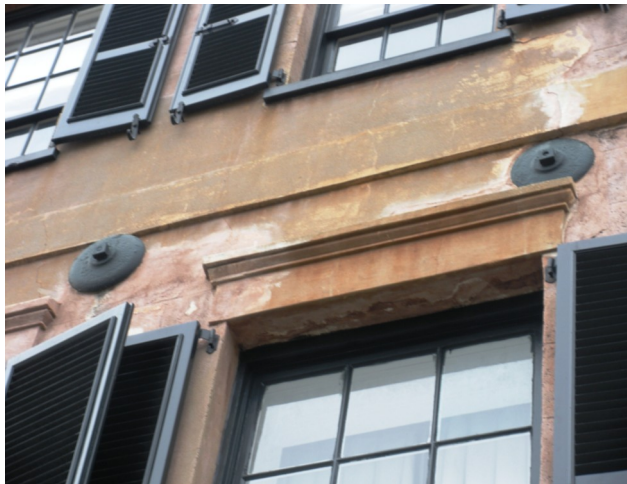
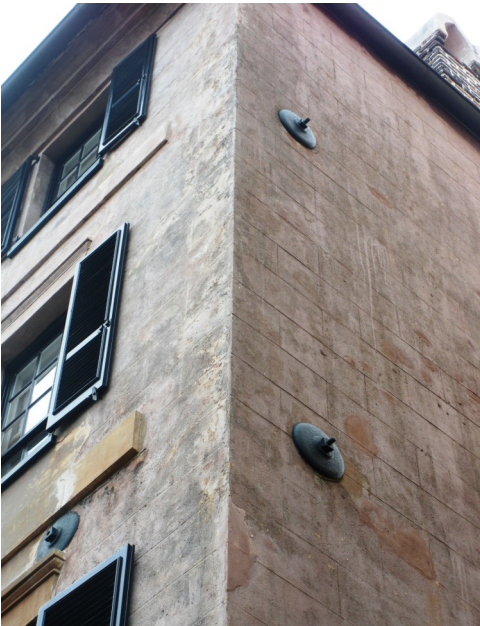
Earthquake Reinforcement Survey Form 85 East Bay Street: Photographs

The 1886 damage assessment report seems to suggest that the structure could only be completely taken down and rebuilt. Yet, the presence of reinforcement suggests that this wasn't the case and the building was in fact saved by reinforcing the remaining walls.

There are no visible signs of deterioration on either of the anchor plates or the painted stucco surface beneath the plates.

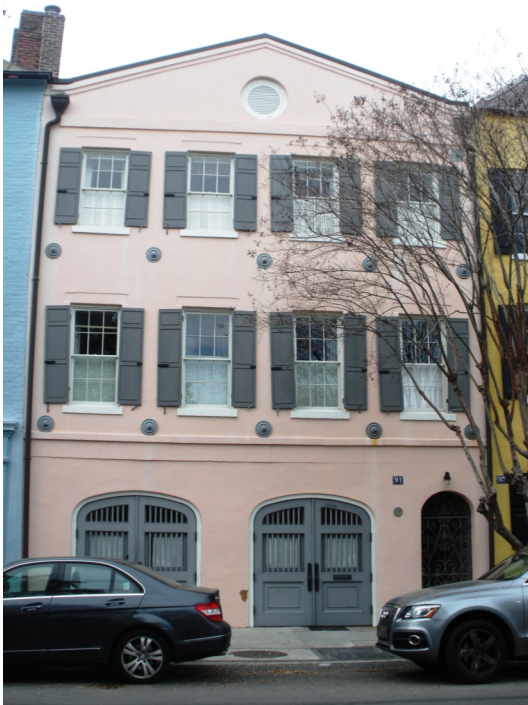
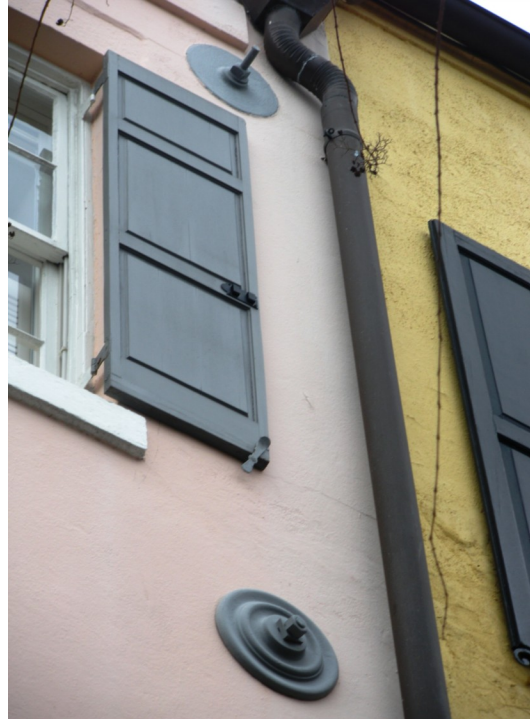
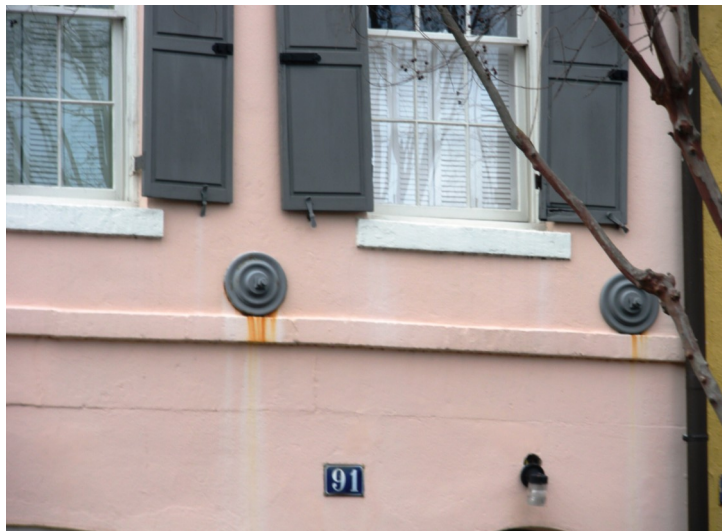
Earthquake Reinforcement Survey Form
91 East Bay Street: Photographs

The 1886 damage assessment for the structure at 91 East Bay Street provides little information regarding the post-earthquake repairs to the building. Whether the building simply suffered little damage or just was not assessed until after repairs were already made can not be determined. However, the difference in form and attachment method between the types of plates on the façade may indicate two separate reinforcement campaigns.

In general, the anchor plates appear to be in good condition. There is slight visible evidence discoloration due to rusting beneath the plates between the first and second floors on the stucco surface.

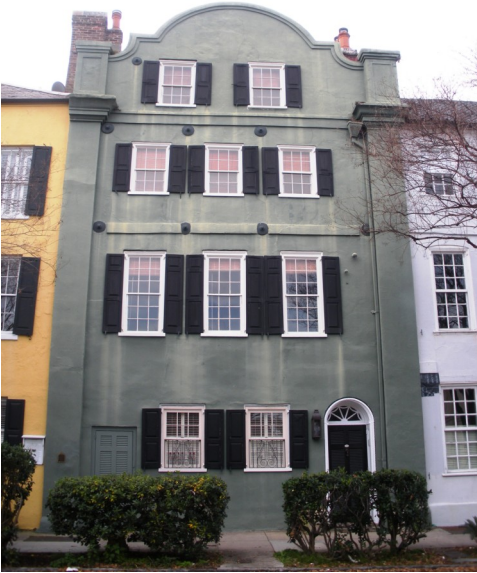
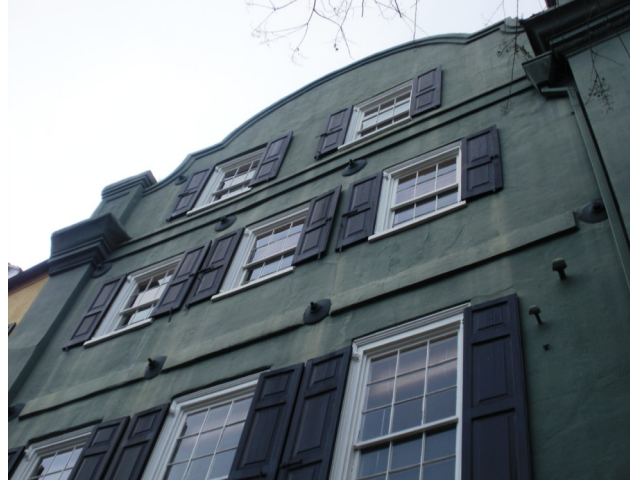
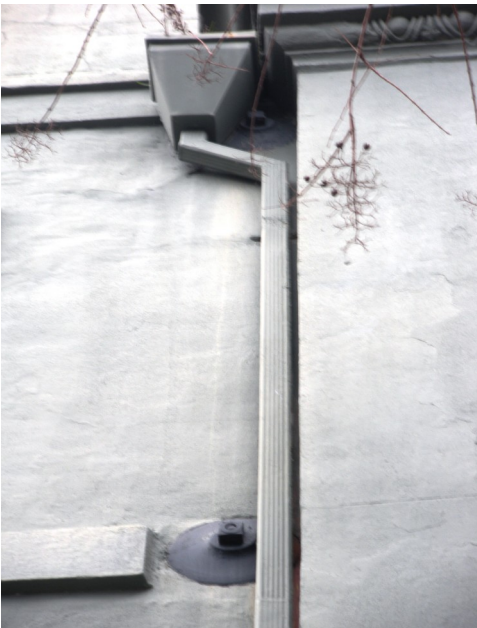
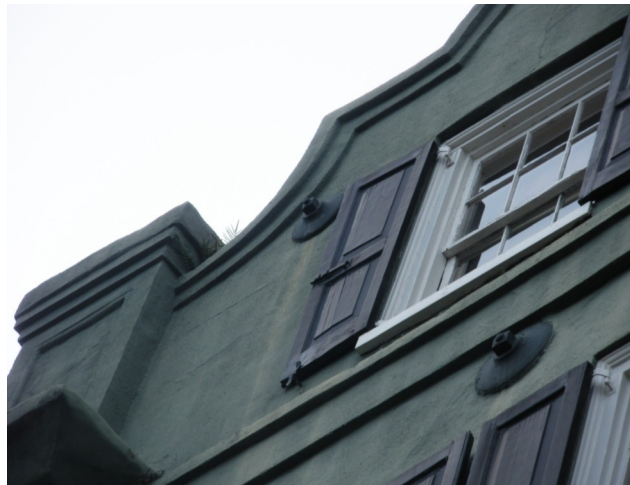
Earthquake Reinforcement Survey Form
95 East Bay Street: Photographs

The 1886 damage assessment indicates that the structure was damaged and recommends repairs to the east and west walls, but does not specifically recommend that the structure be anchored. However, the circular plates visible today are of a quality and form consistent with post-earthquake bolts.

There are no visible signs of deterioration on either of the anchor plates or the painted stucco surface beneath the plates.

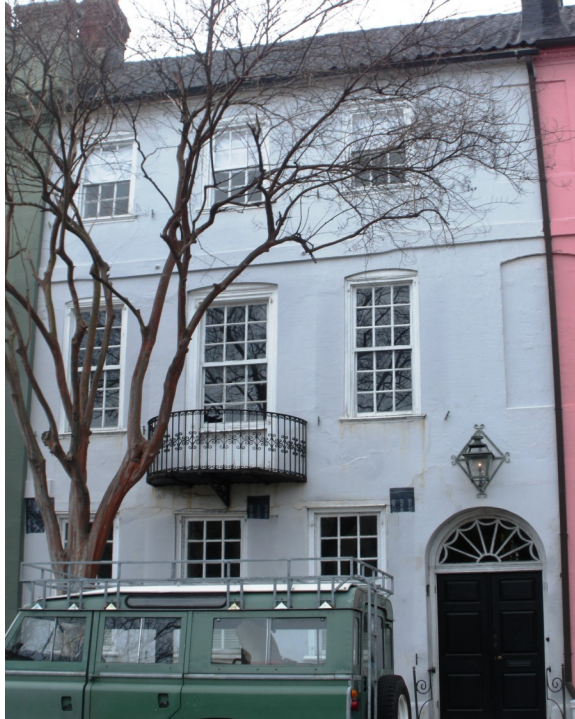
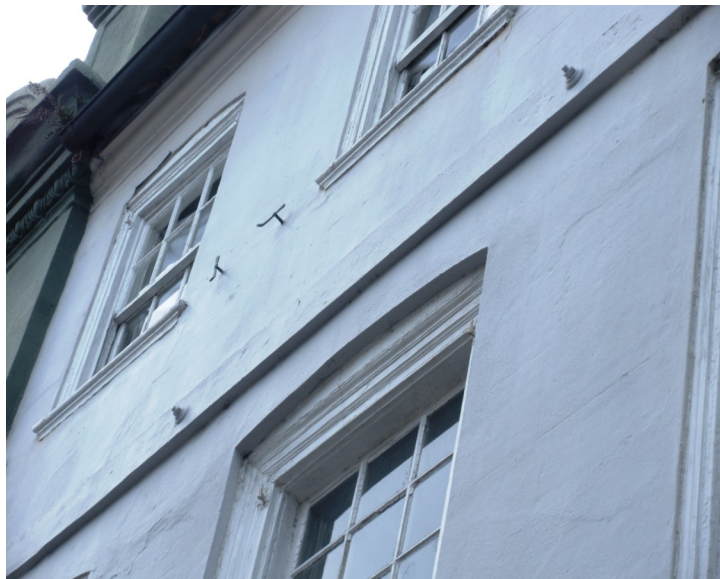
Earthquake Reinforcement Survey Form
97 East Bay Street: Photographs

The 1886 damage assessment indicates that the structure was damaged and recommends repairs to the east wall, but does not specifically recommend that the structure be anchored.

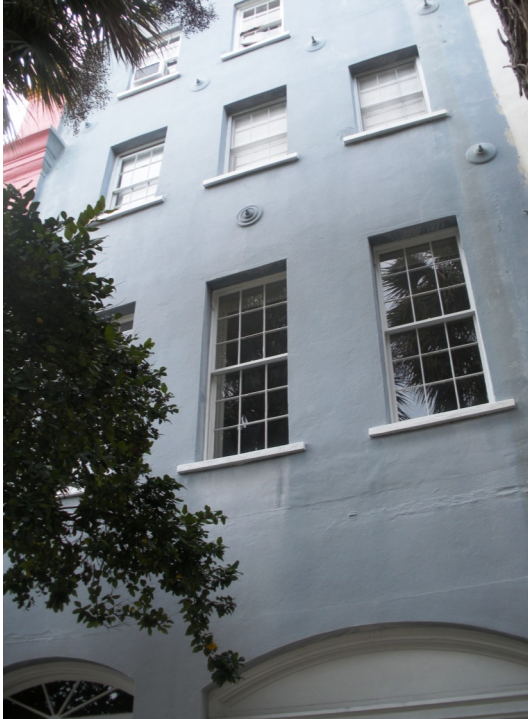
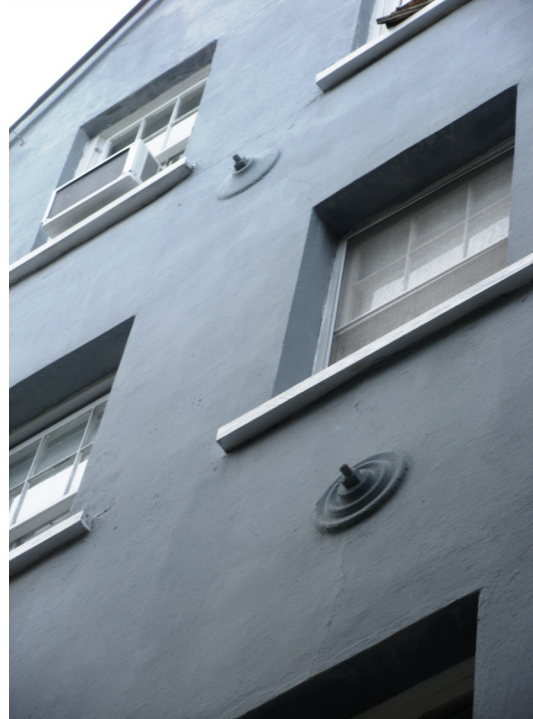
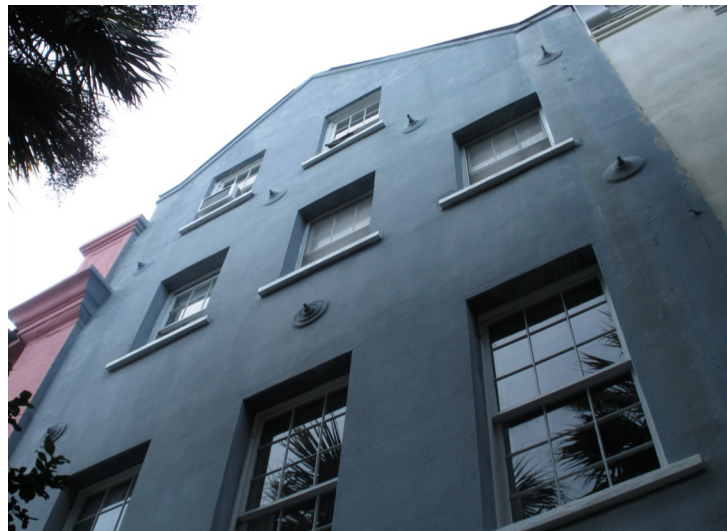
Earthquake Reinforcement Survey Form
103 East Bay Street: Photographs

The 1886 damage assessment indicates that the structure was damaged, especially the east and west walls. The assessment recommended that both walls be replaced entirely. If the walls were indeed replaced, the visible earthquake bolts could have been added as additional reinforcement to the new walls.

There are no visible signs of deterioration on any of the anchor plates or the painted stucco surface beneath the plates.

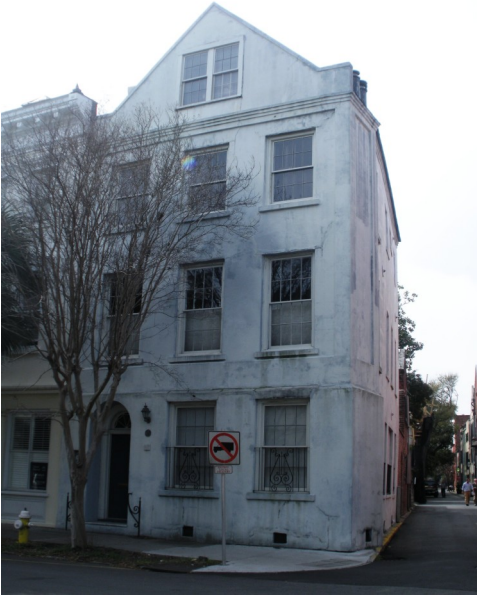
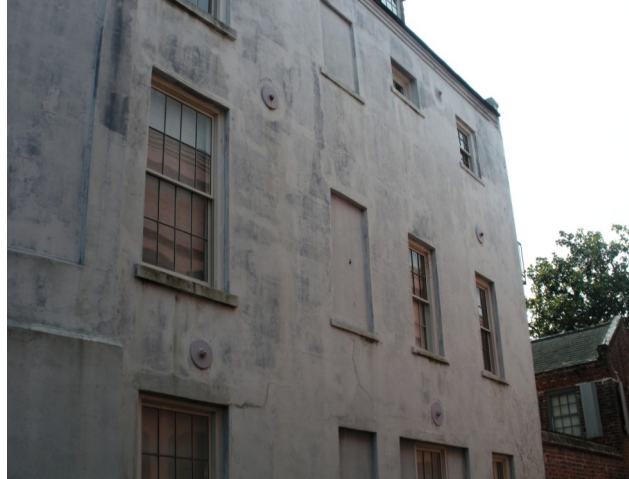
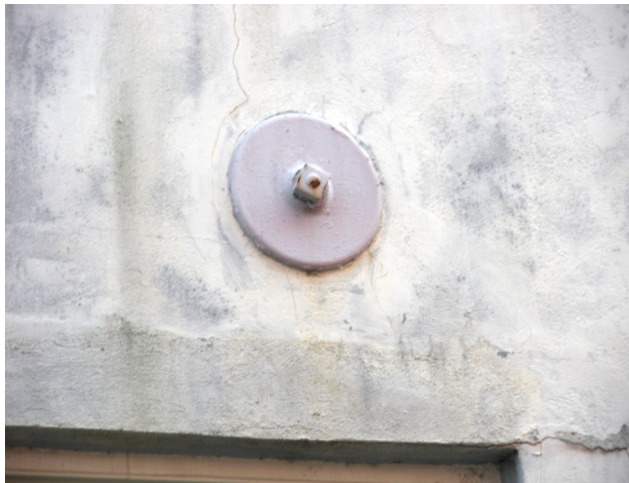
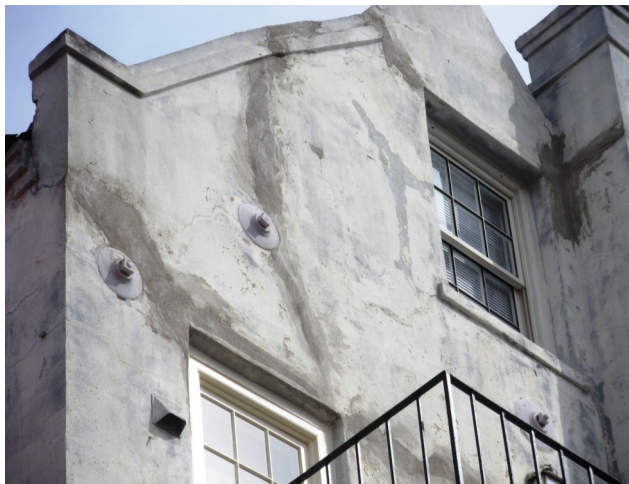
Earthquake Reinforcement Survey Form
107 East Bay Street: Photographs

The 1886 damage assessment for 107 East Bay does not have an remarks for each specific wall. However, the comments indicate that the structure had been previously anchored but remained unsafe. The absence of reinforcement on the front (east) façade supports the claim that the wall dates to post-1886.

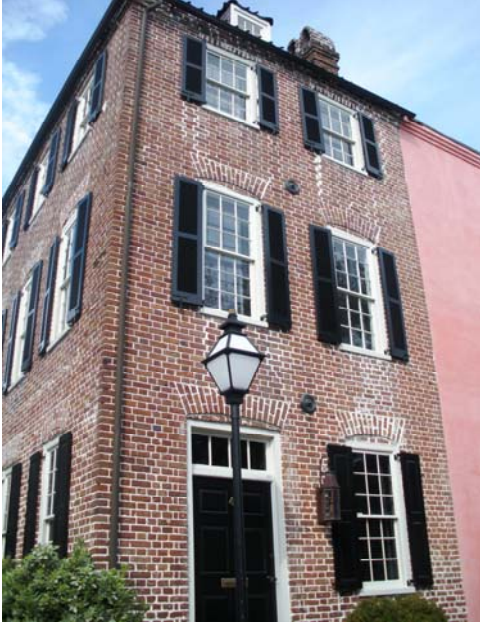
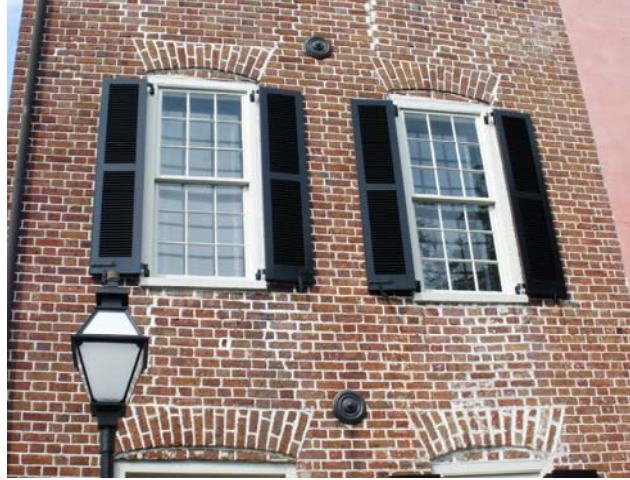
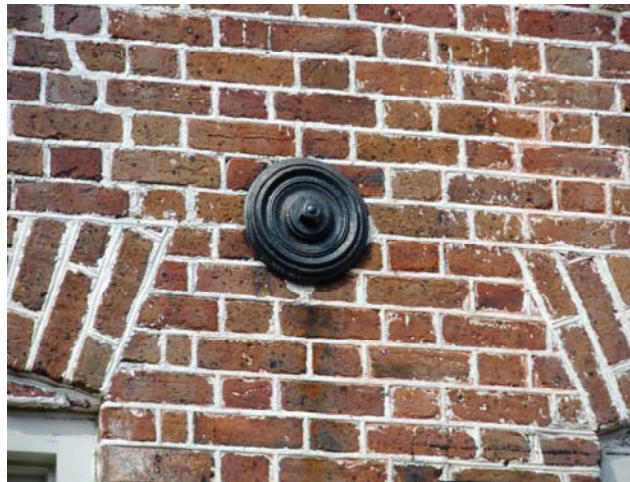
Earthquake Reinforcement Survey Form
4 Elliott Street: Photographs

The 1886 damage assessment indicates that both the north and south walls were badly damaged in the earthquake. It was specifically recommended that the south wall be anchored. Although the north wall is not visible because it faces the back of the property, it is possible that the anchors visible on the south extend all the way through.

There are no signs of deterioration of the anchor plates or the brick surface beneath the plates.
