Ties That Bind: The Emergence of Iron Tie Rod Reinforcement in Load Bearing Masonry Buildings of Charleston, S.C.

A Thesis
Presented to
the Graduate Schools of
Clemson University and the College of Charleston

In Partial Fulfillment
of the Requirements for the Degree
Masters of Science
Historic Preservation

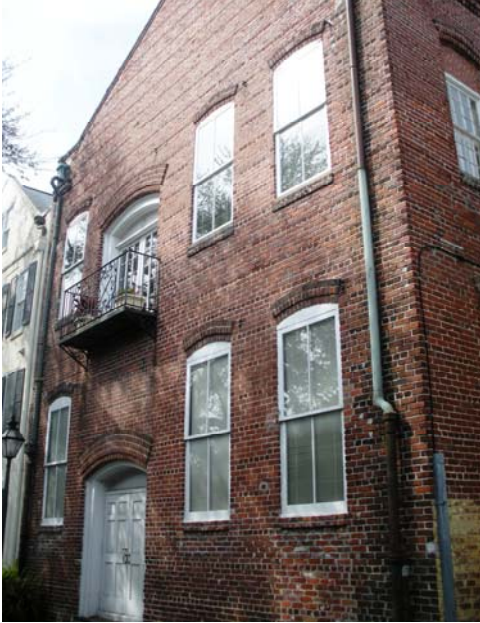
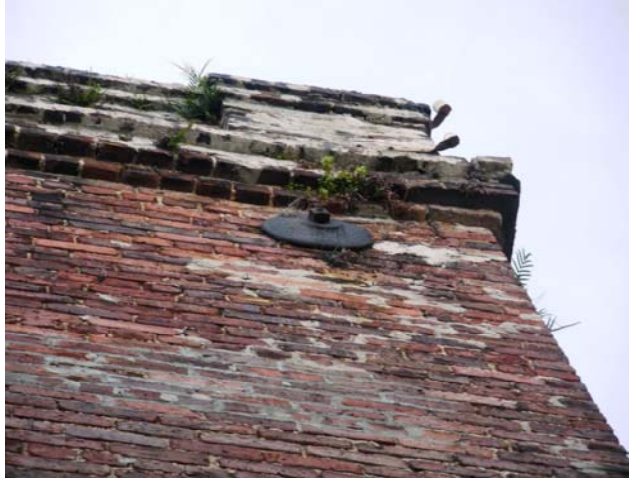
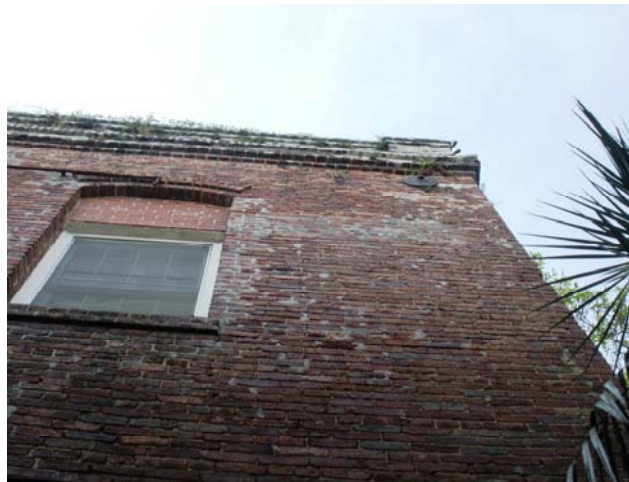
Earthquake Reinforcement Survey Form
10 Elliott Street: Photographs

There are no signs of deterioration of the anchor plates or related deterioration of the brick surface beneath the plates.

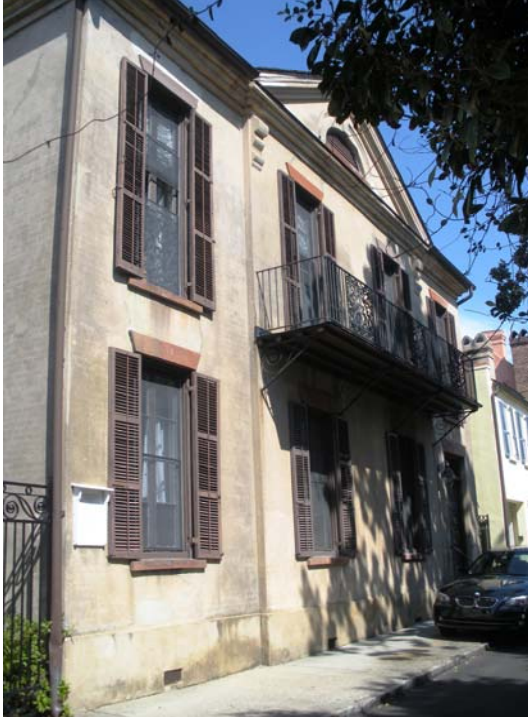
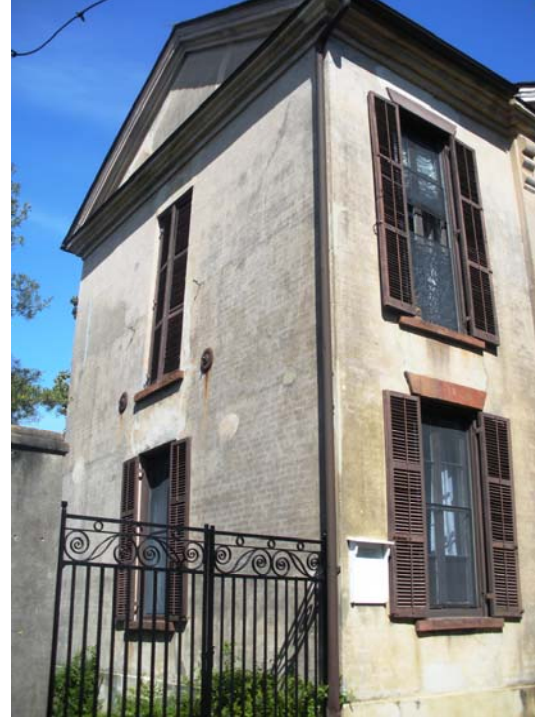
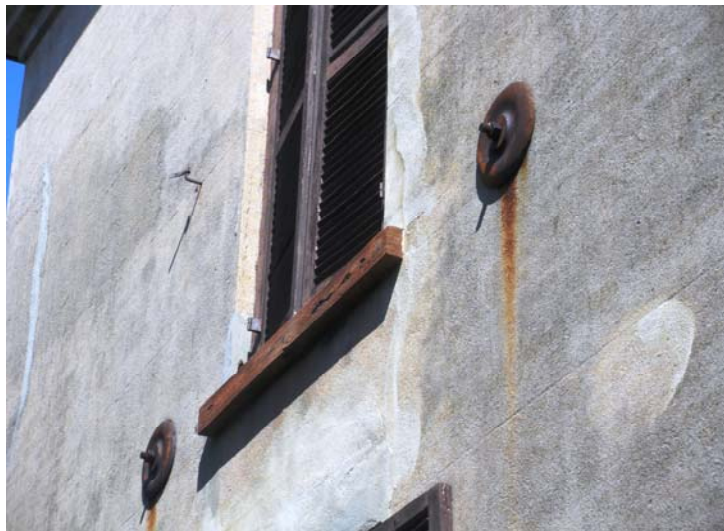
Earthquake Reinforcement Survey Form
8 St. Michael's Alley: Photographs

The 1886 damage assessment indicates that the north and south walls were damaged and specifically recommends anchoring. Interestingly, the west wall was noted as good. Yet, this wall exhibits the only visible reinforcement today.

Some stucco discoloration due to corrosion is visible beneath the plates installed on the west façade. The plates themselves also seem to show a significant amount of surface corrosion and are in need of repainting and sealing.

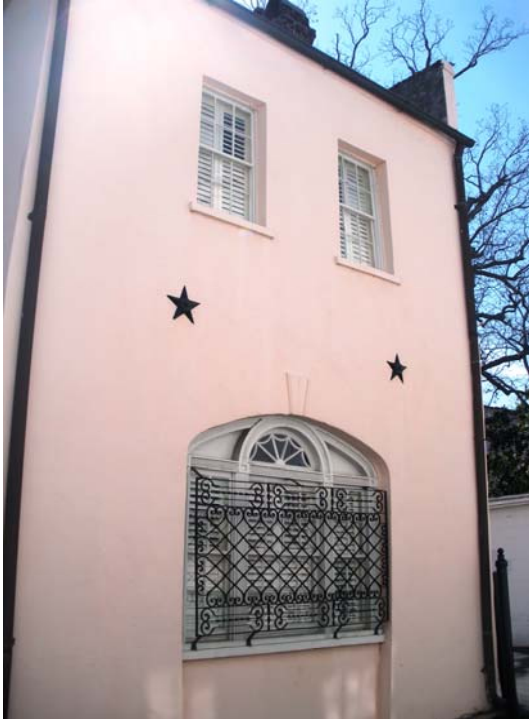
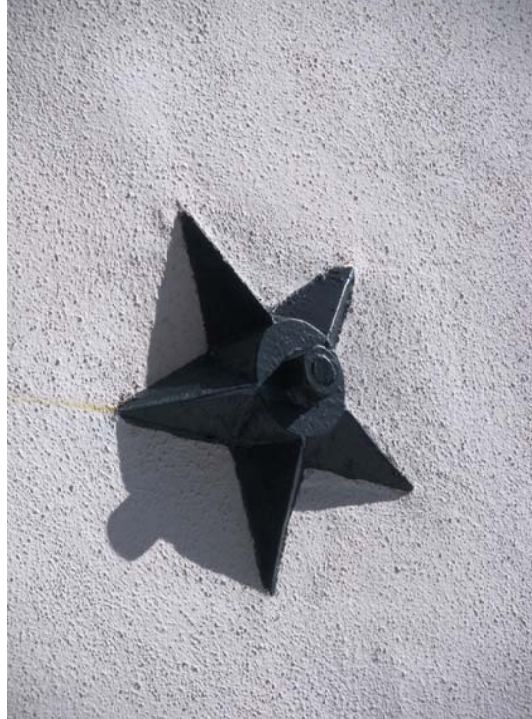
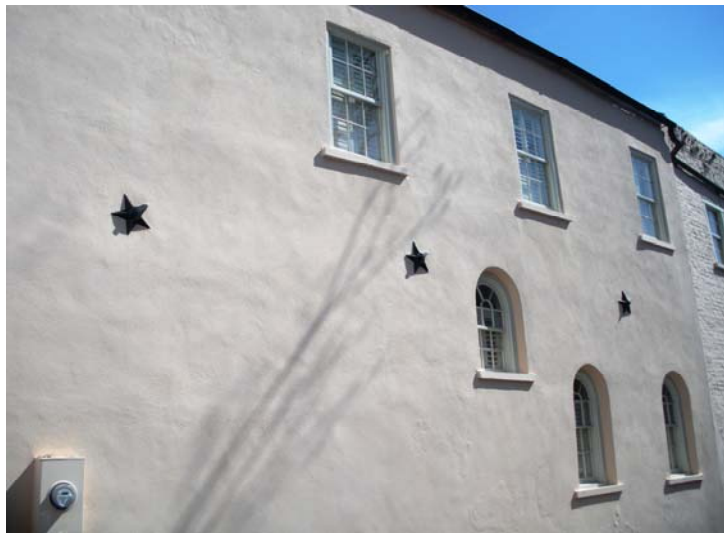
Earthquake Reinforcement Survey Form
II St. Michael's Alley: Photographs

The 1886 damage assessment indicates that all four walls were cracked as a result of the earthquake. It was also noted that the walls were already anchored. This could mean that the walls were either anchored post-earthquake but before the assessment, or were in fact reinforced pre-1886 and subsequently only cracked in the earthquake. It is difficult to determine more without further investigation.

There are no signs of deterioration of the anchor plates or related deterioration of the stucco surface surrounding the plates.

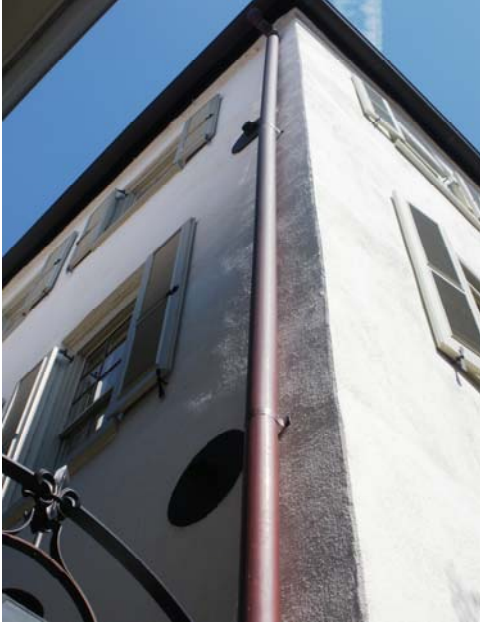
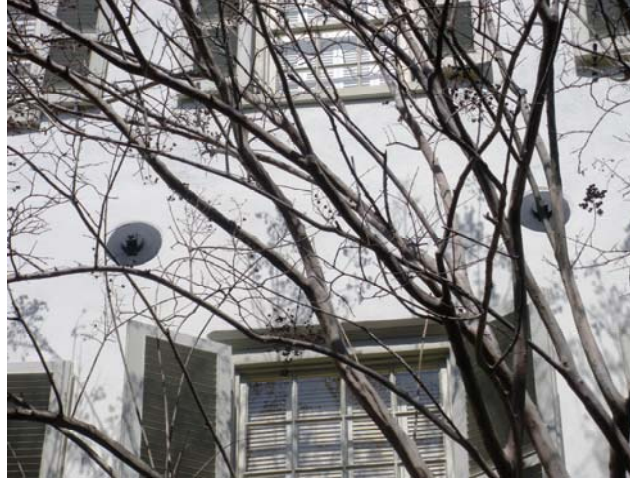
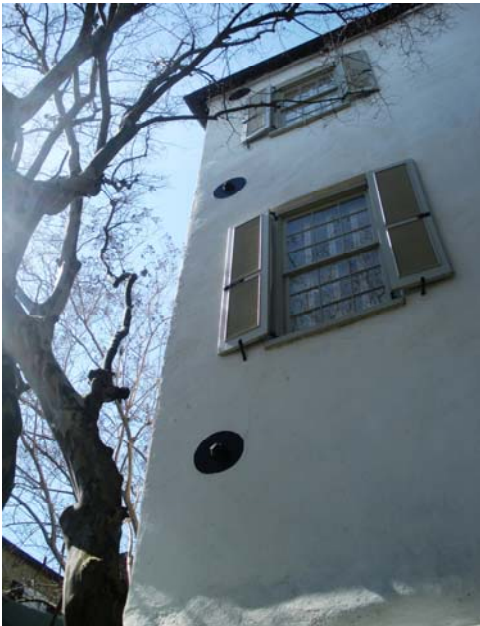
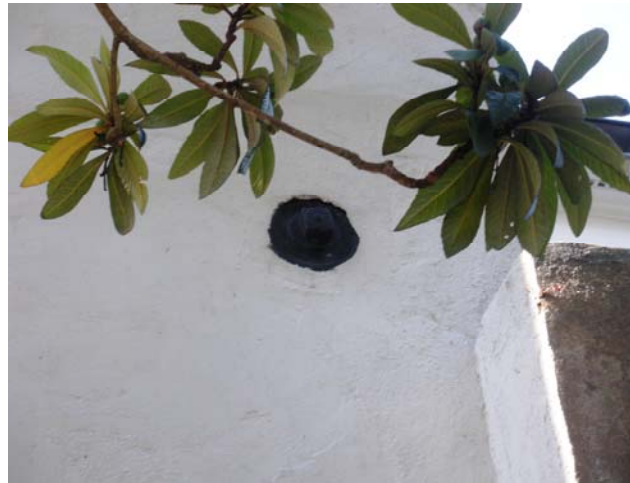
Earthquake Reinforcement Survey Form
6 Tradd Street: Photographs

The 1886 damage assessment indicates that the entire structure was badly cracked as a result of the earthquake. It was also noted that the east and west walls were already anchored. This could mean that the walls were either anchored post-earthquake but before the assessment, or were in fact reinforced pre-1886 and subsequently only cracked in the earthquake. It is difficult to determine more without further investigation.

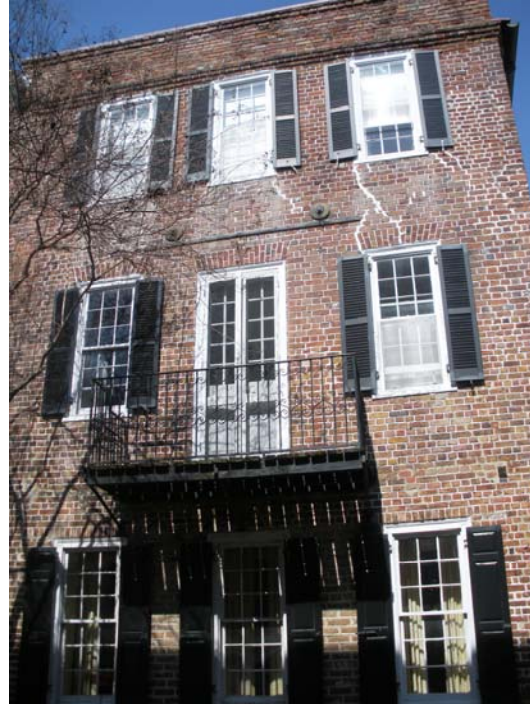
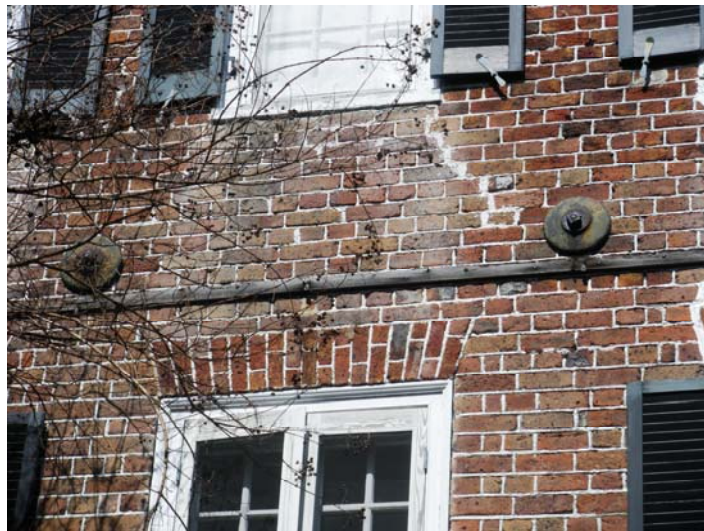
Earthquake Reinforcement Survey Form
12 Tradd Street: Photographs

The 1886 damage assessment indicates that at the time of observation all four walls were in good condition and the structure has been repaired. This could mean that the walls were either anchored post-earthquake but before the assessment took place, or were in fact reinforced pre-1886 and subsequently undamaged in the earthquake. It is difficult to determine more without further investigation.

There are no signs of deterioration of the anchor plates or the brick surface beneath the plates.

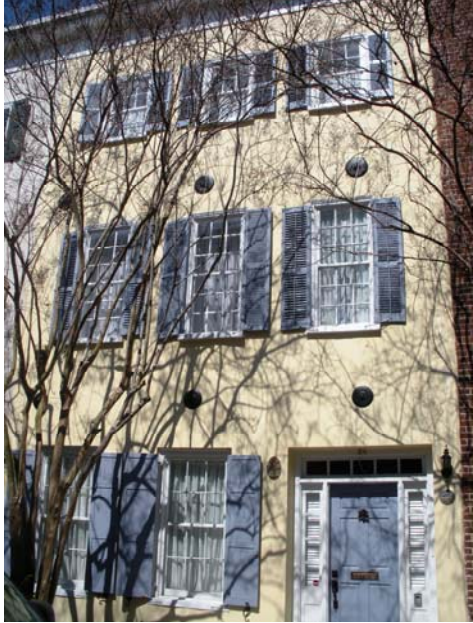
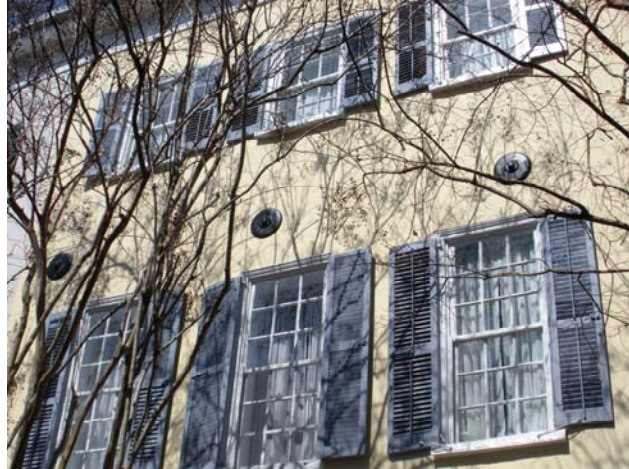
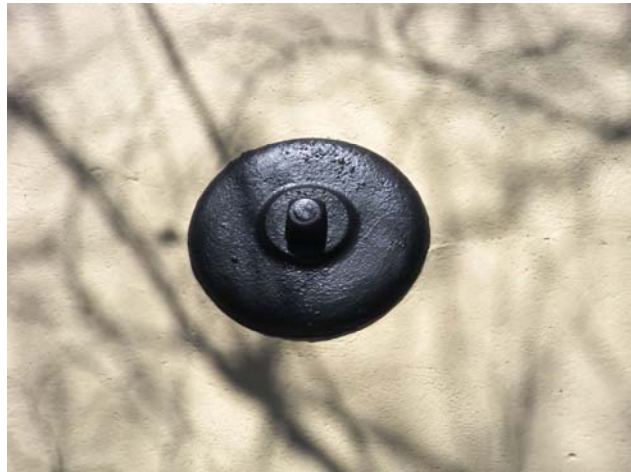
Earthquake Reinforcement Survey Form
14 Tradd Street: Photographs

The 1886 damage assessment indicates that at the time of observation all four walls were in good condition and the structure has been repaired. This could mean that the walls were either anchored post-earthquake but before the assessment took place, or were in fact reinforced pre-1886 and subsequently undamaged in the earthquake. It is difficult to determine more without further investigation.

There are no signs of deterioration of the anchor plates or the stucco surface beneath the plates.

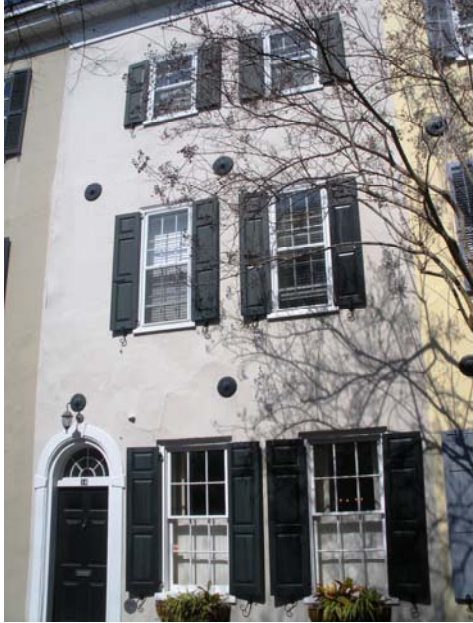
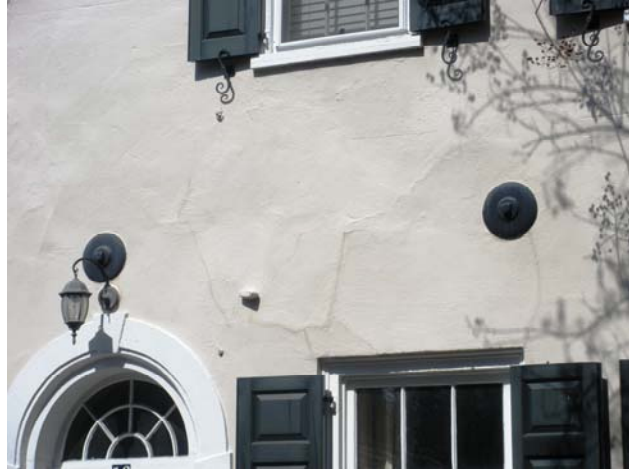
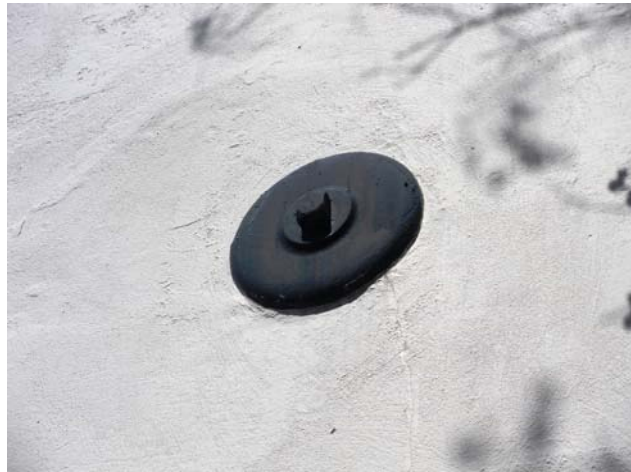
Earthquake Reinforcement Survey Form
16 Tradd Street: Photographs

The structure that occupies 16 Tradd Street exhibits a total of four anchor plates, all visible on the front (south) façade. Two plates each are installed between the first and second & the second and third floors, respectively. The anchor plates are approximately six feet apart and aligned with the left side of the façade. Presumably, these façade tie rods extend only 8-10 feet into the structure. Each of the anchor plates exhibits the same shape & form as those found on number 14 Tradd Street—circular with a relatively plain and slightly convex profile. This likely indicates that these tie rods were all part of the same reinforcement campaign.

The 1886 damage assessment indicates that at the time of observation all four walls were in good condition and the structure has been repaired. In the damage assessment, numbers 14 and 16 Tradd are assessed together. For the purpose of this survey, the structures have been surveyed individually.

There are no signs of deterioration of the anchor plates or the stucco surface beneath the plates.

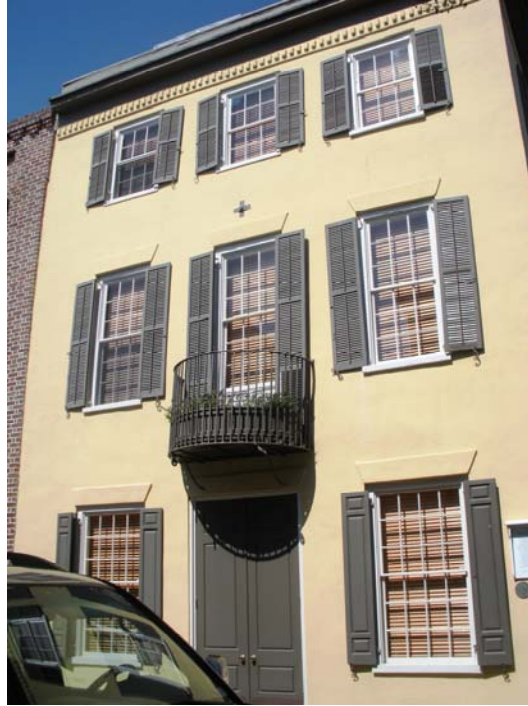
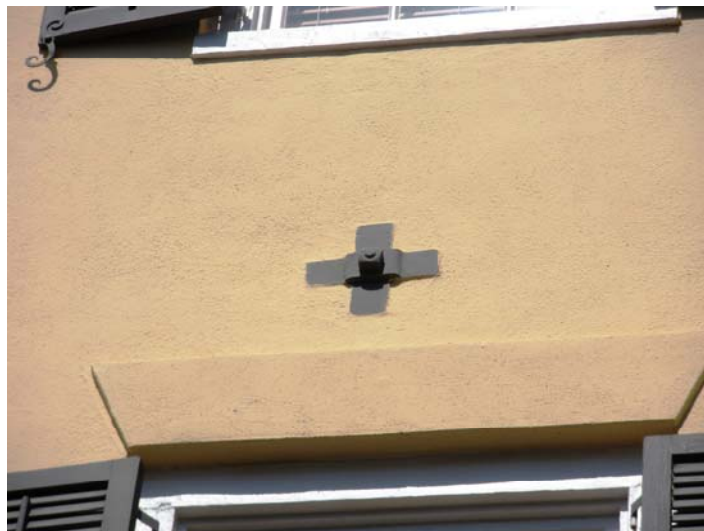
Earthquake Reinforcement Survey Form
26 Tradd Street: Photographs

The 1886 damage assessment indicates that at the time of observation all four walls were in good condition and the structure had been repaired. This could mean that the walls were either anchored post-earthquake but before the assessment took place, or were in fact reinforced pre-1886 and subsequently undamaged in the earthquake. It is difficult to determine more without further investigation.

There are no signs of deterioration of the anchor plates or the stucco surface beneath the plates.
