Energy Efficiency in Historic Structures

ENERGY EFFICIENCY IN HISTORIC STRUCTURES

A Thesis
Presented to
the Graduate Schools of
Clemson University
and
the College of Charleston

by
Sarah Elizabeth Welniak
May 2009

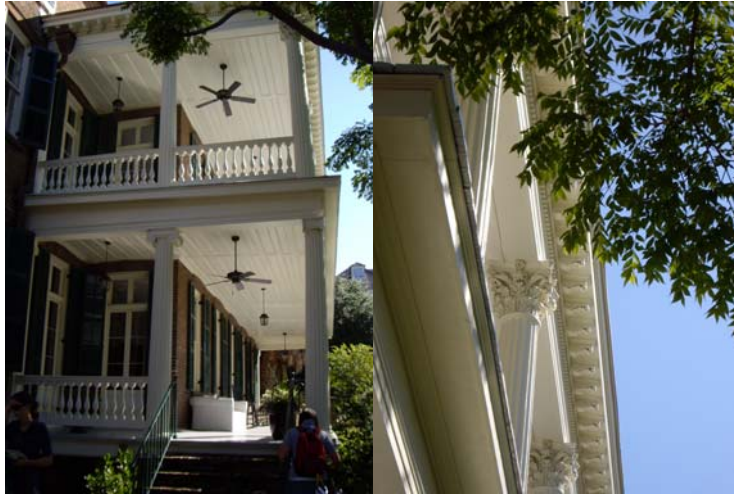
Figure 1: Porches, operable windows and shutters, and large cornices are all inherent energy saving features of historic structures. Photos by author.

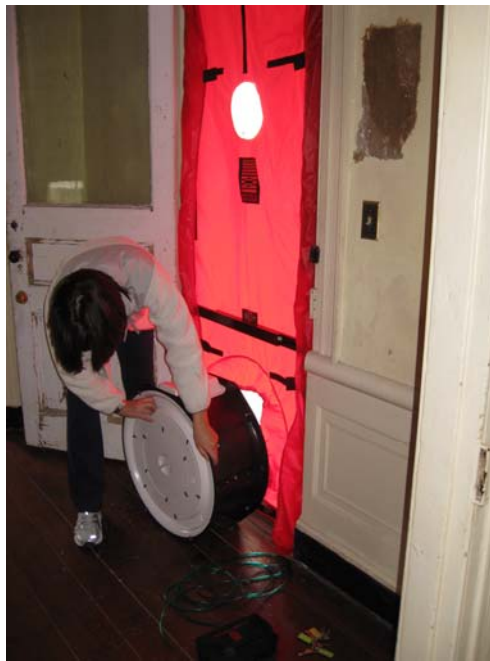
Figure 3: Blower door setup at 63 Smith Street. Photo courtesy April Wood.

It is also important to discuss the function of the blower door and duct blaster, as their readings are an important component to the overall energy audit.³¹ The blower door is a fairly simple apparatus and provides the most practical way to test air leakage in a house. The “door” essentially consists of an adjustable metal frame with an attached

³² The doorframe used must be for an exterior door so the machine can compare leakage to the outside. For this study, the primary entrance to each house was used for the blower door setup.

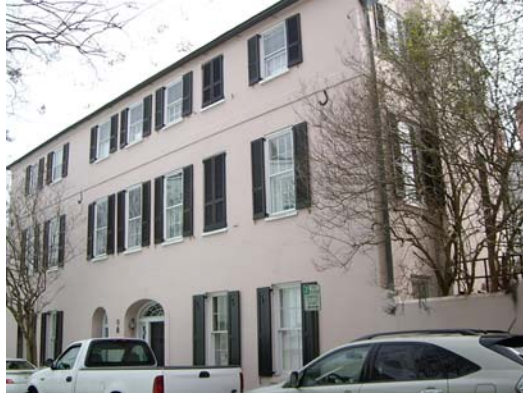
Figure 13: East Façade of 1 Tradd Street: note the operable shutters and storm windows. *Photo by author.*

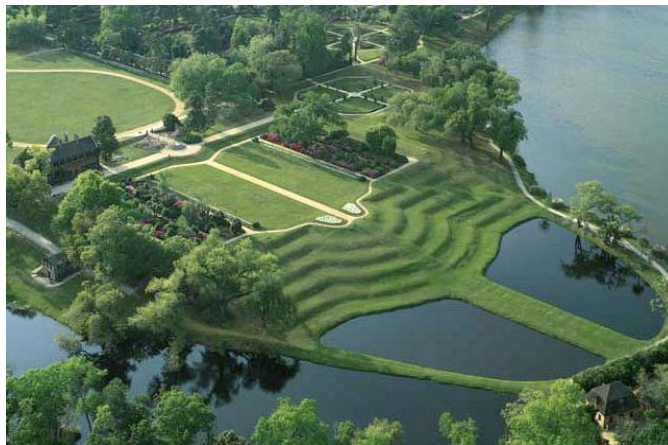
Figure 16: The house museum, located in the upper left corner, is located extremely close to tidal river waters. Photo courtesy The Middleton Place Foundation.

The museum house at Middleton Place has a small crawl space, which should not be insulated. While the house is situated at a high elevation, it is in extremely close proximity to the river and is at risk for moisture underneath the house. Like the other houses in the study, insulating the crawl space here is simply too risky given the surrounding environment.

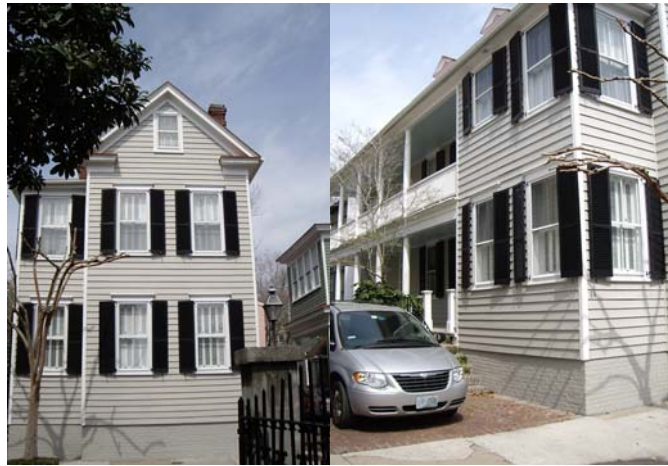
Figure 18: 84 Tradd Street has an enclosed crawl space, which is vented away from the street. Photo by author.

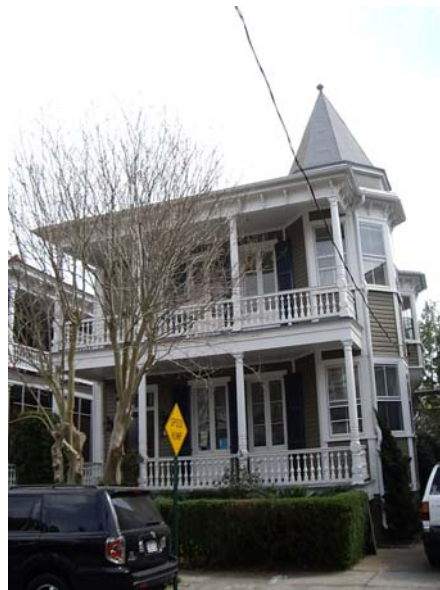
Figure 21: The French-door style windows combined with the shade of its porches once provided much-needed ventilation in its hot climate. *Photo by author.*

Nearly all of the windows in this building are original and are single pane, wood construction, but two are double pane, vinyl replacements. Storm windows are certainly an option for this house, as has been for the other houses in this study; however, like 63 Smith, this house has several floor to ceiling windows that function more like doors, opening out onto the front porches. These make storm windows difficult to use in their original fashion; instead, this study recommends using compatible wood-framed storm windows on the other facades of the house where this application is more practical. This change provides \$344 in annual energy savings for the house.

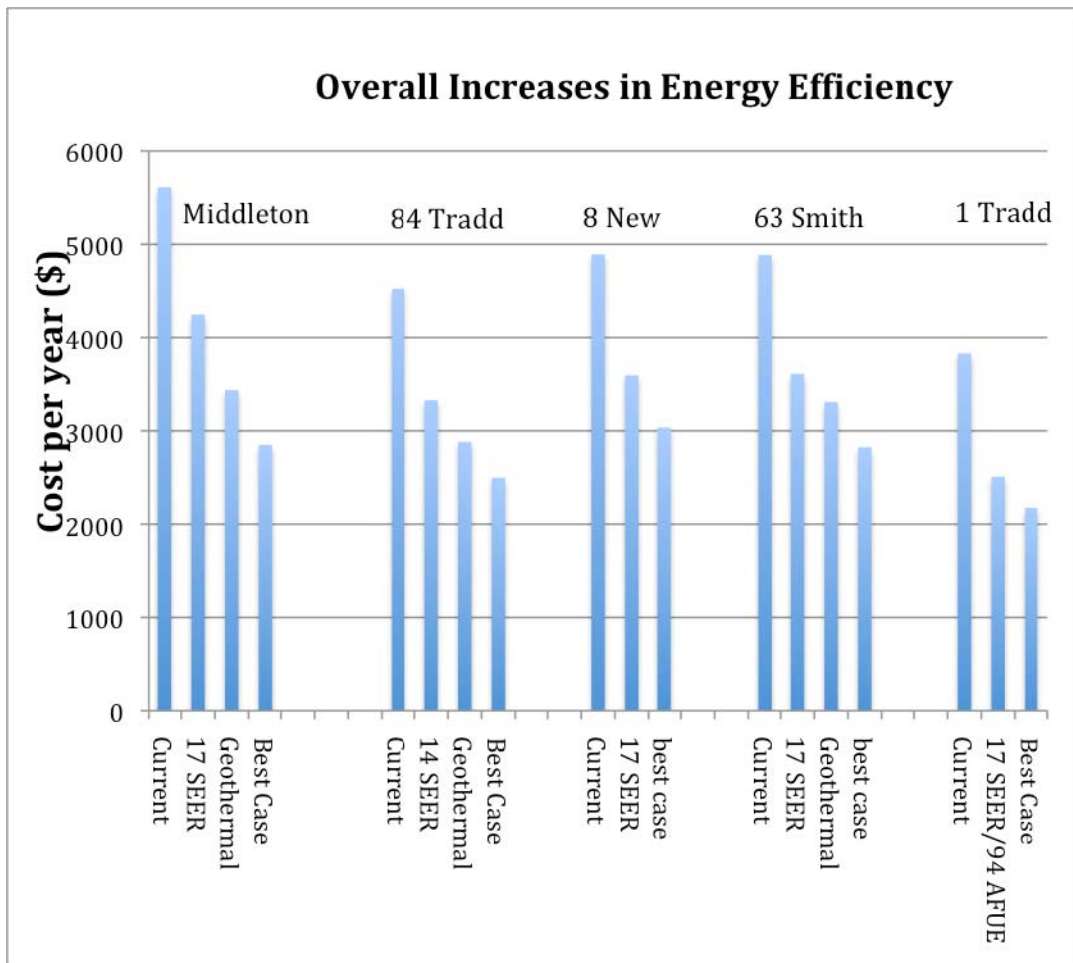
Figure 22: Energy costs for all of the houses in the study. "Best Case" refers to the changes that reduce costs the most, regardless of preservation. Those labeled for their mechanical systems reflect preservation-friendly practice.

All of the buildings studied showed the possibility for significant energy savings each year without jeopardizing the historic materials or assemblies in the house. All of the recommendations made in the study followed the principles set forth by the *Secretary of the Interior's Standards for Rehabilitation* and could be completed with fairly little disruption to the site. When all of these recommendations were combined, the savings was well over \$1000 per year for each house in the study. In fact, the annual energy savings from employing preservation-friendly retrofitting ranged from \$1300 to \$2200 for the buildings studied. Two structures qualified for an Energy Star rating with only the use of preservation- based recommendations on the house. These changes involved anything from basic batt insulation to upgrading the efficiency of the heating and cooling equipment when necessary. Although the recommendations were slightly different for each house based on their unique conditions, none required the removal of historic fabric.
