Masters Theses

12-2011

U.S Inflight Icing Accidents and Incidents, 2006 to 2010.

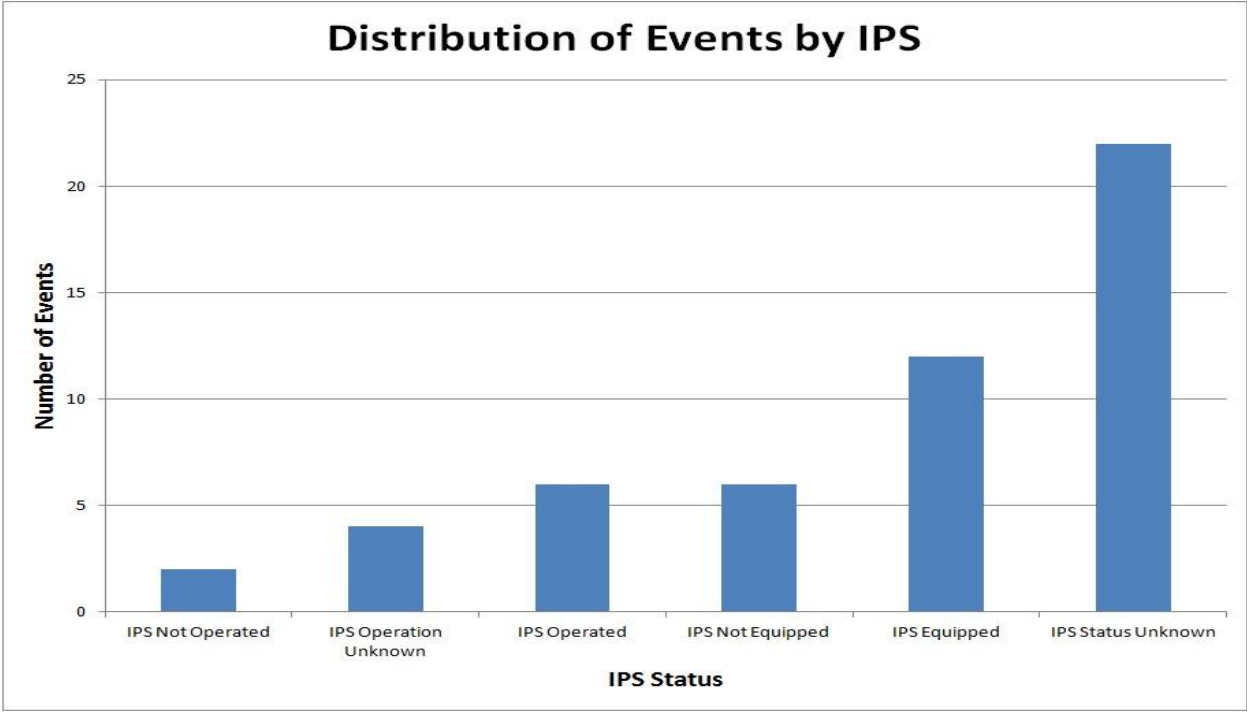
Figure 3: IPS Status and Operation

operated. Some reports also do not state whether the accident aircraft was equipped with IPS. From Figure 3 the status of the IPS equipment was unknown for 22 of the accidents.

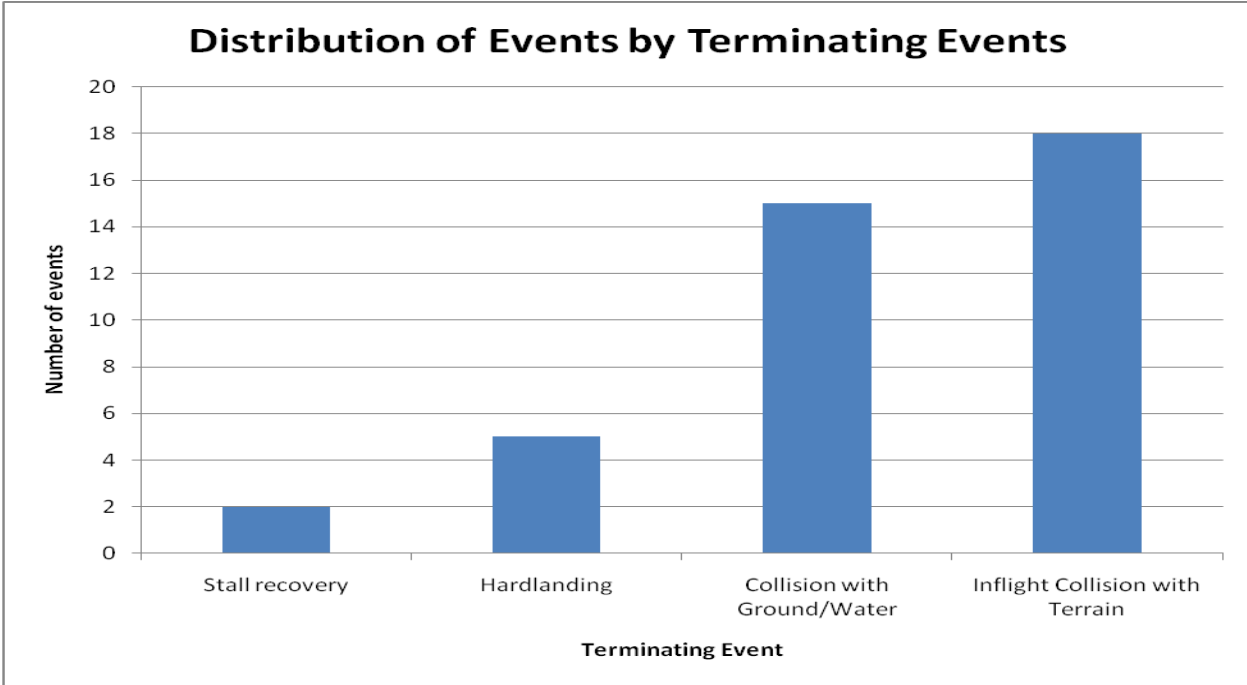
Figure 4: Distribution of Terminating Events

Out of the 40 accidents, only 2 recovered from stall. Five resulted in hard landing, 18 resulted in inflight collision with terrain and 15 resulted in a ground collision with ground or water. This is consistent with what Mr. Green observed from 1978 to 2005. Mr. Green observed that 53% of the accidents resulted in inflight collision with terrain, while 3.08% and 23.82% terminated in stall recovery and hard landing, respectively. Figure 4 shows the distribution of the terminating events from 2006 to 2010.

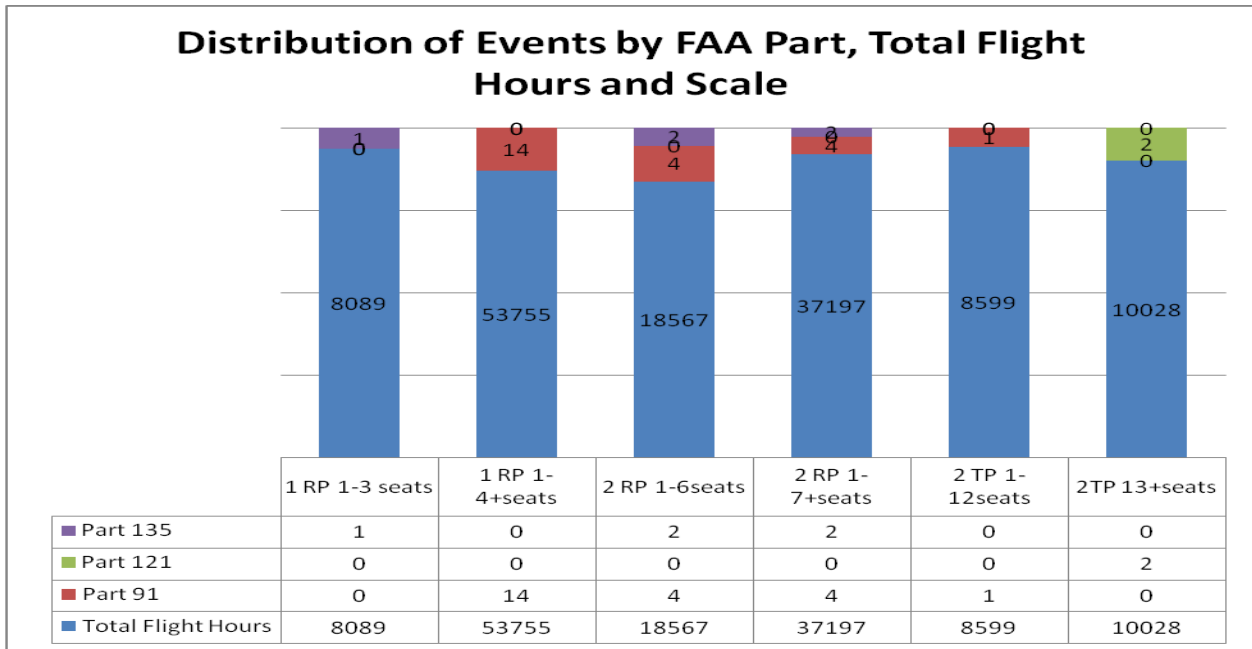
Figure 7: Distribution of Events by FAA Part and Total Flight Hours

The Part 91 aircraft which contributed to 32 out of the 40 accidents also accounted for a greater percentage of the total flight hours as show in Figure 7. The single reciprocal engine 1 to
