A Bio-Wicking System to Prevent Frost Heave in Alaskan Pavements: Phase II-Implementation

**Javad Galinmoghadam, Graduate Research Assistant
Xiong Zhang, Ph.D., P.E.
Chuang Lin, Ph.D.**

**Department of Civil, Architectural, and Environmental
Engineering
Missouri University of Science and Technology**

INE/CESTiCC 19.29

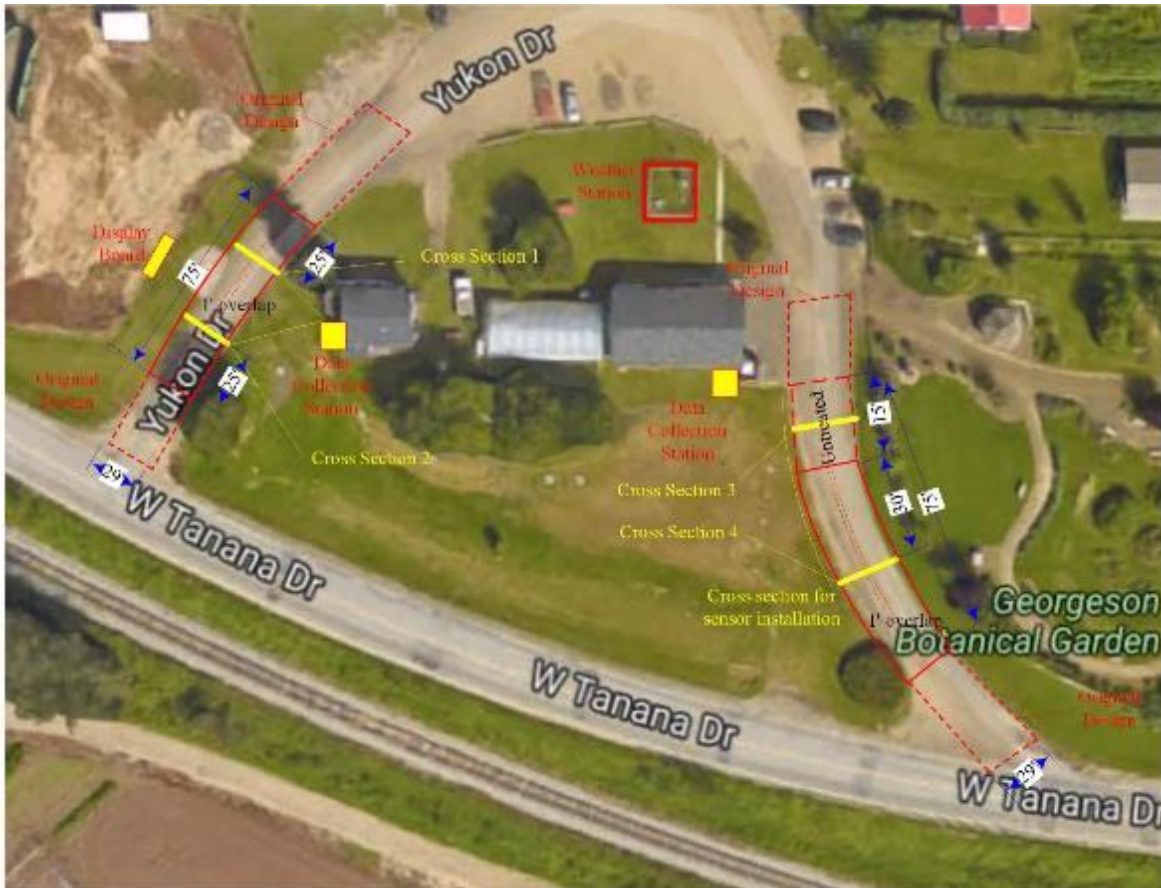
Figure 3.2 Layout of test areas

Figure 3.2 shows the selected two testing areas, one on the west side and the other one on the east side of the Yukon Drive. For the test section on the west side, the red dash line represented the original test area. However, due to the budget limit, the testing area on the west side was finalized to be 29 ft. wide and 75 ft. long and the H2Ri wicking fabric would be installed on top of the subgrade (or in-situ soil). Two locations (cross sections 1 and 2) were selected to install soil moisture and temperature sensors and detailed sensor layout designs will be demonstrated in the following section. The wirings of the sensors were collected and mounted to the data collection station on the east side of the test area (yellow cube in Figure 3.2). On the east side of the Yukon Drive, another test area was chosen. The width of the test area was 29 ft., same as the test area on the west side. However, 15 ft. of the 75 ft.-long test area did not have the H2Ri wicking fabric installed and was considered the control section. Moreover, two locations

within the untreated and treated areas (cross sections 3 and 4) were selected to install sensors. The wirings of the sensors were also collected and mounted to the data collection station located on the west side of the test area.

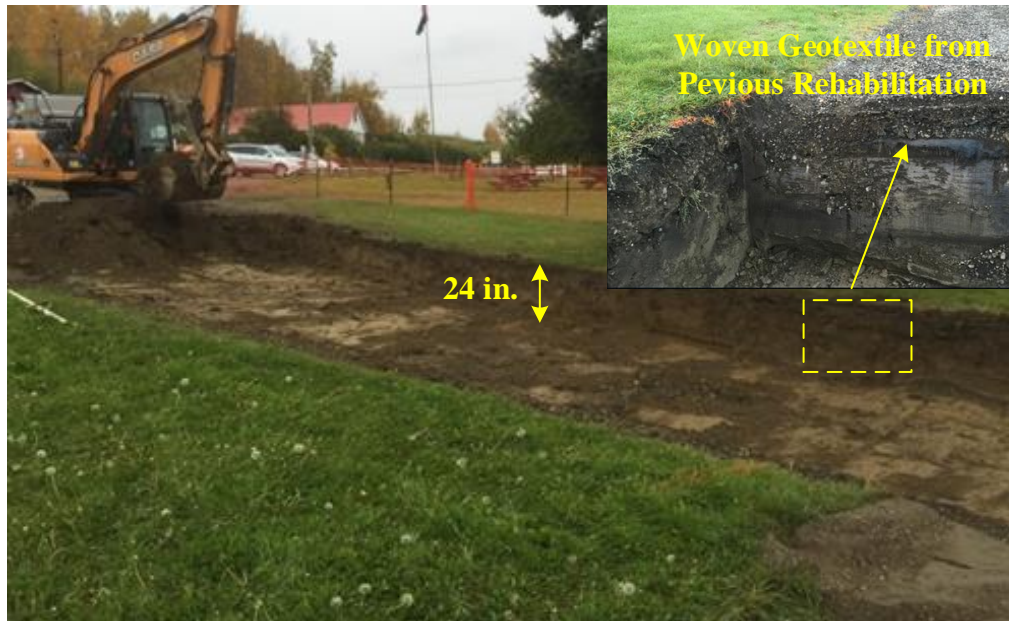
Figure 3.6 Excavation of the test section on the west side

The construction phase of Test Section I started on September 20, 2017 and lasted for four days. The construction work was contracted to Weber Inc. and commenced at the west test area, as shown in Figure 3.6. The topsoil was first removed and the excavation depth was 24 in. During the excavation process, old woven geotextile debris from previous rehabilitation was observed, indicating that the traditional woven geotextile was not effective in dealing with frost boil issues. During the excavation process, the subgrade soil was graded to a 2% grade from west to east so that water flowed to the exit at the southeast corner of the excavation. The excavation

depth was measured and controlled by a GPS device and ranged from 24 in. to 26 in. The final excavation length was 75 ft., and a width of 21 ft. on the north side and 18 ft. on the south side.

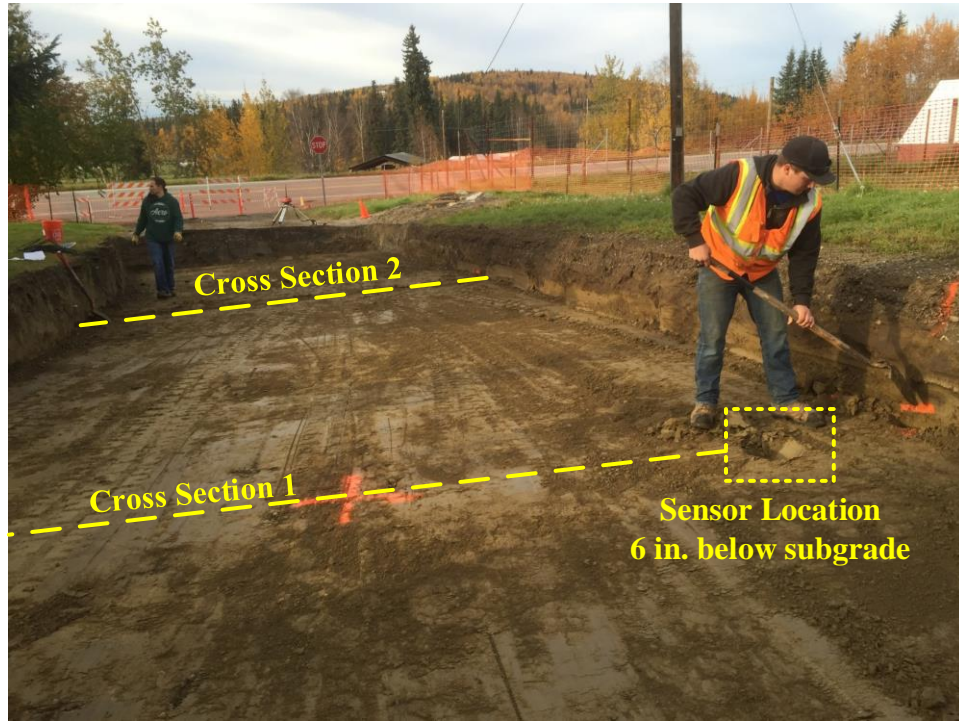
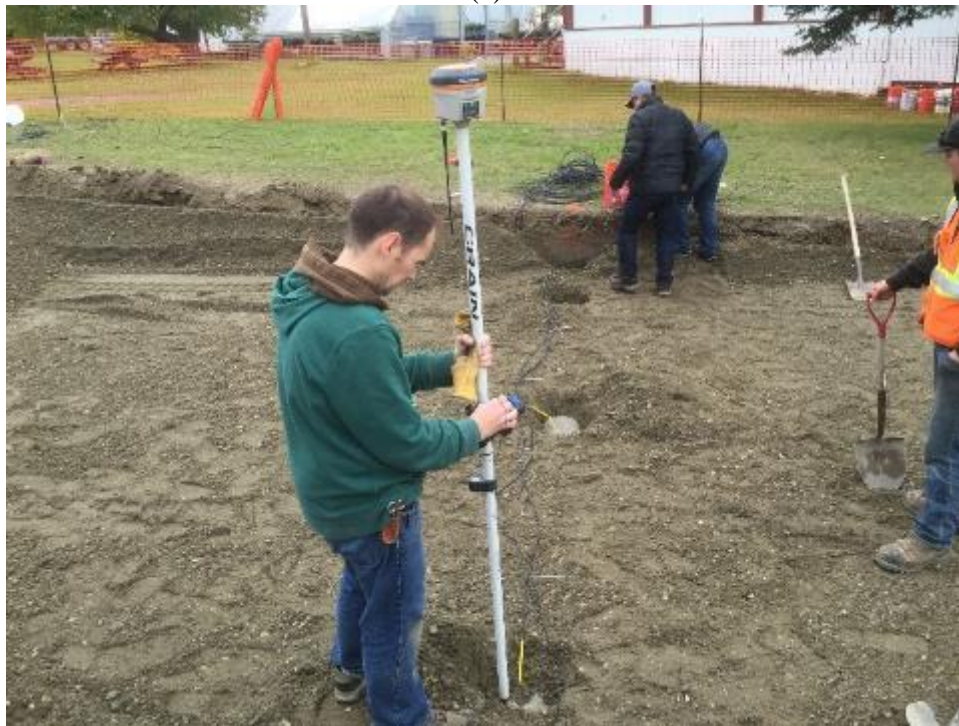
Figure 3.7 Determination of Cross Sections 1 and 2

Figure 3.7(a) shows the determination of the cross sections 1 and 2. After the excavation had been completed, the Cross Section 2, which was 25 ft. north of the edge of west test area, was determined and marked. Then, the Cross Section 1, which was 25 ft. north of Cross Section 2, was also marked. After that, the locations of the first layer of sensors were determined. A shovel was used to dig a 6-in. deep hole into the subgrade soil and a GPS device was used to check the buried depth, as shown in Figure 3.7(b).

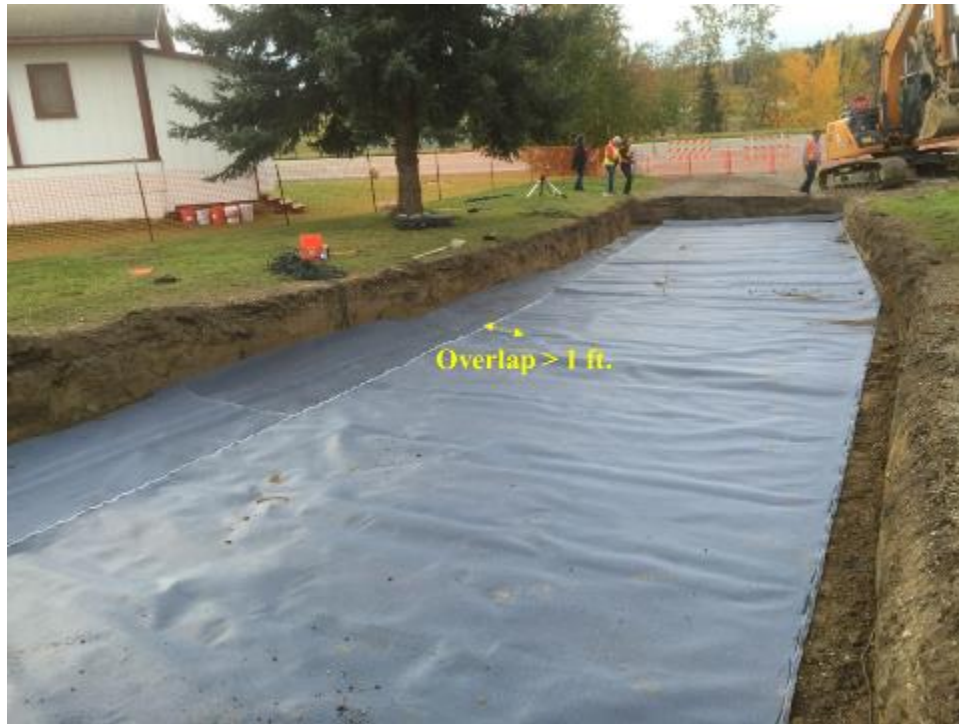
Figure 3.9 Installation of H2Ri wicking fabric

After the first layer of sensors were installed for both Cross Sections 1 and 2, the H2Ri wicking fabric was installed, as shown in Figure 3.9. As mentioned in the test design section, there were several critical aspects requiring special attention. Firstly, the overlapping width of two pieces of the wicking fabrics was 1 ft. Secondly, the wicking fabric at the edge of the roadway should be at the bottom of the wicking fabric installed beneath the main lanes. This requirement allows excess water to flow from the main lanes to the edges. Thirdly, for the wicking fabric installed at the main lanes, the direction of the wicking fiber is parallel to the transverse direction of the road. However, the direction of the wicking fiber is parallel to the longitudinal direction of the road at the edge of the roadway.

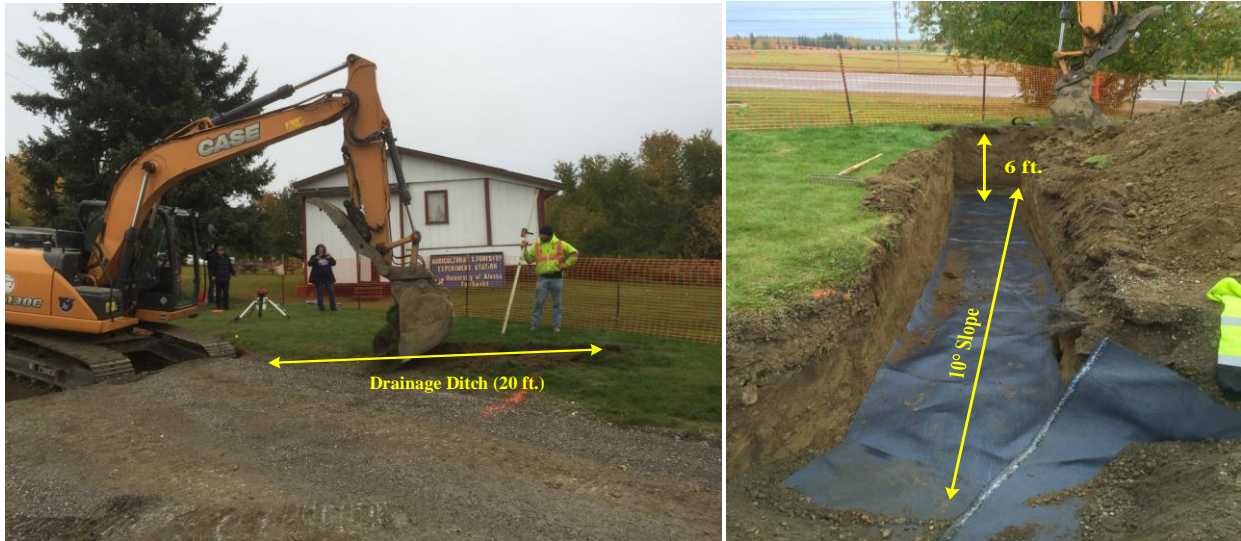
Figure 3.10 Excavation of drainage ditch

After completion of the installment of the H2Ri wicking fabric, a drainage ditch was excavated to direct the excess water to a dry well located on the southeast corner of the test section, as shown in Figure 3.10. The length and depth of the drainage ditch was 20 ft. and 6 ft., respectively. The drainage ditch was leveled to a 10° grade so that the excess water could be directed to the dry well. Then, the subgrade soil was backfilled to the drainage ditch. To direct the surface water to the dry well, a second layer of the H2Ri wicking fabric was installed. One soil moisture sensor was also installed within the backfill subgrade soil to monitor the water content variations within the dry well. Finally, the trench and the dry well were backfilled with Type A fill and compacted to the same grading of the roadway using a vibratory plate compactor.

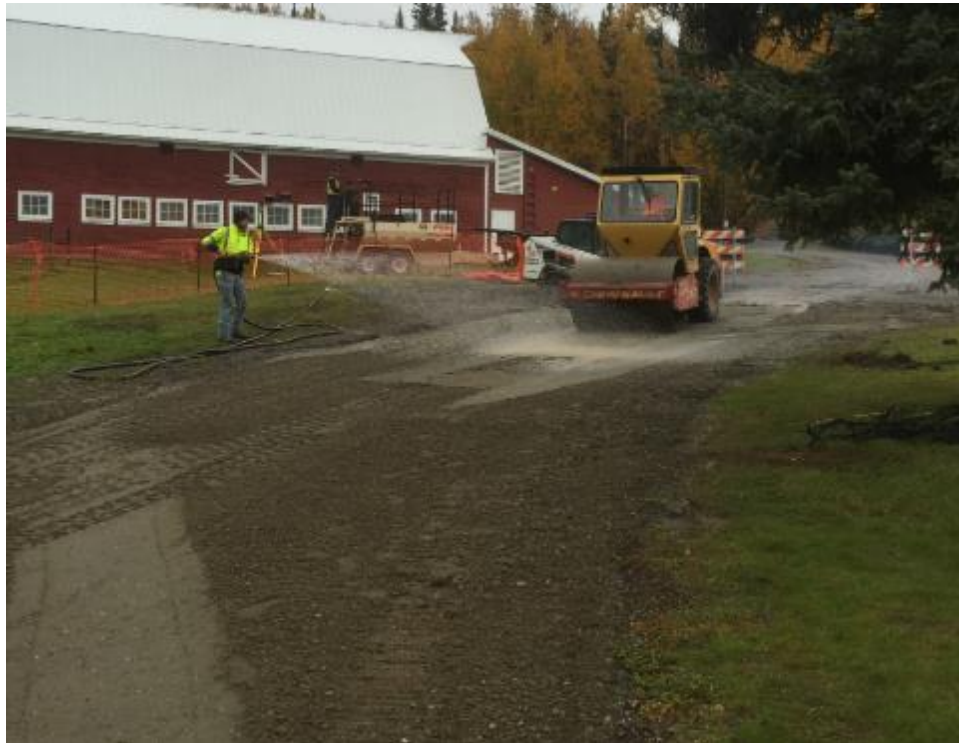
Figure 3.12 Compaction of Type A fill

As for the main lanes of the roadway, the second layer of sensors were installed at Cross Sections 1 and 2 before the Type A fill was placed on site. The sensors were located 2 in. above the H2Ri wicking fabric. After the sensors were installed in place, an intermediate vibrating

compactor was used to compact the Type A fill, as shown in Figure 3.12. Water was spread on the road surface to facilitate the compaction process. The Type A fill was compacted to a thickness of 10 in. and graded to 2 in. below the final road surface grade. Then, the third layer of the sensors was installed. The wiring for the final set of sensors was encased in a flexible steel conduit to protect it from possible damage from the compaction of the finishing layer. The final 2 inches of the roadway were backfilled and compacted with RAP and the final road condition after rehabilitation is shown in Figure 3.13.

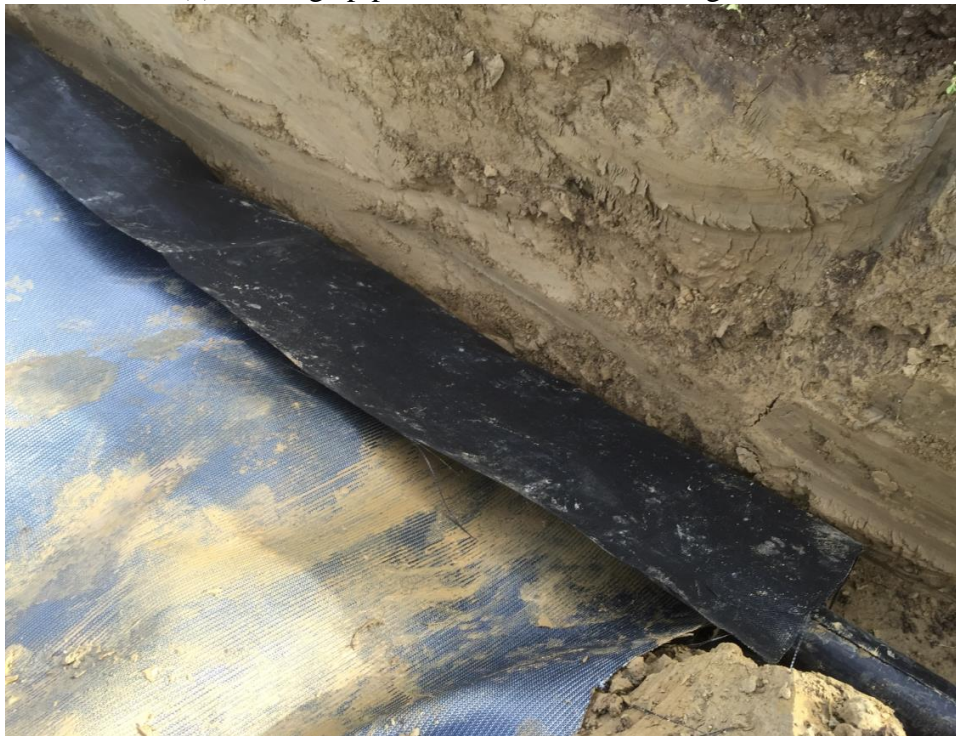
Figure 3.15 Installation of drainage pipe

Error! Reference source not found. shows the installation of the drainage pipe. The H2Ri wicking fabric was extended to the drainage trench. As shown in **Error! Reference source not found.**(a), diameter of the HDPE pipe was 3 inches and was first placed on top of the wicking fabric. The drainage pipe was cut on one edge so that the extended part of the wicking fabric could be inserted into the pipe. **Error! Reference source not found.**(b) shows the protective woven geotextile that covered the top of the H2Ri wicking fabric to prevent the pipe from clogging and the wicking fabric from being contaminated. Then, the drainage trench was backfilled with Type A fill and compacted using the intermediate vibratory compactor. Figure 3.16 shows the completion of the drainage. As shown in the figure, excess water was observed flowing out of the drainage pipe, indicating that the drainage system functioned as expected.

(a) Drainage pipe above the H2Ri wicking fabric

(b) traditional woven geotextile coverage on top of the pipe

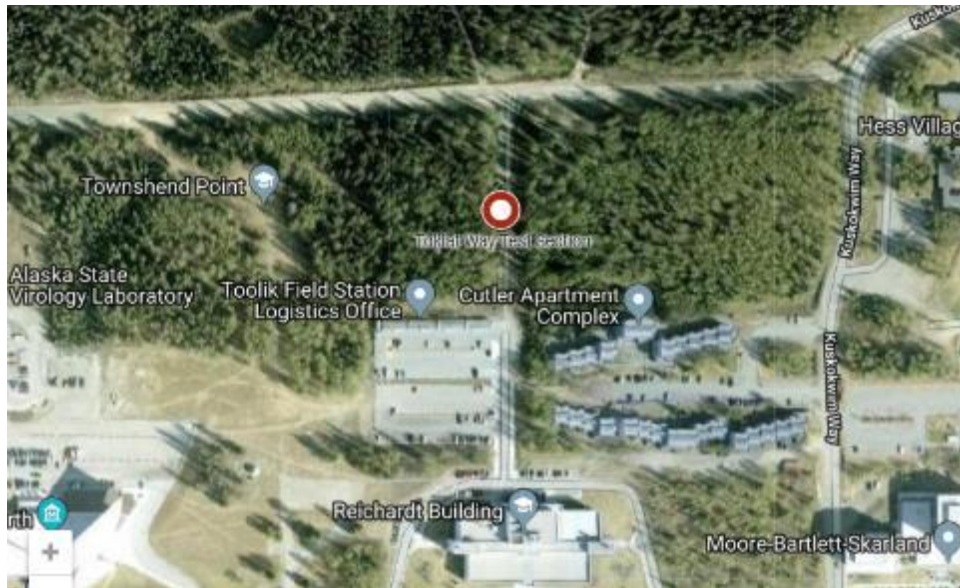
Figure 3.17 Test Section II: Toklat Way

Figure 3.17 shows the top view of the second test section, located on the north side of the Reichardt Building. The in-situ soil is a silty soil which is frost susceptible. According to previous observations, frost heave occurred during the winter and a soft spot was reported in early spring each year. Conventional treatments were not effective in dealing with frost heave issues. The purpose of this test section was to evaluate the effectiveness of the H2Ri wicking fabric to mitigate the frost boil issue.

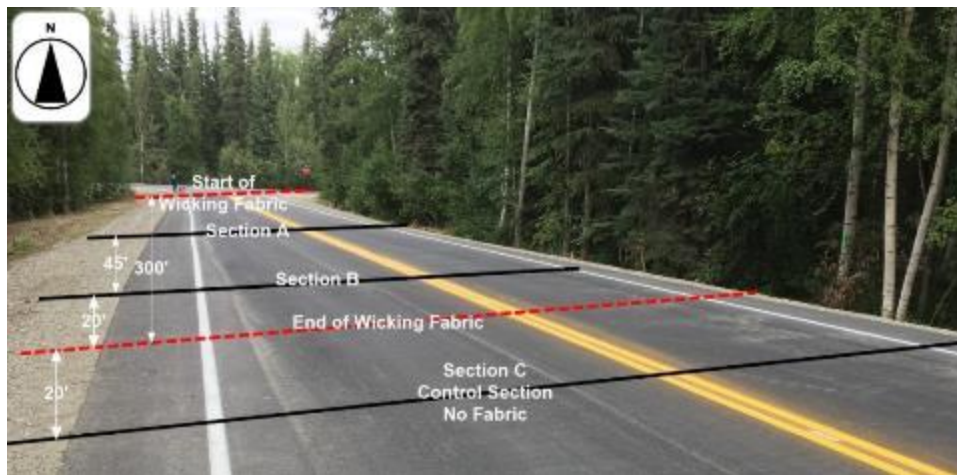
Figure 3.18 Test section layout at Toklat Way

The selected test section started at the T-shape intersection and extended 320 ft. to the south, as shown in Figure 3.18. Within the testing area, a 300 ft. out of 320 ft. test section was installed with the H2Ri wicking fabric while the remaining 20 ft. served as a control section without the wicking fabric. Within the treated area, two sections were selected, including Section A (235 ft. from the starting line) and Section B (280 ft. from the starting line).

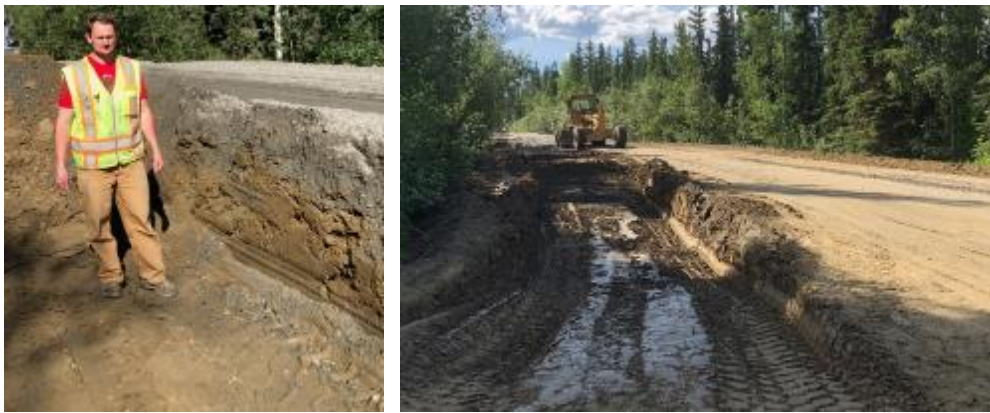
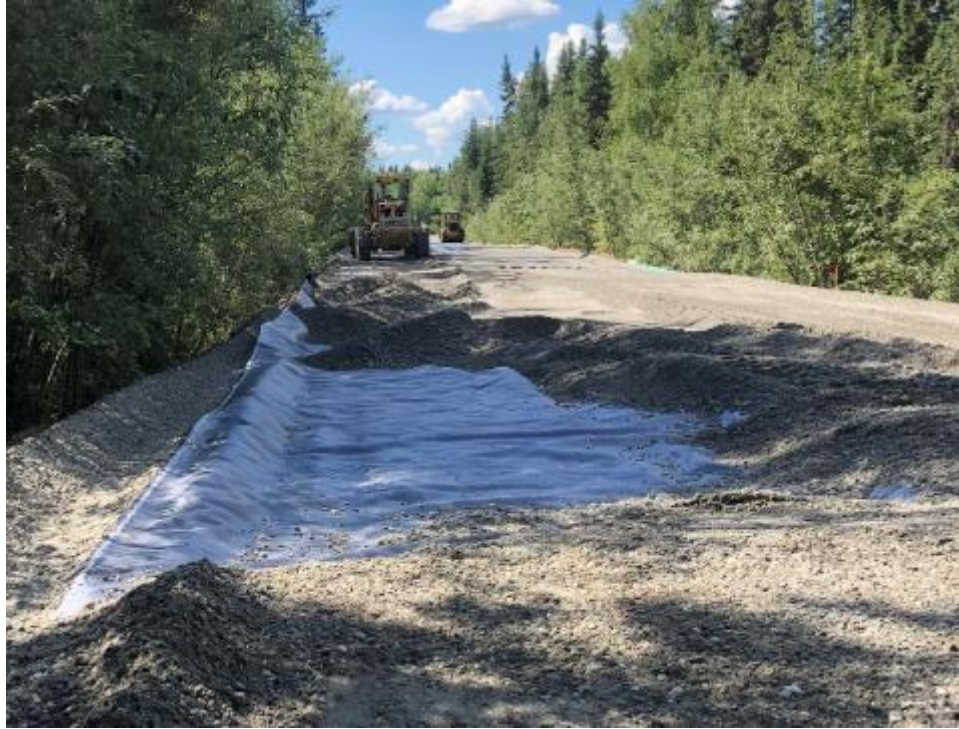
Figure 3.20 Unexpected soft subgrade on site

According to the original test design, the construction process should have commenced in 2017. However, due to budget limits, the construction was postponed to the summer of 2019. The construction ran from June 29, 2019 to July 1, 2019 and the setup of the data acquisition system was completed on July 22, 2019. It is important to point out that during the excavation process, an unexpected area with a very soft spot was observed on site at the northwest corner of testing area, as shown in Figure 3.20(a). When the construction vehicle drove on the soft spot, immediate settlement of the road embankment was observed and the soil behaved plastically. It was highly possible that the subgrade was already saturated. To prove the assumption, the soft area was excavated to a depth of 4 ft. to fully expose the subgrade layer. As shown in the figure, the subgrade was saturated and could not support the overburden traffic load. The cause of such soft subgrade could be explained as follows. Figure 3.20(b) shows the top view of the test section. In general, the elevation of southwest side was higher than the northeast side. During the spring, when snow started to melt, the melting water should flow from the southwest side to the northeast side. However, the elevation of the road embankment was higher than the subgrade and the road itself served as a water dam impeding the water flow. Therefore, the excess water ponded near the intersection and saturated the road embankment. Since the subgrade soil was frost susceptible and remain saturated in early winter due to sufficient water supply from the ponding water, frost heave was expected to occur during the winter time and ice lenses would develop throughout the winter time. Thus, when the subsequent spring arrived, the ice lenses melted and differential settlement was observed and soft spots were expected. The frost boil problem became worse and worse as the freezing-thawing cycle continued. Figure 3.20(c) further shows the 1-1 profile in Figure 3.20(b). Besides the detrimental effect of the ponding water, berms were observed at the edge of the road surface which might be caused by the repetitive

traffic load and snow plowing in winter times. Such berms formed a U-shaped road surface that would impede water drainage in the summer time. The poor drainage conditions would result in saturating the underlying road structures and accelerate the deterioration of the road embankment. The plowed snow was piled at the road slopes and could not be drained out in the early spring, which aggravated the frost boil problem.

However, without additional funding to authorize the engineering change orders, the contractor decided to follow the original design by directly installing the wicking fabric at the bottom of the excavated subgrade soil, as shown in Figure 3.20(d). It is important to point out that none of the test sections covered this soft spot and the soil moisture content within this part of the road could not be monitored. In addition, the authors argue that such treatment might not be able to mitigate the frost boil problem since the excess water could not be properly drained out of the road embankment. With sufficient water supply and the existence of the same type of frost susceptible soil, frost boil problem might reemerge in the coming year.

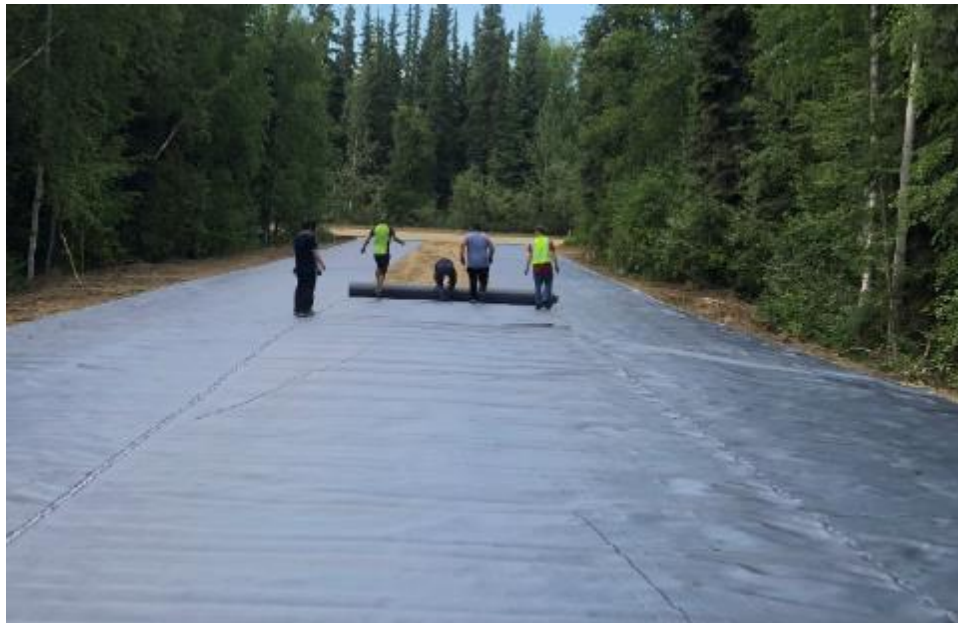
Figure 3.22 Installation of the wicking fabric

Figure 3.22 shows the installation process of the H2Ri wicking fabric. The length of the roadway was much wider than the roll length and three rolls of the wicking fabric were used. It is important to point out that the two rolls at the road edges must be installed prior to the middle one. This requirement facilitated the water draining from the center of the road to the edges and effectively preventing water flowing reversely into the road embankment during heavy rainfalls. In addition, a minimum of 1 foot of overlap was required at the contact area between two adjacent rolls.

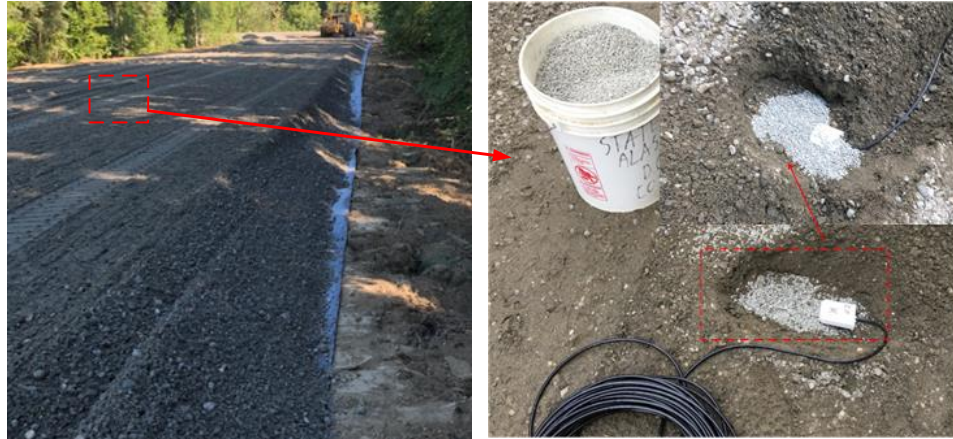
Figure 3.23 Installation of the 2nd layer of sensors

Figure 3.23 shows the installation of the 2nd layer of sensors. This layer of sensors was installed within the subbase layer that is a gravelly material. To ensure the consistency of sensor readings in gravelly material, uniform sand was used as a media. A 2 inch hole was first made and the sensor was put horizontally into the hole with the probes inserting into the sand layer. After that, the hole was backfilled with the subbase material and loosely compacted by hand. After the second layer of sensors were installed, the base course material was shipped on site and compacted with an intermediate roller, as shown in Figure 3.24(a). During the compaction process, water was continuously spread on the road and the surface of the base layer was graded with a 2^o grading in the transverse direction, as shown in Figure 3.24(b). Finally, the 2-inch asphalt surface course was paved on July 1, 2019 and Figure 3.25 shows the road surface condition after the completion of rehabilitation.

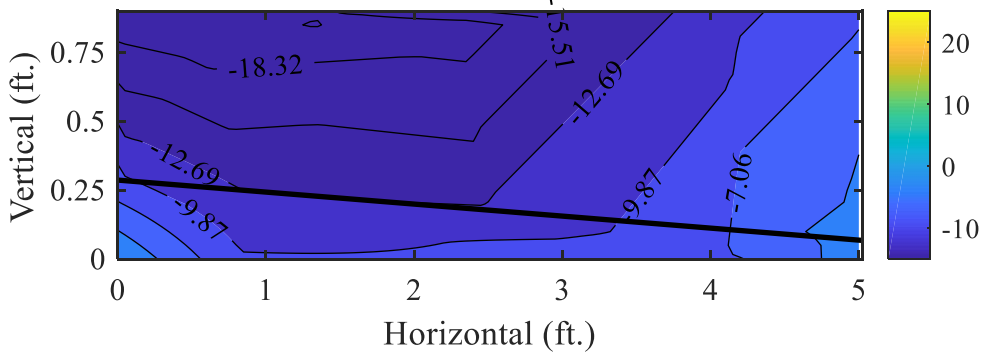
Figure 4.6 Temperature at different sections during thawing on February 1, 2018 at noon

(a) Temperature distribution at Section 1

(b) Temperature distribution at Section 2

(c) Temperature distribution at Section 3

(d) Temperature distribution at Section 4

To further demonstrate the moisture migrations within each test section, the raw data for each sensor was used to generate soil volumetric water content and soil temperature contours. Figure 4.5 Figure 4.6 show the VWC and temperature variations in each test section on February 1, 2018. This day was selected because it was in the middle of the freezing period. In the temperature contours, the freezing front was below the location of the deepest sensors and all the base course material was frozen. Consistent observations were observed in the VWC contours in which the VWC values were lower than 8% in each test section. However, VWC values near the location of the H2Ri wicking fabric were significantly lower than the rest area and the average VWC value was approximately 2% in sections 1, 2, and 4. In contrast, the average VWC was 5% in section 3 where no H2Ri wicking fabric was installed.

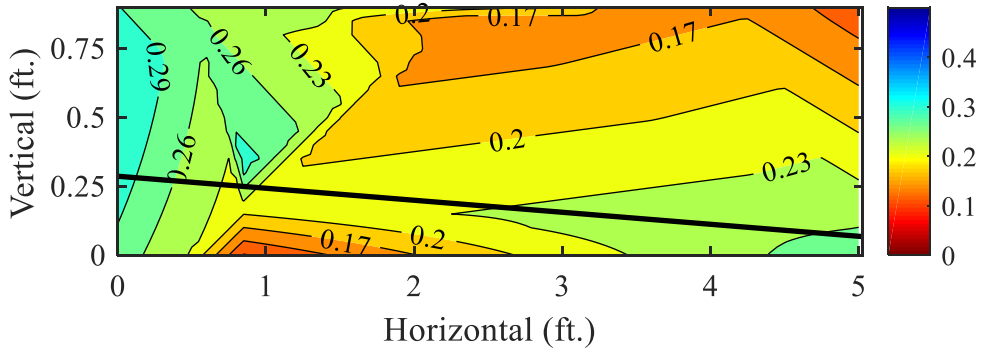
Figure 4.7 VWC at different sections during thawing on May 15, 2018, at noon

(a) VWC distribution at Section 1

(b) VWC distribution at Section 2

(c) VWC distribution at Section 3

(d) VWC distribution at Section 4

Figure 4.7 shows the volumetric water content contours in each section on May 5th, 2018. This moment occurred during the middle of the thawing season and the average air temperature was 10 °C. In each section, the sensors of the 3rd layer, which were installed within the subgrade soil, showed the peak values. In comparison, the VWC values in the 1st layer, underlying the RAP layer, reached average values of 0.17 in section 1 and section 2, 0.1 in section 3, and 0.26 in section 4, respectively. The VWC distribution in the vertical direction was more uniform in section 4, respectively. The VWC distribution in the vertical direction was more uniform in section 3 but with the lowest magnitude. However, an obvious VWC difference was observed between the locations at the wicking fabric and above it in section 4. Figure 4.8 shows that the the temperature values were all above 0°C, indicating that the entire road embankment was unfrozen at this moment of the year.

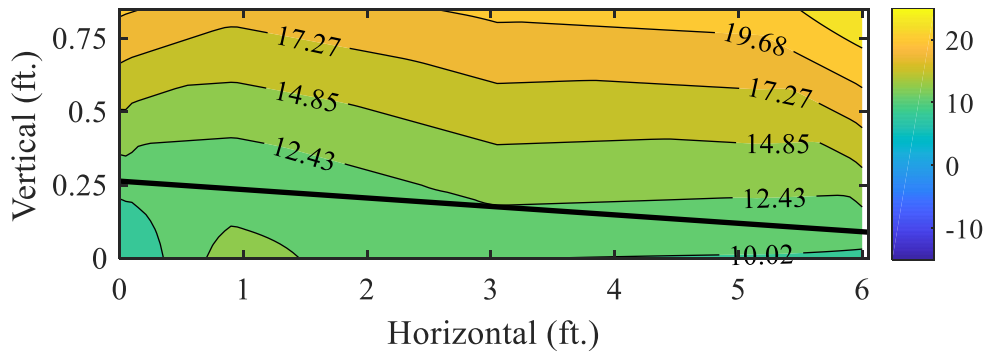
Figure 4.10 Temperature at different sections during thawing on June 20, 2018, at noon

(a) Temperature distribution at Section 1

(b) Temperature distribution at Section 2

(c) Temperature distribution at Section 3

(d) Temperature distribution at Section 4

After the thawing season has passed and all the melting water drained out of the road embankment, the VWC dropped to a lower value and kept constant until the next precipitation occurred. In order to compare the sensor readings at the end of the thawing season, the VWC and temperature contours were provided in each test section on June 20, 2018, as shown in Figure 4.9 and Figure 4.10. The figures explicitly showed the effectiveness of H2Ri in the reduction of water content. In section 1, the VWC value right beneath the RAP layer dropped from 0.17 on May 15 to 0.14 on June 20. In section 2 for the same period at the the same location the VWC dropped from 0.17 to 0.13 and the value dropped from 0.26 to 0.23 in section 4. However, in section 3 where there is no wicking fabric, VWC increased over the same period. This fact indicates that the H2Ri wicking fabric was effective and efficient in draining the excess water out of the road embankment. The soil strength was expected to increase with time and with the soil water content lower than the saturation values, the frost boil issue was expected to be mitigated.
