The Sam Houston Home, 41WA46, Huntsville, Walker County, Texas: 1980-1981 Archeological Investigations and Monitoring

Jody C. Pevey
Prewitt and Associates, Inc.

Archeological investigations at the Sam Houston Home, "The Woodlands," in Huntsville, Walker County, Texas, were conducted by Prewitt and Associates, Inc. from November 1980 through January 1981. Sponsored by the Sam Houston State University, Huntsville, Texas, the work was done in conjunction with restoration of Sam Houston's home, "The Woodlands," and an associated structure commonly known as Houston's "Law Office" (Fig. 1). Restoration work is being done by Cox Construction Company of Fredericksburg, Texas, in conformance with restoration plans developed by Bell, Klein and Hoffman, restoration architects, of Austin, Texas. The archeological work accomplished under the present contract agreement conforms to the provisions of State of Texas Antiquities Permit No. 258; the Principal Investigator was Elton R. Prewitt and fieldwork was supervised by Jody Pevey, Project Archeologist.

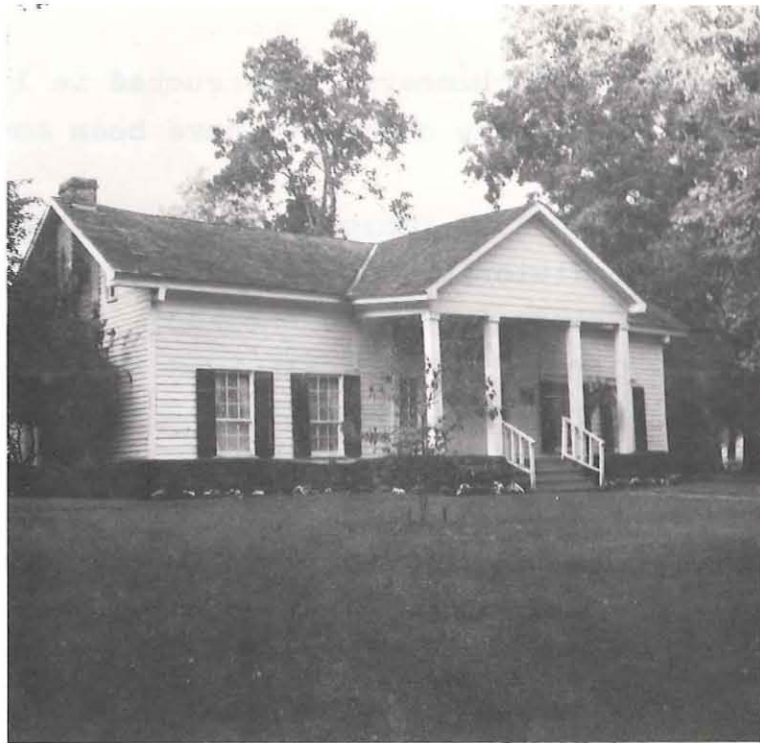
Figure 2

Figure 2. General Site Photographs

- a.* Sam Houston Home, October 1979, looking southwest, before restoration activities.
- b.* Sam Houston Home, November 1980, looking southwest, in-progress restoration activities.

(1) the house proper has been raised and placed on pine supports which coincide indirectly with the exposed 1929 cement foundation piers (Fig. 2a and b);
