Strain and damage monitoring in CFRP fuselage panels using fiber Bragg grating sensors. Part I: Design, manufacturing and impact testing

This is the first paper of a two-paper series describing design, implementation and validation of a **strain and damage monitoring system** for CFRP fuselage stiffened panels based on fiber optic Bragg grating sensors. The **monitoring** system was developed and tested on the basis of three load-scenarios: compression to failure of the undamaged panel, compression to failure of the impacted panel and compression to failure of the impacted and fatigued panel. This paper focuses on the design of the fuselage panel, the design of the **monitoring** system, the embedment of fiber sensors in the panel during manufacturing and the impact testing. The network of the sensors was designed based on a numerical buckling analysis from which the strain field of the panel was computed as a function of the applied compressive load. Embedment of fiber sensors in the panel was done so as to minimize risk of fiber breaking during manufacturing and impact testing and to effectively capture strains that are representative of damage developed in the panel due to comp

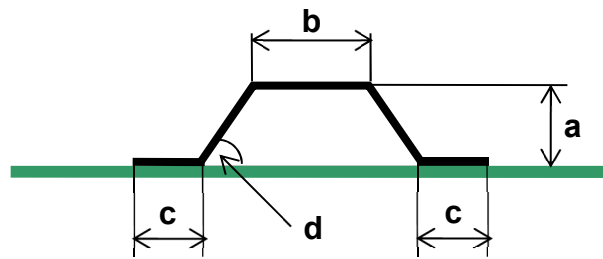
Fig.1

- Fig.1: Schematic and dimensions of the omega stringer.
- Fig.2: FE mesh of the fuselage barrel.
- Fig.3: Variation of design variables with respect to design cycles: a. number of stringers, stringer layup, stringer thickness, skin thickness.

- a:** stringer's height
- b:** stringer's upper cap width
- c:** stringer's lower feet width
- d:** angle of stringer's webs

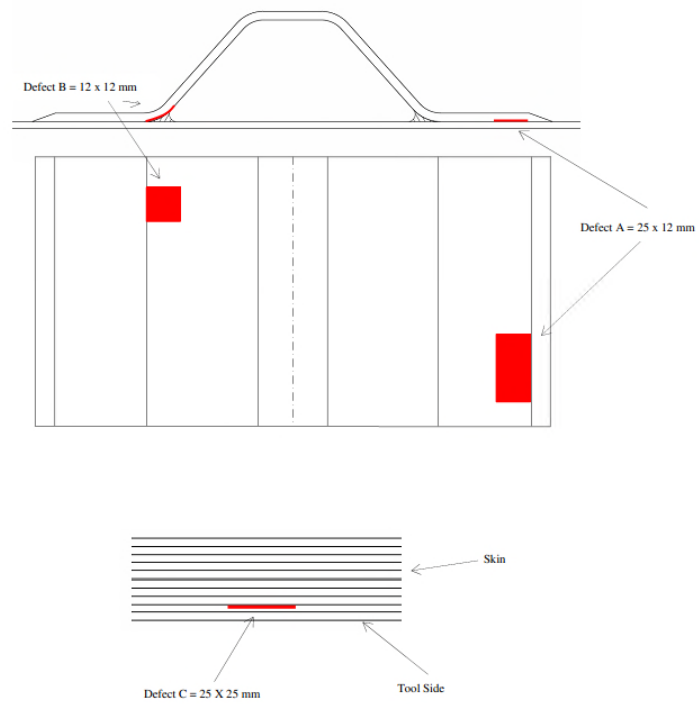
Fig.7

- Fig.7: Schematic illustrating locations of artificial delaminations.
- Fig.8: FE mesh of the flat panel used for buckling analysis.
- Fig.9: Schematic of the boundary conditions applied to the model of the panel.

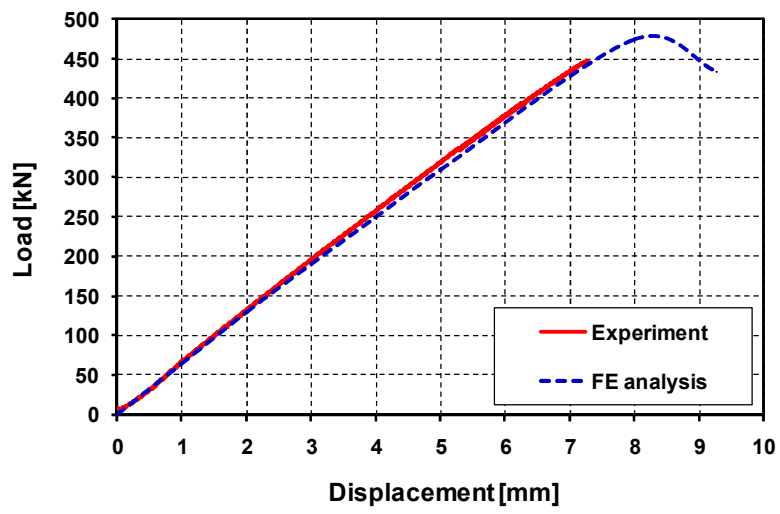
Fig.10

- Fig.10: [Comparison between numerical and experimental \[24\] load-displacement curve of the panel.](#)
- Fig.11: Predicted contour of normal displacement (in mm) and deformed shape of the panel at a. 70 kN and b. 475 kN.

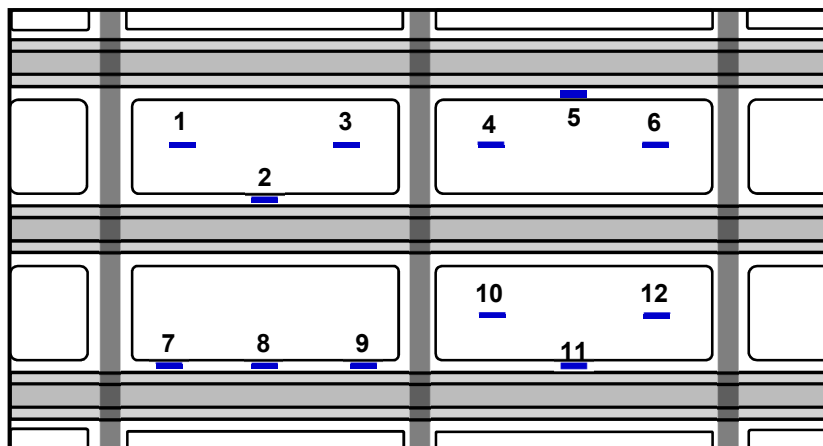
Fig.12

- Fig.12: Positioning of the sensors in the panel.
- Fig.13: a. Configuration of sensor data line, b. Close view of the sensor ingress point.
- Fig.14: C-scan graphs of the panels taken after manufacturing: a. panel_1, b. panel_2, and c. panel_3.

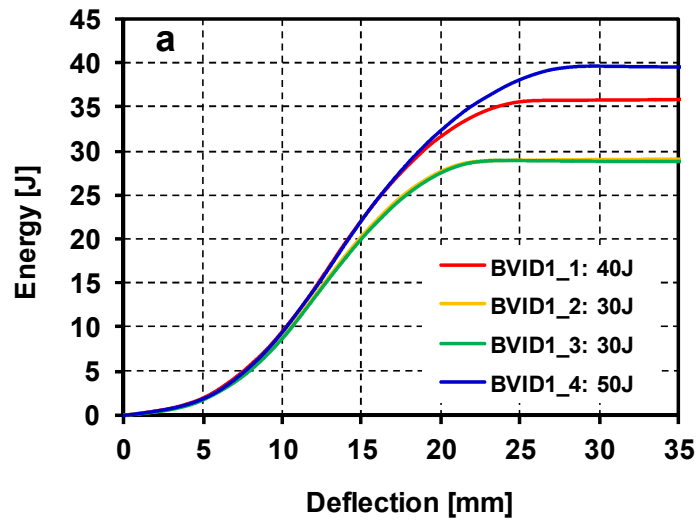
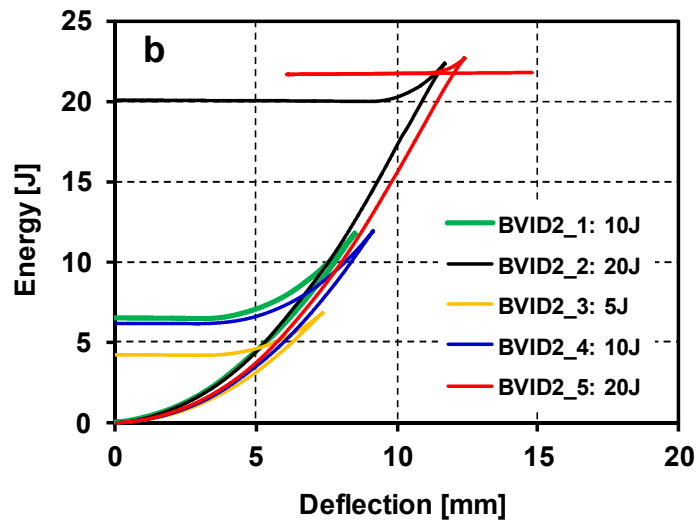
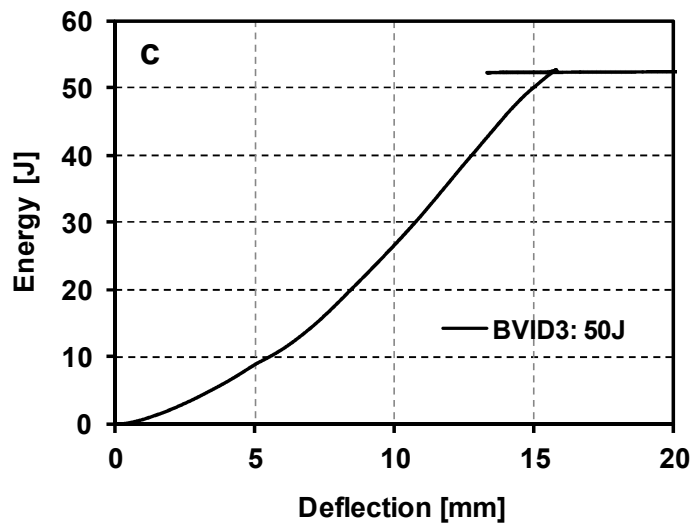
Fig.17

- Fig.17: Plots of energy versus deflection recorded during a. BVID1 test, b. BVID2 test and c. BVID3 test.
- Fig.18: a. Close view of the impact damage at BVID5 location and b. C-scan of the area around BVID5 location.

Initially, panel_3 with BVID was tested. BVID is defined as the indentation of 0.8-1 mm or cut-off energy of 50 J. Due to the unknown impact behavior of the panel, BVID was inclined at each position of the panel by performing repeated impacts with very small energies up to the point where the created impact damage falls within the definition of the BVID. The number of repeated impacts and their impact energy were decided based on the energy-time curve of the first impact and the observed initial impact damage. In Fig.17, the variation of impact energy with respect to the deflection is plotted for the BVID1, BVID2 and BVID3 locations. The plots for the remaining locations are not shown for the sake of brevity. In the case of BVID1 (Fig.17a), four impacts of large energy were necessary to create the desired impact damage. This is because this location lies at the middle of the bay where the panel has smaller local rigidity and a large part of the skin is free to vibrate, thus leading to the release of a considerable amount of energy. However, this is not the case for BVID2 (Fig.17b) and BVID3 (Fig.17c), which lie on the stringer and at the edge stringer, respectively. For these two locations the entire impact energy was absorbed by the panel. Fig.18 shows a close view of the damage developed at BVID5 as well as the C-scan of this area showing the extent of delamination and matrix cracking created due to impact.

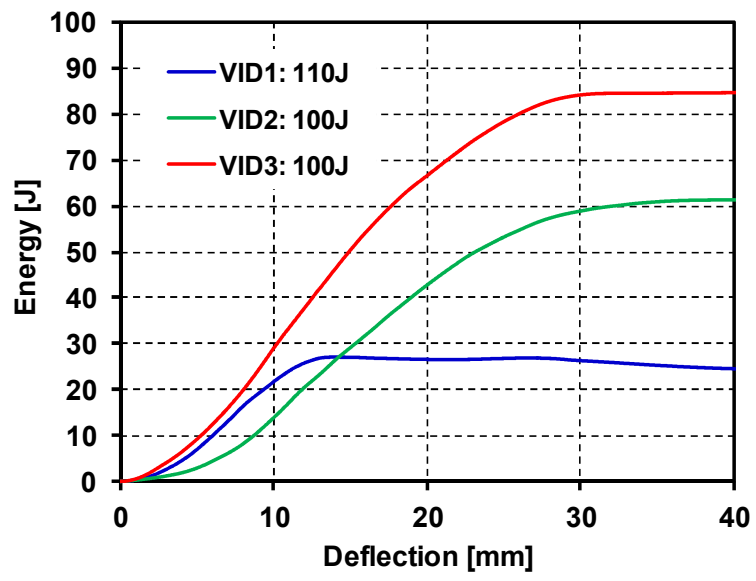
Fig.19

- Fig.19: Plot of energy versus deflection recorded during VID tests.
- Fig.20: Hole created due to impact at VID4 location: a. impacted side and b. opposite side. c. C-scan around VID4 location.

The variation of energy with respect to the deflection for the VID1, VID2 and VID3 locations is plotted in Fig.19. In this case, much larger impact energies were applied as practically there is no threshold for the developed impact damage. In most VID tests, a hole was created in the panel. This is also the case for VID4 shown in Fig.20. The C-scan of the impacted area (Fig.20c) shows the amount of delamination and matrix cracking accumulated around the hole.
