Morphological Study of Epoxy Resin after Electrical Tracking

Abdul Syakur*, Juningtijastuti

This paper will explain the morphological of epoxy resin test samples after electrical tracking during 6 minutes. The morphological analysis was done based on images from SEM devices.

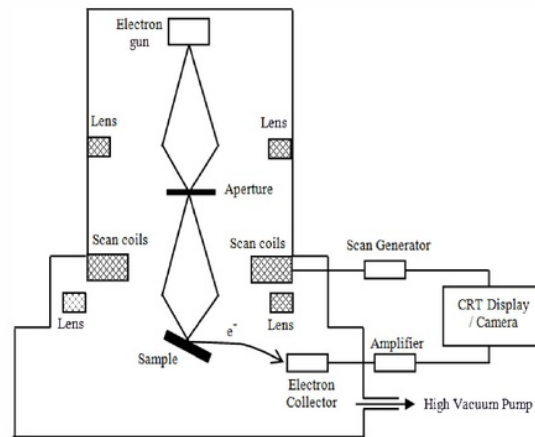
The surface degradation in the form of erosion, cracking and liming on the polymer insulation material that is to characterize the surface of the insulating materials. One method can be used for this purpose is the technique SEM [10]. SEM technique is essentially an examination and analysis of surface micro structures. The data obtained from the surface layer thickness of about 20 μm provides topographical images with any form of protrusions and indentations surface captured and processed by the secondary electrons emitted by the specimen [11]. Work scheme of SEM was showed in Fig 3 as follow:

Fig. 3. Scanning Electron Microscope diagram
