# An Aging Evaluation of the Bearing Performances of Glass Fiber Composite Laminate in Salt Spray Fog Environment

**Abstract:** The aim of the present paper is to assess the bearing performance evolution of pinned, glass-composite laminates due to environmental aging in salt-spray fog tests. Glass fibers/epoxy pinned laminates were exposed for up to 60 days in salt-spraying, foggy environmental conditions (according to ASTM B117 standard). In order to evaluate the relationship between mechanical failure mode and joint stability over increasing aging time, different single lap joints, measured by the changing hole diameter ( $D$ ), laminate width ( $W$ ) and hole free edge distance ( $E$ ), were characterized at varying aging steps. Based on this approach, the property-structure relationship of glass-fibers/epoxy laminates was assessed under these critical environmental conditions. Furthermore, an experimental  $2D$  failure map, clustering main failure modes in the plane  $E/D$  versus  $W/D$  ratios, was generated, and its cluster variation was analyzed at each degree of aging.

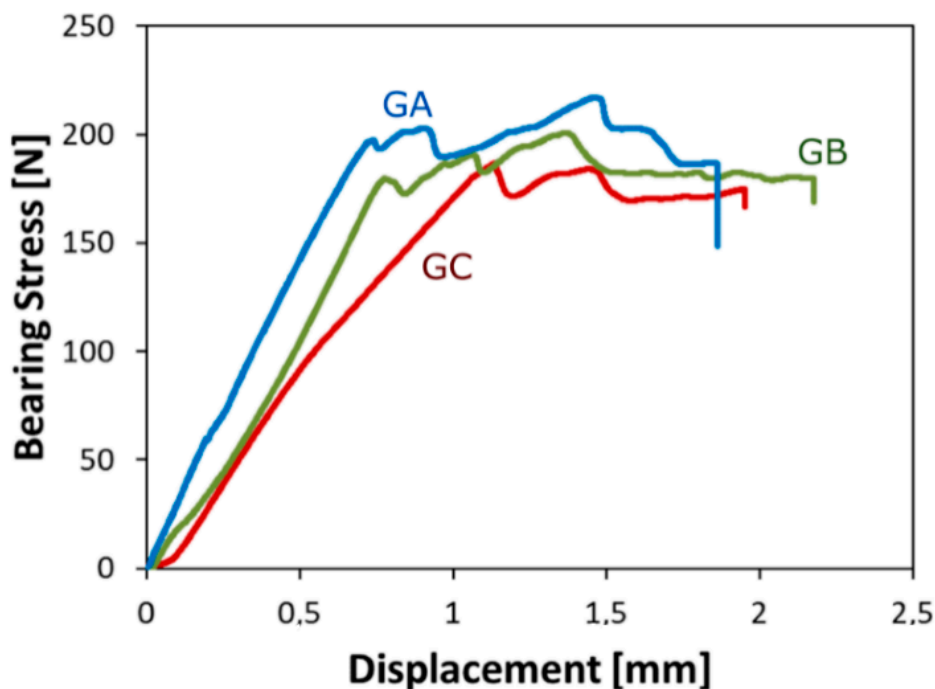
Figure 1 shows the stress versus displacement curves at increasing aging time for pin loaded glass laminates characterized by diameter,  $D = 4 \text{ mm}$ ; width,  $W = 15 \text{ mm}$ ; and edge distance,  $E = 12 \text{ mm}$  (i.e., geometrical ratios  $W/D = 3.75$  and  $E/D = 3.0$ ). Initially, all curves show a linear relationship between stress and displacement. The slope of this trend could be related to the joint stiffness. Afterwards, at increasing displacement, depending on aging time, a gradual deviation from linearity occurs. Finally, all specimens tend to reach a plateau zone at a quite constant stress, beyond which the specimen fails. All the specimens showed a bearing failure mechanism.

**Figure 1.** Stress displacement curves at increasing aging time for pin loaded glass laminates (diameter,  $D = 4$  mm; edge distance,  $E = 12$  mm; width,  $W = 15$  mm).

Due to the applied aging conditions, a slight modification in the stress vs. displacement trend can be evidenced. The unaged glass laminate (sample GA) has good mechanical stability, as identifiable by the acceptable stiffness and strength of the pinned joint. The high stiffness can be argued by the quite stable linear trend in the first part of the curve and by the higher slope in the stress-displacement curve compared to the other batches. Afterward, at about 190–200 MPa, a stress stabilization was reached. A progressive fluctuation in stress at increasing displacement is observed up to reach a maximum stress over 200 MPa, beyond which the failure of the sample occurred. This behavior can be related to the compression collapse of the epoxy matrix just behind the pin/hole contact area.

Instead, analyzing the curve trend on glass laminates aged for increasing exposure time in a salt/fog environment, an evident reduction of their mechanical performances can be shown. A slight reduction of the maximum stress gradually occurs at increasing aging time (about 7% and 14% lower compared to the unaged sample (batch GA) for batches GB and GC, respectively). At the same time, a significant reduction of the linear slope of the curve can be highlighted. This deviation is more sensitive for GC sample where a gradual deviation from linearity can be observed at low stress level. E.g., a stress threshold of about 100 MPa can be identified for GC sample, after which a deviation from the linear trend becomes sensitive. It is widely known that glass-fiber reinforced composites gradually absorb water under salt/fog exposure. This favors softening phenomena of the matrix; thus, leading to the decrease of composites mechanical properties [21,22]. In addition, the loss of fiber-matrix adhesion due to the physical and chemical effects of water molecules on both fibers and the fiber-matrix interface contributes a lot to the deterioration; i.e., the limited capability of the interface area to transfer the stresses implies an irreversible reduction of both strength and stiffness of the aged composites.

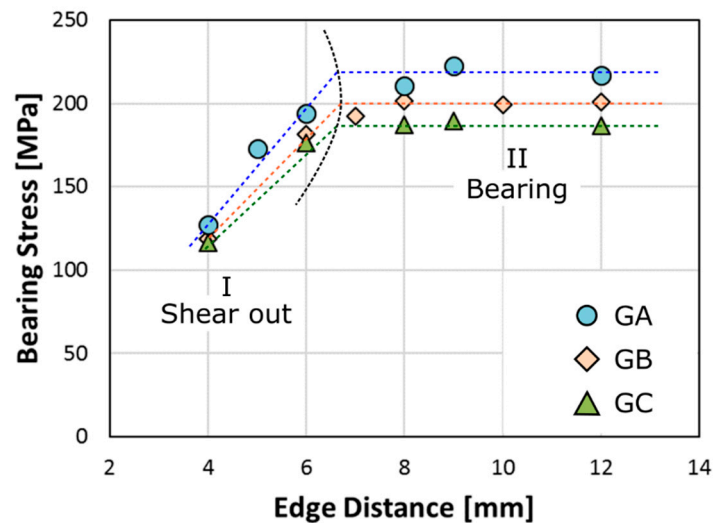
Further information can be acquired by evaluating the maximum bearing stress evolution at increasing edge distance,  $E$ , for pin loaded laminates with hole diameter  $D = 4$  mm and width  $W = 15$  mm ( $W/D = 3.750$ ) for all batches (Figure 2). A gradual increase of the maximum bearing stress ( $\sigma_b$ ) occurs with an increasing  $E/D$  ratio until a critical threshold value can be observed, accordingly to previous results [23,24].

**Figure 2.** Bearing stress evolution at increasing edge distance,  $E$ , for pin-loaded laminates with hole diameters  $D = 4$  mm and widths  $W = 15$  mm ( $W/D = 3.750$ ) for all batches.

In the experimental evolution of the curves, a bilinear trend has been identified. Each segment can be attributed to a specific and distinct fracture mechanism. In particular, the triggering of damage phenomena related to shear out fracture mechanisms are favored at low edge distance (region I). This phenomenon occurs considering the high stress level generated in the region just behind the pin contact area. This area is very restricted (edge distance,  $E$ , is in the range 4–6 mm), stimulating localized stress that activate a catastrophic shear fracture at very low stress values. This fracture mechanism is strongly dependent on the distance of the hole center from the laminate edge. This is confirmed by the high slope of the linear trend in this region, for which it is clear that there is a significant increase in bearing stress due to a slight increase of distance  $E$  ( $\sigma_b$  increase about of 50%, for all batches due to an increase of  $E$  distance from 4 toward 6 mm). A slight reduction of the slope of the shear out trend can be identified at increasing aging time. Although the reduced diameter of the pin (4 mm) significantly exalts the stress concentration in the pin/hole contact area stimulating the bearing failure mechanism [12].

Afterward, for edge distance higher than 6–8 mm (i.e.,  $E/D > 1.5$ –2.0) the bearing stress reaches a plateau (region II). In this region, the prevailing failure mechanism is bearing mode [10] and, for this reason, the stress value reached is indicated as bearing stress at failure. As can be seen from the horizontal trend of the curve of the region II, the bearing stress is also independent by  $E$  and remains almost constant at increasing the edge distance. For this joint configuration, as clarified also in Figure 1, a progressive compression collapse of the composite laminate just behind the pin-hole contact area takes place.

At the same time, it is possible to point out that the maximum stress gradually decreases with increasing aging time. GB and GC batches exhibit a lower bearing stress than the unaged one. In particular, after two months of aging in salt fog environment, a failure stress reduction of 16% can be identified in comparison to unaged samples (about 220 MPa and 185 MPa, for GA and GC, respectively).

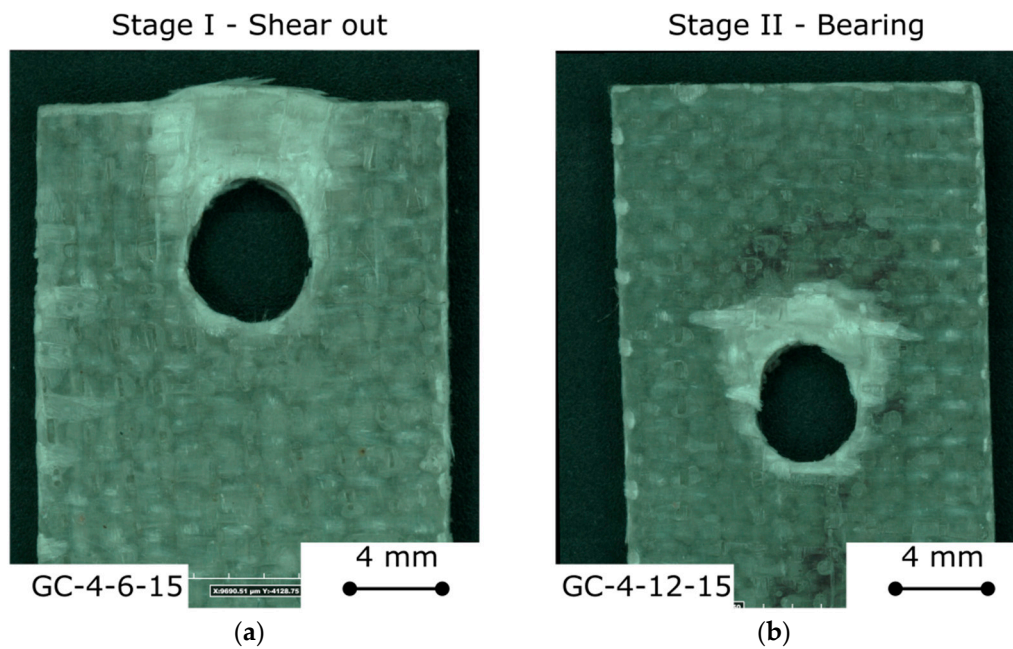
**Figure 3.** Fracture images of (a) GC-4-6-15 (b) GC-4-12-15 samples.

The fracture image of GC-4-6-15 sample, used as reference sample of stage II damaging for shear out, is reported in Figure 3a. In the upper section of the joint toward the free its edge a shear crack longitudinally propagated along the applied load direction are clearly identified. This premature damage mechanism was triggered due to the proximity of the hole from the sample free edge that significantly reduced the shear out resistance limit for this type of joint geometry.

The fracture image of GC-4-12-15 sample, used as reference sample of stage II damaging (i.e., bearing) is reported in Figure 3b. The sample shows a large and localized compression collapse area on the pin/hole contact surface area due to the occurrence of bearing failure mode. Moreover, it was shown that some kink bands evolve radially from the hole edge, thus indicating a progressively extension of the damaged zone and favoring the laminate collapse through damage mechanisms such as delamination [25]. Furthermore, the kink bands induce local deformations at the fiber-matrix interface thus activating secondary failure premature modes [26]. As a consequence, a mixed damage process due to fiber plies kink bands, shear cracks and layers interface delamination evolve to large-scale delamination phenomena, reducing the joint's mechanical stability [10]. The softening of the epoxy matrix due to the water absorption, favors the formation of a large compression collapse area on the pin/hole contact surface area without the occurrence of shear cracks. As already shown by Malmstein et al. [27], the failure mechanism of composites becomes more ductile after hygrothermal aging due to the long time exposure under salt/fog, reducing the occurrence of cracking phenomena, and at the same time, favoring the fiber/interface through dominated fracture.

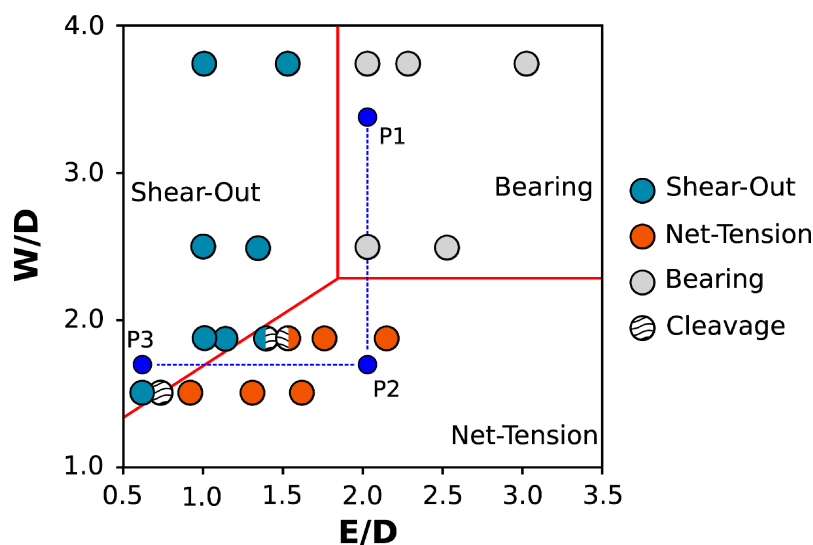
In order to better assess the effect of the joint geometry modification on the failure mechanisms of the pinned joint, a 2D topological failure map of the GC aged glass composite laminates (aged for 60 days in the salt/fog environment), at varying  $E/D$  and  $W/D$  ratios ( $x$ - and  $y$ -axes, respectively), is shown in Figure 6. To better evidence the representative groups of each failure mode, a specific marker color was applied for each observed failure mechanism. Combined color markers are related to mixed failure modes.

**Figure 6.** Failure mechanisms in  $E/D$  versus  $W/D$  plot for GC (60 day) batch.

The bearing fracture, gray circle marker, becomes the main failure mechanism for high  $W/D$  and  $E/D$  ratios (see point P1 in Figure 6). Although, due to a reduction of  $W/D$  ratio, maintaining the constant  $E/D$  ratio (this is achievable making a larger diameter, but keeping the distance of the hole from the edge,  $E$ , constant) at point P2 was where a net-tension fracture occurred. In particular, a transition from bearing to net tension failure mode can be highlighted at about  $W/D = 2.2$ . When hole diameter  $D$  is increased, maintaining at the same time-constant laminate width  $W$ , the reduced cross section induces a higher stress concentration. That, in turn, favors a premature fracture of the sample through net tension mode afterward, inducing a reduction of  $E/D$  ratio, and keeping constant the  $W/D$  ratio (this is achievable applying a lower edge distance, preserving a constant diameter). Then, point P3 is reached, where a premature fracture due to shear-out mechanisms was observed. Indeed, lowering the  $E$  value, and keeping constant the other joint geometrical parameters (i.e.,  $D$  and  $W$ ), makes the distance of the hole from the sample's free edge decrease. The reduced shear cross section favors a premature shear out fracture, even if a mixed mode (i.e., cleavage) can be observed, as evidenced by the transition region at the boundary between net tension and shear out fracture mechanics [5]. When this combined fracture mechanism happens, it means that neither net tension nor shear out mode is predominant [5,12].

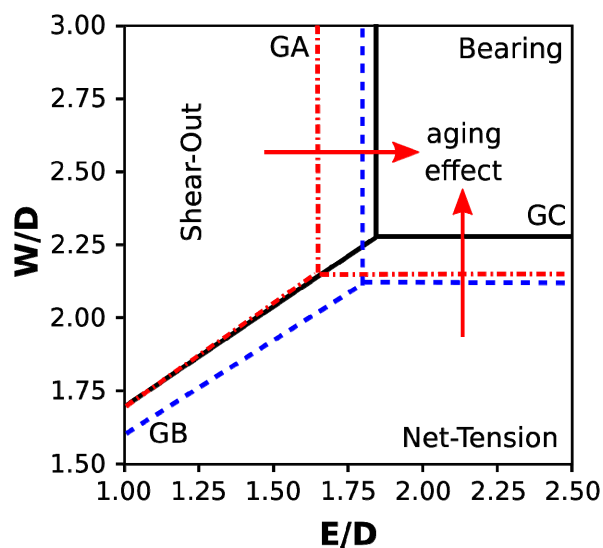
Relevant information on how the salt and mist chamber's aging conditions affect the damage to fiberglass joints can be traced by correlating the evolution of fracture line transitions at varying aging times. In this sense, Figure 7 shows the failure map in the  $E/D$  versus  $W/D$  plot for the pinned-glass composite joints with increasing aging time.

**Figure 7.** Failure map in  $E/D$  versus  $W/D$  plot for pinned-glass composite joints over increasing aging time.

The composite laminate degradation, imposed by the critical salt/fog environment to which it was subjected, led to a gradual reduction of the bearing region, located in the upper right corner of the map. In particular, for GA samples (unaged specimens), the bearing region was identified in the  $E/D$  and  $W/D$  ratios 1.64 and 2.15, respectively. Instead, as previously discussed, due to 60 days of aging in a salt/fog environment, those threshold values increased up to 1.84 and 2.28 respectively. This indicates that a reduction of threshold geometrical ratio of about 10% can be identified for glass composite joints aged in the critical environmental conditions.

After only 30 days of aging (blue straight lines, GB batch), the  $W/D$  threshold that defines the transition between net tension and bearing is almost constant compared to unaged one (i.e., from 2.15 to 2.12). Instead, a relevant modification of  $E/D$  threshold ratio can be observed (about 9%, from 1.64 to 1.80). This indicates that shear-out is the mechanism of fracture that is most affected by critical environmental conditions at short aging times. In fact, analyzing this region for the GA and GB batches shows that a significant increase in its area occurs. This behavior was due to a significant reduction in the fiber/matrix interfacial adhesion, which favors the triggering and propagation of shear cracks in heavy stressed areas.

A further increase in the aging time up to 60 days (i.e., GC batch) favors a net-tension fracture. In this case, long aging time stimulates high water adsorption by glass-fibers, which progressively degrade [29,39,40]. Due to the low hydrophilic behavior of glass-fibers, the high sorption phenomena are triggered by preferential pathways at the fiber/matrix interfaces, induced by debonding, delamination or matrix swelling [31,41,42]. It is worth noting that, initially, the degradation phenomena act at the fiber/matrix interface, causing mainly, a shear-out resistance decrease. Subsequently, due to long aging times, the degradation phenomena more effectively affect the net-tension mechanism. Therefore, the predisposition of the aged joint for these two fracture mechanisms (shear-out and net-tension) takes place, reducing the effective bearing region claimed in the joining design phase.
