# Wearing Surface Testing: Yukon River Bridge

## Final Report (Part 1)

11. SUPPLEMENTARY NOTES				
12a. DISTRIBUTION / AVAILABILITY STATEMENT			12b. DISTRIBUTION CODE	
13. ABSTRACT (Maximum 200 words) The Yukon River Bridge, also known as the E.L. Patton Bridge, carries the twolane Dalton Highway and the trans-Alaska oil pipeline across the Yukon River at a 6% grade. It is 30 feet wide, with 6 spans; it was designed to withstand -60 degrees Fahrenheit temperatures, huge ice loads from the river, truck loads hauling supplies to the oil fields, the oil pipeline, and, in the future, a gas line. Over 30 years, the timber decking has been replaced several times — in 1981, 1992, 1999, and 2007. The trees that produced the original decking were massive old-growth firs, strong and close-grained. Subsequent decking has come from younger trees, which produce softer wood. As timber quality has decreased, time between replacements has also decreased, while material costs increase. Every time the Yukon River Bridge deck is resurfaced, it costs the public millions of dollars. Further, in the past only timber was used, and the quality of this material is decreasing as the cost is increasing. It

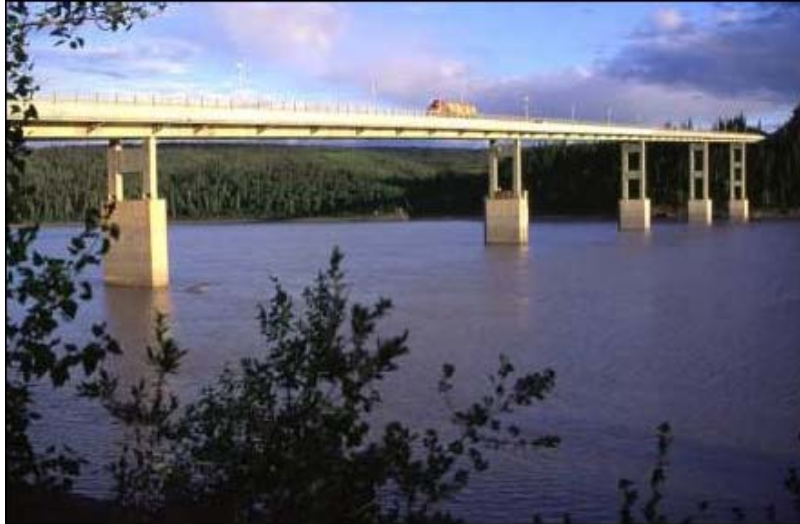
**Figure 1: Yukon River Bridge.**

The Yukon River Bridge is a two-lane highway bridge with an orthotropic steel deck structure located about 50 miles north of Fairbanks, Alaska, on the Dalton Highway (see Figure 1). The bridge was designed to carry highway traffic and the Trans-Alaska oil pipeline across the Yukon River. When the bridge was built in the early 1970s, a two-layer temporary timber wearing surface was installed over the steel deck. Because the bridge is on a 6% grade, trucks typically use tire chains to provide traction. The chains tend to cause serious wear on the timber surface over time. Due to severe climate changes and intense loading from passing trucks, timber surfaces deteriorate at a rapid rate.

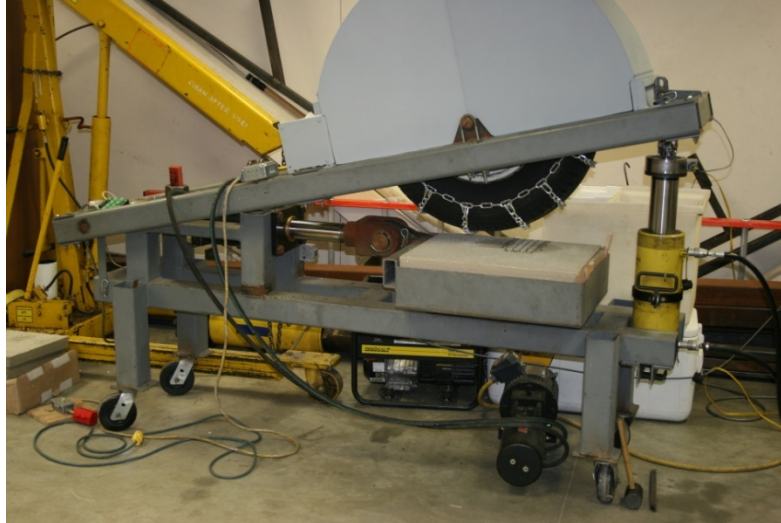
**Figure 2: Traction and chain-wear test equipment.**

Since there was no known laboratory test equipment for determining wear due to tire chains, a testing apparatus was developed by Muench. This testing apparatus consists of a lower and upper steel frame, with a 14-ply 235/85R16 tire attached to the upper frame that spins on an axle. A tray is placed underneath the tire on the lower frame, which is attached to a hydraulic ram that pushes and pulls the tray back and forth over a distance of 7.87 in. (20 cm). The upper steel frame is attached to another hydraulic ram that elevates one end of the upper frame on a pivot, which in turn raises or lowers the tire onto the tray that contains a wearing surface panel to be tested. Electric load cells are attached to each hydraulic ram to measure the vertical and horizontal force on the tire as the tray moves in a direction. These readings are recorded by a data collector and displayed on a nearby laptop. The laptop uses proprietary software designed to

work with the data collector to allow for calibration and corrected readings. The apparatus is approximately 23.62 in. (60 cm) wide and 90.55 in. (230 cm) long and weighs around 4,500 lb (20 kN). The tray of the test machine is 18 in. (45 cm) wide by 24 in. (61 cm) long by 5.91 in. (15 cm) thick. Figure 2 is a picture of the traction chain-wear test equipment.

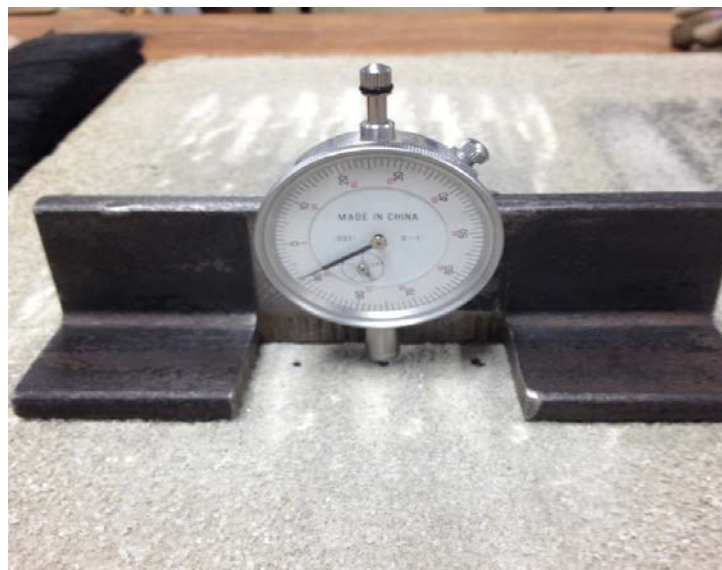
**Figure 3: Gouge depth measurements.**

Test results for both chain lashing and chain dragging are shown in the following two tables. Table 5 lists the amount of gouging damage that the test panels showed after being subjected to five cycles of chain dragging. Figure 3 shows how the gouge depth measurements were taken on a given test panel after being subjected to a chain-dragging test.
