STUDY OF DAMAGE CHARACTERISTICS IN COMPOSITE STRUCTURES FROM SIMULATED LIGHTNING STRIKES

ABSTRACT

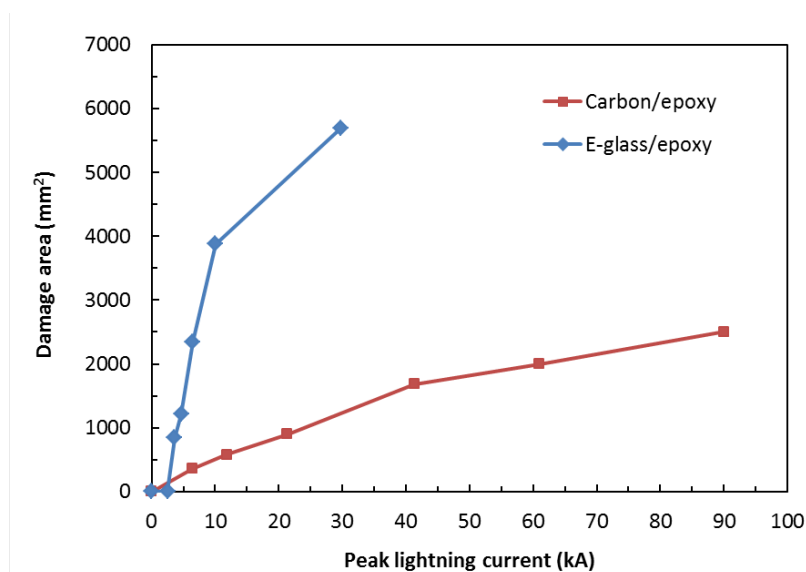
Fig. 6 Relationship between lightning current and damage area for laminates

When an electric energy of the lightning current was deposited on the surface of each carbon/epoxy specimen, local temperature within the lightning channel must have arisen to an extremely high level due to its finite conductivities in the in-plane directions. Since the direction of the lightning strike was in the insulative thickness direction, the attached lightning arc hence sublimated the surface resin in its path. Then the heat flow was obstructed by the exposed but firmly in-position carbon fibre tows. By this time, part of the heat flow or the thermal energy was diverted to the electrically-connected in-plane fibre directions where the resistance of the dissipations was significantly less, the remaining of the diffused heat flow for the given thermal energy had the significantly limited capacity to further sublimate the next resin layer between the top ply and the next ply down. Within a duration of less than 30 ms, a significantly higher level of lightning current or AI was needed for resin of the second ply to be sublimated. This understanding is in agreement not only with the qualitative surface inspection results in Table 1 but also with the trend of the damage area results in Fig. 6. The trends of the damage areas with the increase in AI were similar, as shown in [3].

Fig. 6 shows the parabolic variations of damage areas with the increase in peak current, which seems to decay towards the upper end of the lightning current range. Nevertheless, the very different trends from the different composite laminates had the different damage mechanisms. For the carbon/epoxy specimens, this trend seems to suggest that the thermal energies converted from the electrical energies had not been consumed just within the lightning channel. Instead, the areas covered by all three regions in Fig. 4 seem to be about three times of the lightning channel. Although the local temperatures in the lightning channel may well have been around 1000°C , the duration of such high temperatures could be extremely short so that resin sublimation was largely confined within the lightning channel. For the E-glass/epoxy specimens, the decaying parabolic trend indicates that the most of the electrical energies had gone into a generation of delaminations and their enlargements.

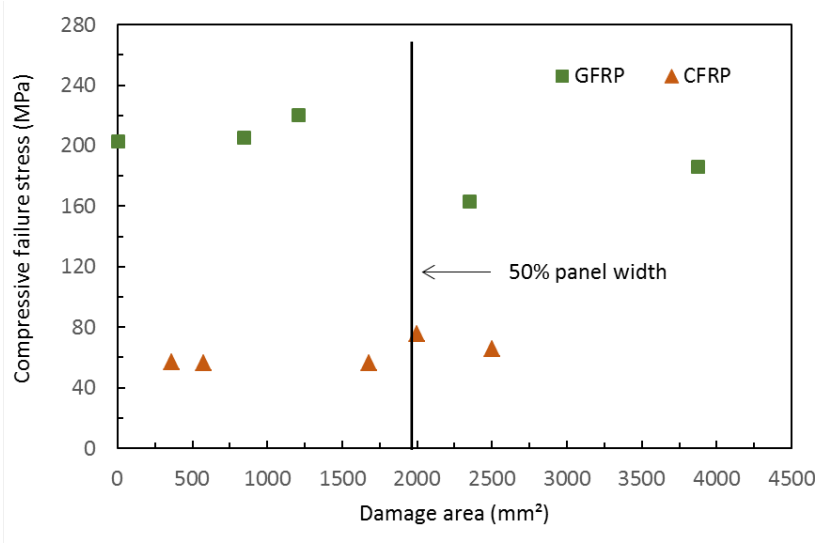
Fig. 7 In-plane compression test results of lightning struck carbon/epoxy and E-glass/epoxy panels

To ultimately develop an in-depth understanding for the nature of the damage in the lightning struck composite specimens, the lightning strike damaged panels were further tested for their residual in-plane compressive strengths. The methodology follows that used for the residual in-plane compressive strengths of impact-damaged composite panels. The overall test results for compressive failure stresses are presented in Fig. 7 against damage areas. In the diagram, the term of compressive stress was used, rather than residual compressive strength, is because all the panels but one (G2-1) failed prematurely close to one of the loaded ends, as shown in Fig. 8. For the carbon/epoxy panels, this finding strongly suggests that the lightning damage was relatively shallow close to the surface of these panels and the respective extents of fibre tufting and delamination are relatively small. This is in agreement with the earlier examinations. If the depth of the damage were deeper than two plies, the panels could have failed in the mid-section region, when the extent of those two panels in the width direction is greater than 50%. This is because such damage with a presumed severity ought to be sufficient to instigate a further propagation in the width direction under in-plane compressive loads, thereby triggering a catastrophic failure of the panels. For the E-glass/epoxy panels, the panels with the delamination extent of 40 mm or greater were again expected to fail around the mid-section region, whereas the two least damaged panels were expected to fail close to the panel ends. However, the only one (G2-1) out

of the three most damaged panels failed in the mid-section region and the other two (G2-4 and G2-5) did not, which is surprising.
