# EXPERIMENTAL STUDY OF IMPACT DAMAGE RESISTANCE AND TOLERANCE OF COMPOSITE SANDWICH PANELS

P. Nash, G. Zhou\*, S. Gahlay and M. Burt

Department of Aeronautical and Automotive Engineering, Loughborough University, Loughborough, Leicestershire LE11 3TU, UK

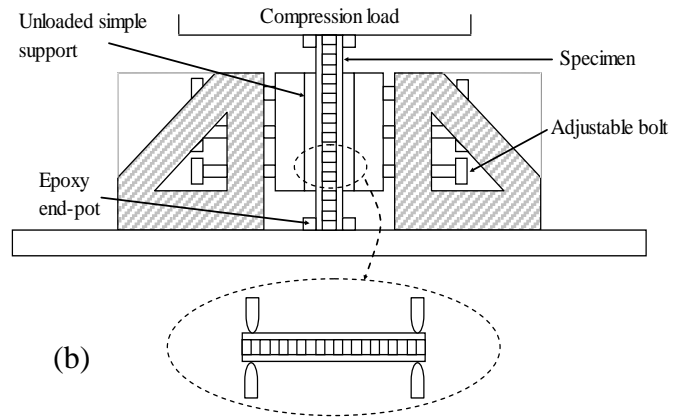
Fig.3. (a) In-plane compression specimen and (b) experimental set-up for compression

In each in-plane compression test, a panel was placed in a purpose-built support jig, as illustrated in Fig. 3(b). The jig provides simple support along the unloaded edges, which were free to move in the width direction during loading. Quasi-static load was applied to the panel at the machined ends via a Denison testing machine at less than 0.5 mm/min. Load, strain and cross-head displacement in all tests were recorded. All tested panels were cut up for study of damage mechanisms. The loading direction coincided with the  $0^\circ$  direction in the skins of panels.

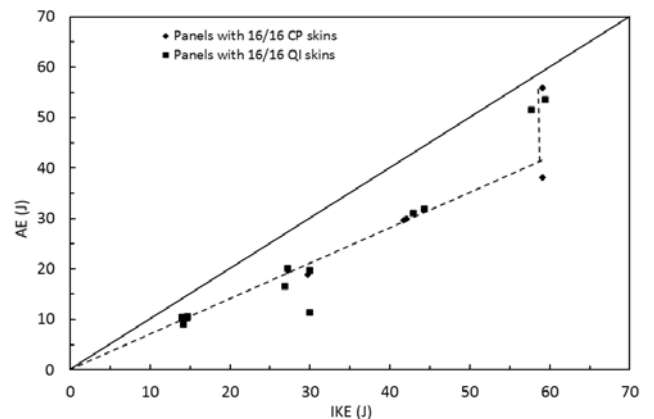
Fig.4. Energy absorption of symmetrical thick panels with 70kg/m<sup>3</sup> core

was followed by a continued core crushing with either the onset or propagation of delaminations. Eventually, skin ply fracture occurred. These early onset mechanisms are responsible for around 70% of absorbed energy in the panels, for both symmetrical and unsymmetrical panels, as seen in Fig. 4 and Fig. 5, with the occurrence of fiber fracture increasing this absorption to upwards of 95%. In symmetrical panels, the point at which fiber fracture occurs is typically just before 60J (Fig. 4). Comparatively, the unsymmetrical panels exhibit a more ambiguous point of fiber fracture, resulting in a region from 35J up to 60J where fiber fracture has been observed (Fig. 5). A cross section of a damaged unsymmetrical 16/12 panel impacted at 35J is shown in Fig. 8, which shows extensive crushed core and skin delaminations in the impacted (16-ply) skin. The bottom (12-ply) skin remained intact in all cases and the maximum crushed depths at the upper end of the impact energy ranges reached about the middle of cores at the highest impact energy. This offers some experimental evidence to justify the desire for removing a couple of plies in the distal skin for further weight reduction while maintaining the impact damage resistance. There was no local skin-core debonding. The extent of crushed core was generally greater than the extent of skin delamination. There was no noticeable difference in these characteristics between symmetrical and unsymmetrical panels.

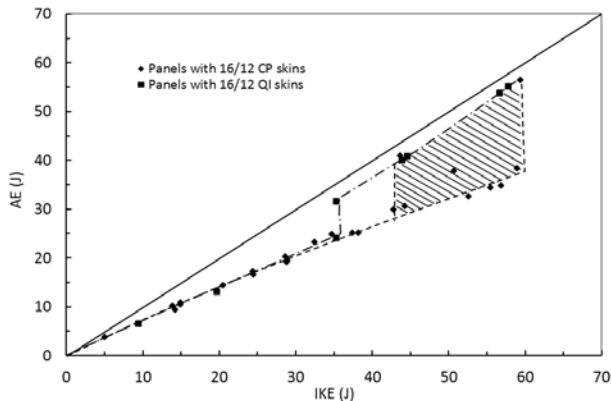
Fig.5. Energy absorption of unsymmetrical thick panels with  $70\text{kg/m}^3$  core

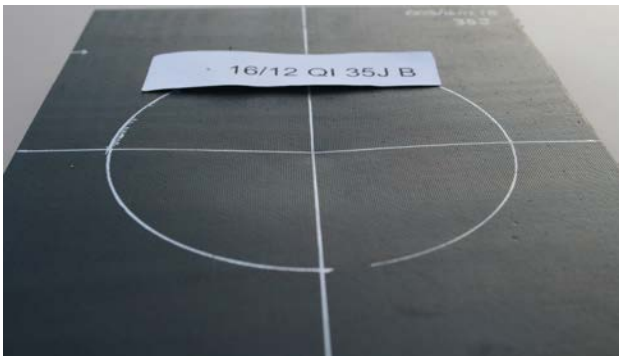
Fig.6. A 16/12 QI carbon/epoxy sandwich panel with  $70\text{kg/m}^3$  core impacted at 35J

The initiation and propagation characteristics of damage mechanisms in impacted sandwich panels in bending were examined extensively via impact response curves, visual observations with the aid of systematic microscopic inspections and cross sectioning. These techniques were shown in [1-3] to be very effective. Thus this approach with the same techniques was deployed for current sandwich panels. Impact at the lower end of the impact energy range typically produces a surface dent, as shown in Fig. 6. A further increase of impact energy resulted in ply fracture on the impacted skin, as shown in Fig. 7.

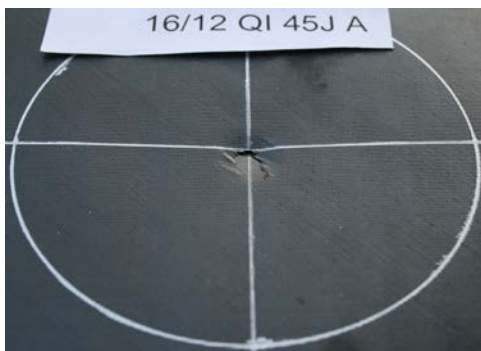
Fig.7. A 16/12 QI carbon/epoxy sandwich panel with  $70\text{kg/m}^3$  core impacted at 45J

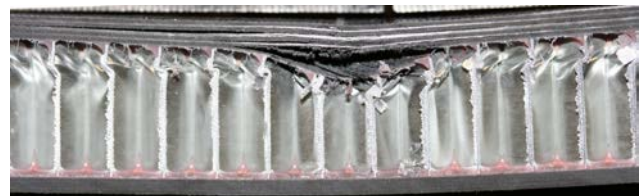
Fig.8. A 16/12 sandwich panel with  $70\text{kg/m}^3$  core impacted at 35J

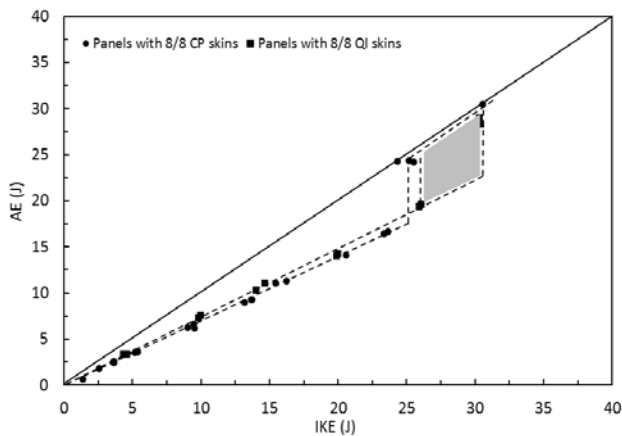
Fig.9. Energy absorption of symmetrical thin sandwich panels with  $70\text{kg/m}^3$  core

The energy-absorbing characteristics of the impacted thin symmetrical panels are shown in Fig. 9 for two types of panels with skins in cross-ply and quasi-isotropic lay-ups. In the initial region, a linear increase in energy absorption is around two thirds of impact energy. As in the thick panels, the initial damage was found to be due to core crushing, with some delamination observed. The initial damage was

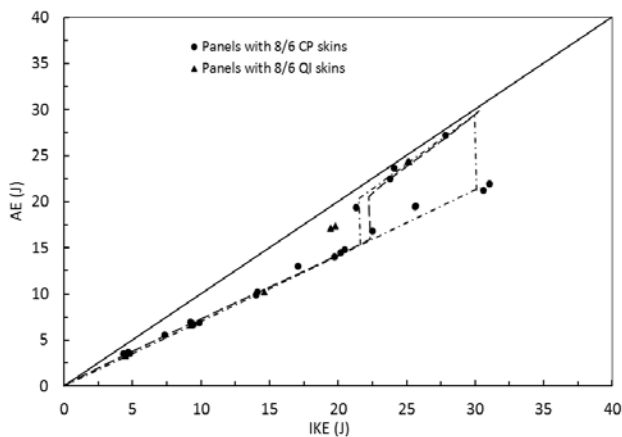
Fig.10. Energy absorption of unsymmetrical thin sandwich panels with  $70\text{kg/m}^3$  core

followed by a continued core crushing with either the onset or propagation of delaminations. Once skin fracture occurred, the absorbed energy is increased abruptly up to over 90%. Shown in Fig. 10, the overall energy-absorbing features of unsymmetrical cross-ply and quasi-isotropic panels are very similar to those from the symmetrical panels. It is noticeable that the region in which fiber fracture is likely to occur is once again bigger in the unsymmetrical panels.

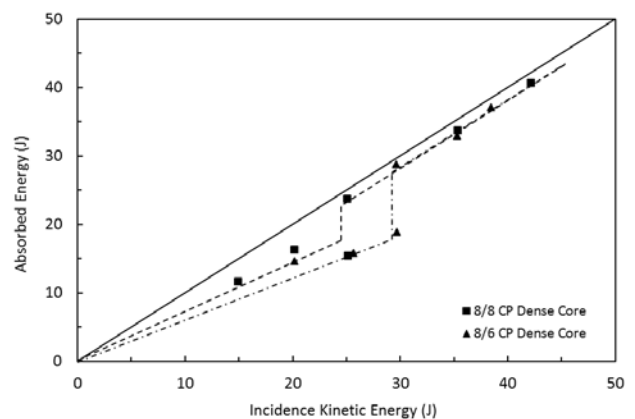
Fig.11 Energy absorption of symmetrical sandwich panels with a core density of  $144 \text{ kg/m}^3$

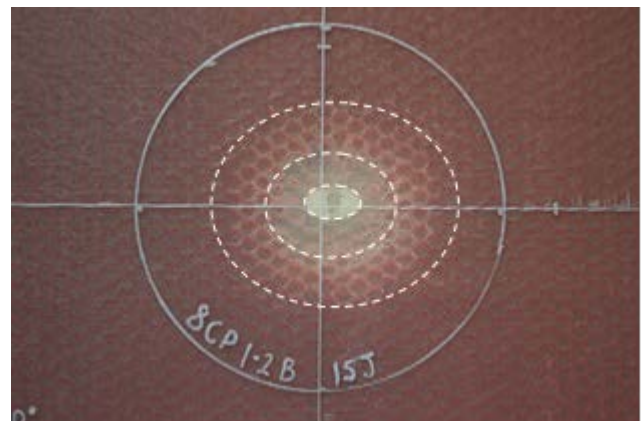
Fig.13. Impact damage in an 8/8 CP E-glass/epoxy panel with  $70 \text{ kg/m}^3$  core impacted at 15J

Damage assessment of the impacted E-glass/epoxy panels in comparison to the carbon/epoxy panels due to the translucency of the skins. The 3 usually non visible damage mechanisms can now be identified without the need for destructive inspection. As shown in Fig. 13 by the 3 dashed circles, delamination, debond, and core crush (from inner to outer circles) are all easily recognizable by visual inspection. Interestingly the  $0^\circ$  and  $90^\circ$  directions for core crush and delamination regions can now be recorded, allowing comparison of damage propagation in both main fiber directions.

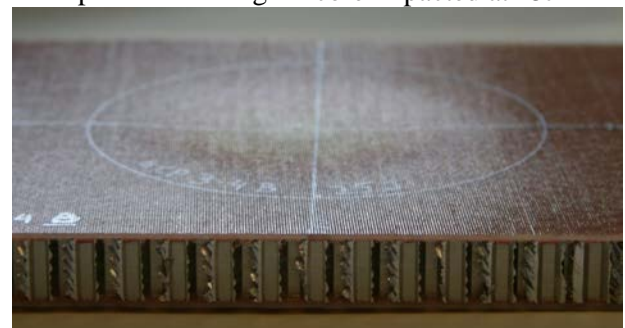
Fig.14. Impact damage in an 8/8 CP E-glass/epoxy panel with  $70 \text{ kg/m}^3$  core impacted at 25J

Fig. 16 shows one of only 2 cross sectioned panels used to validate the visual inspections of the damage mechanisms. In the 16 ply panel, which was impacted at 18J, a single delamination at the midpoint of the skin can clearly be seen in the top impacted skin, whereas the bottom skin remains undamaged. Core crush extent can be seen to be the dominating damage mechanism, extending much beyond the delamination length. A small amount of core debond can be seen in the central region under the impact location. Impact at the lower end of the impact energy range typically results in a surface dent in the impacted skin, shown clearly in Fig. 14.

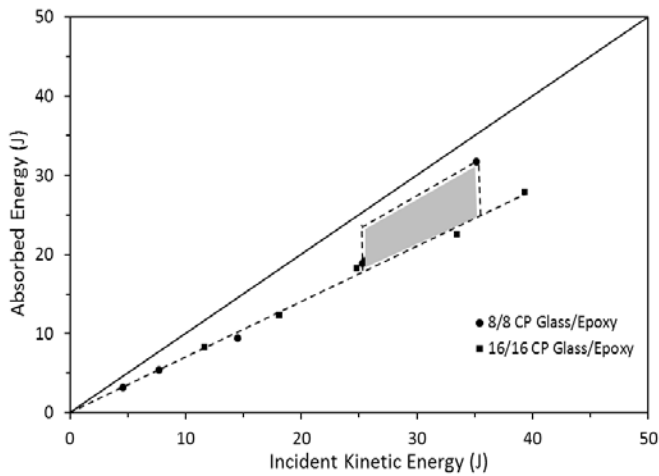
Fig.15. Energy absorption of sandwich panels with E-glass/epoxy skins and with a core density of 70 kg/m<sup>3</sup>

With the damage mechanisms established, it is identified that in a similar manner seen in the carbon/epoxy panels, initial damage is found to be core crushing, with a sharp increase in core crush length measured in even low impact energies. Due to the similarity in trends in the lower range of impact energies for core crush lengths and absorbed energy, it can be inferred that the core is the primary damage mechanism in initially absorbing the impact, further confirming the importance of the cores role in impact performance as seen in the carbon/epoxy tests. Delaminations were found only in the impacted skin in both thicknesses of panel, with the thick skins developing larger delaminations than then the thin skins at the higher range of the impact energies. This is likely due to energy of the impact being absorbed by the occurrence of interfacial debond in the thin panels between the 10-15J range. Fiber fracture was only observed in the thin skinned panels at 35J, and can be seen in Fig. 15 to increase the energy absorbed to around 95%. The grey region

in the figure indicated an area of uncertainty as to where fiber fracture will definitively occur. As mentioned, a cautious approach was used in testing the thicker panels, with the final impact energies not being enough to cause fracture in the impacted skin, hence the trend is shown to be wholly linear in Fig. 15.

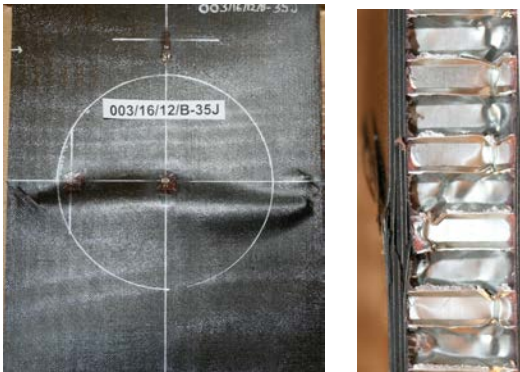
Fig.18. Photographs showing front and side view of an impact-damaged sandwich panel after CAI test

Nearly all the impact-damaged sandwich panels failed around the mid-section region, which was weakened by the presence of impact damage. An example from the thinner 8/6 panels is shown in Fig. 17, whereas an example from the thicker 16/12 panels is shown in Fig. 18, in which the longitudinal shearing through the core is clearly visible.

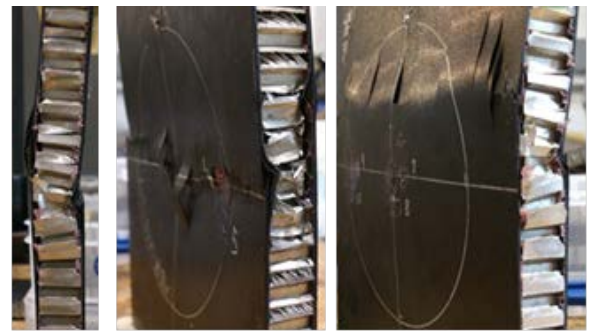
Fig.19. Photographs showing side, front and rear views of impact-damaged 8/6 carbon/epoxy 140kg/m<sup>3</sup> core sandwich panel

An example of failed unsymmetrical panels with a dense core is shown in Fig. 19. Unlike the lower density examples above, there is very little evidence of shearing through the core. Looking at the example response for an impacted unsymmetrical panel in Fig. 21 the initial strain response is very linear and steep, differing from the control response in Fig.20 which shows a high level of deformation in the far field location, implying an even application of compressive load in the two skins, helped by the strength of the core constraining the relative in-plane movement of the skins. At approximately 18kN there is clear evidence of damage propagation through the panel, with the most significant deformations in the outer region of the mid-section. Due to the location, the deformation in both longitudinal and transverse directions, and early onset of this event, it is very likely that the skin has debonded from core. Between 20kN and 40kN 2

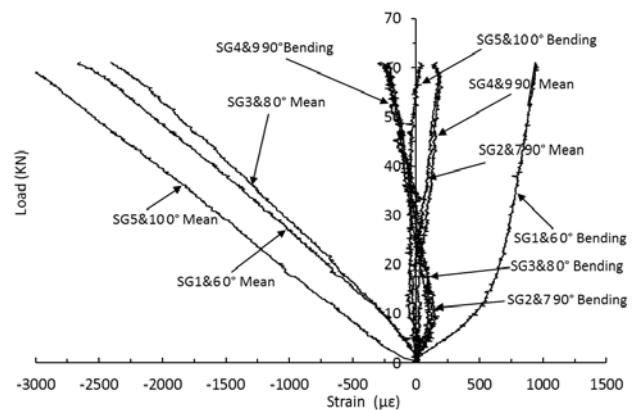
Fig.20. Load-strain curves of an in-plane compression test on a 8/6 CP control panel with 140kg/m<sup>3</sup> core

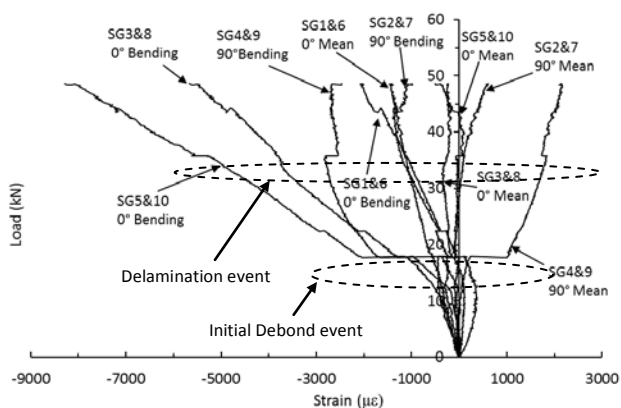
Fig.21. Load-strain curves of an in-plane compression on an 8/6 CP 25J impact-damaged panel with 140kg/m<sup>3</sup> core

further incidents cause noticeable increase in strain. An image captured at 40kN shown in Fig. 22 shows a clear propagation of delamination through the mid-section region of the distal thin skin. Since nothing was visible at 35kN, the likely initiation of this is highlighted in Fig. 21. This delamination drastically reduces the resistance in the mid-section, causing failure in this region not long after the delamination propagated. Failure in the mid-section depicted in Fig. 18 is indicative of most mid-section failures, showing arrested skin fracture and kink bands developing in the transverse direction on the impacted side, with severe debond causing bending or compressive failure in the distal skin usually off centre towards the edge of the debonded area.

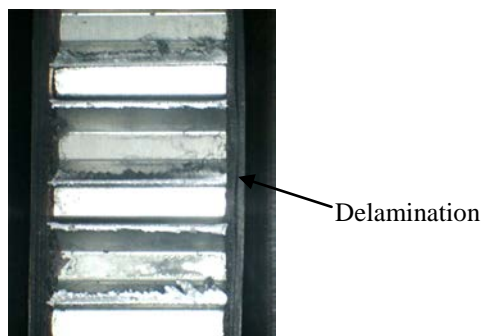
Fig.22. Photograph showing delamination propagation in 8/6 CP carbon/epoxy panel with 140kg/m<sup>3</sup> core during test

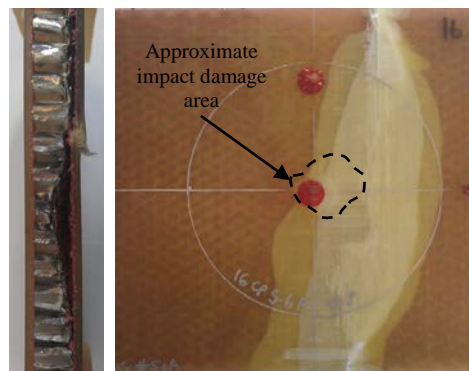
Fig.23. Photographs showing a side and front view of an impacted E-glass/epoxy sandwich panel

Similar to the carbon/epoxy panels, establishing an accurate baseline compressive strength proved difficult for this width/length ratio for the E-glass/epoxy panels. Premature end failures were observed in both thin and thick panels. This problem extended into the majority of the thick skinned panels. The toughness of the E-glass construction, as previously mentioned, was underestimated during the impact testing, and the impact range was not sufficient enough to induce mid-section failure in all the thick panels. Hence the compressive data is on the whole fairly untrustworthy. Shown in Fig. 23 is one of the thick panels that failed in the mid-section. Due to the translucency, the failure mechanisms and damage propagation can be seen clearly. Large areas of delamination in the central region would have cause drastic local instabilities in the mid-section region, leading to the failure. The core crush pattern

also shows the sinusoidal mode of bending the panel experienced before failure. Through the thickness fracture is also evident on the impacted skin along the transverse direction.

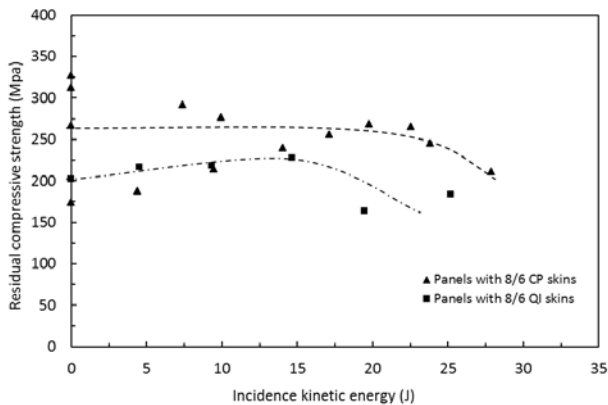
Fig.24. A variation of residual compressive strength with IKE for unsymmetrical sandwich panels with  $70\text{kg/m}^3$  core

Observing the skin thickness variations in unsymmetrical panels has surfaced one fundamental difference. Thicker skinned unsymmetrical panels behave almost identically to the symmetrical equivalents. However, the thin skins do not experience an initial drop in performance after the application of impact damage. The thin skinned panels are far more sensitive to the uneven compressive loading of skins due to the effective shifting of the neutral plane, leading to the baseline performance suffering compared to the symmetrical counterparts. When the thin unsymmetrical panels undergo impacts, the existing imbalance is effectively evened out, causing a much more symmetrical loading condition, resulting in little or no drop in compressive strength in the lower range of impact energies, as seen in Fig. 24.

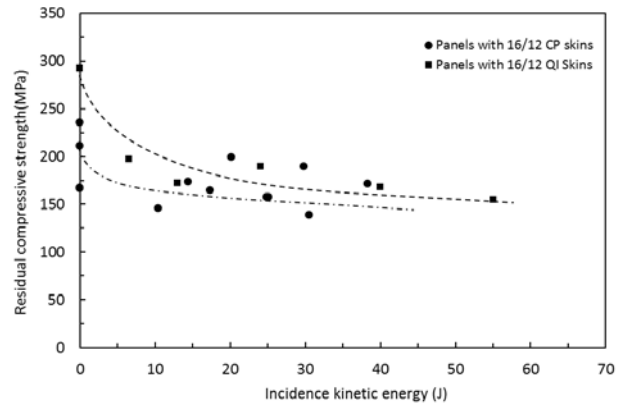
Fig.25. A variation of residual compressive strength for thick unsymmetrical sandwich panels with  $70\text{kg/m}^3$  core

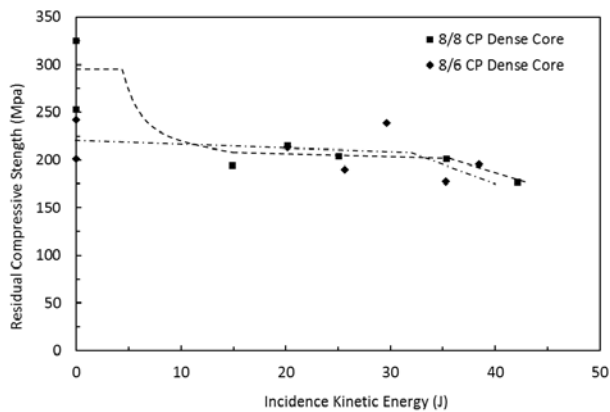
Fig.26. A variation of residual compressive strength with IKE for sandwich panels with 140kg/m<sup>3</sup> core

Damage tolerance for carbon/epoxy panels with a denser core follows the pattern exhibited previously by the lower density examples. The symmetrical panels show a fairly sharp initial drop off in compressive strength, which plateaus in the range of 15-35J, indicating that once the presence of delamination and core crush are established, further increasing these damage mechanisms has little effect on the compressive performance. With the introduction of the fiber fracture mechanism, a further drop off is observed. This trend is almost mirrored by the unsymmetrical panels, the only difference being no initial drop off due to impact damage. The initial compressive strength of the panels is seen to be greater in the symmetrical panels, since the neutral plane no longer coincided with its mid-plane due to its unequal skin thicknesses. However, as previously witnessed, the CAI strength of the unsymmetrical panels experiences a resurgence, due to this initial imbalance being 'evened out' by the thicker skin being subjected to an impact. This can be seen in Fig. 26, with the unsymmetrical panels showing comparative strength to the symmetrical panels up to 30J, with even a hint of improved performance up to this point. The occurrence of fiber fracture in both cases causes a further decrease in compressive resistance.

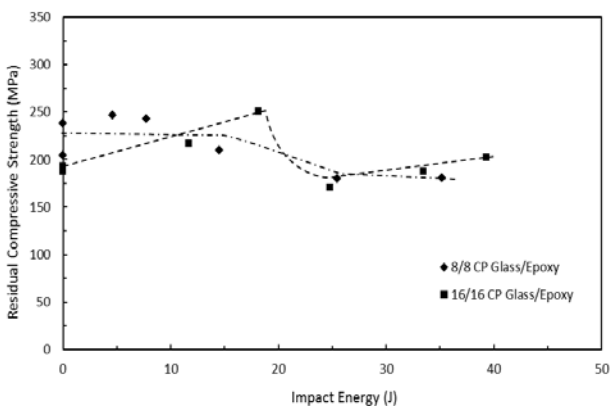
Fig.27. A variation of residual compressive strength with IKE for sandwich panels SG

The damage tolerance, shown in Fig. 27, of the thick 16/16 CP E-glass/epoxy panels is hard to assess at this stage, without obtaining true compressive failures for the impacted panels, the strength values associated with end failure are not accurate. The thin E-glass panels exhibit a fairly good tolerance to impact damage up to around 15J, where a slight drop off in compressive strength is seen as the impact damage is further developed in the panel, with the panel containing a fractured impact skin showing a reduction of around 20%.
