# Damage assessment in CFRP laminates exposed to impact fatigue loading

George Tsigkourakos<sup>1\*</sup>, Vadim V Silberschmidt and I A Ashcroft

Wolfson School of Mechanical and Manufacturing Engineering, Loughborough University, Leicester-shire, LE11 3TU, UK

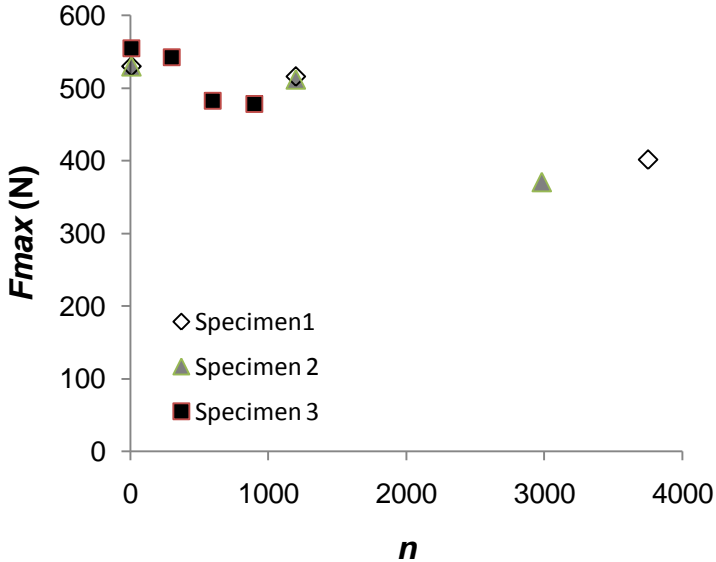
**Figure 4.** Deterioration of  $F_{max}$  as a function of number of cycles.

The reduction in  $F_{max}$  with increasing number of impacts can be seen in figure 4. This is accompanied with a reduction in stiffness, as shown in figure 5. These two figures indicate that the studied response is changing as a function of damage accumulated in the sample as a result of the repeated impacts.
