Smart Bondline Monitoring of an Efficient Industrial Thermoplastic Aircraft Window Frame

In this work, a smart thermoplastic window frame for a regional aircraft has been designed and manufactured. The aim of the work was to design a smart sensing system for monitoring of a bonded thermoplastic aircraft window frame in operation. The conductive tracks were designed and inkjet-printed onto the window frame and their disruption was used as an indication of a damage event created within the bondline. Based on the electrical resistance measurements, the method was able to detect a damage that was created in the bondline due to an impact event. To verify the proposed methodology, ultrasonic C-scan inspection was also performed.

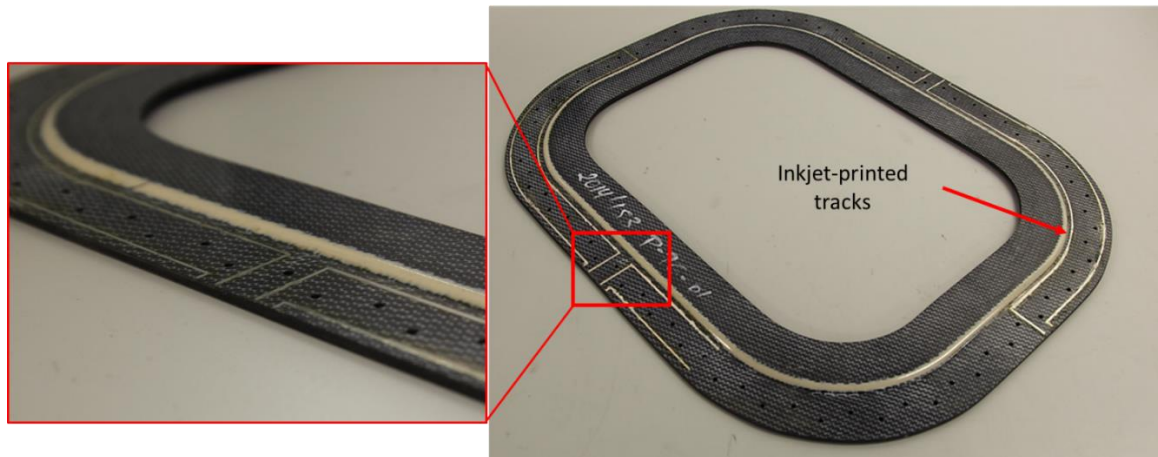
Figure 3 Inkjet printed tracks onto the window frame

The tracks have been designed to monitor the bondline at both edges of the bonded surface. It is likely that the damage starts from either side of the bonded surface. The geometry of the sensors have also been designed to divide the monitored region into 4 different quadrants each with a different terminal. This results in not only detecting damage, but also localizing which quadrant the damage is present. Prior to the printing process the surface of the thermoplastic window frame was thoroughly cleaned using isopropanol. To electrically isolate the silver tracks from the conductive carbon fibers, thin lines of a dielectric polymeric ink (DM-INI-7003) were inkjet-printed onto the surface of the window frame. The printing of the polymeric ink was performed using a piezoelectric inkjet printer. The piezo voltage was selected at 20 V and the jetting frequency was set at 5kHz. The substrate temperature was selected at 30 °C and the drop spacing was 35 μm . The width of the printed tracks was set at 1 mm. The polymeric ink was cured using a UV-LED system for 10 mins. At the end of the curing process, a silver nanoparticle suspension was employed for the development of the conductive silver-based tracks onto the cured polymeric lines using the same inkjet printer. The concentration of the nanoparticles within the ink was approximately 30-35 wt. %, and their diameter was under 50nm. The viscosity varied from 10 to 18mPa·s and the surface tension was between 35 and 40 mN·m⁻¹. The width of the printed tracks was 0.5mm. To ensure an enhanced electrical conductivity, 3 layers of silver-based ink were printed on top of each other. Sintering of the ink took place in a laboratory oven for 1 hour and the selected temperature was 150°C. The resulting window frame with the inkjet-printed tracks is depicted in Figure 3. In order detect any debonding occurred at the edges of the bondline (either from the inside or the outside) two conductive tracks were printed.
