Master's Thesis

Wooden pegs in the retrofit
of timber constructions

University of Minho

Portugal | 2019

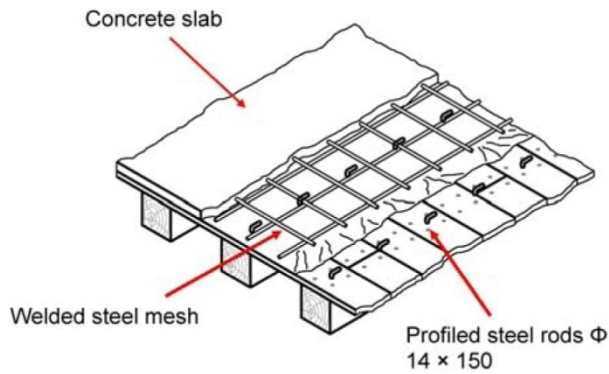
Figure 2 – Strengthening technique with concrete slab [11].

The most common method used to reinforce an existing timber floor, in the recent past, was the introduction of a concrete slab connected over the existing timber structure through metal fasteners (Figure 2) [10]. This method has lost some use in historic constructions, due to the lack of reversibility, load increase and the poor results that have been registered recently, especially in seismic zones. More precisely, this technique is now considered not satisfying in historic buildings because brings a

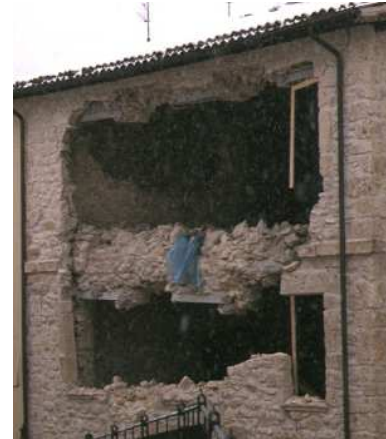
Figure 3 – Example of strengthening with concrete slab after seismic event.[12]

consistently higher stiffness in the floors which the bearing structure in masonry was not designed to support. The result is an inability of the structure to transmit and absorb the horizontal forces which the structure is subjected, which can lead to damages of part of the masonry wall (Figure 3).

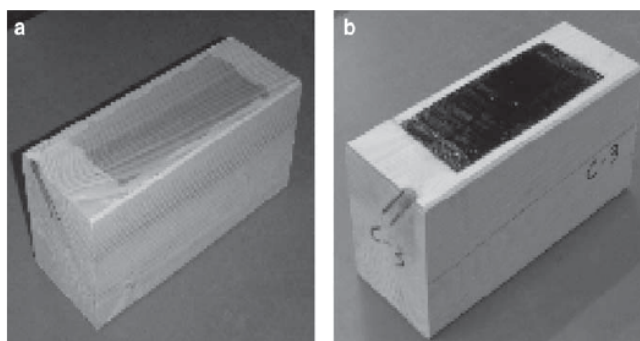
Figure 4 – Application of layer (a) and FRP strip (b) [2].

Another technique which is often not used when it comes to historic timber floors, especially in case of a painted intrados, is the application of FRPs in form of strips or bars which can be installed on both floor's boards or in the lower face of the timber beam element. If strips are used, the application of a thin adhesive layer is necessary for both configurations (Figure 4 and Figure 5). The use of this technique is often not used due to its costs. As for the previous considered technique, this method is not reversible and thus incompatible with the principles of conservation.

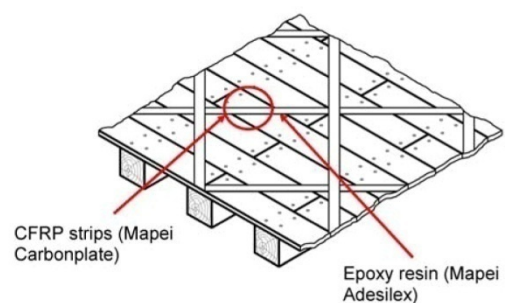
Figure 5 – Strengthening technique with CFRP and epoxy resin [11].

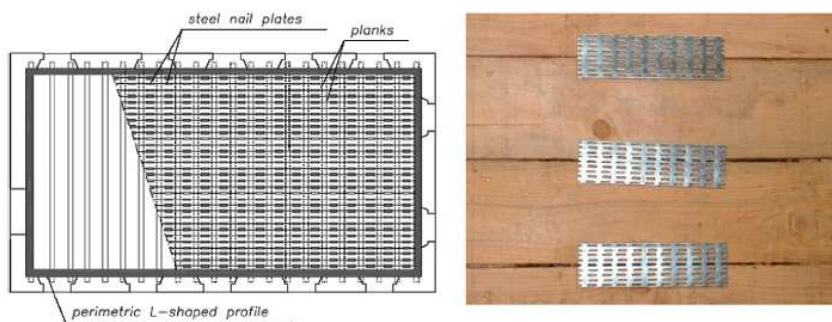
Figure 6 – Use of steel plates to connect timber floor's plank [3].

Steel connections in form of metal plates can be used to connect the planks of an existing timber floor to avoid slip between the elements due to shear (Figure 6)[3]. However, due to the different thermal behaviour of the materials, this technique could lead to the presence of condensation in the interface between the two elements, and to an alteration in the moisture content of the timber elements.

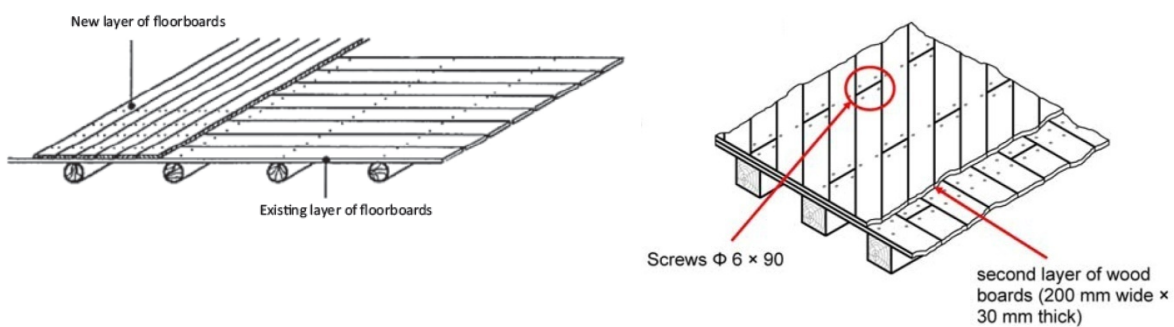
Figure 7 – Orthogonal layer of floorboards over an existing structure [3][11].

A strengthening method used in the past especially in seismic zones considered the application of a new floorboard, laid orthogonally or at 45° on the existing one, to increase both stiffness and strength (Figure 7).

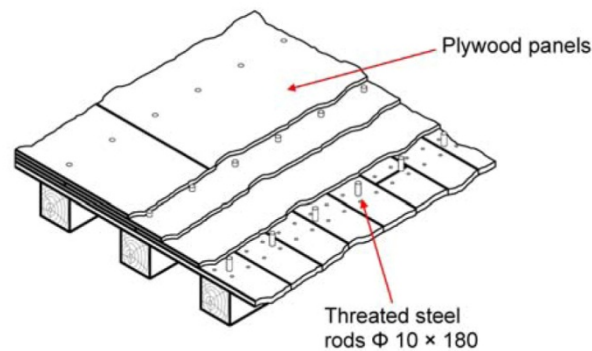
Figure 8 – Strengthening technique with plywood and steel rods [11].

Another approach considers the application of plywood panels on more layers and connected with steel rods (Figure 8) to increase both strength and stiffness. All those methodologies which consider the use of timber are preferred due to their adherence to the principles of the Venice Charter, even though the presence of steel elements could imply issues related with the coexistence of non-compatible materials.

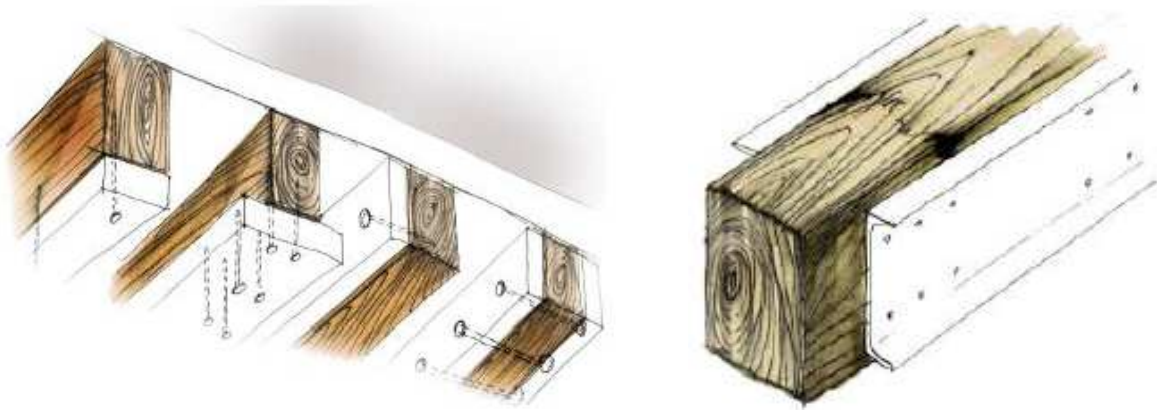
Figure 9 – Example of increased cross-section with timber planks (left) and steel elements (right) [14].

Several approaches can be adopted to provide a higher stiffness of the timber beams: different material such as steel or timber can be used as well as different type of fasteners, also the location of the retrofitting can change considering the peculiar configuration of the considered timber structure. Figure 9 shows two examples of application on timber beams which consider the application of timber and steel elements. This method can also be applied on structural element of both timber roofs and floors [13]. Figure 10 shows a truss repaired by means of this procedure.

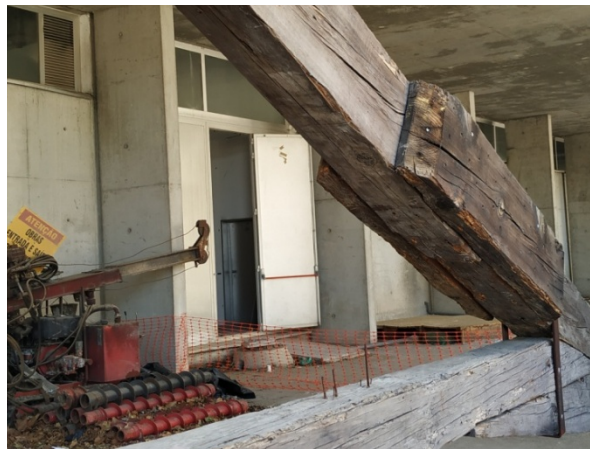
Figure 10 – Example of repairing on a timber truss.

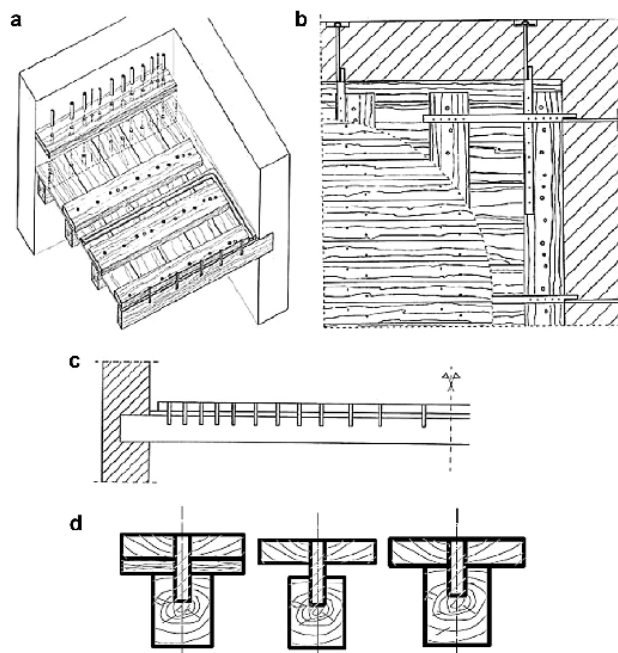
Figure 11 – Strengthening intervention timber-to-timber connected with timber pegs: (a) axonometry, (b) plan, (c) section, (d) different type of cross section, with and without existing boarding [2][3].

The procedure studied and used in the experimental campaign carried out by the University of Padua [2] [3] considers the application of new timber planks on the existing structure beams by means of timber pegs. For compatibility reasons the dowels are made of hardwood placed as connection with a dry technique. No additional material is used in order to improve the adhesion in the interface. A T-beam is thus composed and normally the flange is separated by the net through the existing boarding. Figure 11 shows plans, axonometric view and cross-sections denoting the application of this technique.

This kind of connection is subjected to shear, which is transferred by the dowels between the timber layers creating a composite beam with semi-rigid connections [16]. For this reason a higher number of timber pegs is placed along the beam where shear is prevalent, such as near the end of the beams (Figure 11c).

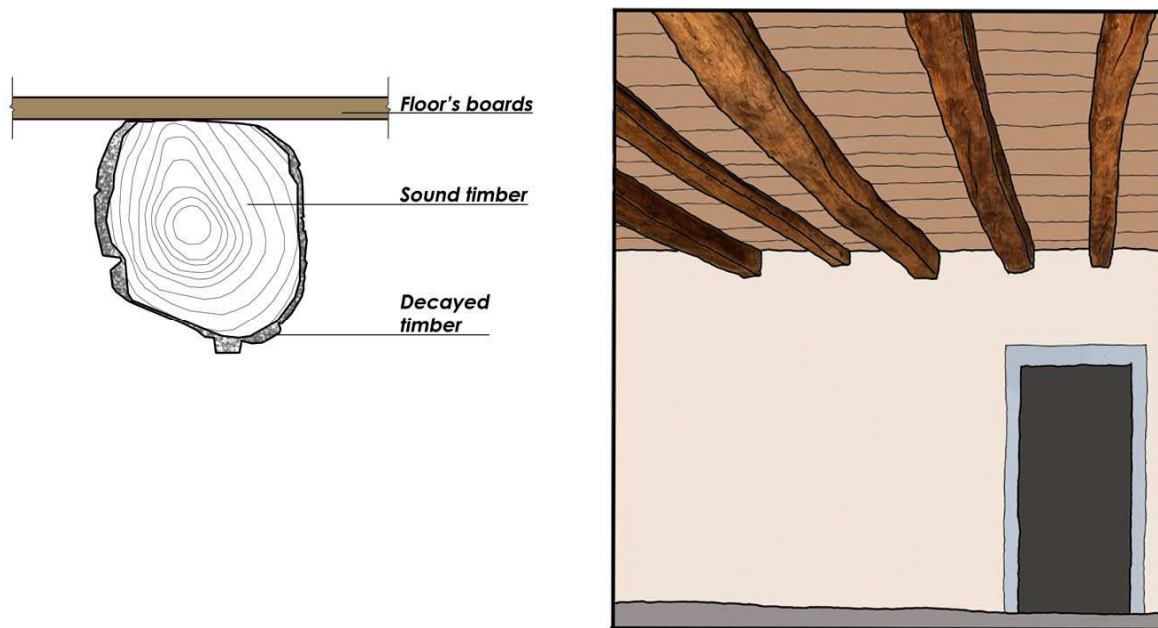
Figure 12 – Example of a timber floor.

The procedure to follow in order to apply retrofitting planks on the side of the timber beams is extremely similar to the one needed for the implementation of the structure by the application of the planks on the extrados of the beam. Nevertheless, some peculiar arrangements are needed due to the location of the technique itself. First of all, it is mandatory to proceed with a mirrored and symmetric installation on both sided of the beam in order to avoid an irregular distribution of the stresses, as any non-symmetric application of this retrofitting technique can negatively affect the global behaviour of the timber structure. This and other steps are presented in the following guidelines for the proper installation of the procedure, considering a timber floor composed by irregular beams and simple timber boards connected by means of nails (Figure 12), which is a current situation found in existing timber structures on North Portugal.

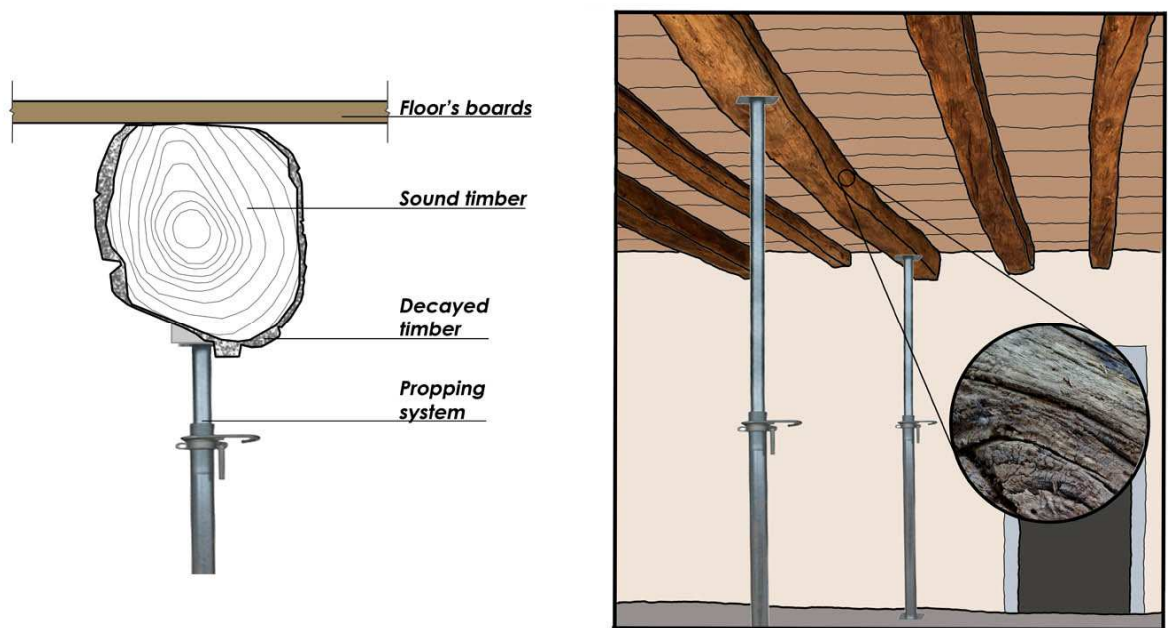
Figure 13 –Step 1: propping, visual inspection, location and estimation of the decayed cross-section.

When in presence of an element needing reinforcement, before any intervention is carried out, a propping system has to be installed in order to avoid any further damages or collapse during the procedure (Figure 13), as well as to guarantee the safety of all workers. After this, it is possible to proceed with a visual inspection to identify the presence of decay or other relevant damages. Non-destructive tests (NDTs) such as drilling resistance and pin penetration tests are strongly recommended in this phase in order to evaluate an approximation of the depth of decay that has to be removed and the quantification of the residual cross-section. This evaluation allows to evaluate if the structural element presents deeply decayed sections which are to be replaced or if the grading and the extension of the decay requires to intervene on either the entire length of the timber beam or simply in correspondence of the critical cross-sections. The absence of an active insect or fungi attack has to be also verified and, if present, appropriate countermeasures are mandatory. The propping system is maintained in position for the entire duration of the work.

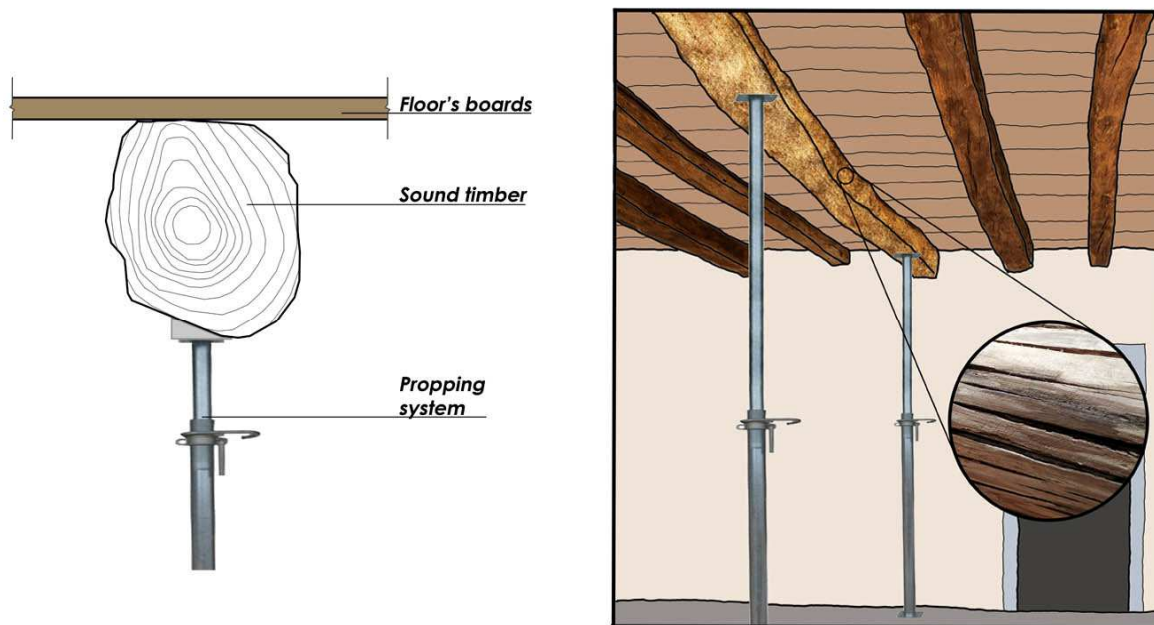
Figure 14 – Step 2: removal of the decayed section.

The second step focus on the treatment of the existing structure through the elimination of the decayed part (Figure 14), This can be done manually or with the help of an proper machine. It is important to underline that no sound timber should be removed in order to reach a straight and smooth surface, every natural irregularity is maintained as long as proved not decayed. If old metal elements such as nails are present, it is advised to remove them as much as possible, without bringing more damage to the structure. Secondly, repair techniques are applied in case their need was pointed out in the previous step. During this step, the propping system may have to be locally removed or changed from its location. This must be made always ensuring that the element is being supported in safe conditions.

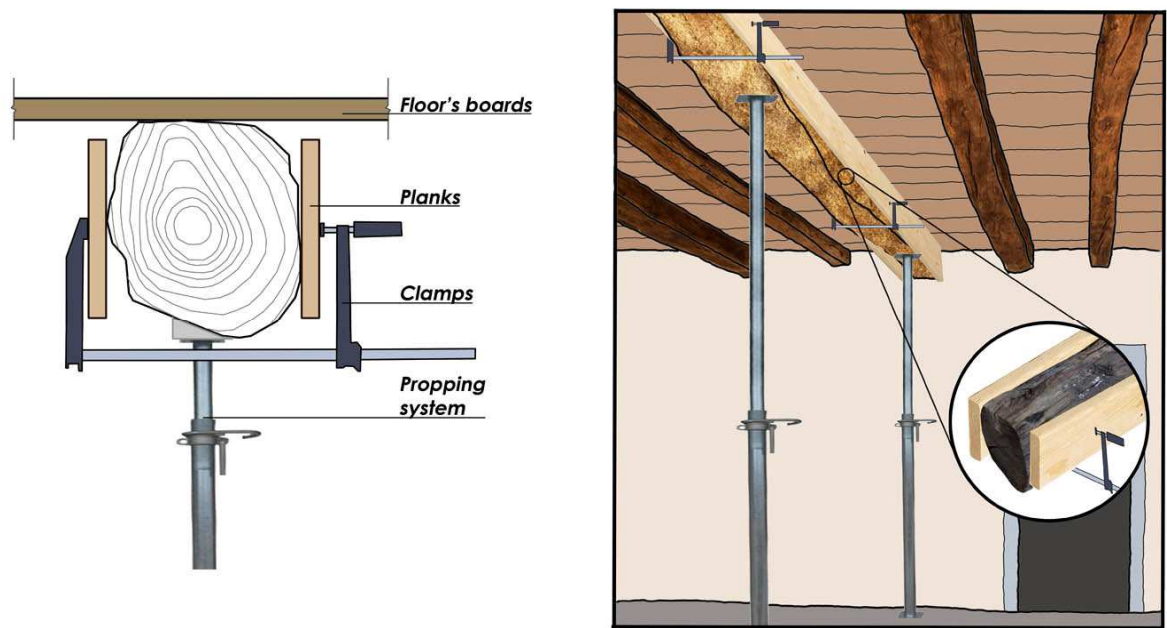
Figure 15 –Step 3: installation of the planks.

Once a sound base is guaranteed, in the third step of the procedure the planks are applied and maintained in their location by means of clamps (Figure 15). If the strengthening technique is applied for the entire length of the beam, the planks are recommended to have exactly the same length of the beam itself (Figure 16). The planks are to be inserted in the bearing wall previously opened, at least for a depth equal to the length of the beam itself. This gap is located on both sides of the beam's end to respect the necessity of symmetry. No fasteners are needed in the cross-section of the bearing wall in order to avoid huge openings in the masonry and because the planks are maintained in position by the wall itself. It is important to underline how this strengthening technique also participates actively giving a contribution to the bearing capacity of the existing structure and, unlike the traditional technique that is applied on the extrados, avoiding additional dead load maintained directly by the element in need of strengthening.

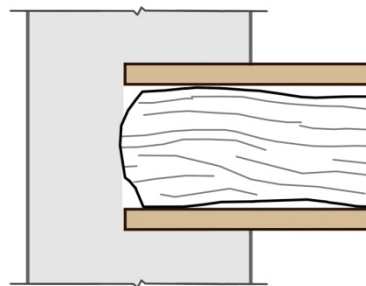
Figure 16 – Detail of the planks in the bearing wall.

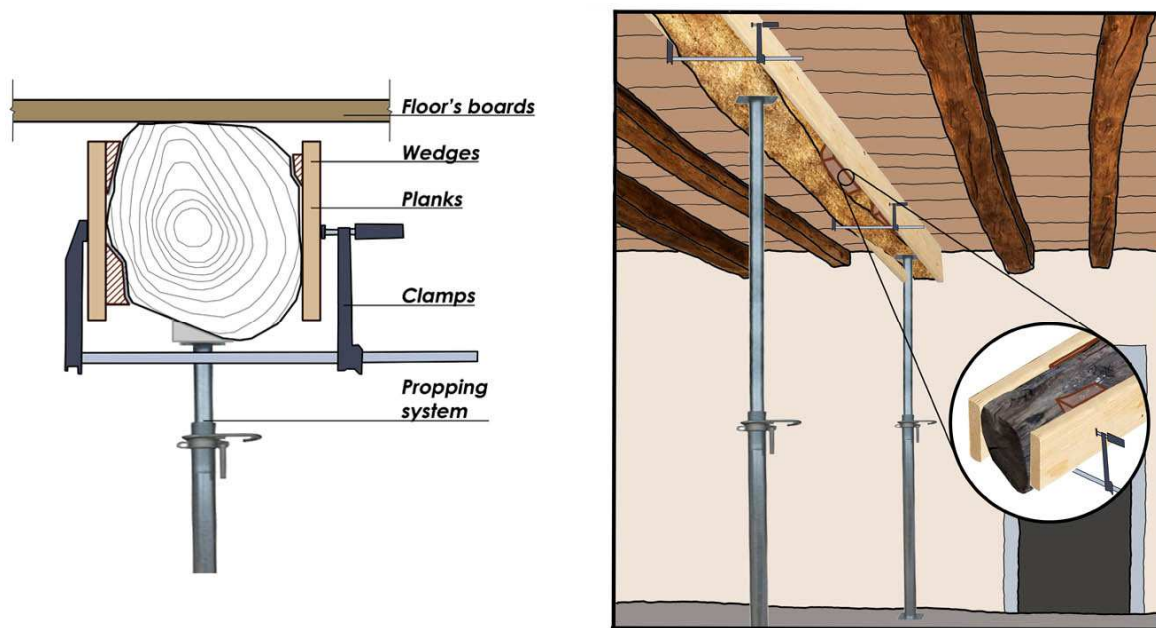
Figure 17 –Step 4: wedges positioning.

wedges, preferably of the same timber species of the planks, which are custom-made in situ depending on the presented irregularities. These wedges are hammered in the gap between the beam and the plank and, at the discretion of the carpenter (or onsite worker), may be connected to the structural system by means of glue (e.g. white wood glue) (Figure 17). Dimension and shape of the wedge are parameters that may influence the choice to use of white glue. It is firmly recommended to avoid the use of very rigid glues as the intention is only to maintain the wedge in position prior to the placement of the wooden pegs.

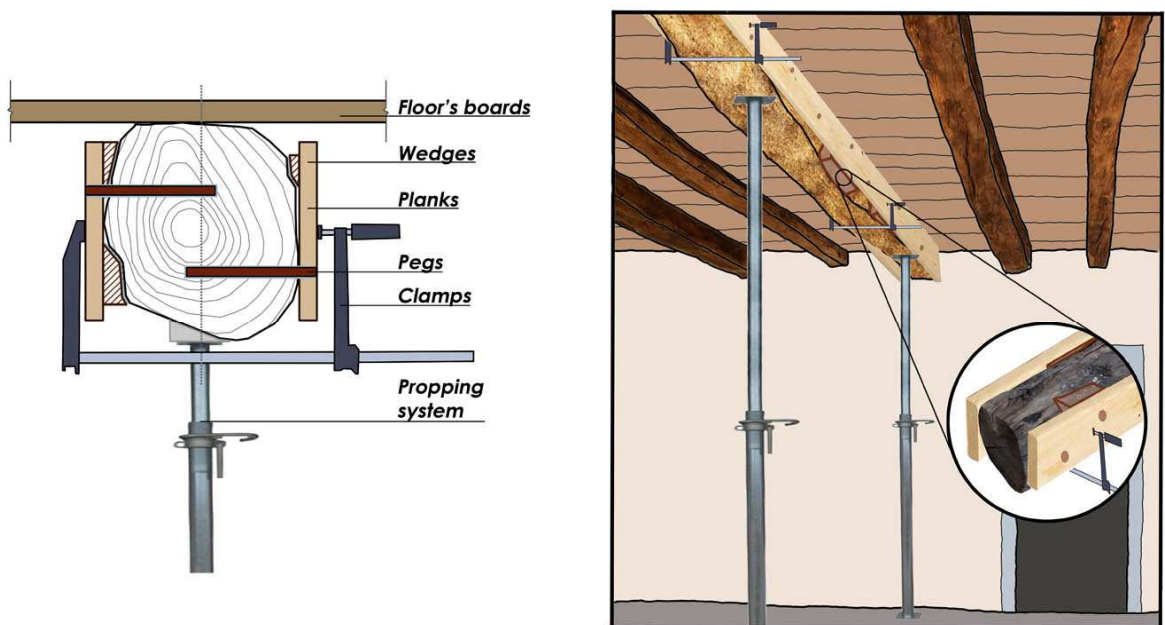
Figure 18 – Step 5: coring of the pegs' holes.

In this step, the holes of the timber fasteners are cored and the peg is inserted right after (Figure 18). It is recommended to proceed always symmetrically and progressively from one end of the beam to the other, and to intervene on both the sides at the same time alternating the sides of application. For this specific strengthening method, the penetration length is not defined by the code rules as it depends on the cross-section of the beam itself, more precisely the hole has to be at least 2 cm longer than half of the base of the beam, in this way an overlap of the area of interest of the pegs is guarantee. This aspect is extremely important due to the symmetry of the approach: if pegs shorter than half of the beam base were used, a failure line is induced during the procedure. This could lead to the formation of internal cracks along the grain direction. In the worst scenario this can cause the division of the cross- section creating two independent beams. This is especially critical for small width sections and when using large diameter pegs. The use of longer pegs allows an uniform distribution of

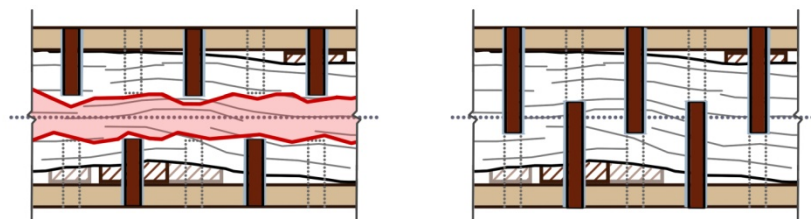
Figure 19 – Plan with cored holes shorter than half of the beam's thickness (left) and overlapped (right).

the stresses along the cross-section (Figure 19). As the rule code in [5] highlights, it is recommended to drill a hole with a diameter 1 mm thinner than the diameter of the used peg.

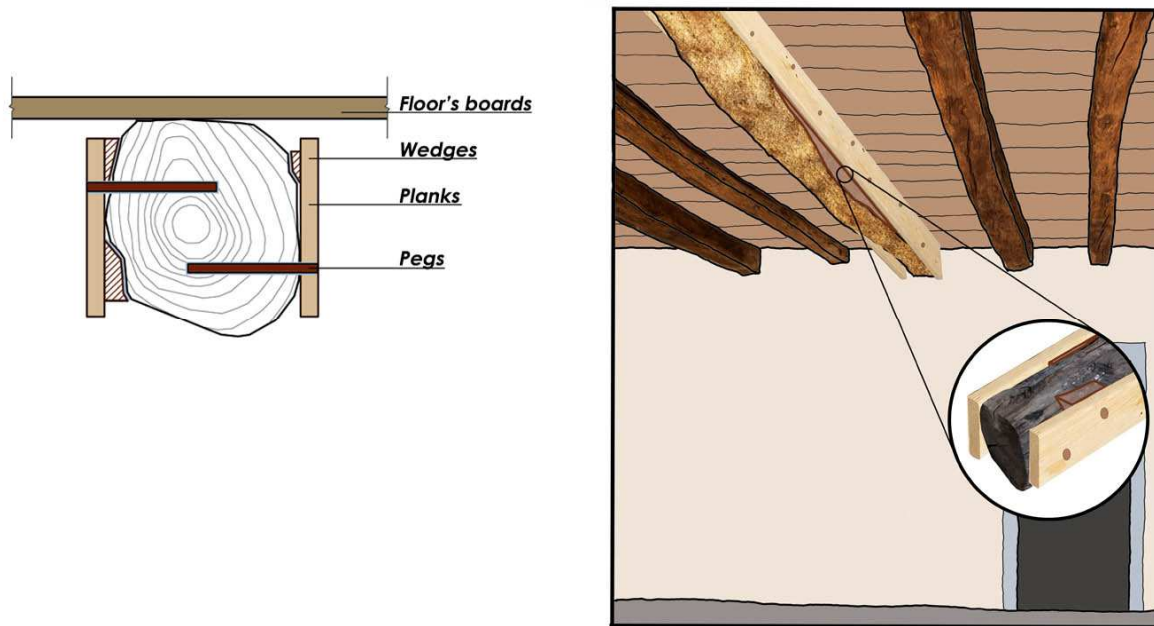
Figure 20 – Step 6: Removal of the propping system.

Once the installation of the pegs is finished and the holes in the wall are filled, the propping system can be removed (Figure 20). Because of its dry nature, this technique does not require an additional time to set and to influence the structure.

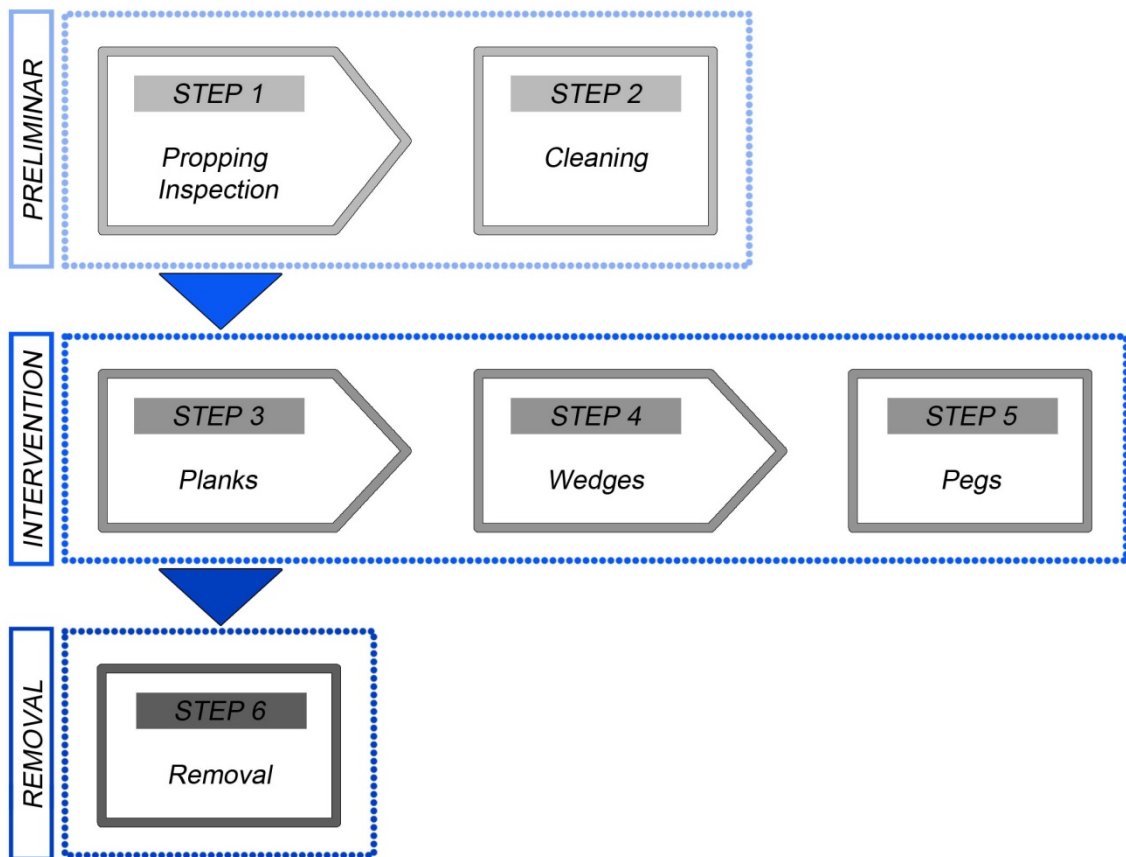
Figure 21 – Summary of the step of the strengthening technique.

The overall procedure of the technique, described in the previous topic, can be grouped in three main phases. The first one regards all the actions aimed to the preparation of the structure and to the intervention, being composed by steps 1 and 2 (installation of the propping system, inspection and cleaning). This section corresponds to the preliminary works do be done before the retrofitting technique itself. The following phase corresponds to the intervention itself structured on the steps 3, 4 and 5 which focus respectively on the installation of planks, wedges and pegs. The final section sees the dismantle of the propping system. Figure 21 shows the structure of the method.

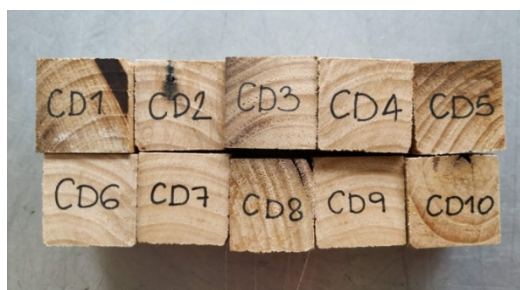
Figure 22 – Density samples.

Destructive tests in order to compute the density were carried out on 10 samples (Figure 22) cut with dimensions of 25x20x20 mm³ as defined by the code.

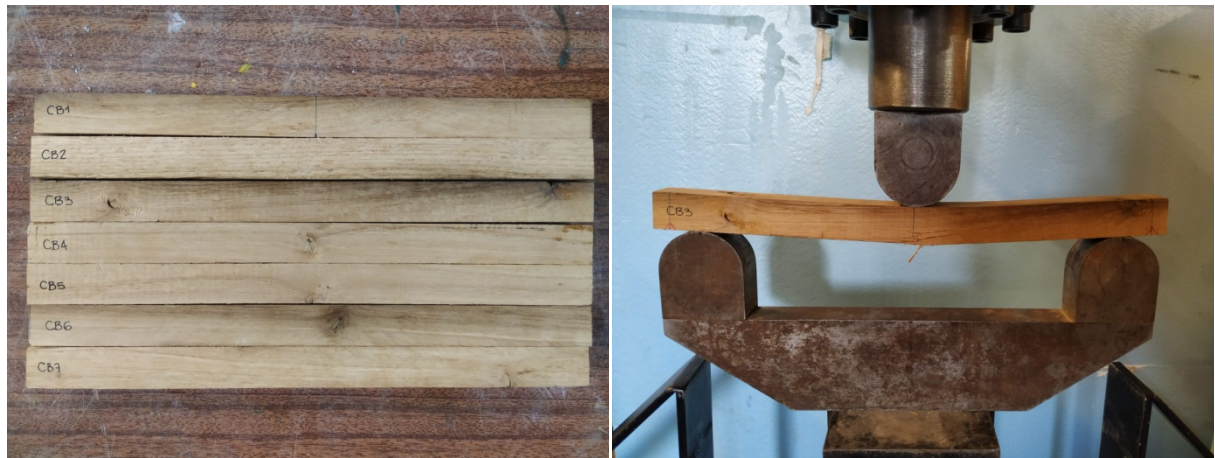
a) Specimens before the tests.

b) Bending test setup.

Figure 23 – Procedure of the bending tests.

A total amount of 7 samples with dimensions 300x20x20 mm³ were tested with an actuator of 100kN at a displacement rate of 0.035 mm/sec (Figure 23). The specimens were retrieved from the end parts of the samples used in the double shear tests. Because all the samples were taken from old Chestnut beams which displayed a consistent pattern of damage and defects composed mainly by thin cracks and small knots, the specimens were cut with extreme attention in order to obtain elements composed by clear wood. In the cases where these conditions were not possible, the specimen was orientated in order to have the defect in the compressed face so that the failure mode (Figure 24) would not be influenced by it.

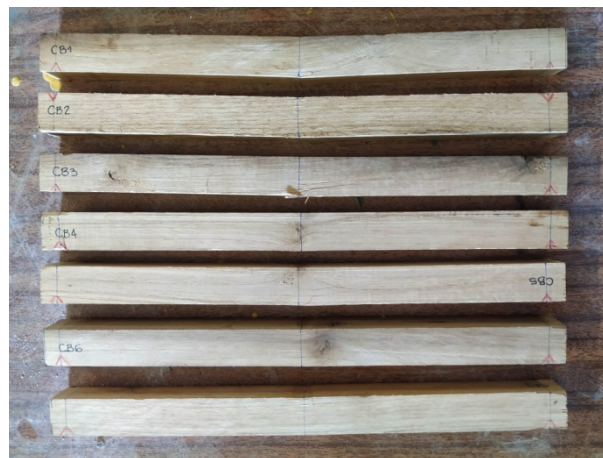
Figure 24 – Failure modes of specimens tested for bending strength.

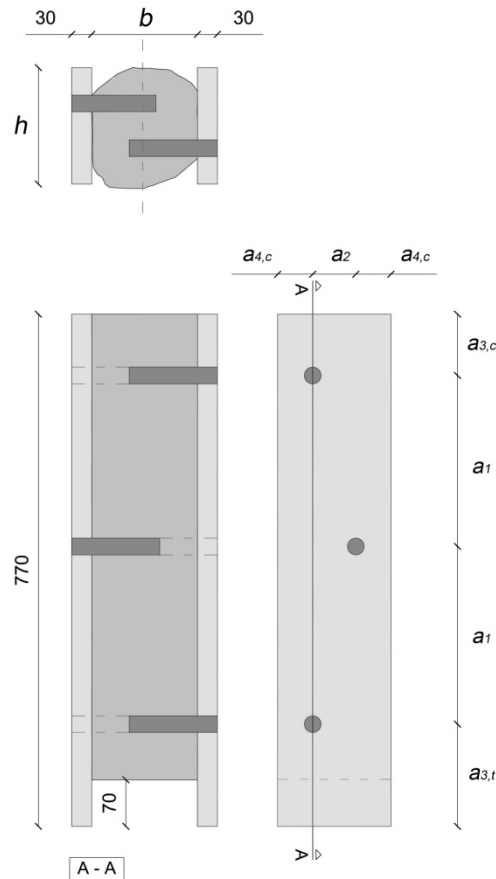
Figure 25 – Design for the double shear tests.

Considering a variation in the geometry caused by the intrinsic irregularity of the studied elements, Figure 25 shows the design followed in the construction of the double shear samples.

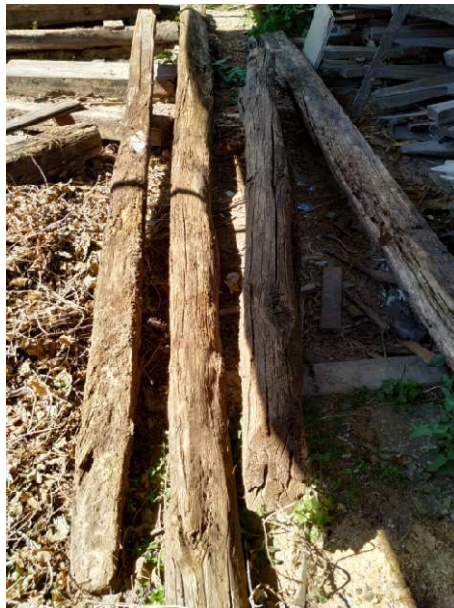
Figure 26 – Chestnut beams used for the samples.

Old chestnut beams of an average length equal to 2.80 m originally from different timber floors of private houses which were removed as a consequence of structural renovation, were used as base for the samples.

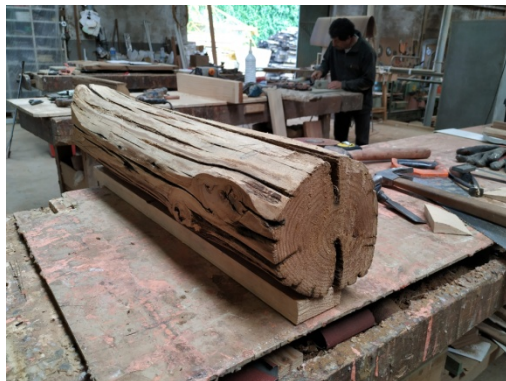
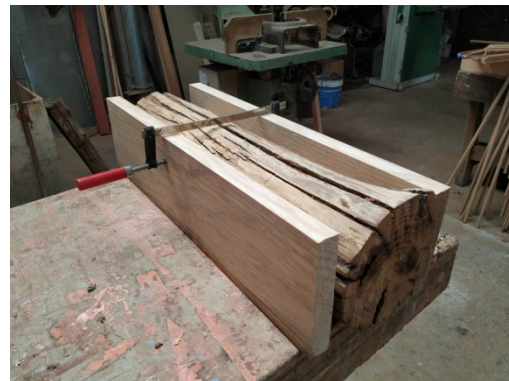
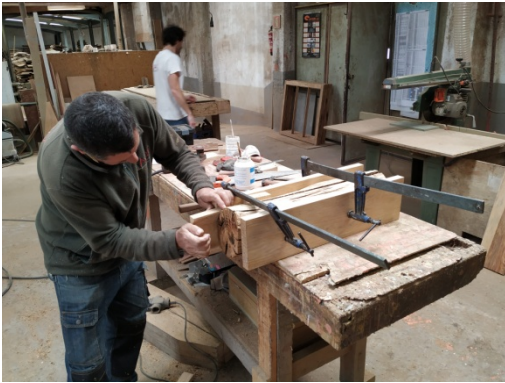
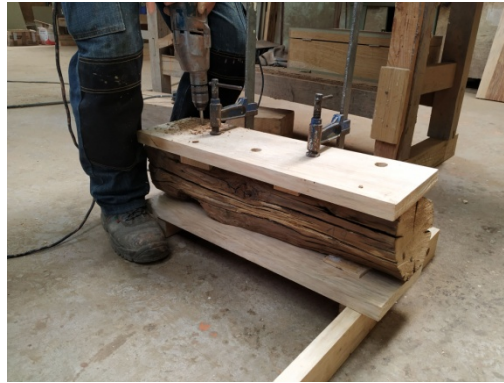
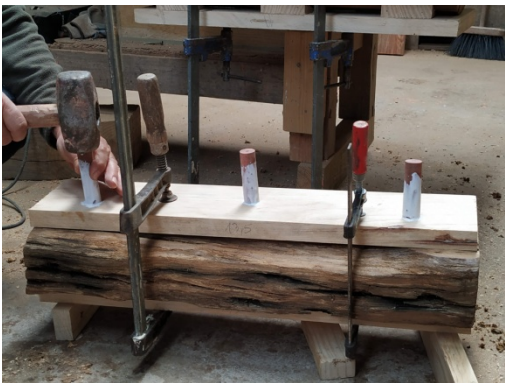
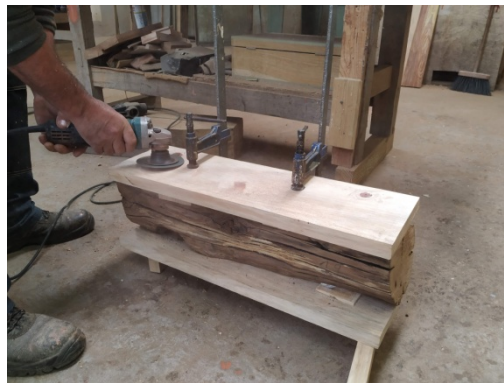
Figure 27 – Procedure to the construction of the tests.

Following the guidelines exposed previously, the specimens were built as Figure 27 shows. It is important to highlight that in this case the holes were all cored before the introduction of the pegs due to the reduced dimension of the specimen itself. On the real scale is recommended to insert one peg at a time has to promote a better fit of the planks with the element to be retrofitted.

a) Cleaning of the surface.

b) Positioning of the planks.

c) Introduction of the wedges.

d) Coring of the holes for the pegs.

e) Introduction of the pegs.

f) Filing of the surface.

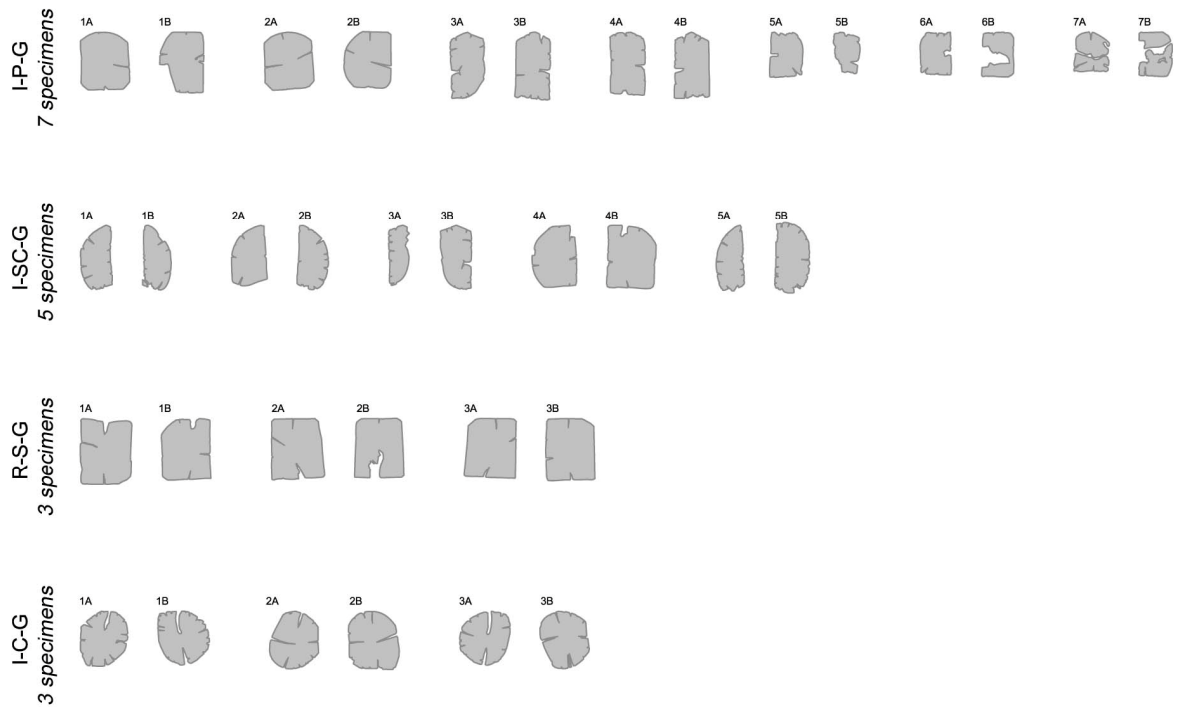
Figure 28 – Grouping and labelling of the samples.

A geometrical survey followed by a visual grading inspection was made for all the samples in order to separate them into different possible samples as to estimate their structural behaviour. A preliminary division in groups of the elements was thus necessary and to reach this purpose factors like shape of the cross section and the presence of glue was considered. Eventually the panorama provided 18 glued samples divided in 4 groups and 12 unglued sample divided in 3 groups. Figure 28 shows their grouping along with the cross-section of both the end of the specimen. The labelling of the specimens is based on three groups of letters, where the first refers to if the cross-section is regular (R) of irregular (I), the second letter refers to the geometry of the cross-section: circular (C), squared (S), semi-circular (SC) or with parallel edges (P). The last letter explains if the sample is glued (G) or unglued (NG).

a) Glued elements

b) Unglued elements.

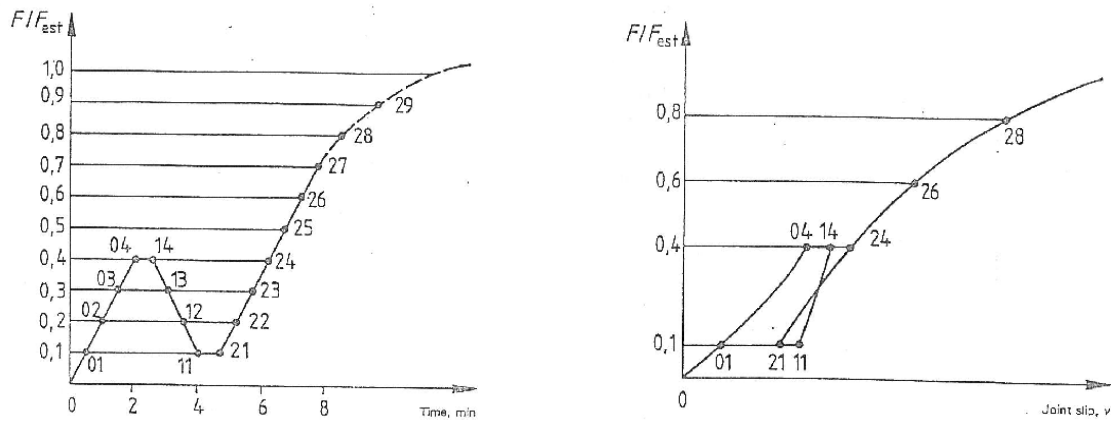
Figure 30 – Loading procedure (left) and idealized load-deformation curve and measurements[27].

The procedure adopted was composed by the following steps: with a force-control approach a load of 16kN equal to $0.2F_{max,est}$ was applied monotonically and then maintained for 30 seconds. Secondly the force was reduced at 4 kN equal to $0.1 F_{max,est}$ and maintained again for 30 seconds. Eventually the load was increased until the sample reached failure with a constant velocity of 0.16 mm/sec, after the failure the test stopped once the force reached 0.5 of the maximum vertical load recorded during each

Figure 30 shows graphs of the loading procedure and the expected load-deformation curve.

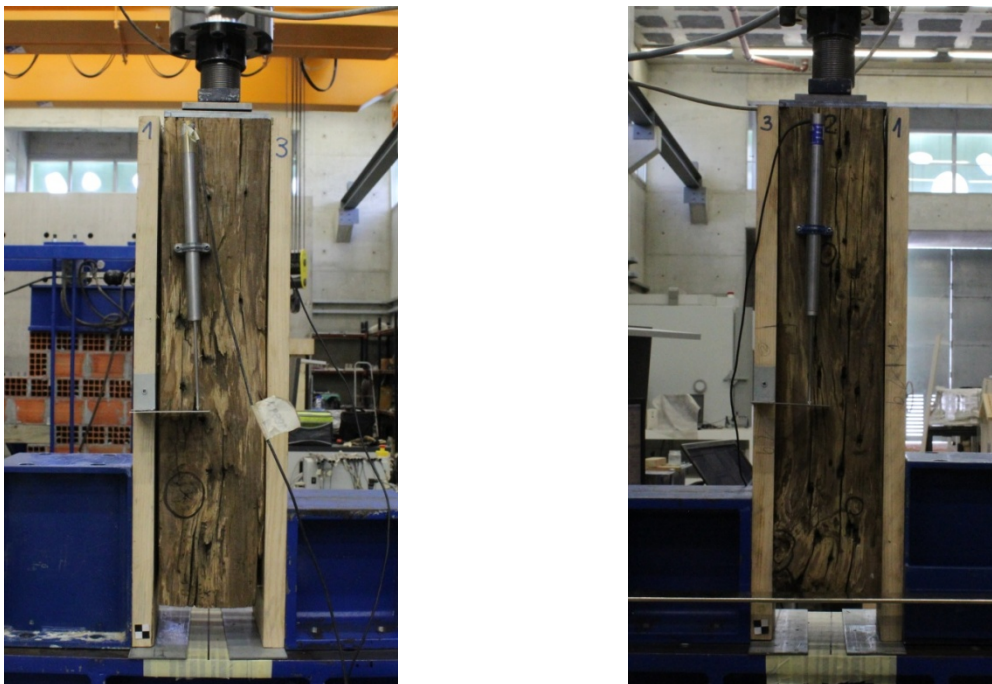
For each test the sample was confined laterally in order to avoid horizontal displacements and was maintained in position with the use of clamps, two LVDTs were then applied on the front and on the back of the test specimen in order to record the relative vertical displacement between both the reinforcement planks and the middle element (Figure 31).

Figure 31 – Sample R-S-NG-1 front (right) and back (left).

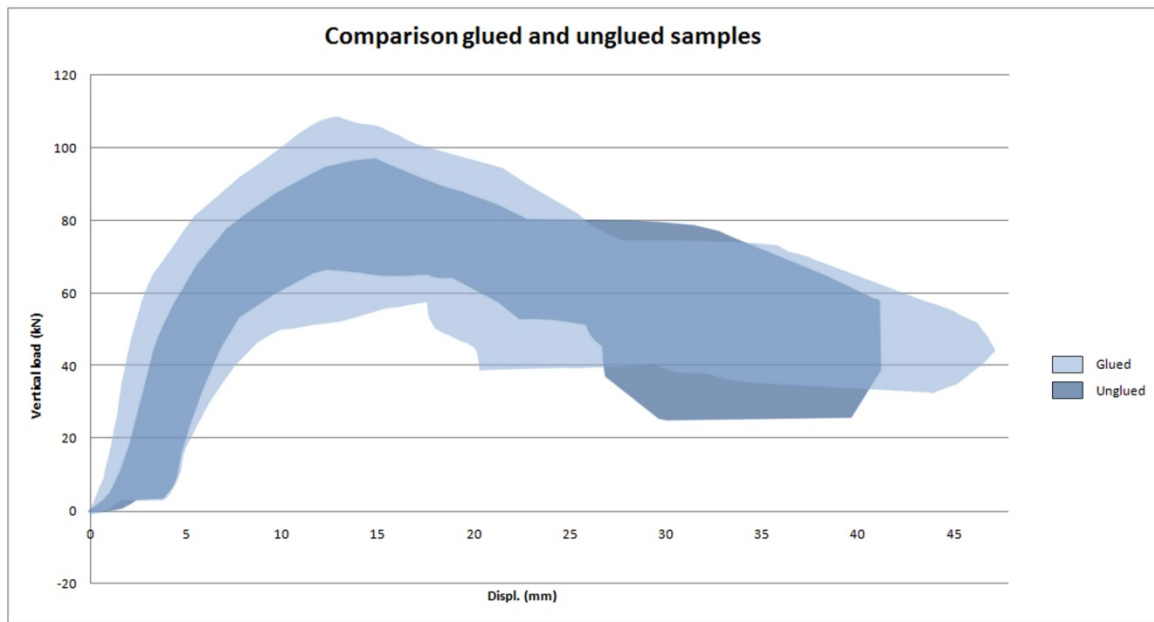
Figure 35 – Envelope of load displacement curve.

Data from all the 30 specimen were collected and analysed, values of maximum, minimum and mean vertical load and slip were recorded. Table 7 shows these values while Figure 35 shows the overlap of the areas of influence of the two types of tested sample. It is possible to notice how the glued samples reached a higher maximum load than that of the unglued specimens (111.49 kN against 97 kN) but at the same time provided a less uniform response when compared with the unglued specimens. In fact, the obtained standard deviation was equal to 29.18 kN for the unglued sample and 14.24 kN for the glued elements which allowed to evaluate the coefficient of variation (CoV). For glued elements a value of $CoV=15.73\%$ was found, while unglued elements the value was $CoV=8.96\%$ proving how the unglued samples provided a more unified behaviour.

Figure 34 shows the plot of the load-displacement relation evaluated through the double shear test for both glued (Figure 34a) and unglued (Figure 34b) specimens. These were used in order to plot the envelopes of load-displacement curves (Figure 35).

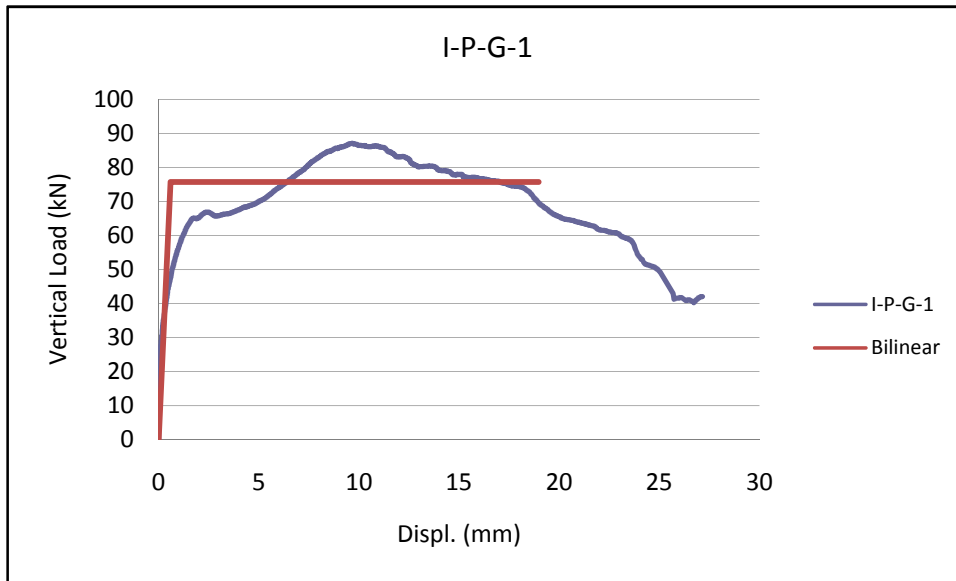
Figure 36 – Sample I-P-NG-1 estimation of stiffness.

The ductility was then evaluated for each sample (example in Figure 36) through the computation of the Equivalent Energy Elastic-Plastic Curve (EEEP) [28] based on the bilinear curve representative of the balance of the energy dissipation as the area below the curve is equal to the area over it. The bilinear curve is evaluated through the initial stiffness K which lays between 0% and 40% of the peak load and is represented by the first line, while the deformation at failure is equal to 80% of the peak load. The yield load is evaluated with equation (6).

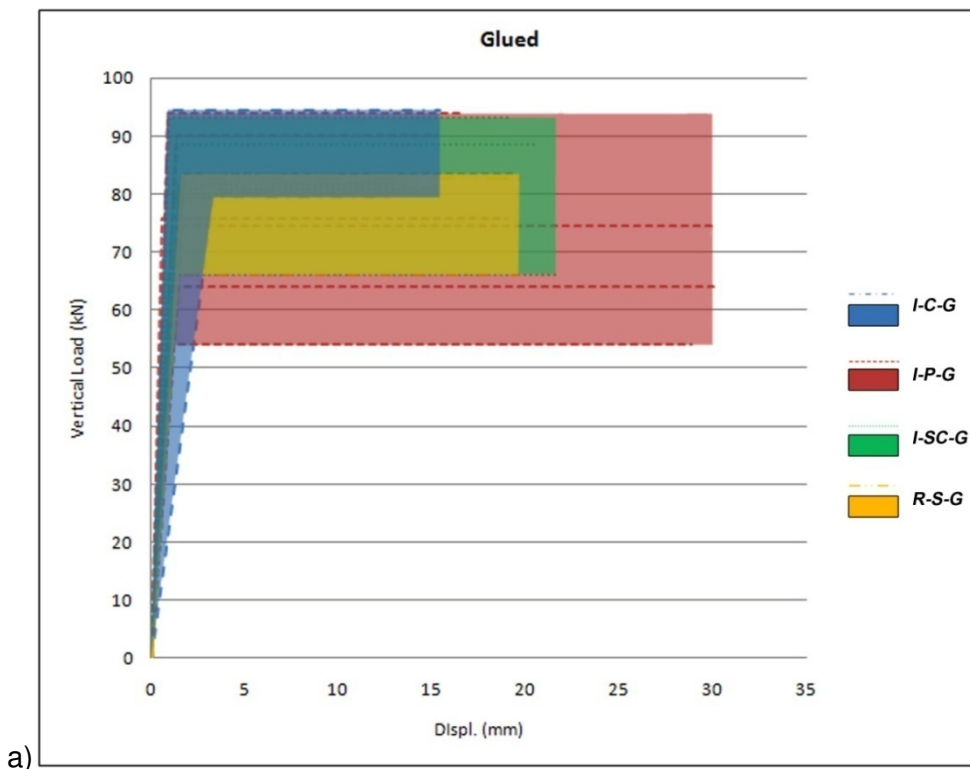
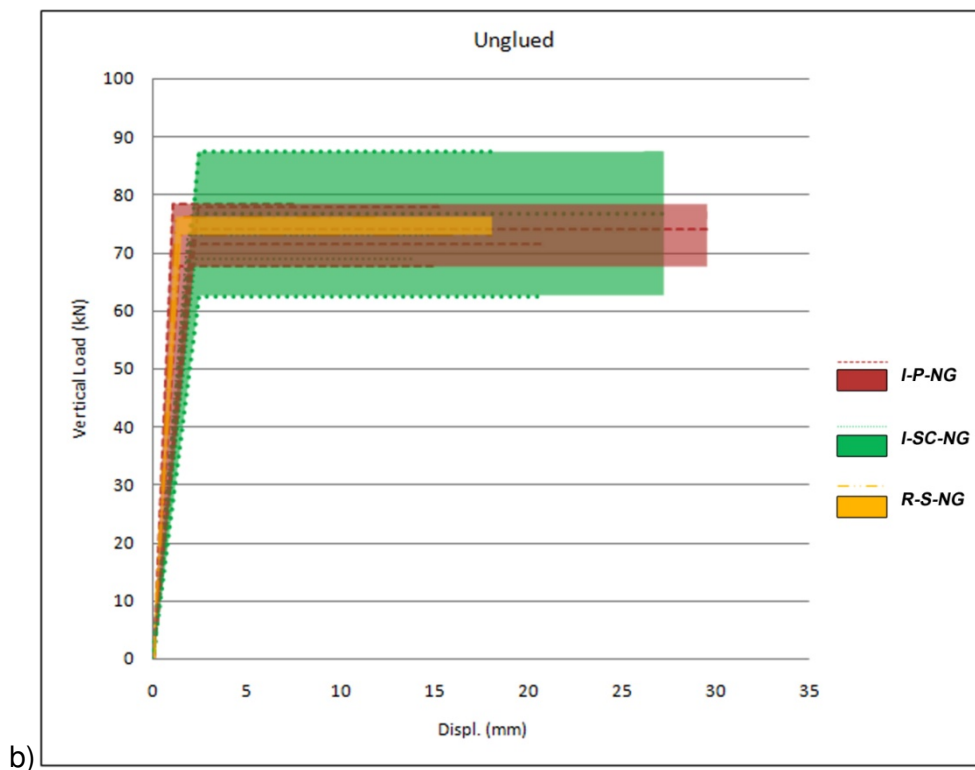
Figure 37 – Bilinear envelope curves for glued (a) and unglued samples (b).

Values of stiffness for both glued and unglued samples were calculated with the help of the software MATLAB. Figure 37a and b shows the envelopes respectively for glued and unglued samples, where the chromatic differentiation is ruled by the criterion based on the cross-section's shape used to originally subdivide the samples.
