Master's Thesis

Wooden pegs in the retrofit
of timber constructions

University of Minho

Portugal | 2019

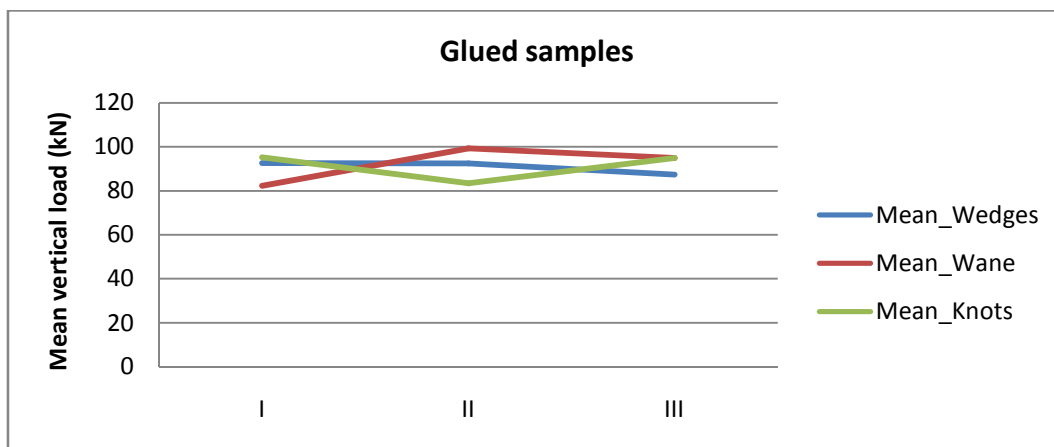
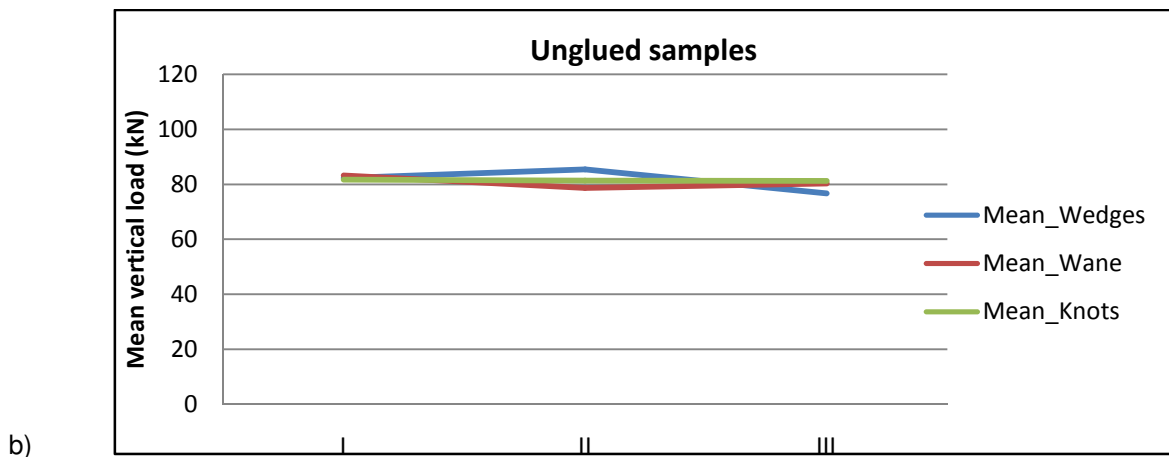
Figure 38 – Plot of mean values of vertical load considering the visual grading for glued (a) and unglued (b) specimens.

The values collected were plotted and analysed. Regarding the glued samples (Figure 38a) it is possible to notice a light influence when the wedges are considered, as the higher the grading the higher the mean vertical load recorded. Nevertheless, this correlation is not strong enough to be considered univocally predominant in the structural response of the samples. On the other hand no substantial difference is noticeable in the case of unglued specimens which display an almost constant response (Figure 38b).

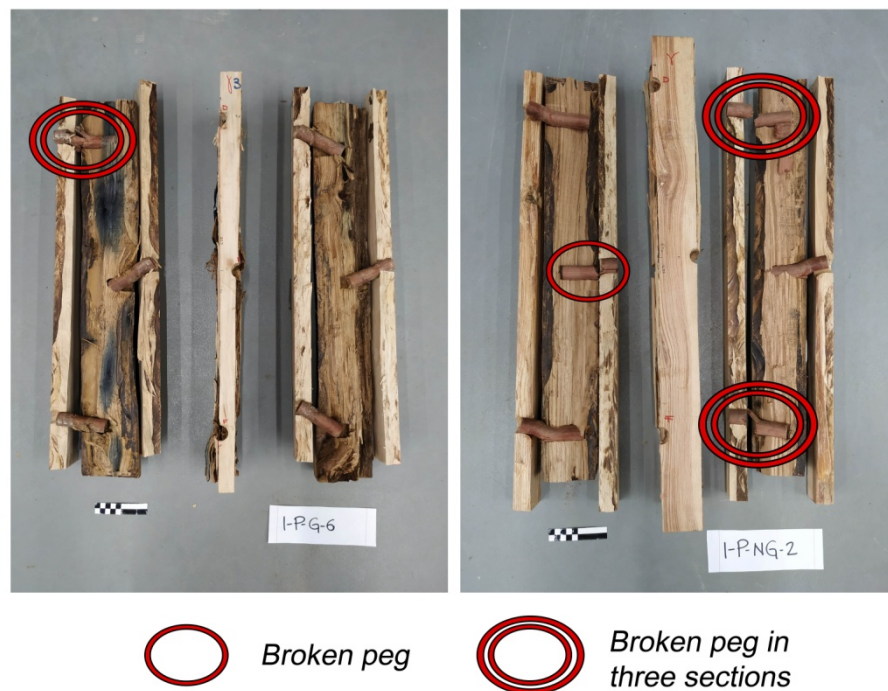
Figure 40 – Samples I-P-G-6 (left) and I-P-NG-2 (right) after the cut.

In general, a higher amount of brittle failure of the connection was recorded in the unglued samples. An example of more ductile behaviour was performed by the glued specimens. Figure 40 compares a glued sample (I-P-G-6 on the left) with an unglued example (I-P-NG-2 on the right): 3 out of 6 pegs connecting the unglued sample failed in a brittle way, while in the glued example 5 fasteners out of 6 maintained a ductile behaviour.

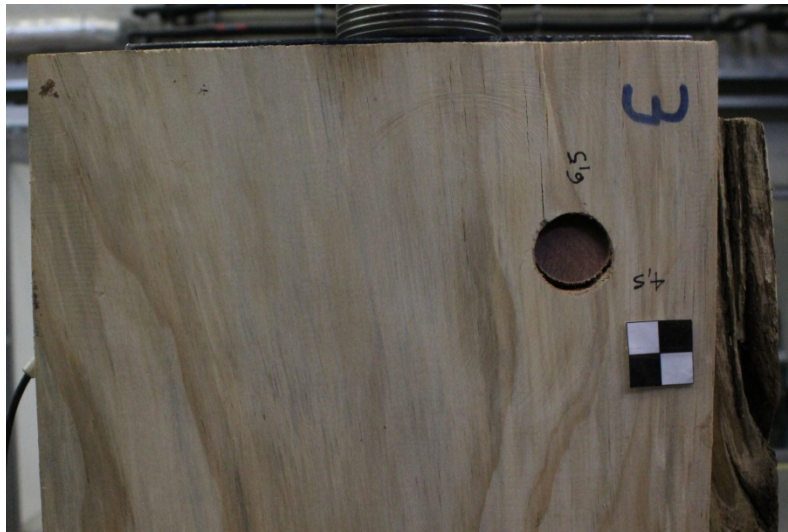
Figure 41 – Failure of sample I-SC-G-1.

Of all these the values, marked in green are the one which did not suffer failure dependent on that spacing value, in yellow the values which suffered minor damages such as the formation of cracks which did not reach collapse and the elements which suffered a failure are highlighted in orange. It is important to underline that, out of all the undersized minimum spacing, only one sample faced the formation of a crack (Figure 41) and only one reached the collapse of the edge (Figure 42), both of them were placed in the unloaded end.

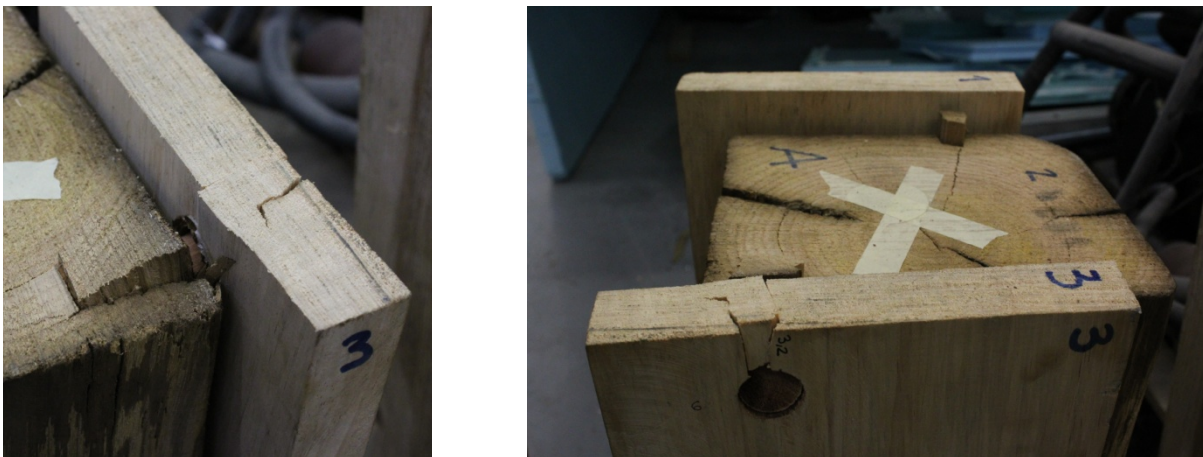
Figure 42 – Failure of sample R-S-G-3.

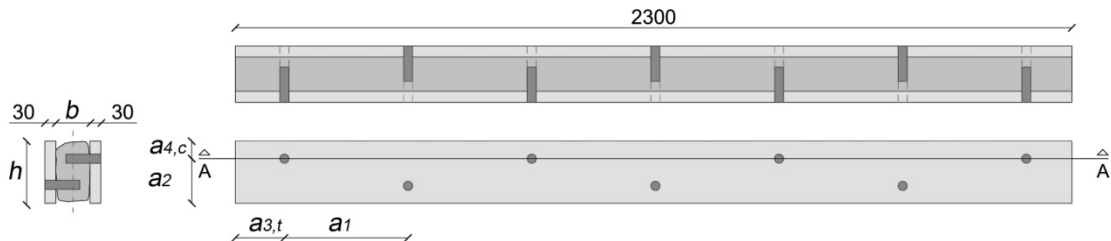
Figure 43 – Design for the 4-point bending tests.

Equal in length, the two elements displayed some irregularities regarding the geometry of the cross-section. Figure 48 shows the design followed for the construction of the two reinforced beams which were assembled in the carpentry and brought ready to be tested.

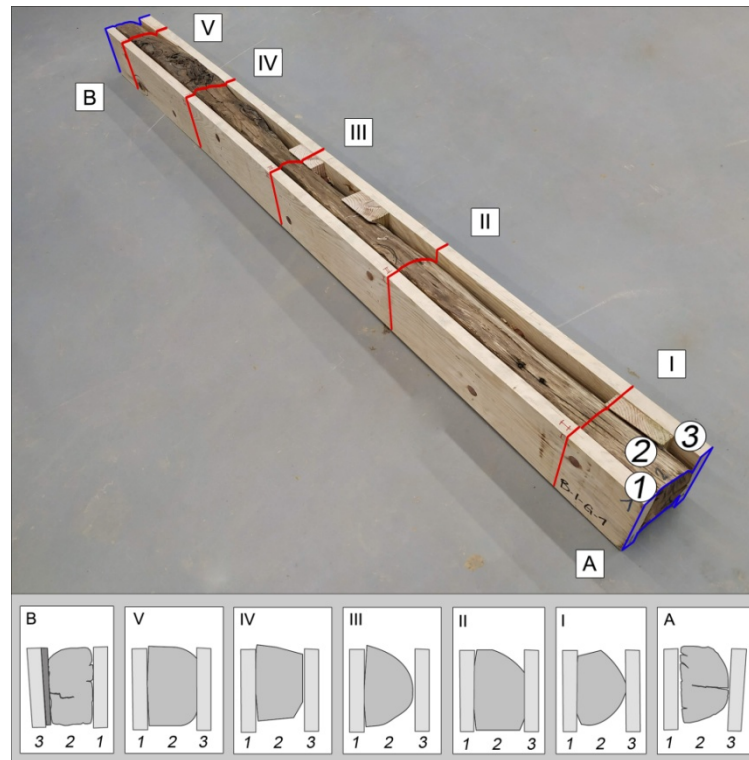
Figure 44 – B-I-G-1 location of the five cross-sections.

Following the same methodology as for the 30 sample tested in double shear, an accurate and detailed geometrical survey was required by the peculiar irregularity of the specimens. In order to provide a satisfying accuracy in the process, values for area, inertia and visual grading were evaluated as the mean value among the two main faces A and B of the beam and 5 internal cross-sections. These were named in roman numbers from I to V and located at 50 cm of distance starting from the centre of the span. Figure 44 and Figure 45 show the location of the internal cross-section respectively for B-I-G-1 and B-I-NG-1 used in the survey. The geometrical survey performed on the beams was done manually: after an initial location of all the 5 cross-section, measurements of the planks and the central element were progressively taken. The irregularity of the timber beam was measured on the two visible faces aiming to illustrate a simplified but precise representation of the cross-section. The two sides of the chestnut element which were not visible because covered by the pine planks, were estimated with a conservative approach through a straight connection between the two visible and measurable faces. Figure 46 shows an example of the performed survey. Once concluded the manual measurement, all the drawings were converted in two dimensional drawings and the values of area and inertia were calculated considering both the central element alone and the composite beam. Table 14 and Table 15 present the values of area and inertia found for the different cross-sections.

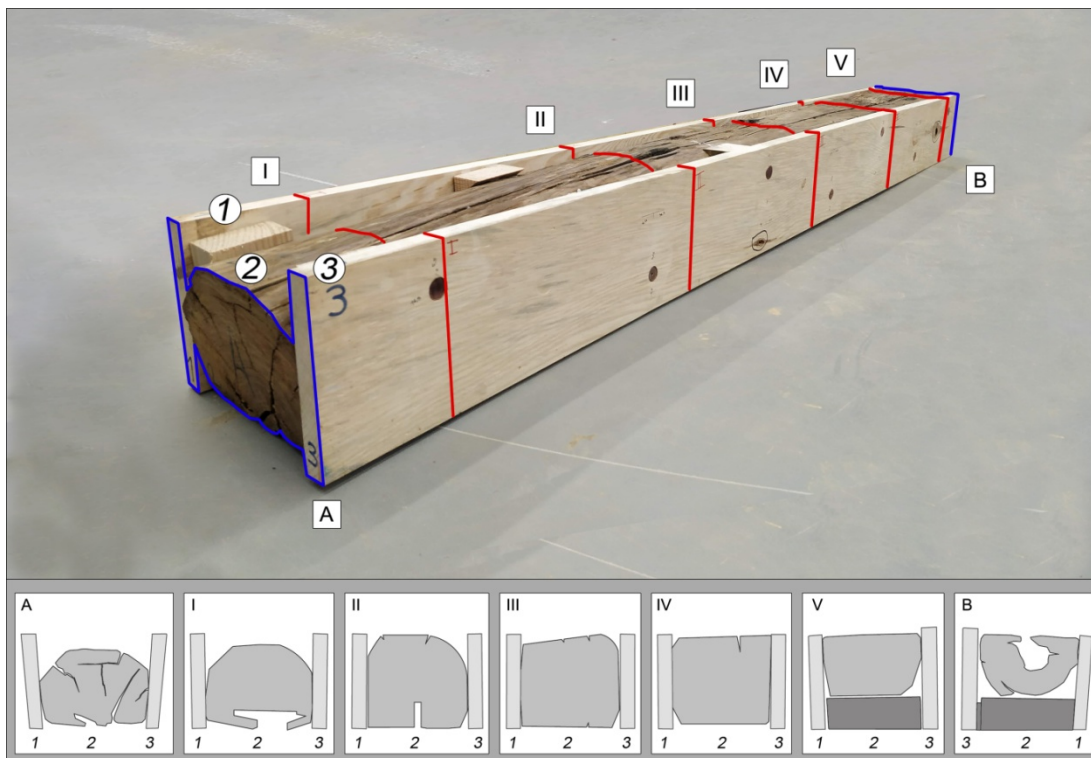
Figure 45 – B-I-NG-1 location of the five cross-sections.

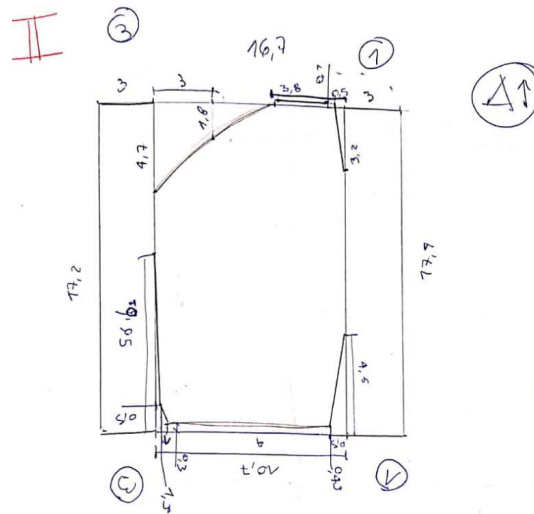
Figure 46 – B-I-G-1: example of geometrical survey of the cross-section II.

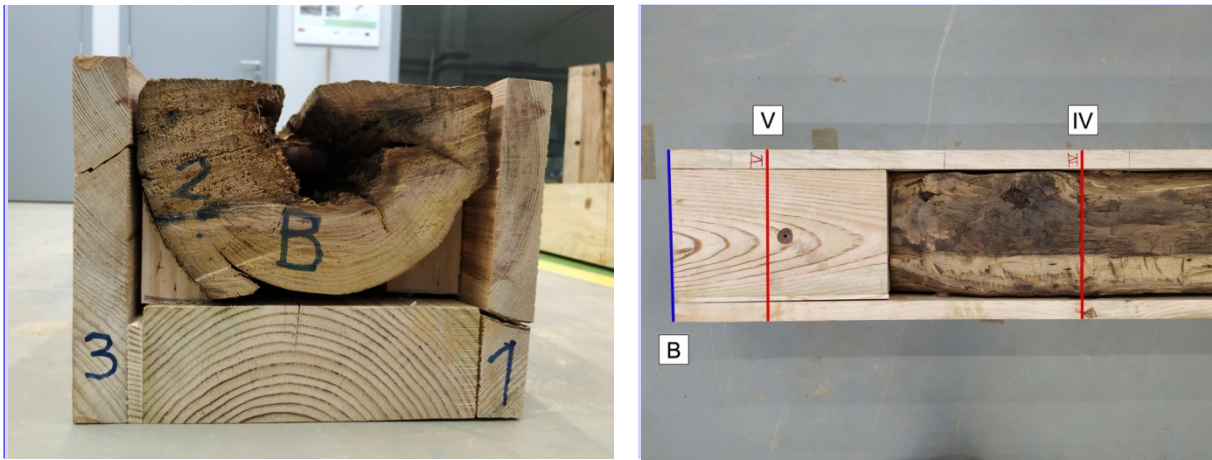
Figure 47 – B-I-NG-1: decay due to insect attack on the face B (left) and along the intrados of the opposite end (right).

reported as the most extreme between the two. In this case an evident decay due to insect attack was located in the intrados of the beam from the face A to the cross-section II (Figure 47)

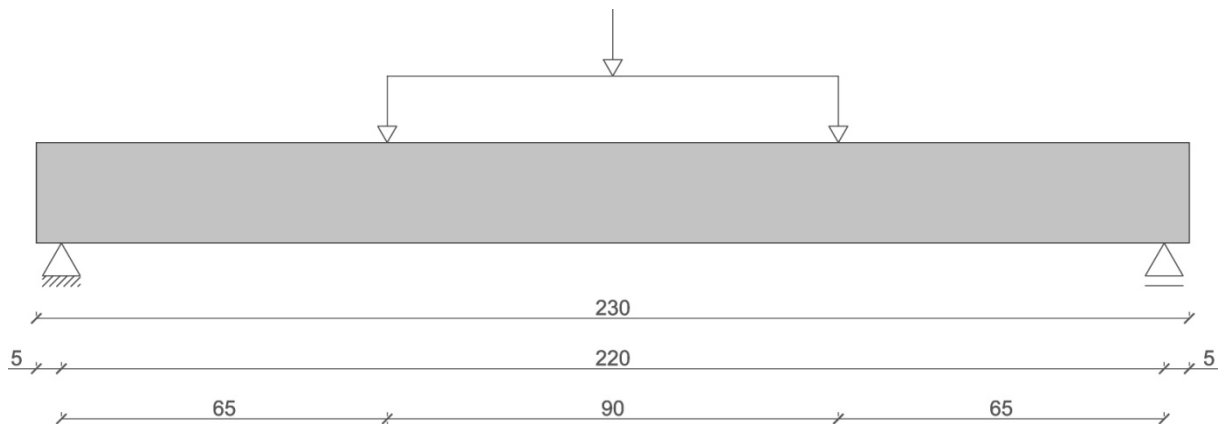
Both the beams were simply supported and loaded symmetrically along their length in two points located at 65 cm from the lateral supports (Figure 48).

Figure 48 – Set up of the 4-poin bending test [29], measurements in cm.

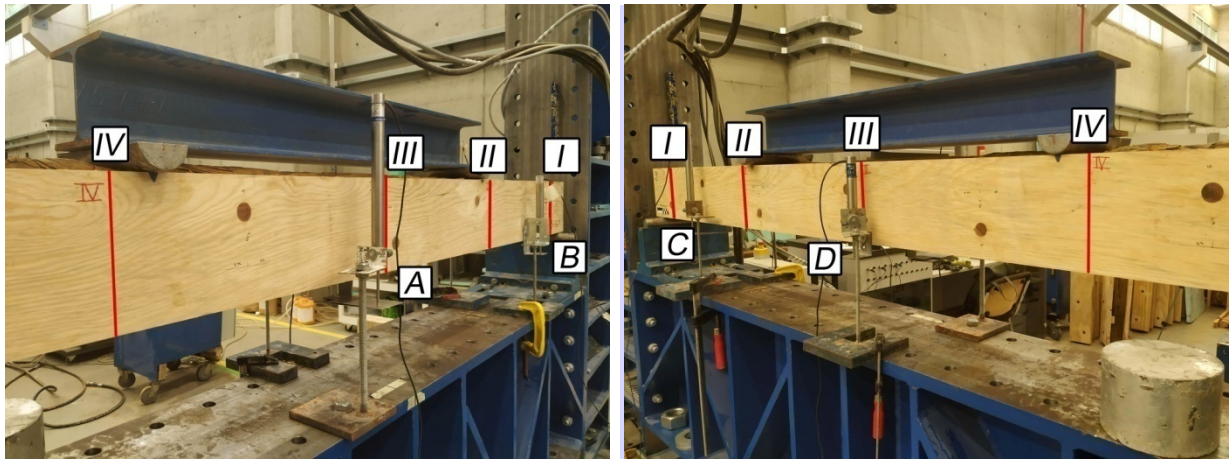
Figure 49 – B-I-G-1: location of the LVDTs on the front (left) and back (right).

In order to monitor the vertical displacement of the central element in chestnut with respect the pine planks, a total amount of 4 LVDTs were placed: 2 in the middle of the span and aligned with cross-section III, the other two were located on the right end and aligned with the peg present between the internal cross-sections I and II (Figure 49). More precisely, the LVDTs A and C were connected to the chestnut element, while the B and D to the external planks.

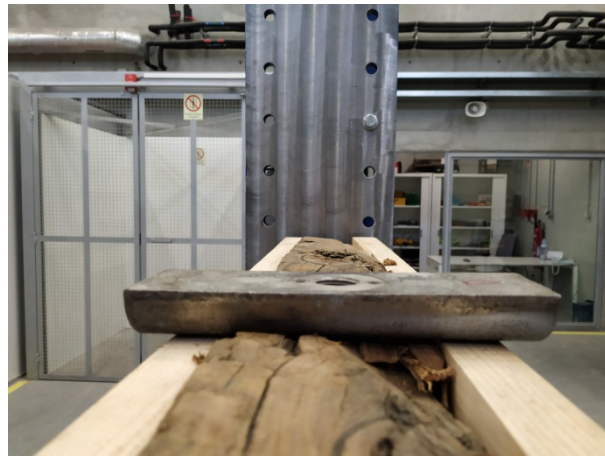
Figure 50 – B-I-G-1: extrados smoothed in order to provide a plain surface for the loading point.

The extrados of the sample was also smoothed in order to provide a plain surface so that the vertical load could be uniformly applied on the specimen (Figure 50).

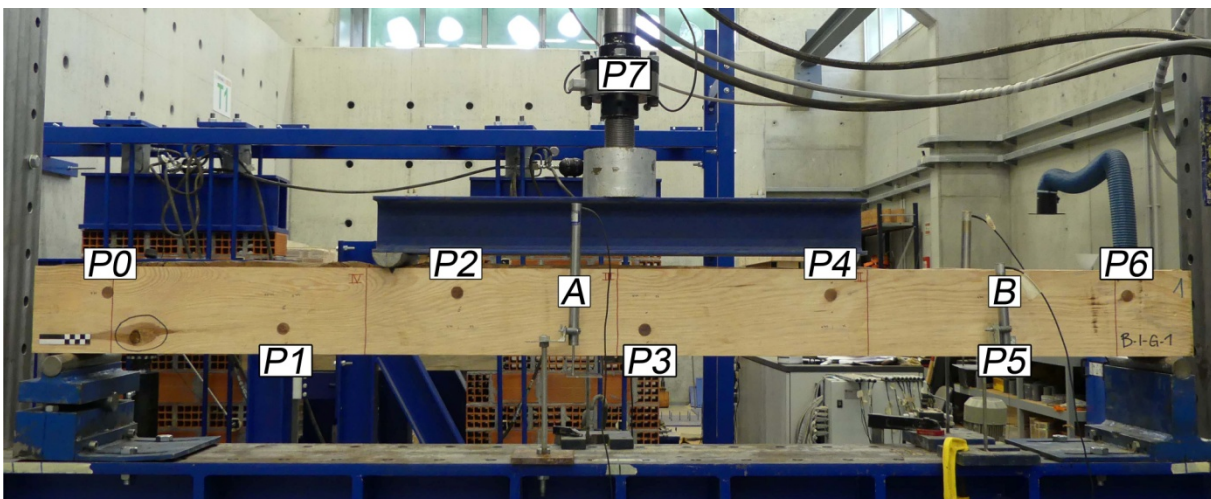
Figure 51 – B-I-G-1: test setup and location of pegs.

The first tested was the beam with the pegs inserted with the help of white glue. Figure 51 shows the sample before the test being carried out and highlights the pegs numbered progressively as previously described.

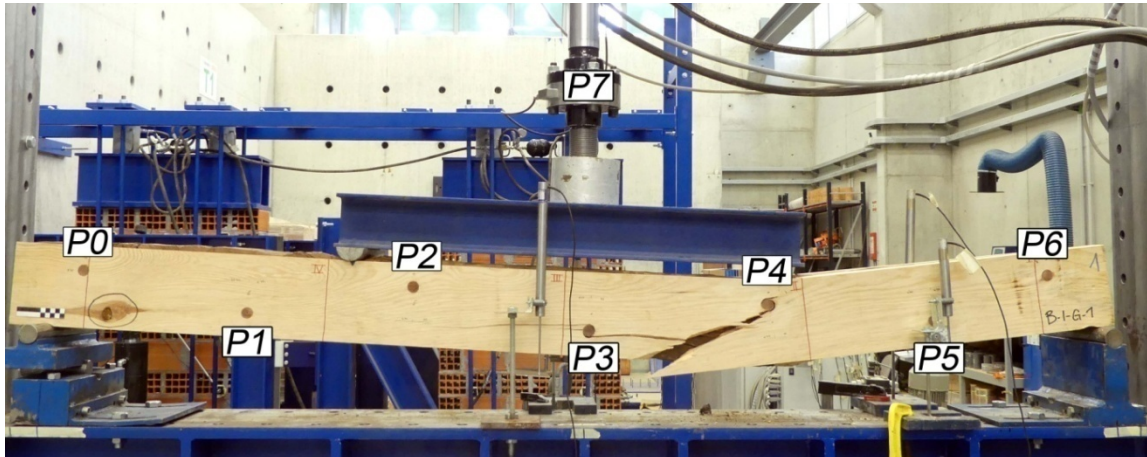
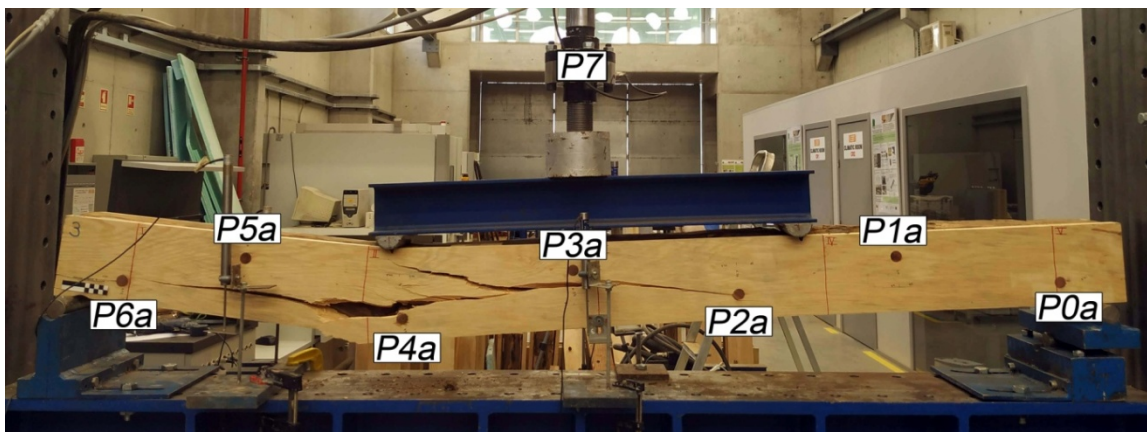
Figure 53 – B-I-G-1: failure on the front plank (a) and the back plank (b).

The failure occurred at a maximum load of 60.5 kN on the front plank (plank number 1) between the pegs P4 and P3 near the right support of the vertical load (Figure 53a). The failure initiated by the presence of a group of knots in the intrados of the beam (Figure 53d), caused the formation of an oblique crack that connected the two fasteners and partially the fibre in tension. This phenomenon is mirrored in the plank number 3 on the back of the beam (Figure 53b). When the failure occurred the sudden loss of energy caused an abrupt horizontal displacement visible in Figure 54b. On the back of the sample, located in P4a was noticed the consequently failure of the corresponding peg on the other side of the element due to the presence of a knot in the chestnut beam (Figure 54e). None of the pegs experimented failure nor ductile deformation.

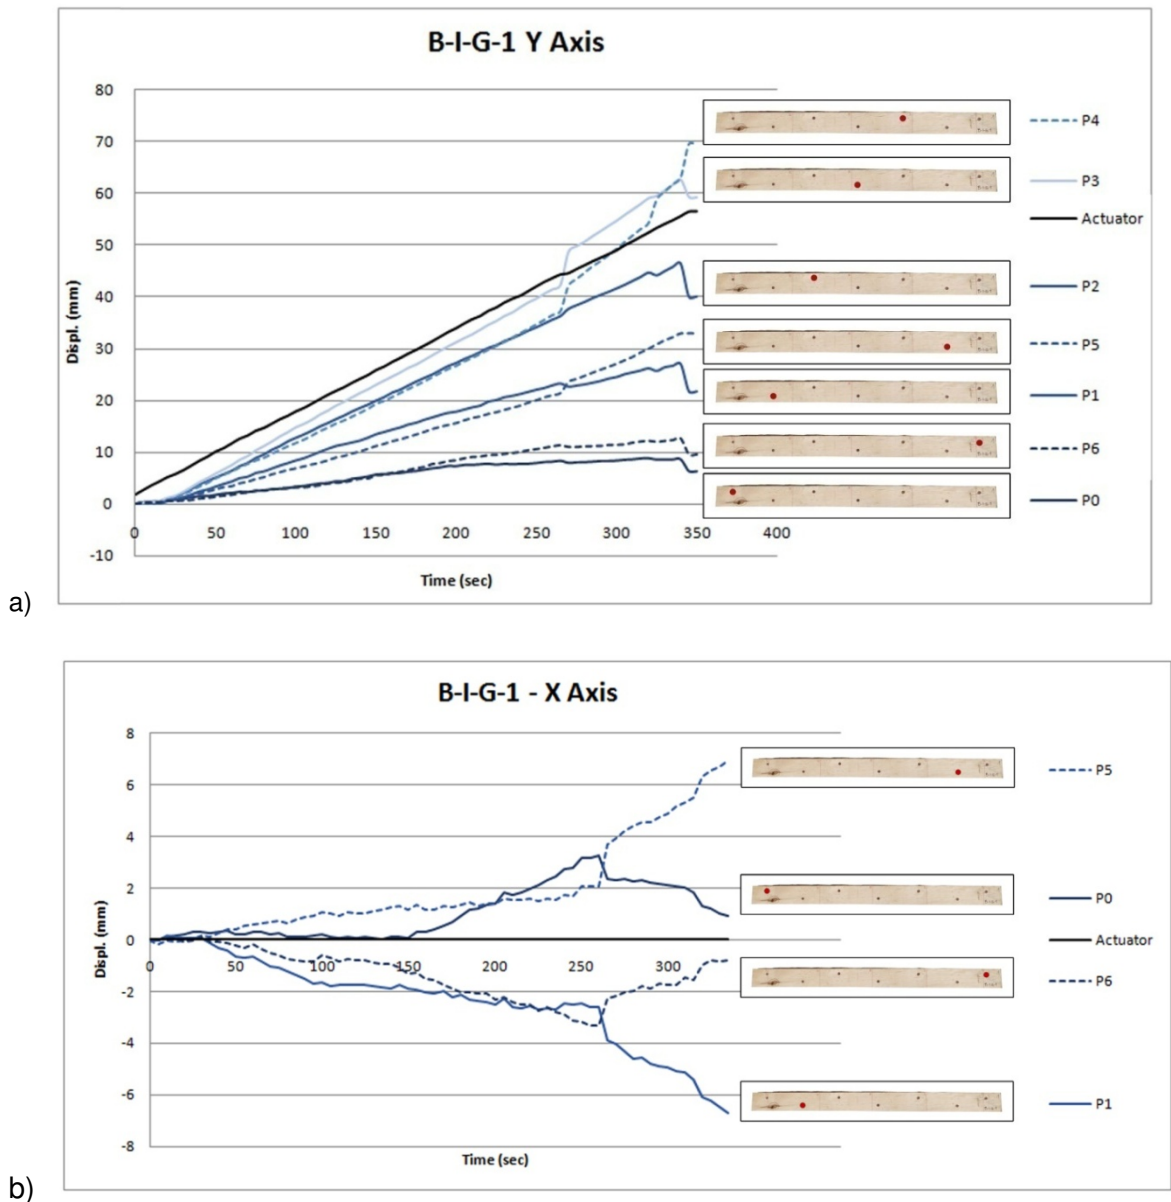
Figure 55 – B-I-G-1: displacement of the pegs on the y axis (a) and x axis (b).

Through the analysis of the time lapse recorded during the test was possible to estimate the displacement of each peg present on plank number 1 by a correlation time-displacement, both vertical and horizontal displacement were considered (Figure 55 a and b). It is possible to notice how for the

vertical displacement a mirrored behaviour was monitored for the couple of pegs P0-P6, P1-P5 and P2-P4. Same performance occurred regarding the horizontal displacement for the couple of pegs P0-P6 and P1-P5. The fasteners P2, P3 and P4 were not considered for the horizontal displacement (Figure 55b) because they lied inside the area of application of the vertical load (Figure 56), therefore not subjected to shear actions and having a very small value of displacement.

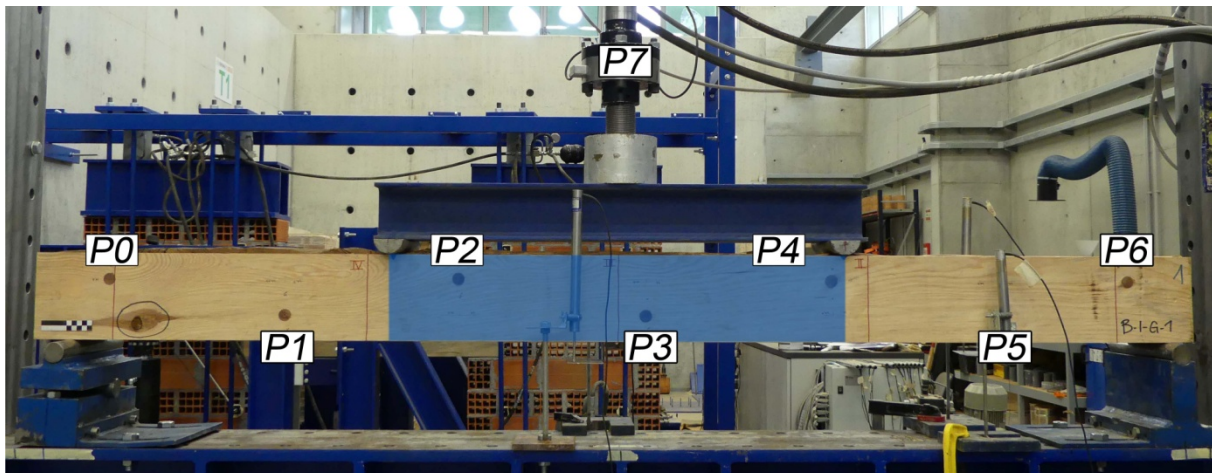
Figure 56 – B-I-G-1: pegs within the point of load application.

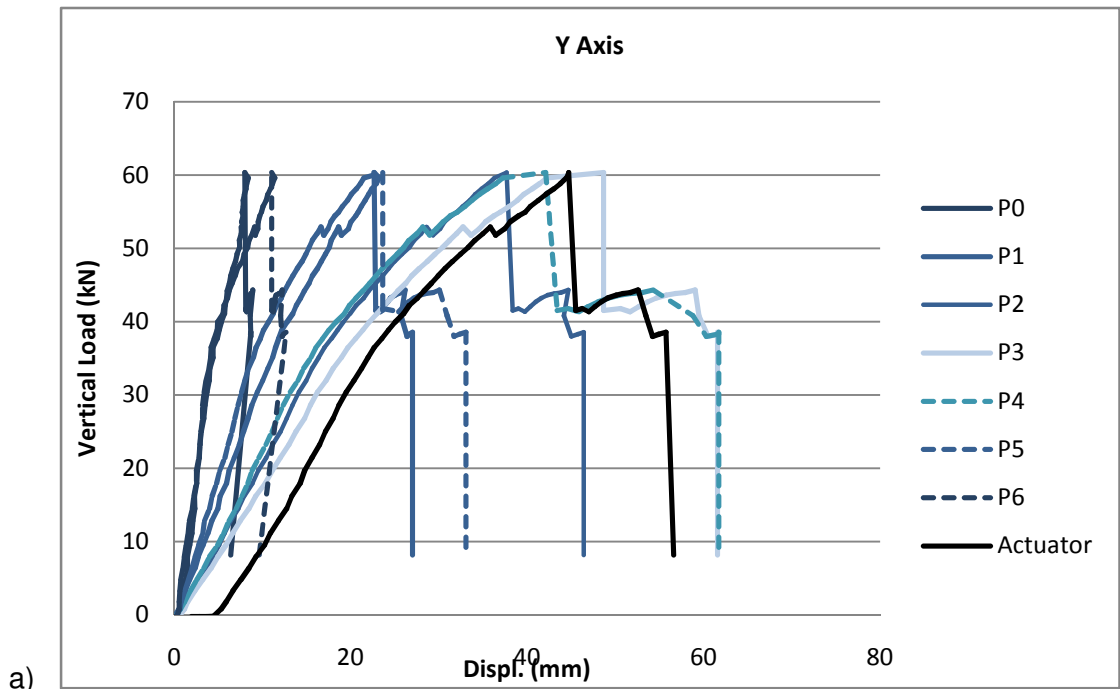
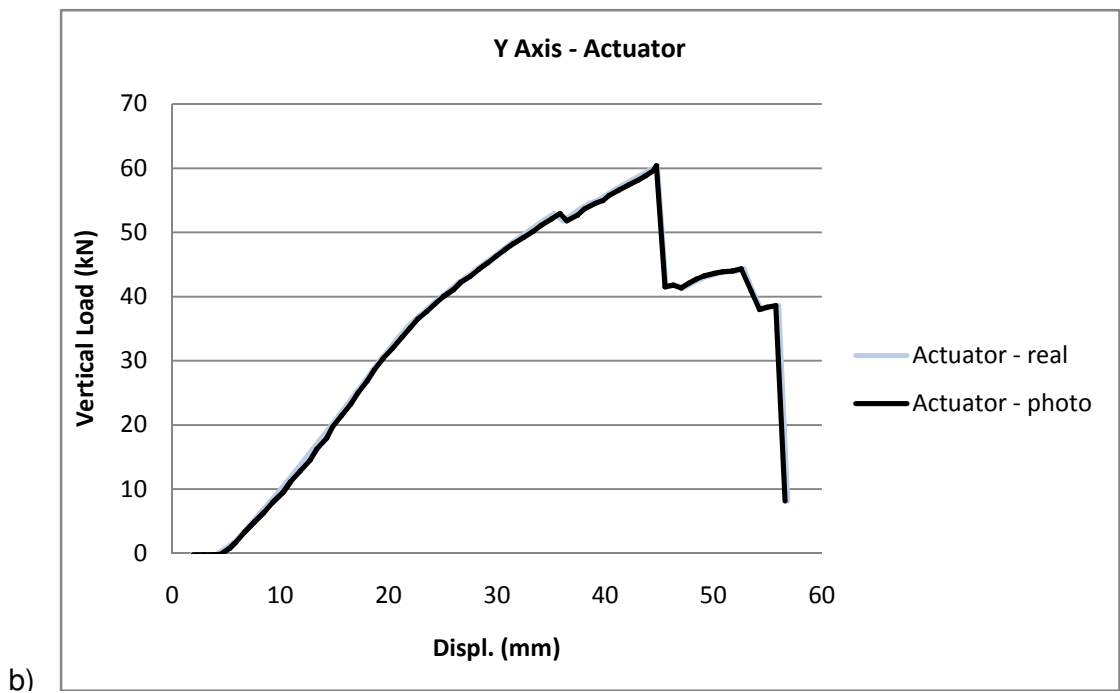
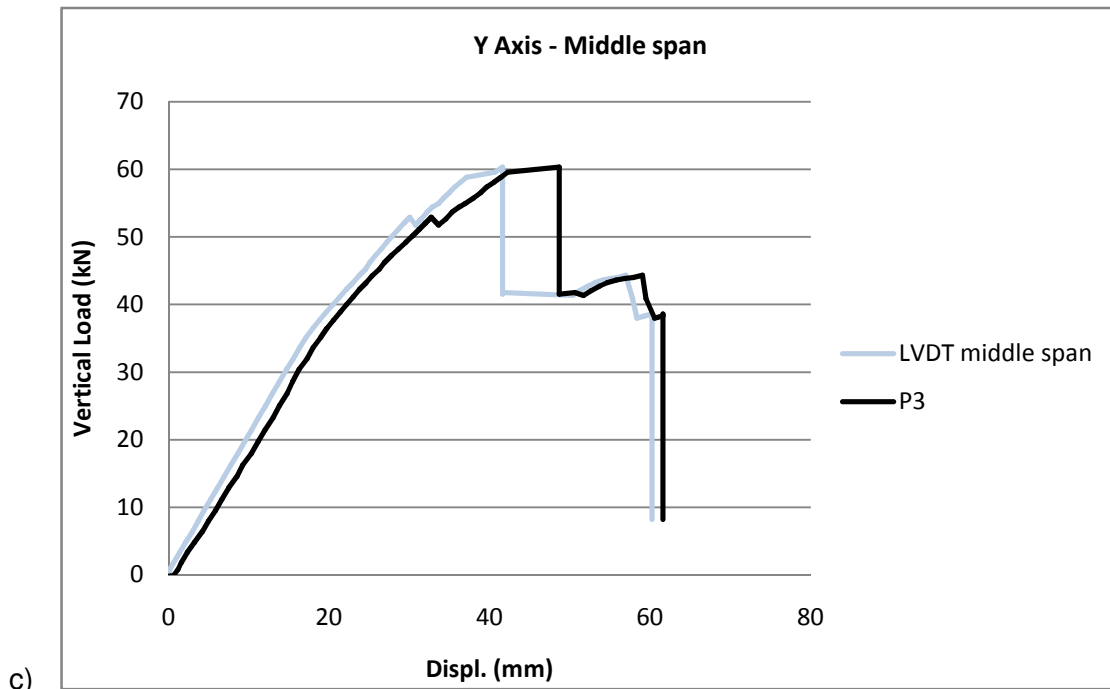
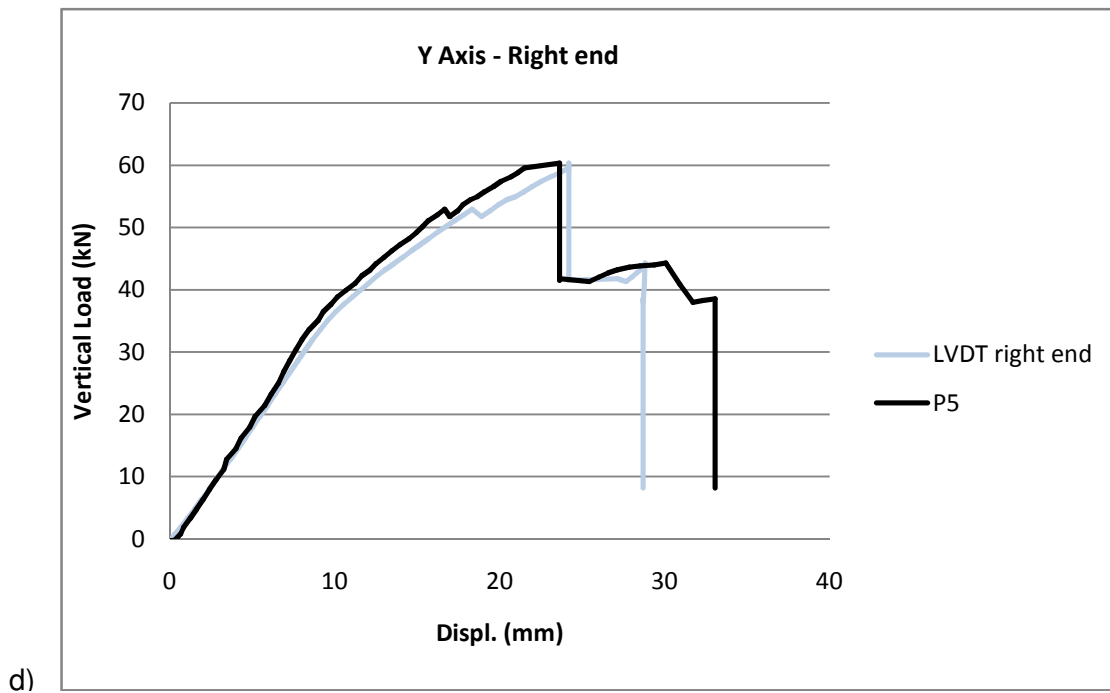
Figure 57 – B-I-G-1: comparison between LVDTs and displacement of the pegs.

A correlation between the time-displacement relation extrapolated from the video analysis and the force-displacement documented during the test was found. This allowed to plot a graph force-displacement of the 6 fasteners of B-I-G-1 and a consequential comparison between the values provided by the LVDTs. Figure 57 shows the plotting of all the fasteners (a), followed by a comparison between the displacement of the actuator accordingly with the performed test and the video analysis (b), the same comparison for the LVDT located in the middle of the span and the peg P3 (c) and the LVDT located between the cross-section I and II compared with the displacement of P5.

Although some inaccuracies were present, one can say that the overall result was satisfying as was possible to estimate the displacement that the peg which brought to failure the structure can be estimated. In this particular case the peg which firstly collapsed was P4 which experienced a vertical displacement equal to 61 mm due to the presence of a knot in the intrados of the beam.

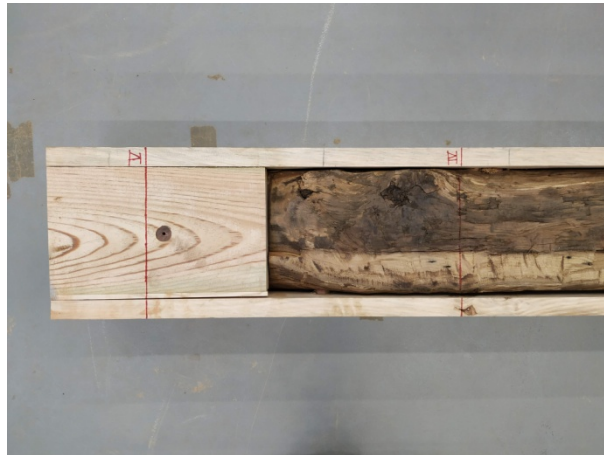
Figure 58 – B-I-NG-1: plank located in the intrados of the beam.

Another peculiarity of the specimen is the presence of a plank located as wedge in the intrados of the beam, as the cross-section in that end was insufficient respect the height of the planks (Figure 58).

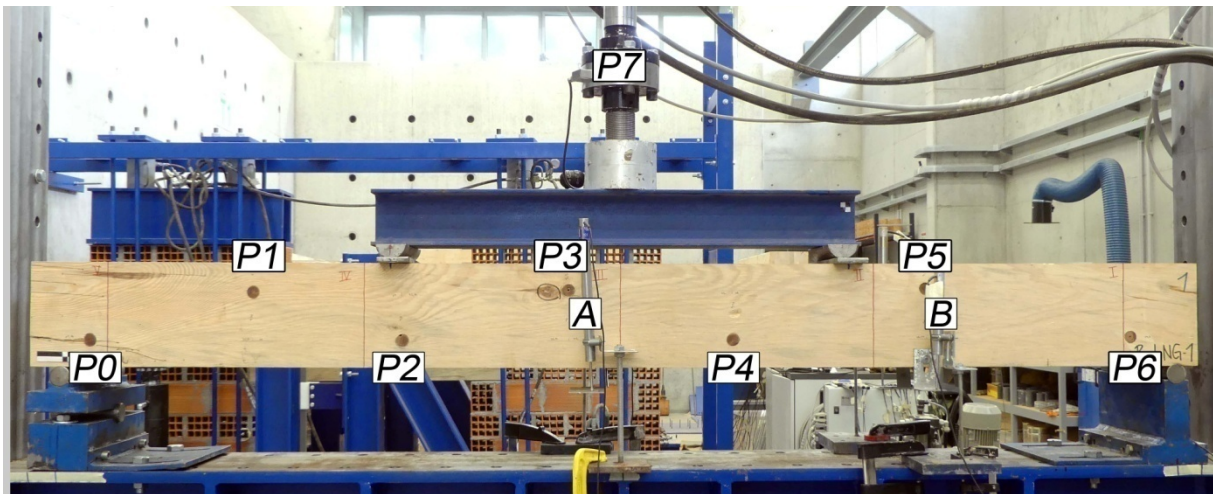
Figure 59 – B-I-NG-1: location of pegs.

As done previously for B-I-G-1, the pegs were numbered progressively from P0 to P6 and the actuator was named P7 in order to allow a visual analysis of the time lapse with the software Python (Figure 59).

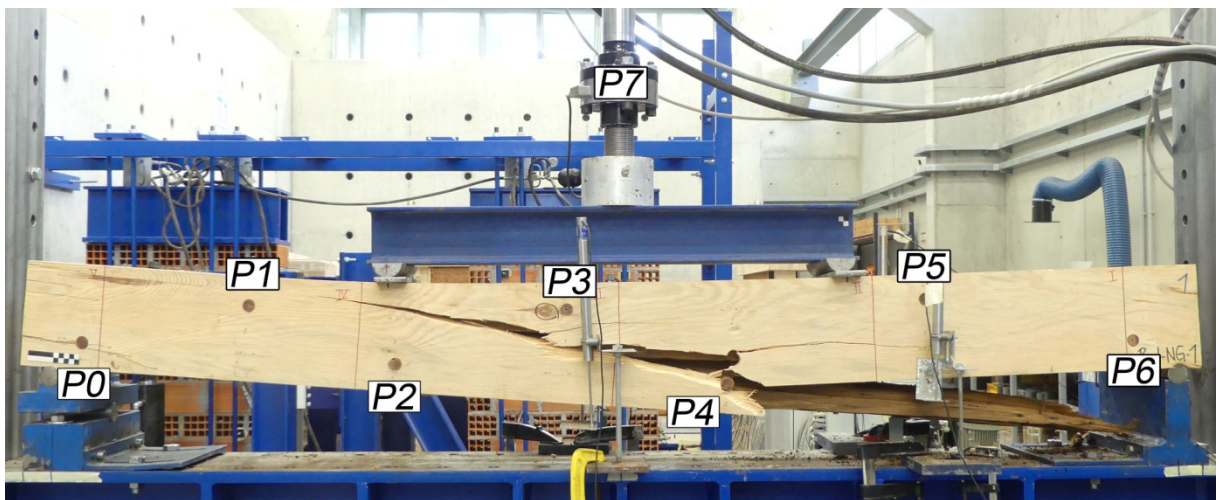
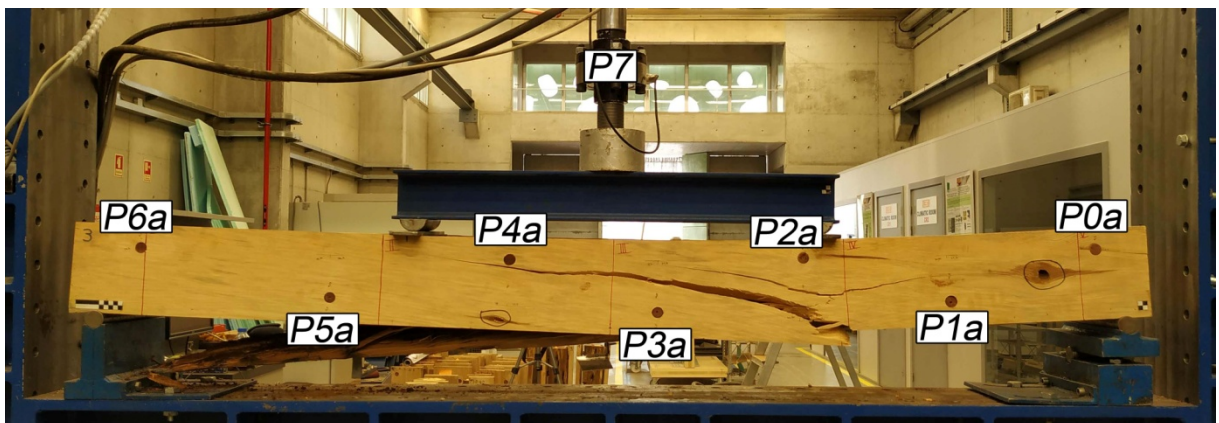
Figure 61 – B-I-NG-1: failure on the front plank (a) and the back plank (b).

As postulated previously, a higher vertical load than the glued sample was recorded, in fact the beam collapsed with a load equal to 95.8 kN due to failure of the chestnut member. Figure 61 (a and b) shows a detachment of part of the timber beam in the intrados between cross-sections I and III. This event caused the sudden failure of the back plank (plank number 3) through the formation of a similar crack located on the opposite side of the beam which expands from P4a to the intrados under P2a (Figure 61 b). This caused a twist along the cross-section which eventually lead also the plank number 1 to collapse and the formation of a crack parallel to the fracture occurred in the chestnut element, which from P4 almost reached P1 (Figure 61a).

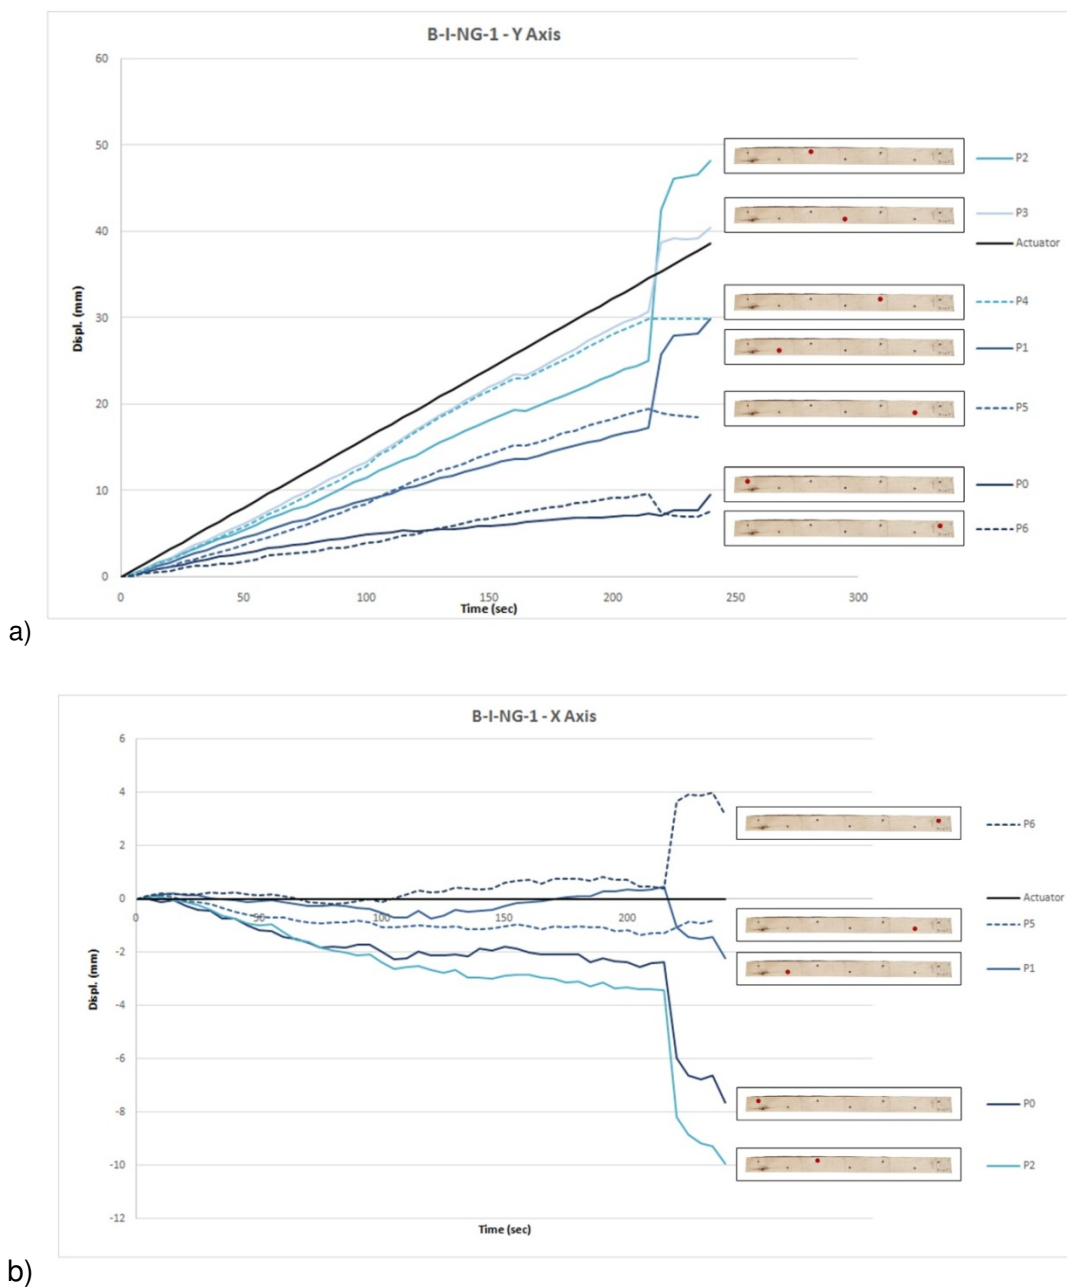
Figure 63 – B-I-NG-1: displacement of the pegs on the y axis (a) and x axis (b).

As done for the first bending test, the displacement on the y and x axis was plotted on the relation time-displacement through the video analysis of the time lapse (Figure 63a and b). The same

symmetric behaviour noticed previously for the couples of pegs P0-P6, P1-P5 and P2-P4 is visible in the graph reporting the displacement along the y axis. While P3, as the closest peg in the middle of the span, registered a slightly higher vertical displacement (Figure 63a). On the other hand, Figure 63b shows the displacement on the horizontal axis, here the fastener P3 and P4 were neglected because lying between the two application points of the vertical load. Unlike B-I-G-1, P2 was not neglected because located exactly under the left point of application of the vertical load and therefore still subjected to shear (Figure 64).

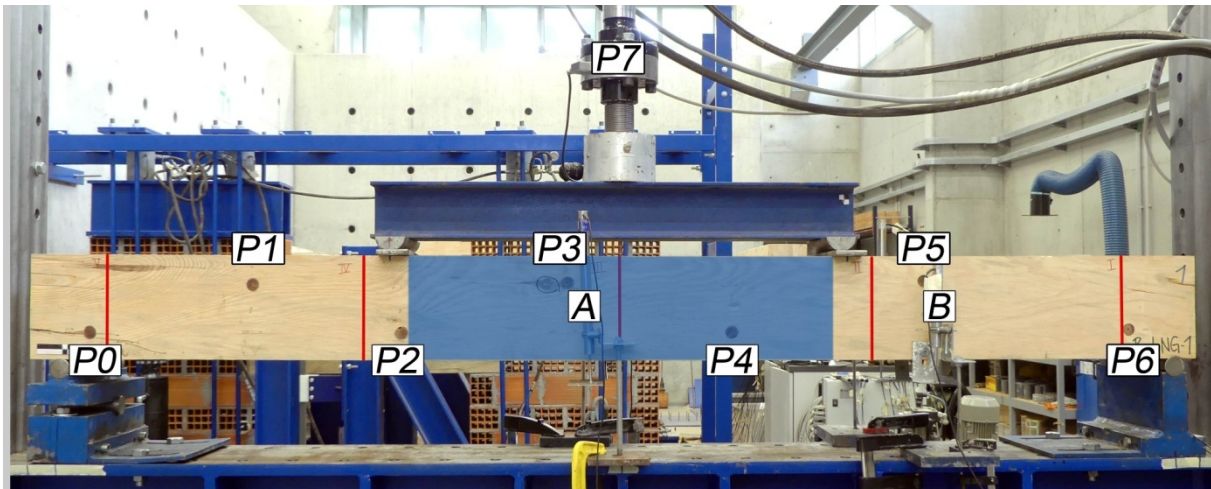
Figure 64 – B-I-NG-1: pegs within the point of load application.
