Master's Thesis

Wooden pegs in the retrofit
of timber constructions

University of Minho

Portugal | 2019

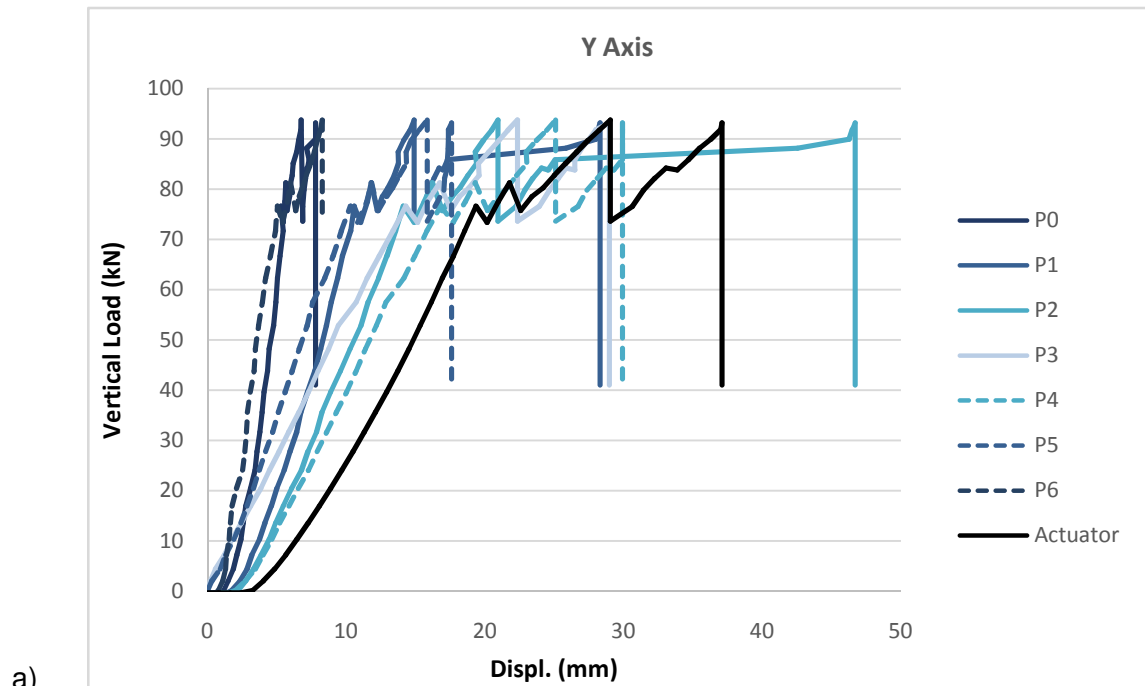
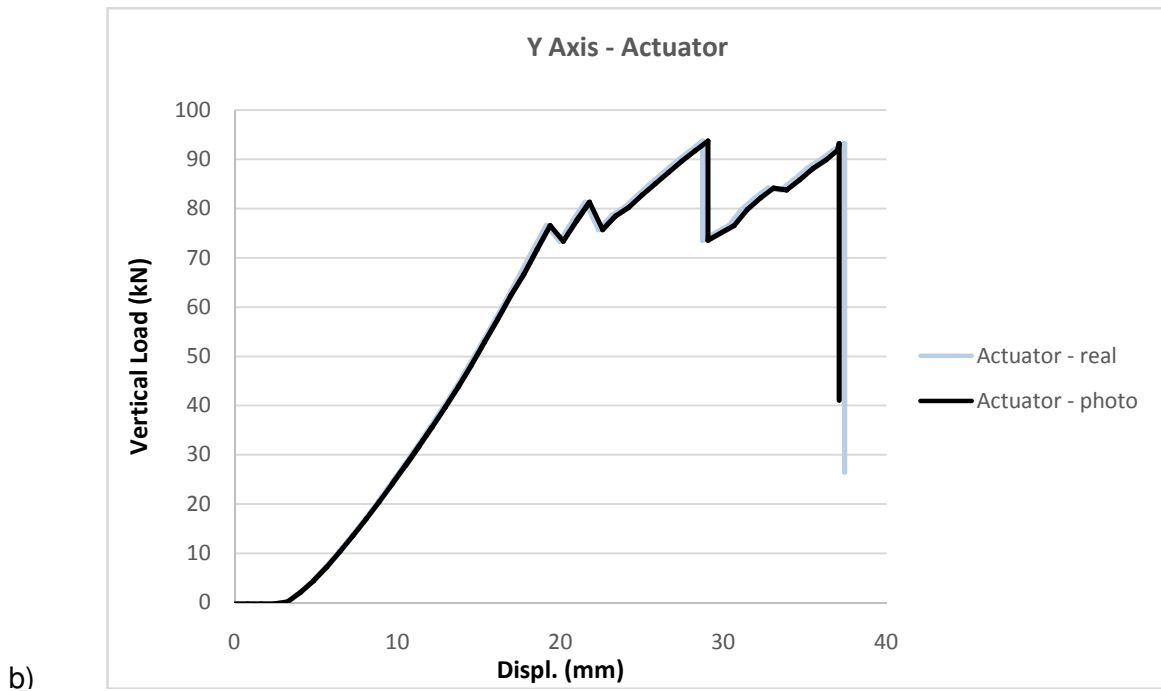
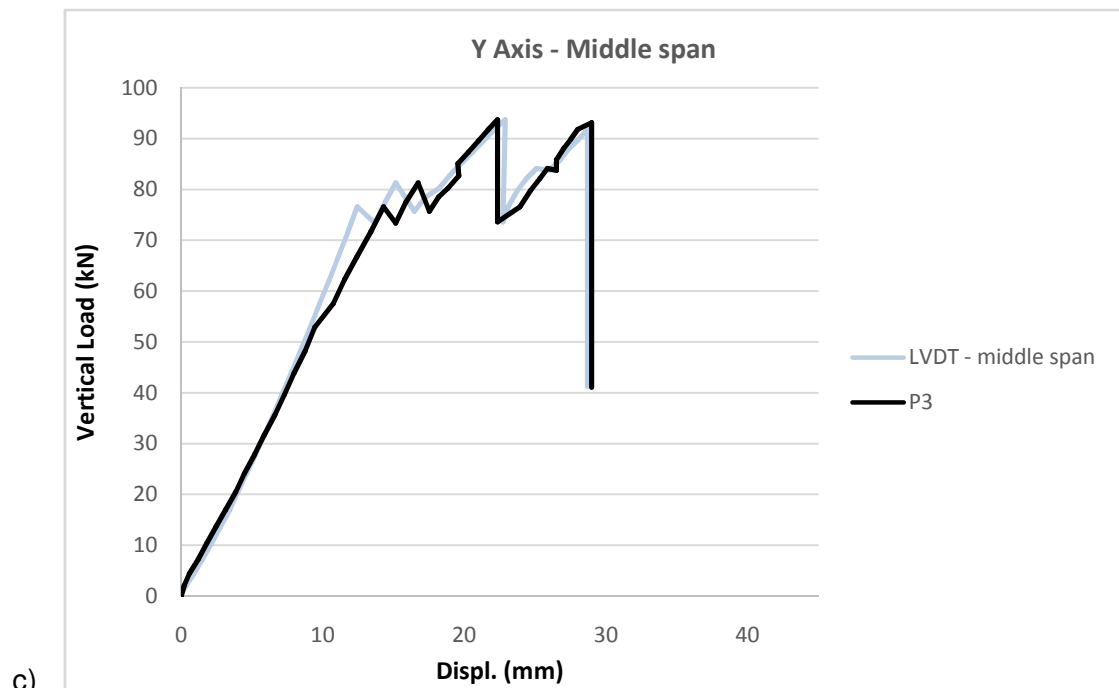
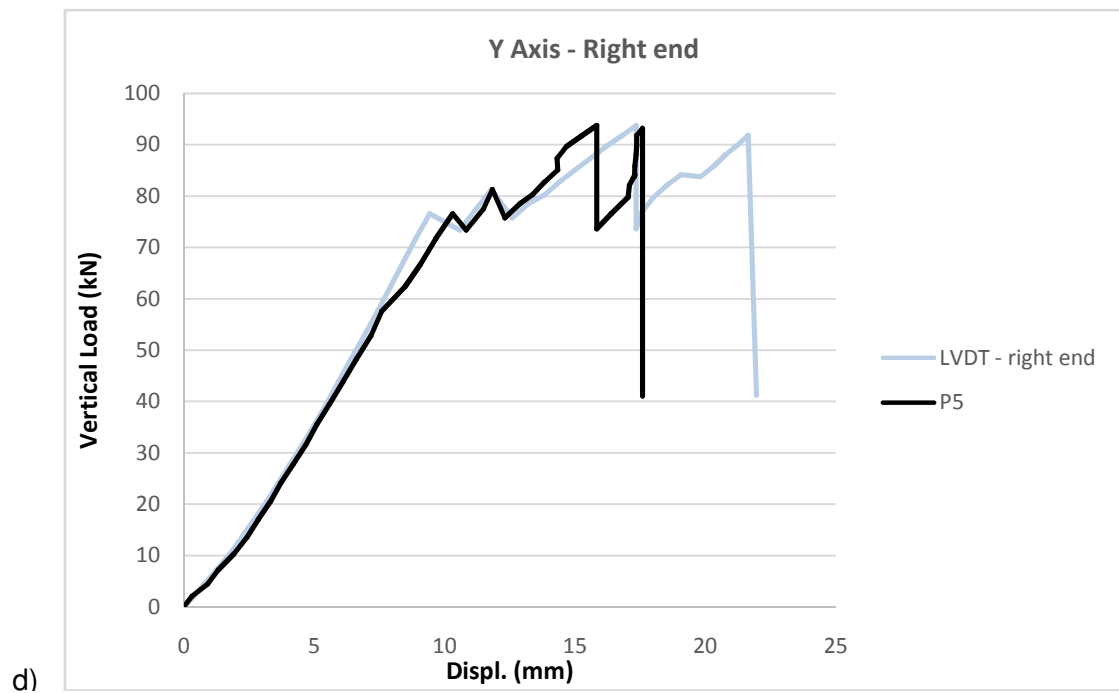
Figure 65 – B-I-NG-1: comparison between LVDTs and displacement of the pegs.

Eventually the vertical displacement of the pegs based on time-displacement extrapolated from the video analysis was converted in force-displacement. A comparison between the values provided by the LVDTs during the tests was thus possible. Figure 65a shows the behaviour of all the pegs, while Figure 65b compares the vertical displacement of the actuator with the displacement of P7. Figure 65c shows the relation between the LVDT along the cross-section III related with P3, while Figure 65d displays the comparison between the LVDT B and the peg number 5. Except for Figure 65c, the presented comparison provides a satisfying correlation. The difference of result in the plot regarding the end of the beam, is related with the twisting effect that occurred at the failure and the location of the two elements, as P5 was close the extrados and the location of the LVDT was in the intrados. Moreover, due to the fact that the collapse occurred on the back of the sample, is not possible to provide an estimated vertical displacement of the peg.

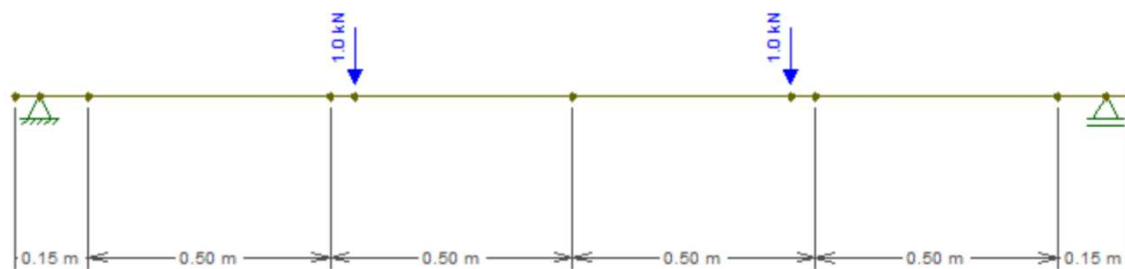
Figure 66 – Representation of the numerical model.

The geometry of each beam, without planks, was taken by segments considering the mean value of area and inertia of the nearest measured cross-section. A representation of the model is given in Figure 66, with indication of the length of each considered segment. For these models a linear elastic material model was considered with brittle failure when the ultimate bending strength was reached. The load was applied by consideration of two point loads with equal value along the simulation and the beam was considered to be simply supported, aiming at simulating the experimental setup configuration.

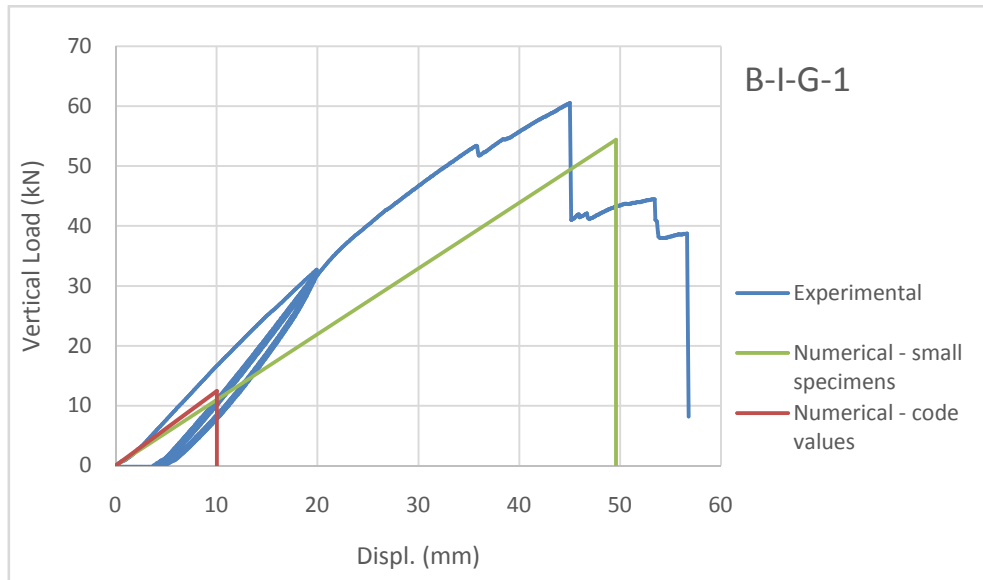
Figure 67 – B-I-G-1: Comparison between experimental and numerical results.

The results are presented in Figure 67 and Figure 68 respectively for the beams B-I-G and B-I-NG. In the case of the beam B-I-G, comparing to the numerical model assuming the results taken from the small clear specimens, it is clearly visible that the implementation of the retrofit solution allowed to obtain a higher load (11.3% higher), even if a lower displacement (9.2% lower) is seen for the failure moment. The increase of inertia and area were sufficient to guarantee a better performance and to obtain a stiffer element than the individual chestnut beam. In this case, it is also important to notice that failure itself was not governed by any significant existing defect on the chestnut element. On the other hand, for beam B-I-NG the retrofitted solution did not reach the same level of load predicted by the model. This is mainly due to the reason that the chestnut beam itself governed the failure with a large detachment of part of the beam due to the existence of a significant crack and inner decay. Therefore, the numerical model could not efficiently reflect the existing beam due to the existence of these very significant defects. Nevertheless, it must be noted that the retrofitting solution allowed to avoid a complete brittle failure of the beam as the planks were able to sustain load even after the local failure of the inner beam. In any case, it is important to note that the efficiency of the planks was more visible on the B-I-G beams since their height and width with relation to the cross-section were significantly higher. This is especially important due to the increase of inertia to the beam.

In both cases, it was found that the consideration of the values given by the reference codes were very conservative in terms of bending strength even if suitable for indication of the bending modulus of elasticity.

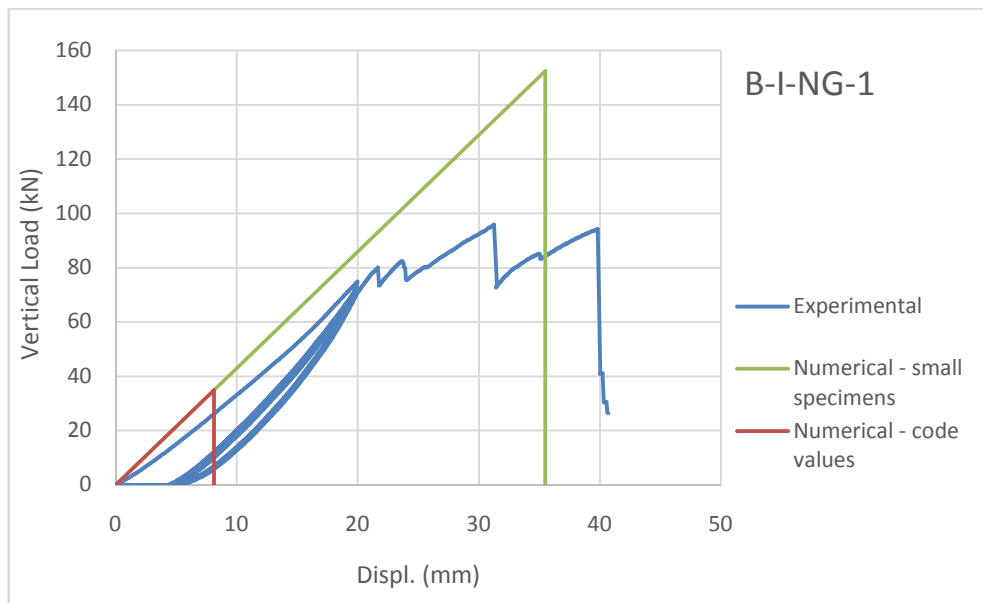
Figure 68 – B-I-G-1: Comparison between experimental and numerical results.
