The Dalmarnock Fire Tests on a Cast Insitu Concrete Structure

TG 4.3 *fib* 2007 THE DALMARNOCK FIRE TESTS ON A CAST INSITU CONCRETE STRUCTURE

In July of 2006 three full scale fire tests were undertaken on a 23 storey cast in situ concrete structure. This paper provides an overview of the experimental set up of Test One which involved a fully developed post flashover fire in a 17m² compartment. Full scale fire tests on concrete structures are in-frequent and complete data sets rare. This experiment provides a complete data set for both the fire behaviour and the structural response in both the heating and cooling phases of the fire. The fire behaviour and subsequent structural response are examined and explained.

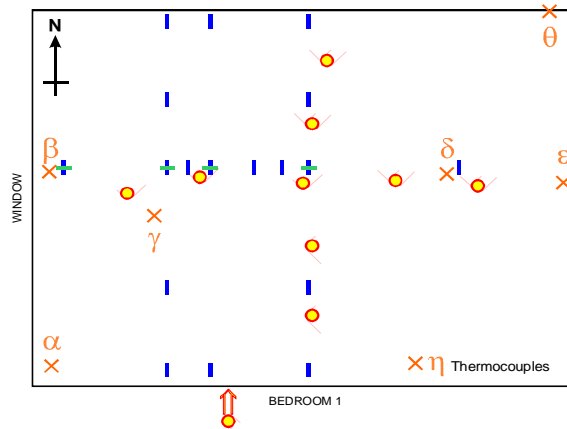
Figure 5: Locations of structural instrumentation Replace with CAD equivalent

The thermal response of the slab was measured by placing thermocouples through the depth of the slab at six different locations which are indicated in fig 5. The thermocouples were placed in an 18 mm diameter drilled hole. Four thermocouples were positioned across the height of the core before it was refilled with grout. Care was taken to ensure that a layer of grout protected the bottom thermocouple from the being directly exposed to the hot gases within the compartment.

As described earlier the thermal response of the slab was measured at six different locations (see fig 5). Temperatures measured by these thermocouples are displayed in fig 8.

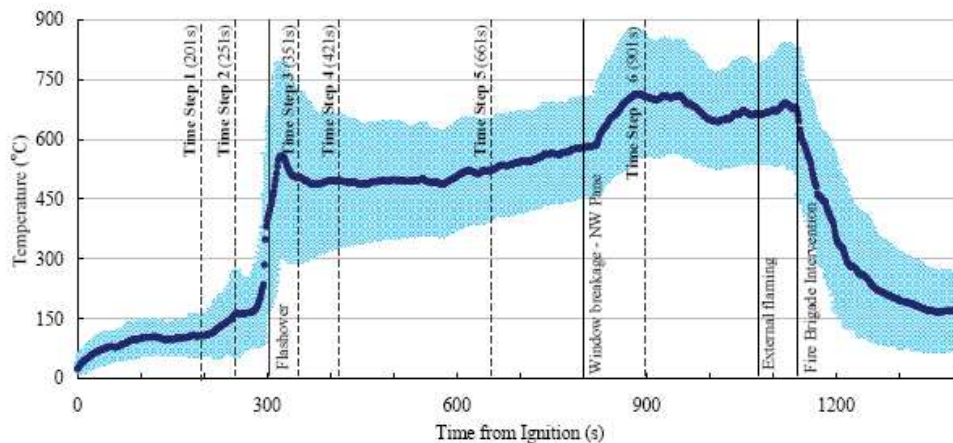
Figure 6: Gas-phase average compartment temperature-time curve variation with shaded regions indicating the standard deviation of temperature throughout the compartment

Figure 6 shows a plot of the average compartment temperature for the duration of the fire which gives an indication of the general fire behaviour over time. For the first 100 s temperatures rise steadily, this represents the localised burning of the sofa. The fire then begins to spread and at 300 s there is a steep spike in average temperatures relating to flashover, the point at which burning engulfs the entire room. Temperatures then drop to a quasi steady state followed by a slow rise. After breakage of the first window pane, there is again a sharp rise in temperature suggesting burning in the compartment prior to this had become ventilation controlled. After 19 minutes the fire brigade entered and extinguished the fire
