2015 Smart Mater. Struct. 24 025037

High frequency guided ultrasonic waves for hidden fatigue crack growth monitoring in multi-layer model aerospace structures

Abstract

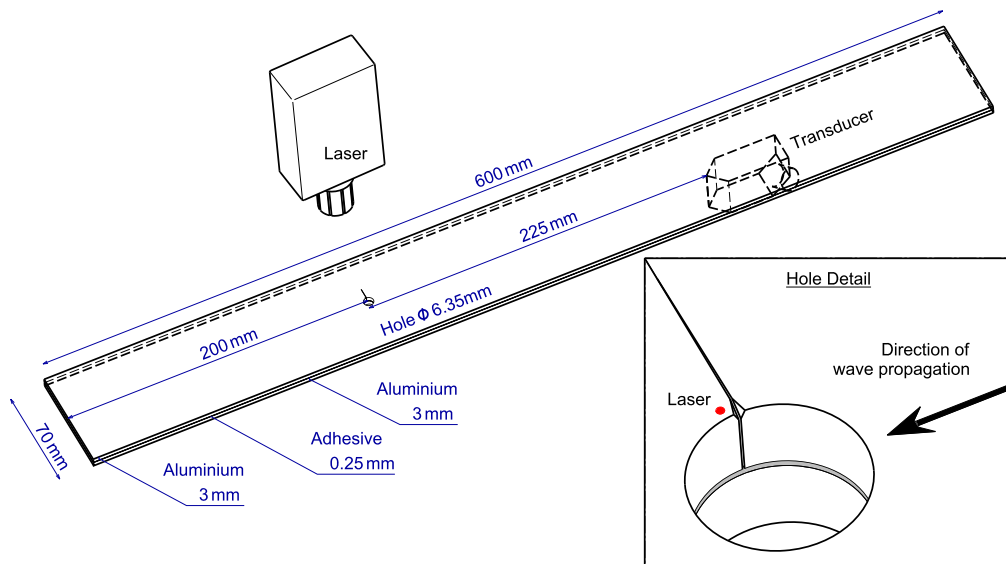
Figure 1. Schematic of experimental setup and multilayer specimen.

temperature according to the manufacturer instructions. The sealant thickness was measured along the centre line using a digital micrometre and found to have a standard deviation of less than 6% relative to the nominal thickness of 0.25 mm (range: 0.22–0.26 mm). The fastener hole with $\frac{1}{4}$ inch diameter (6.35 mm) was drilled 200 mm from one end of the specimen on the specimen centre line as shown in figure 1.

starter notch at a distance of 225 mm from the fastener hole, so that the main wave propagation line crosses the centre of the hole (figure 1). It had been found previously [31] that this transducer configuration excited both the fundamental anti-symmetric and symmetric modes A_0 and S_0 , as well as the higher A_1 mode. For the multi-layer specimen the A_0 mode shape consists of an individual bending of the two aluminium adherents (in-phase), while the S_0 mode shape is characterized by elongation and compression in the in-plane direction. Both

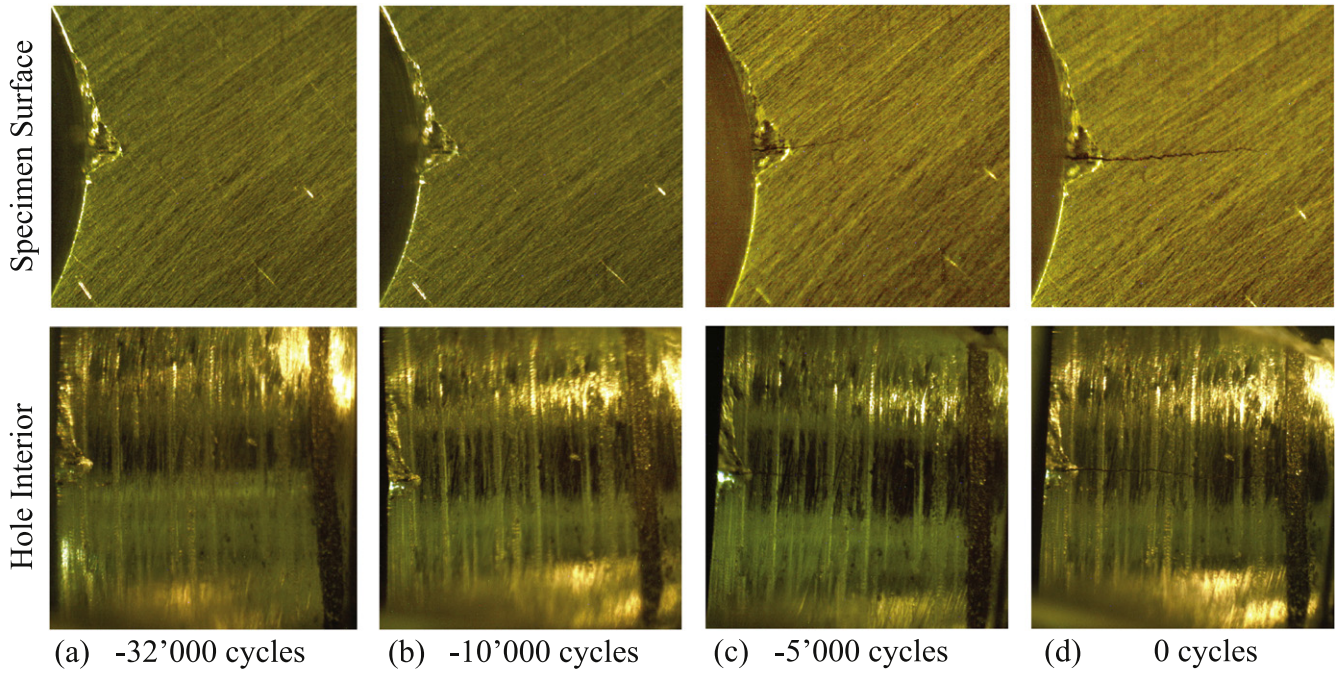
Figure 2. Microscopy photographs taken during fatigue cycling on specimen surface and within fastener hole: (a) –32 000 cycles (baseline measurement), no crack; (b) –10 000 cycles, crack length 0.77 mm, crack depth 0.85 mm; (c) –5000 cycles, crack length 1.32 mm, crack depth 1.53 mm; (d) zero cycles, crack length 2.49 mm, crack depth 3.00 mm (through aluminium layer).

The specimens were subjected to cyclic tensile loading in a servo-hydraulic testing machine with the loading axis parallel to the specimen length. For the specimen geometry the stress concentration factor at the side of the through-thickness hole is approximately 2.75 (compared to average stress level). Therefore a maximum load of 54 kN was selected so that the maximum stress in the aluminium plates at the side of the hole was just below the yield strength of the material, to avoid plastic deformation on the undamaged side. The cyclic loading was performed with a stress ratio $R=0.1$ and a cycling frequency of 7 Hz. A small triangular notch (45° to specimen back surface and hole) of approximately 0.4 mm length and depth (range: 0.32–0.54 mm) was introduced using a very fine file at 90° to the axis of tensile loading to prescribe the location of fatigue crack initiation. The stress level at the side of the hole (and starter notch) was well above the fatigue strength of the material. The cyclic loading was interrupted every 1000 cycles, holding the specimen under maximum tensile load to avoid crack closure during the ultrasonic measurements. Further measurements should investigate the relevance of the load (and the resulting crack opening) on the ultrasonic signals and thus detection sensitivity for fatigue cracks. The crack size was measured optically on the damaged specimen surface (crack length) and through the hole thickness (crack depth) by means of an optical microscope. Typical photographs of the observed fatigue crack growth are shown in figure 2 for one specimen.

Fatigue crack growth during cyclic loading was monitored in five specimens using noncontact laser measurements as described in section 2. Typical time traces are shown in figure 5 for the same specimen and crack lengths as in figures 2 and 3.

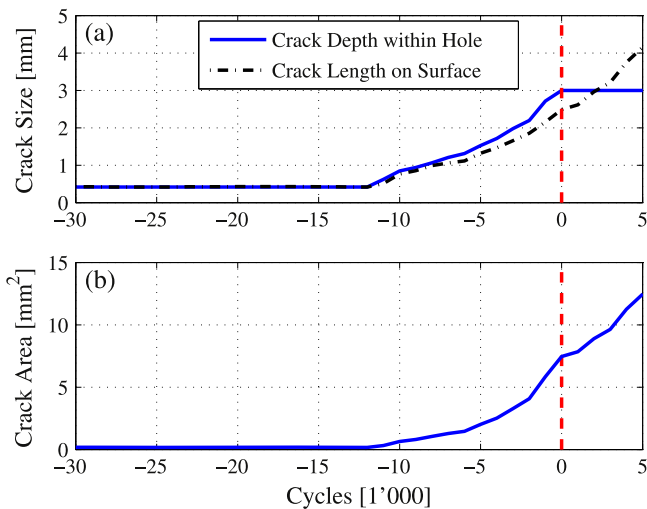
Figure 3. Typical optically measured crack growth during fatigue cycling; (a) crack length (dashed–dotted, black) on specimen surface and crack depth (solid, blue) within fastener hole; (b) crack area; zero cycles (dashed, red) indicates crack through damaged aluminium layer.

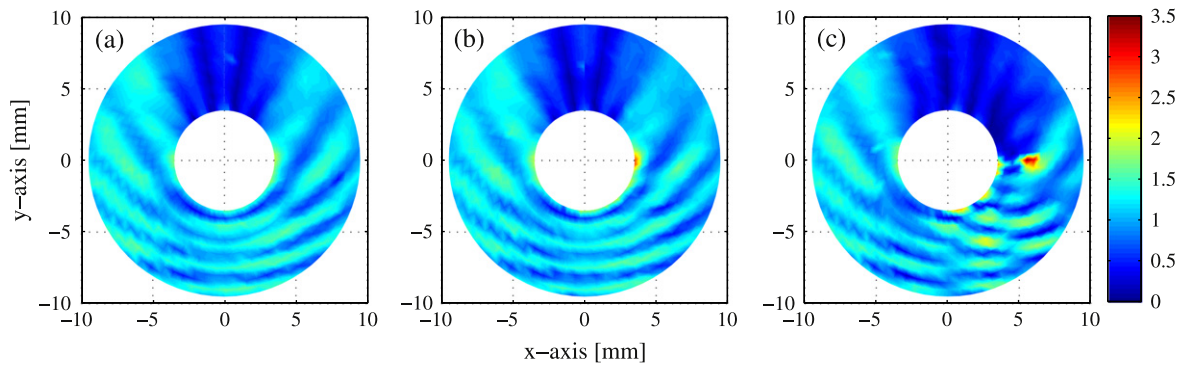
Figure 4. Scattered wave field around fastener hole measured using laser interferometer, incident wave propagating bottom to top; (a) no damage; (b) part-thickness fatigue crack at right-hand side, length 0.88 mm, depth 0.61 mm; (c) fatigue crack through aluminium layer, length 3.04 mm, depth 3.00 mm.

For one fatigued tensile specimen the scattered guided ultrasonic wave field around the fastener hole was measured for different lengths of the fatigue crack as shown in figure 4. The ultrasonic signal on the specimen surface containing the fatigue crack was measured using the laser interferometer on a radial grid as described above. For each measurement point the time trace was time gated to isolate the relevant wave pulse from reflections at the specimen sides and higher wave modes propagating at a slower group velocity. Using fast Fourier transform (FFT) the corresponding amplitude at 1 MHz was extracted and displayed colour-coded in figure 4. The amplitude was normalized such that the amplitude of the incident wave at the hole centre corresponds to unity. The incident wave propagates from bottom to top and is scattered at the hole. The radially scattered wave interacts with the incident wave depending on the relative phase angle and results in high and low amplitudes around the fastener hole [15]. In figure 4(a) a clear and symmetric pattern around the undamaged hole can be observed with an area of low amplitude behind the hole as a large part of the incident wave is blocked.

seen in figure 4(b). Only close to the damage location on the right-hand side of the hole ($x=3.5$ mm, $y=0$ mm) a local increase in amplitude and a small shift of the scattered wave field was observed. Once the fatigue crack had grown through the thickness of one of the aluminium layers a significantly larger change of the scattered wave field was observed (figure 4(c)). The fatigue crack blocks part of the incident guided wave pulse and an area with reduced amplitude was seen behind the damage location. Locally at the crack high amplitude due to the scattering was observed as well as a change in the scattering pattern on the right-hand side with additional guided wave interference. This indicates a significant additional wave back-scattered from the fatigue crack. Based on these results it was decided to initially monitor the wave amplitude at a location just behind the fatigue crack location where optimum sensitivity is expected.

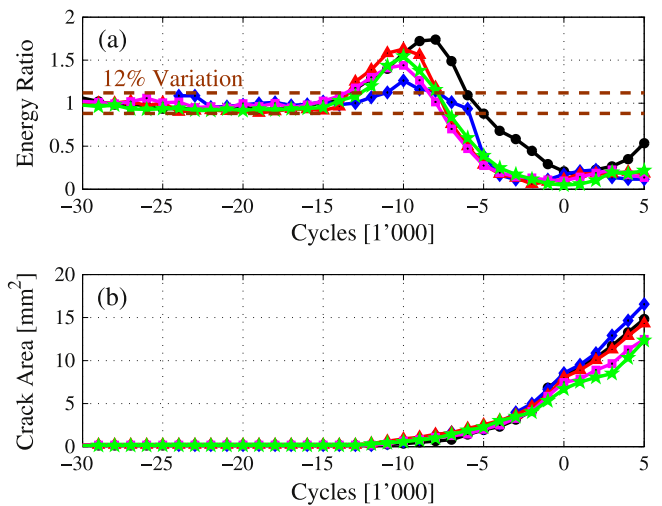
Figure 6. (a) Energy ratio of guided wave pulse measured with laser interferometer at location behind fatigue crack close to hole for five specimens (solid lines); 12% amplitude variation shown (dashed); (b) optically measured crack area for five specimens; plotted against number of cycles before crack grown through thickness.

where $x_0(t)$ is the baseline signal (averaged from the first ten measurements) at the start of the cyclic loading. The energy ratios against the number of cycles for the five specimens are plotted in figure 6(a), with zero cycles representing the crack having grown through the damaged aluminium layer (depth=3 mm) for each specimen. The largest variation observed until –15 000 cycles, when no macroscopic crack

was optically visible for any specimen, was just under 12% (dashed line in figure 6(a)). Other evaluation criteria such as maximum amplitude of the signal envelope and amplitude at 1 MHz from FFT were investigated. In line with previous findings for fatigue cracks in a single metallic layer [25], overall a similar behaviour for all criteria was observed. The amplitude criteria showed smaller variations of about 6%, but showed a smaller influence of the fatigue crack growth and it was thus decided to employ the energy ratio criteria. For all

specimens an initial increase in guided wave pulse energy was observed with the growth of a small, quarter-elliptical fatigue crack. At $-10\,000$ cycles four out of the five specimens showed an increase of at least 40% for a maximum crack area of 0.89 mm^2 . For one of the specimens (blue line in figure 6(a)) an increase of 26% at $-10\,000$ cycles was observed, corresponding to a crack area of 0.59 mm^2 . The increase in amplitude for a small quarter-elliptical crack is in line with the observations from the scattered wave field (figure 4(b)) but different to what has been reported for single metallic layers where no amplitude increase was observed [25]. Different phenomena could explain this initial increase in amplitude very close to the quarter-elliptical fatigue crack. The part-thickness crack leads to a local decrease of the bending stiffness of the multi-layered specimen and thus a larger out-of-plane displacement. Another possible interpretation is a localized boundary layer at the fatigue crack due to the ultrasonic wave scattering. Simulations of the high frequency guided wave interference and scattering (e.g., using finite elements) would help to understand this phenomenon better. With the growth of the quarter-elliptical crack in the aluminium layer all specimens showed a subsequent decrease in energy ratio as shown for the time trace in figure 5(c). At -5000 cycles for four out of the five specimens a drop in the energy ratio of at least 60% was observed (fifth specimen (black line): 12% drop) with a largest crack area of 2.53 mm^2 . At zero cycles, when the crack had grown through the damaged aluminium layer for all specimens a drop in energy ratio of at least 80% was observed. The energy ratio curve (against cycles) for one specimen (black line in figure 6(a)) appeared to lag behind. The data was double-checked but no obvious cause or difference in the crack growth pattern was found. The visually observed fatigue crack growth rates for all specimens were reasonably repeatable, with only small differences in crack area before the crack had grown through the

aluminium layer (zero cycles in figure 6(b)). In order to allow an easier comparison of the changes in energy ratio with crack area these were plotted against each other in figure 7. The pattern discussed above with an initial variation of up to 12% (dashed line), increase in energy for a quarter-elliptical crack of about 1 mm^2 and subsequent drop with increasing crack area can be observed in figure 7. Taking a safe criterion to reliably call a fatigue crack, a minimum drop in amplitude of 25% was specified (twice the observed variation).

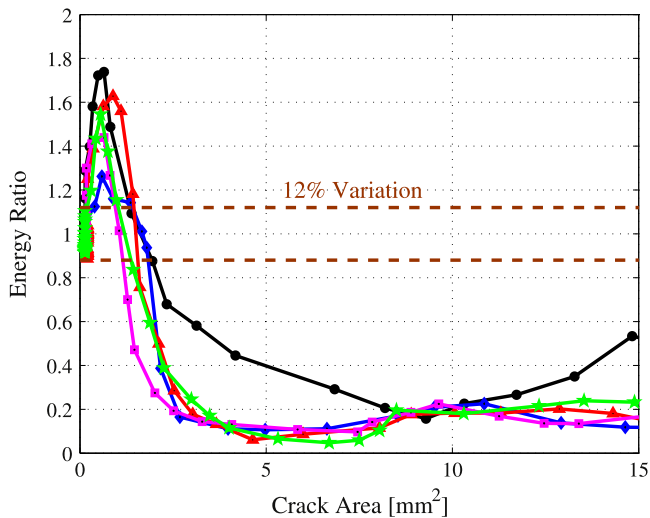
Figure 7. Energy ratio of guided wave pulse measured with laser interferometer at location behind fatigue crack close to hole for five specimens (solid lines); 12% amplitude variation shown (dashed); plotted against optically measured crack area.

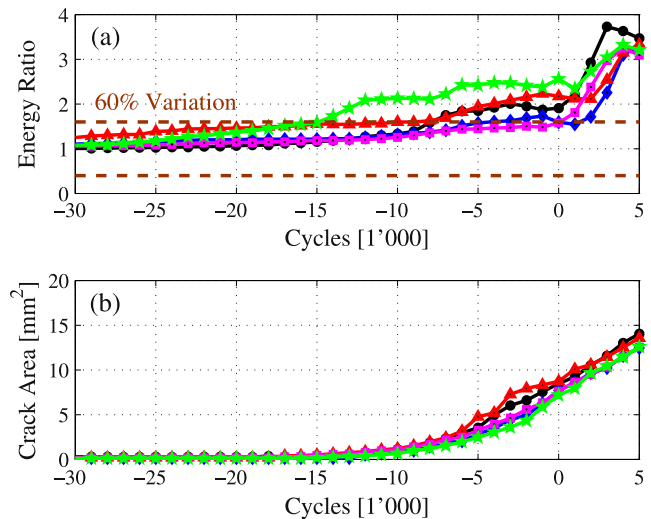
Figure 9. (a) Energy ratio of P/E pulse measured from 225 mm stand-off distance from hole for five specimens (solid lines); 60% amplitude variation shown (dashed); (b) optically measured crack area for five specimens; plotted against number of cycles before crack grown through thickness.

growth measurements for the previous five specimens the crack area measurements for the five specimens in figure 9(b) follow a reasonably similar pattern. For most of the specimens an initial increase of the energy ratio was noted at about $-10\,000$ to $-5\,000$ cycles in figure 9(a). A second, sharper increase to an energy ratio of at least three was observed for all specimens by 4000 cycles, when the crack through the aluminium layer had grown to a length of at least 3.5 mm. The energy ratio versus crack area is shown in figure 10 for simpler interpretation. Up to 60% variation for two of the specimens and 22% variation for the other three specimens

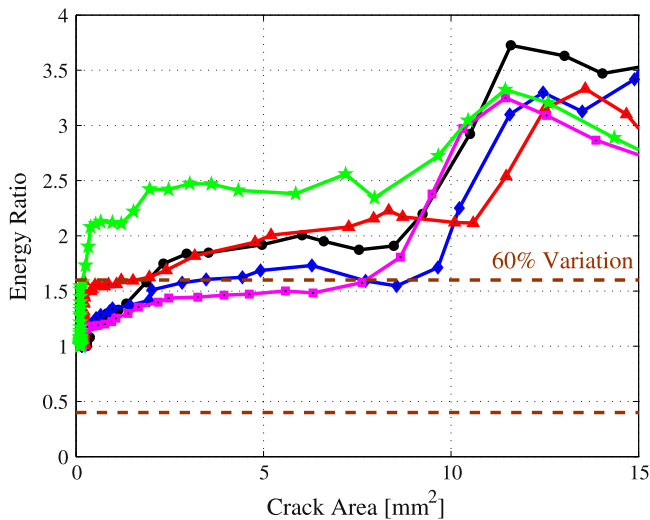
Figure 10. Energy ratio of P/E pulse measured from 225 mm stand-off distance from hole for five specimens (solid lines); 60% amplitude variation shown (dashed); plotted against optically measured crack area.

can be observed before the crack was detected optically. Especially one of the specimens (green line in figure 10) showed a significantly different behaviour compared to the other specimens. From a closer analysis of the observed crack growth, ultrasonic signals and specimen no reason for this could be discerned. Taking a similar criterion for crack detection as for the laser measurements a threshold of a 120% change in energy ratio was set. The largest crack area of 11.5 mm² for this corresponds to a crack length of 3.83 mm through the aluminium layer and coincides with the observed sharp increase in energy ratio for all specimens. For individual specimens a smaller fatigue crack might be called, but in order to avoid false calls the current criterion provides a reasonable safety margin. The detectable length for a hidden fatigue crack from a stand-off distance without access to the damaged plate side is in line with a threshold value mentioned previously [4]. Further improvements might be possible once the repeatability of the proposed SHM methodology has been investigated in more detail and an improved understanding of the exact interaction of the high-frequency guided wave modes with the fastener hole and fatigue crack has been obtained.
