A review of aeronautical fatigue investigations in Finland April 2011 - February 2013

A REVIEW OF AERONAUTICAL FATIGUE INVESTIGATIONS IN FINLAND APRIL 2011 – FEBRUARY 2013

Presented at the 33rd Conference of the International Committee on Aeronautical Fatigue and Structural Integrity (ICAF), Jerusalem, Israel, 3-4 June 2013

Compiled by Aslak Siljander

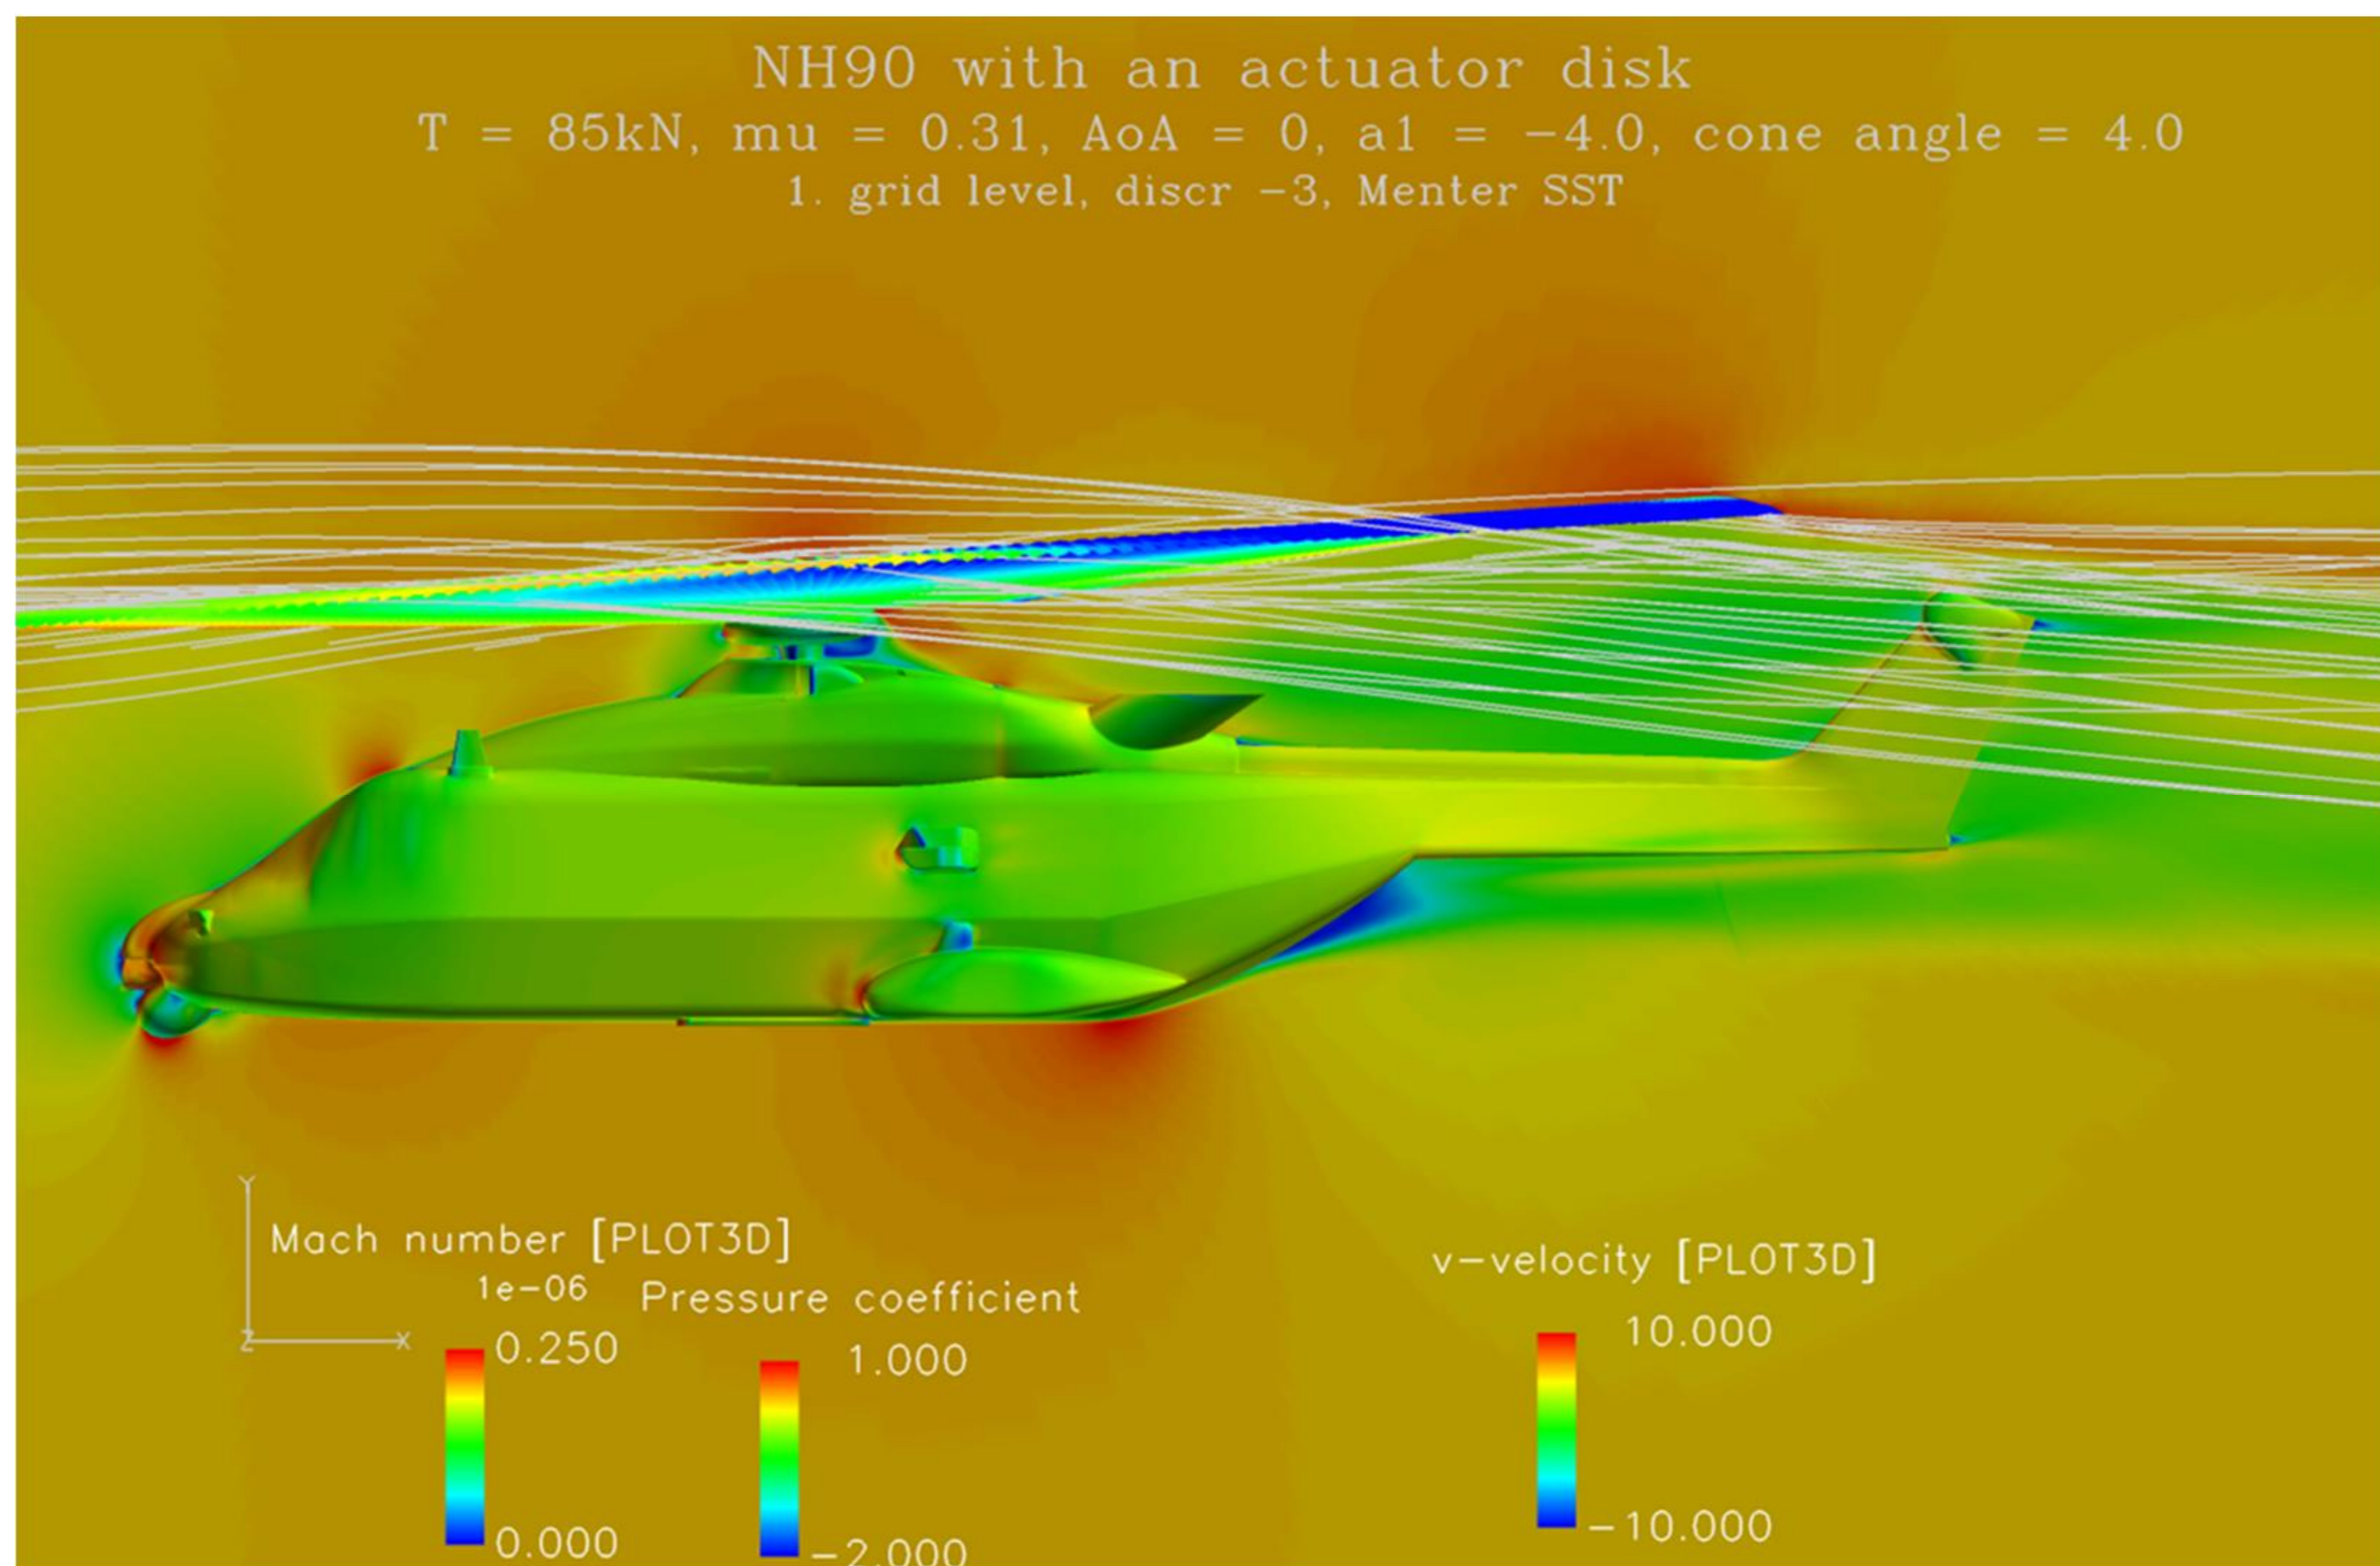
Figure 6: Computed flowfield around NH90 in cruise. Picture by courtesy of Patria Aviation.

In cruise at zero angle of attack, the lift of the fuselage is negative and is caused by its shape with little rotor influence. The computed lift magnitude corresponds to about 7 per cent of the helicopter weight. The fuselage drag is about the same as the horizontal component of the thrust vector tilted 4 degrees forward. The results conform to expectations, but there are no real data available for validation. The computed flowfield is illustrated in *Fig. 6* by the pressure distribution on the fuselage, Mach number distribution on the nominal symmetry plane, vertical velocities on the rotor plane and by some streamlines.

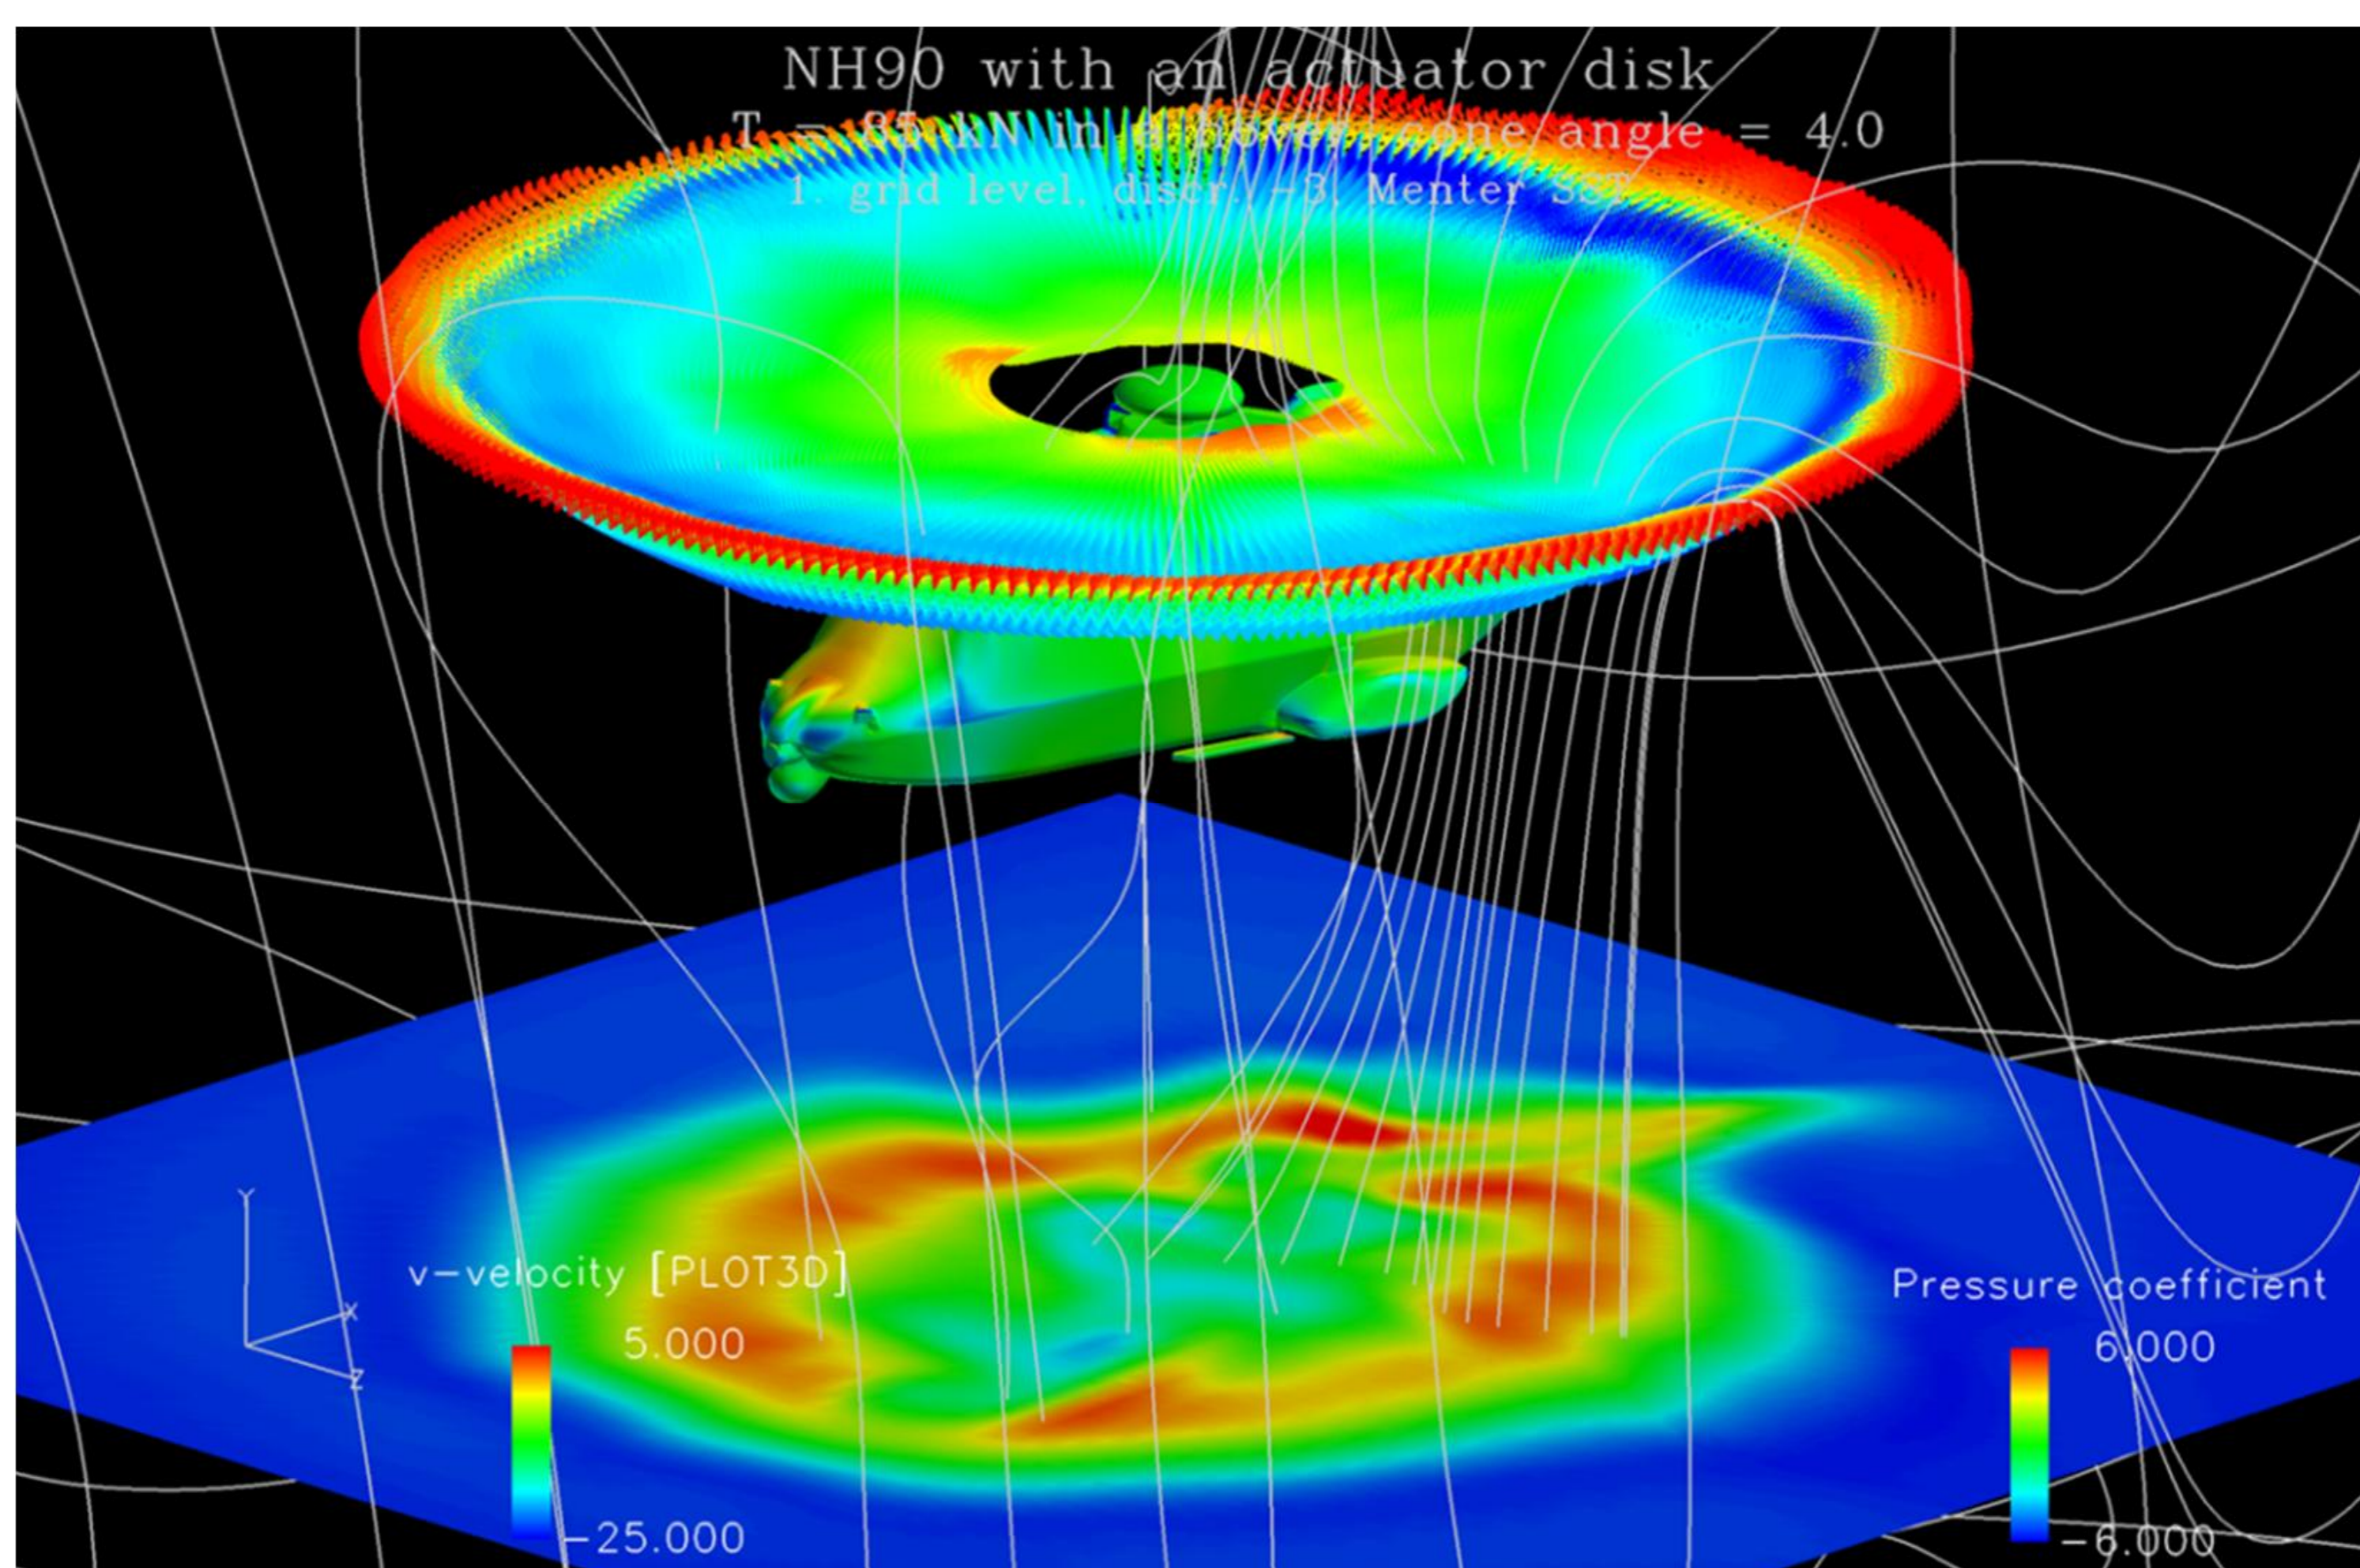
Figure 7: Computed flowfield around NH90 and on a horizontal plane below it in hover. Picture by courtesy of Patria Aviation.

In the hover case, the averaged down-force acting on the fuselage and entirely caused by the rotor blowing again represents about 7 per cent of the helicopter weight, and the horizontal forces are small. Also the moment balance is reasonably good. **Fig. 7** shows the fuselage pressure distribution and vertical velocity on the rotor plane and on a plane 6 meters below the fuselage. It is clearly seen that the fuselage disturbs the rotor outflow strongly and the pattern below the helicopter is far from axisymmetric. On the rotor disc plane, the distortion effects of the fuselage are also clearly visible

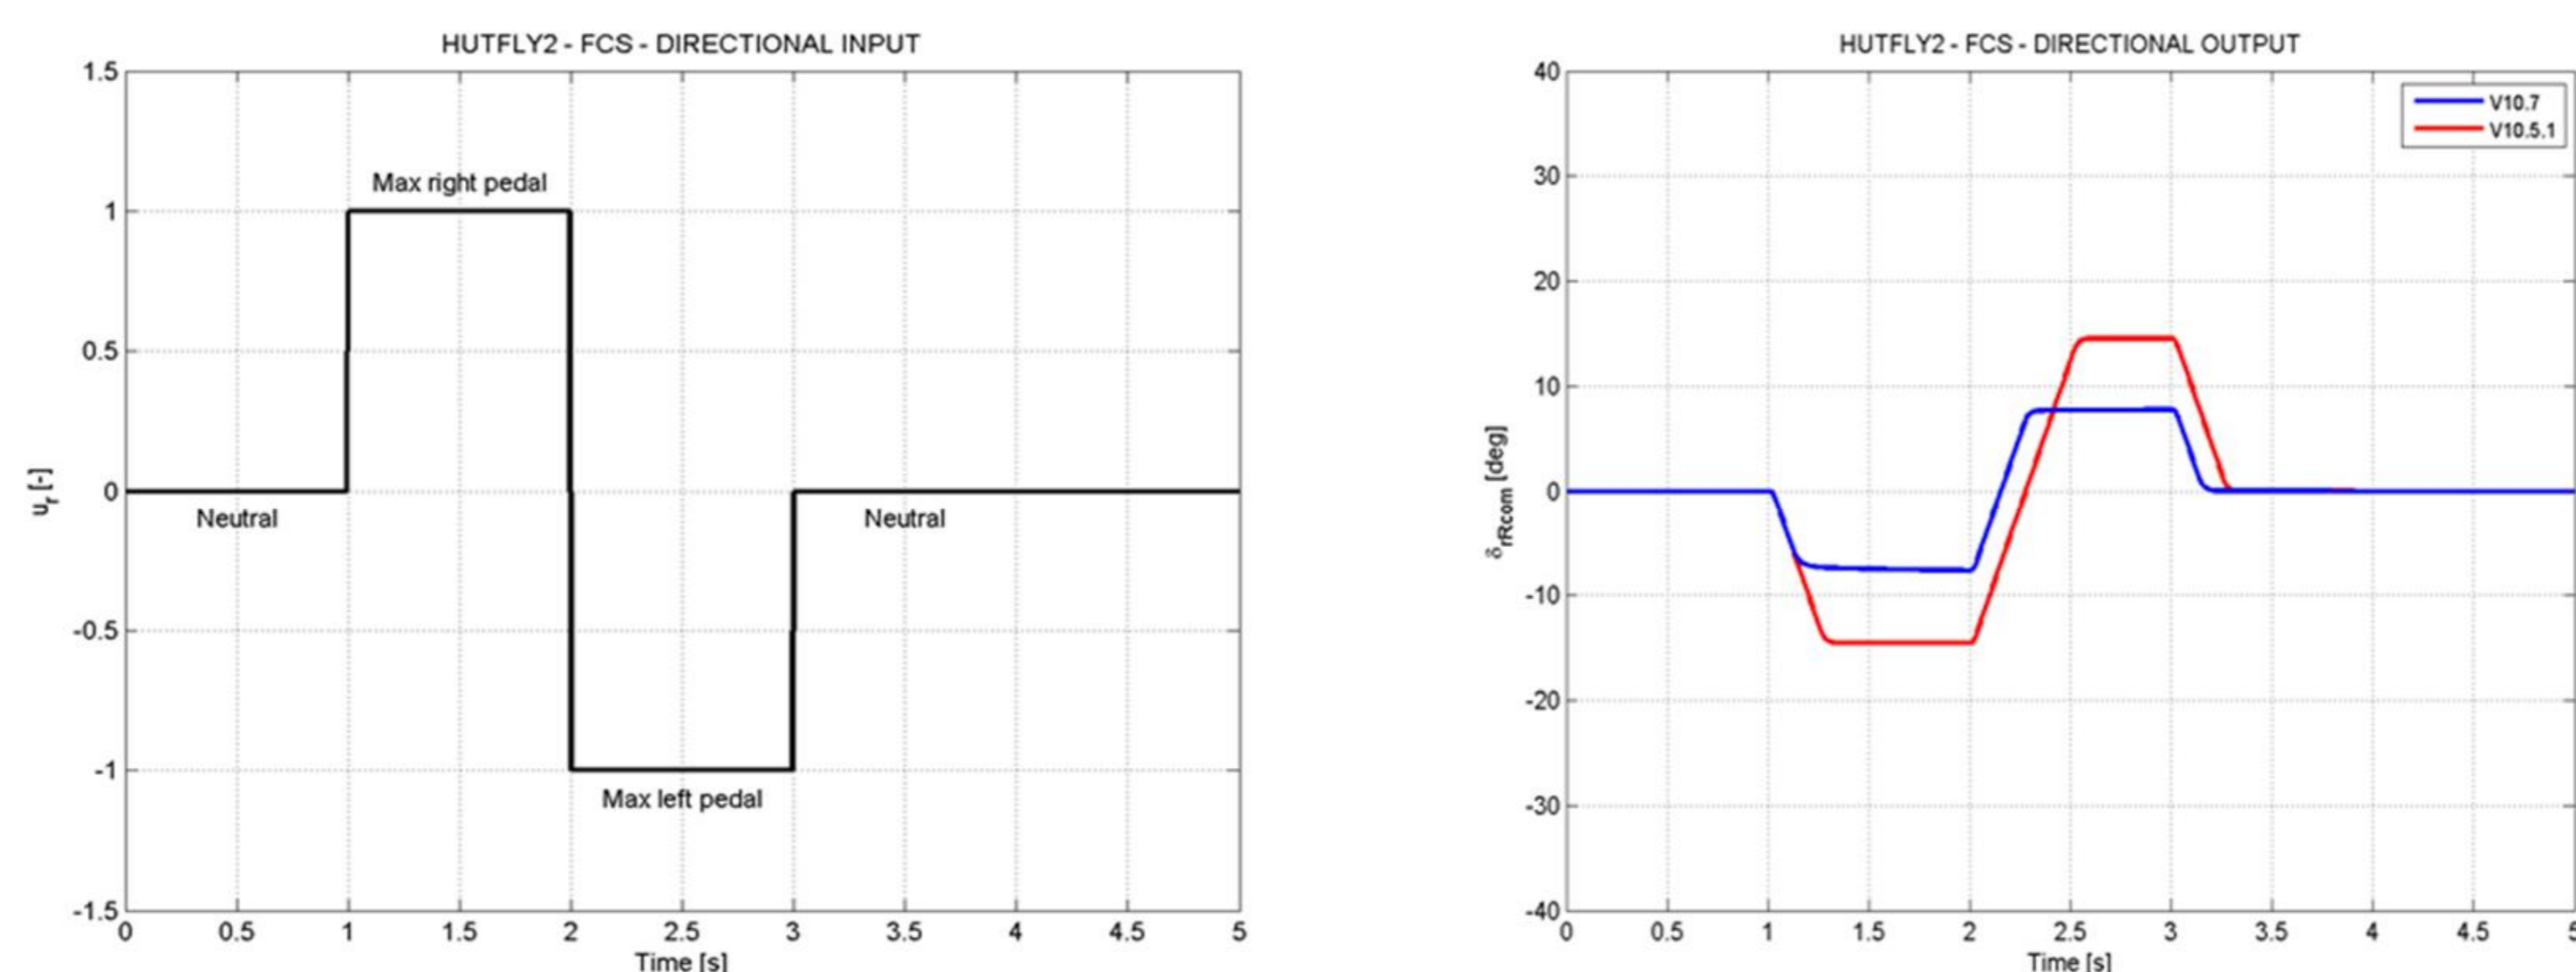
Figure 9: Right rudder actuator command as a response (output; shown right) for the normalized directional control doublet (input, shown left). In output, the red line represents the actuator command from the reference FCS V10.5.1 –model and the blue line represents the command from the upgraded FCS V10.7 –model. Picture by courtesy of VTT.

The essential phase in the development of the system is verification and validation (ver/val). Validation is yet to be done. At the moment, verification of the upgraded FCS model includes the time history comparisons of the given pilot inputs. For example response of the directional control (i.e. rudder) doublet without aerodynamics can be seen from **Fig. 9**. From the figure it can be seen that for the same input, the commanded rudder deflections are smaller in the upgraded FCS version than in the reference version due to the increased full pedal input departure resistance. Rate limiters have been remained the same which is manifested by the identical slopes of the responses.

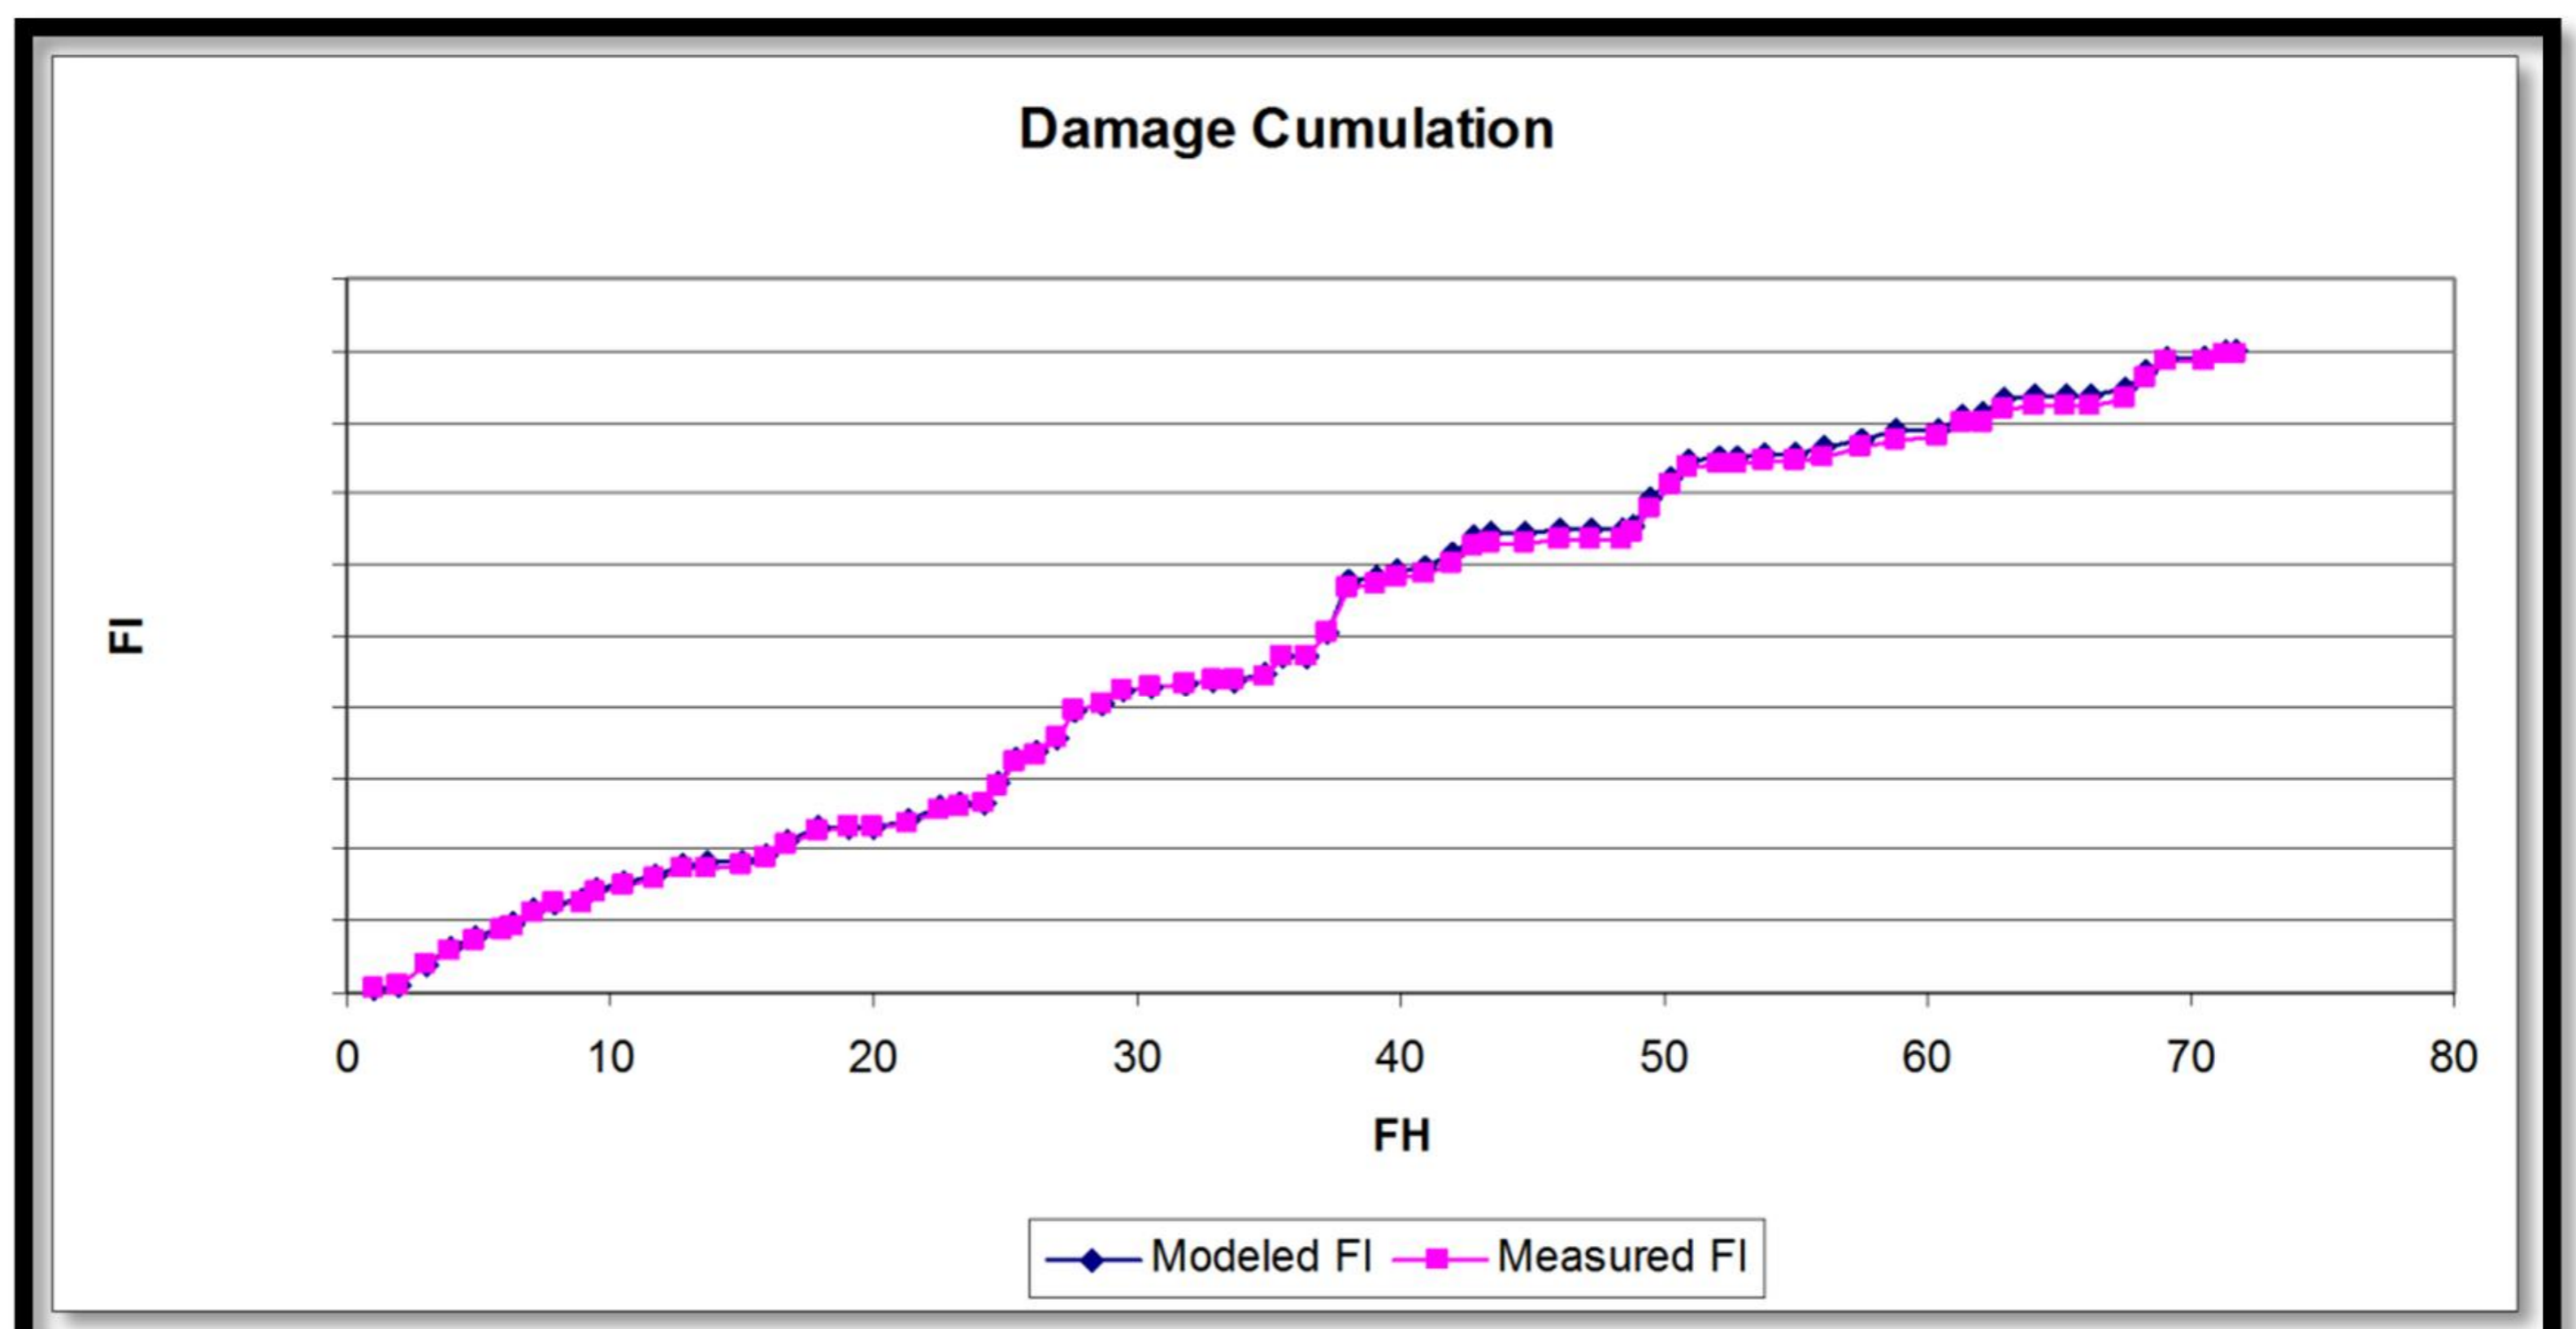
Figure 18: A proof of in-service performance of the parameter based fatigue life analysis. Modeled and measured damage accumulation over period of 70 FH. Picture by courtesy of Patria Aviation.

Fig. 17 and **Fig. 18** show flight specific damage scatter and accumulation plots from the in-service performance assessment.

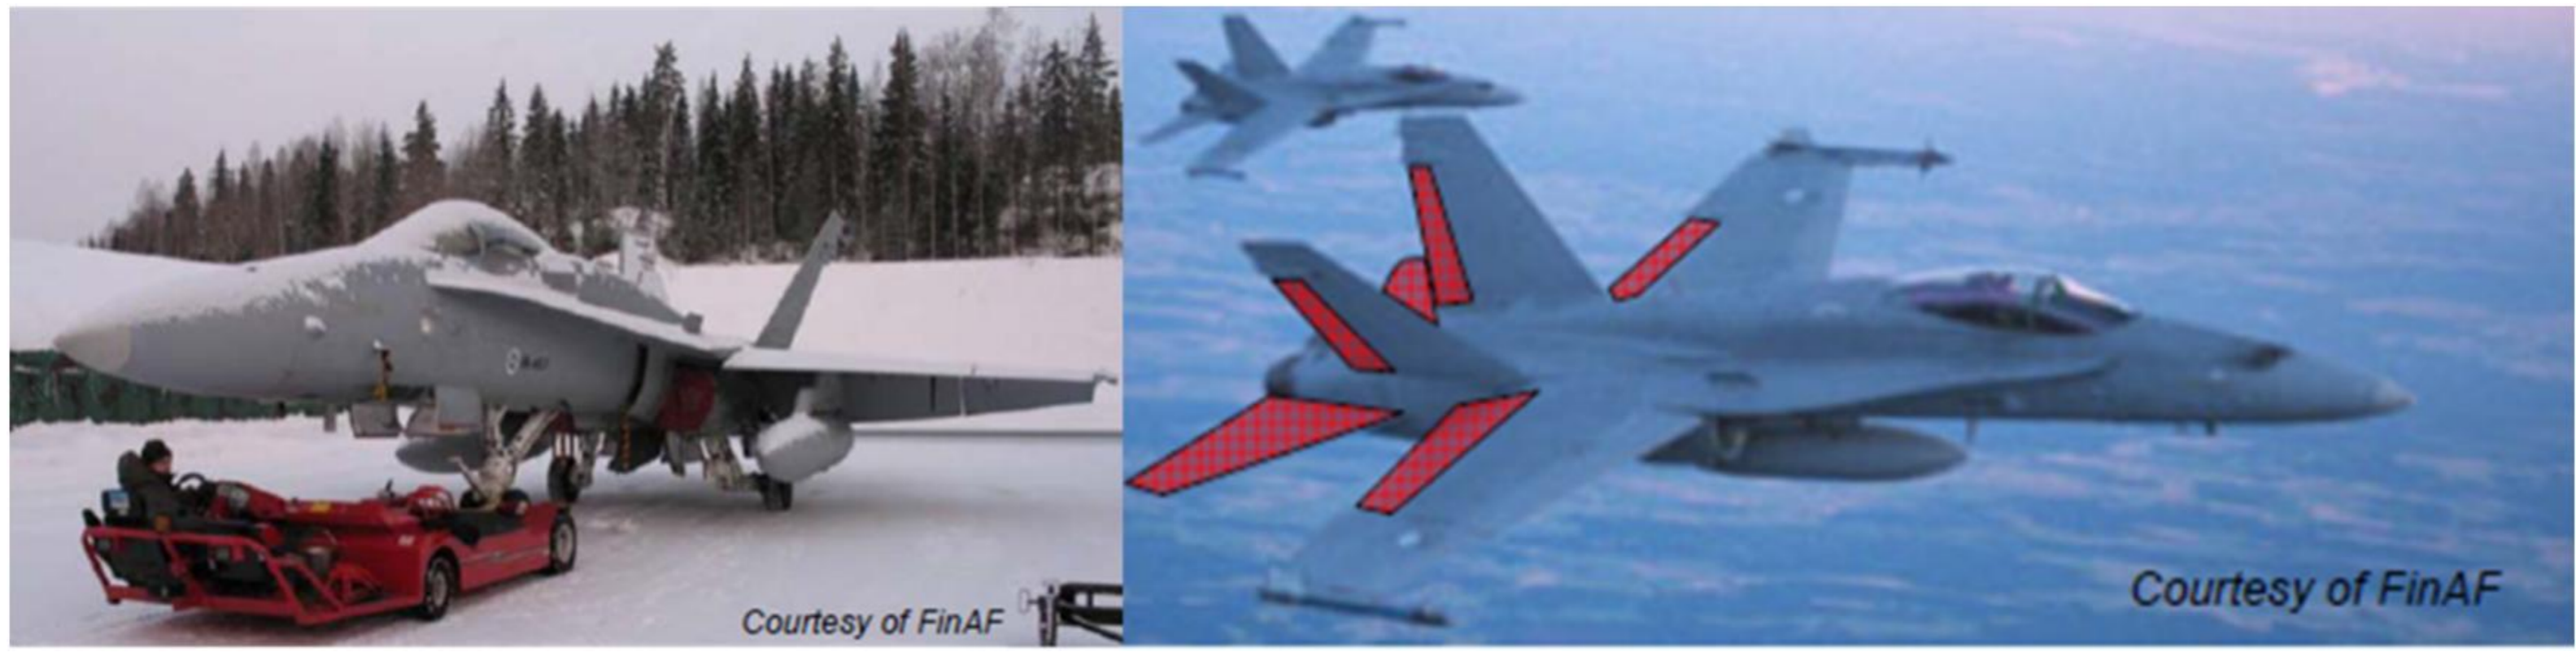
Figure 20: *The optimal thermographic inspection exploiting phase transition of water. **Left:** To succeed in the thermographic inspections, it is of paramount importance to ensure adequate cooling (freezing) of the aircraft before starting of the measurements. **Right:** The inspection consisted of six different flight surfaces (10 locations) in one sequence of inspection checks. Picture by courtesy of the FINAF.*

The target of the work was to find a suitable procedure to detect penetrated water from the composite aircraft structures by using thermographic investigation method exploiting the phase transition of water. Previous thermographic activities were highlighted in [4 Chapter 13.2.3.1]. Since then, it was verified that 6 different flight surfaces (10 positions), **Fig. 20**, can be inspected during one inspection route at optimal temperature range with the developed thermographic method. One inspection route consists of rudder, trailing edge flap (around the middle and the main hinges) and horizontal stabilizer (pinion and main hinge) from both sides of the aircraft.

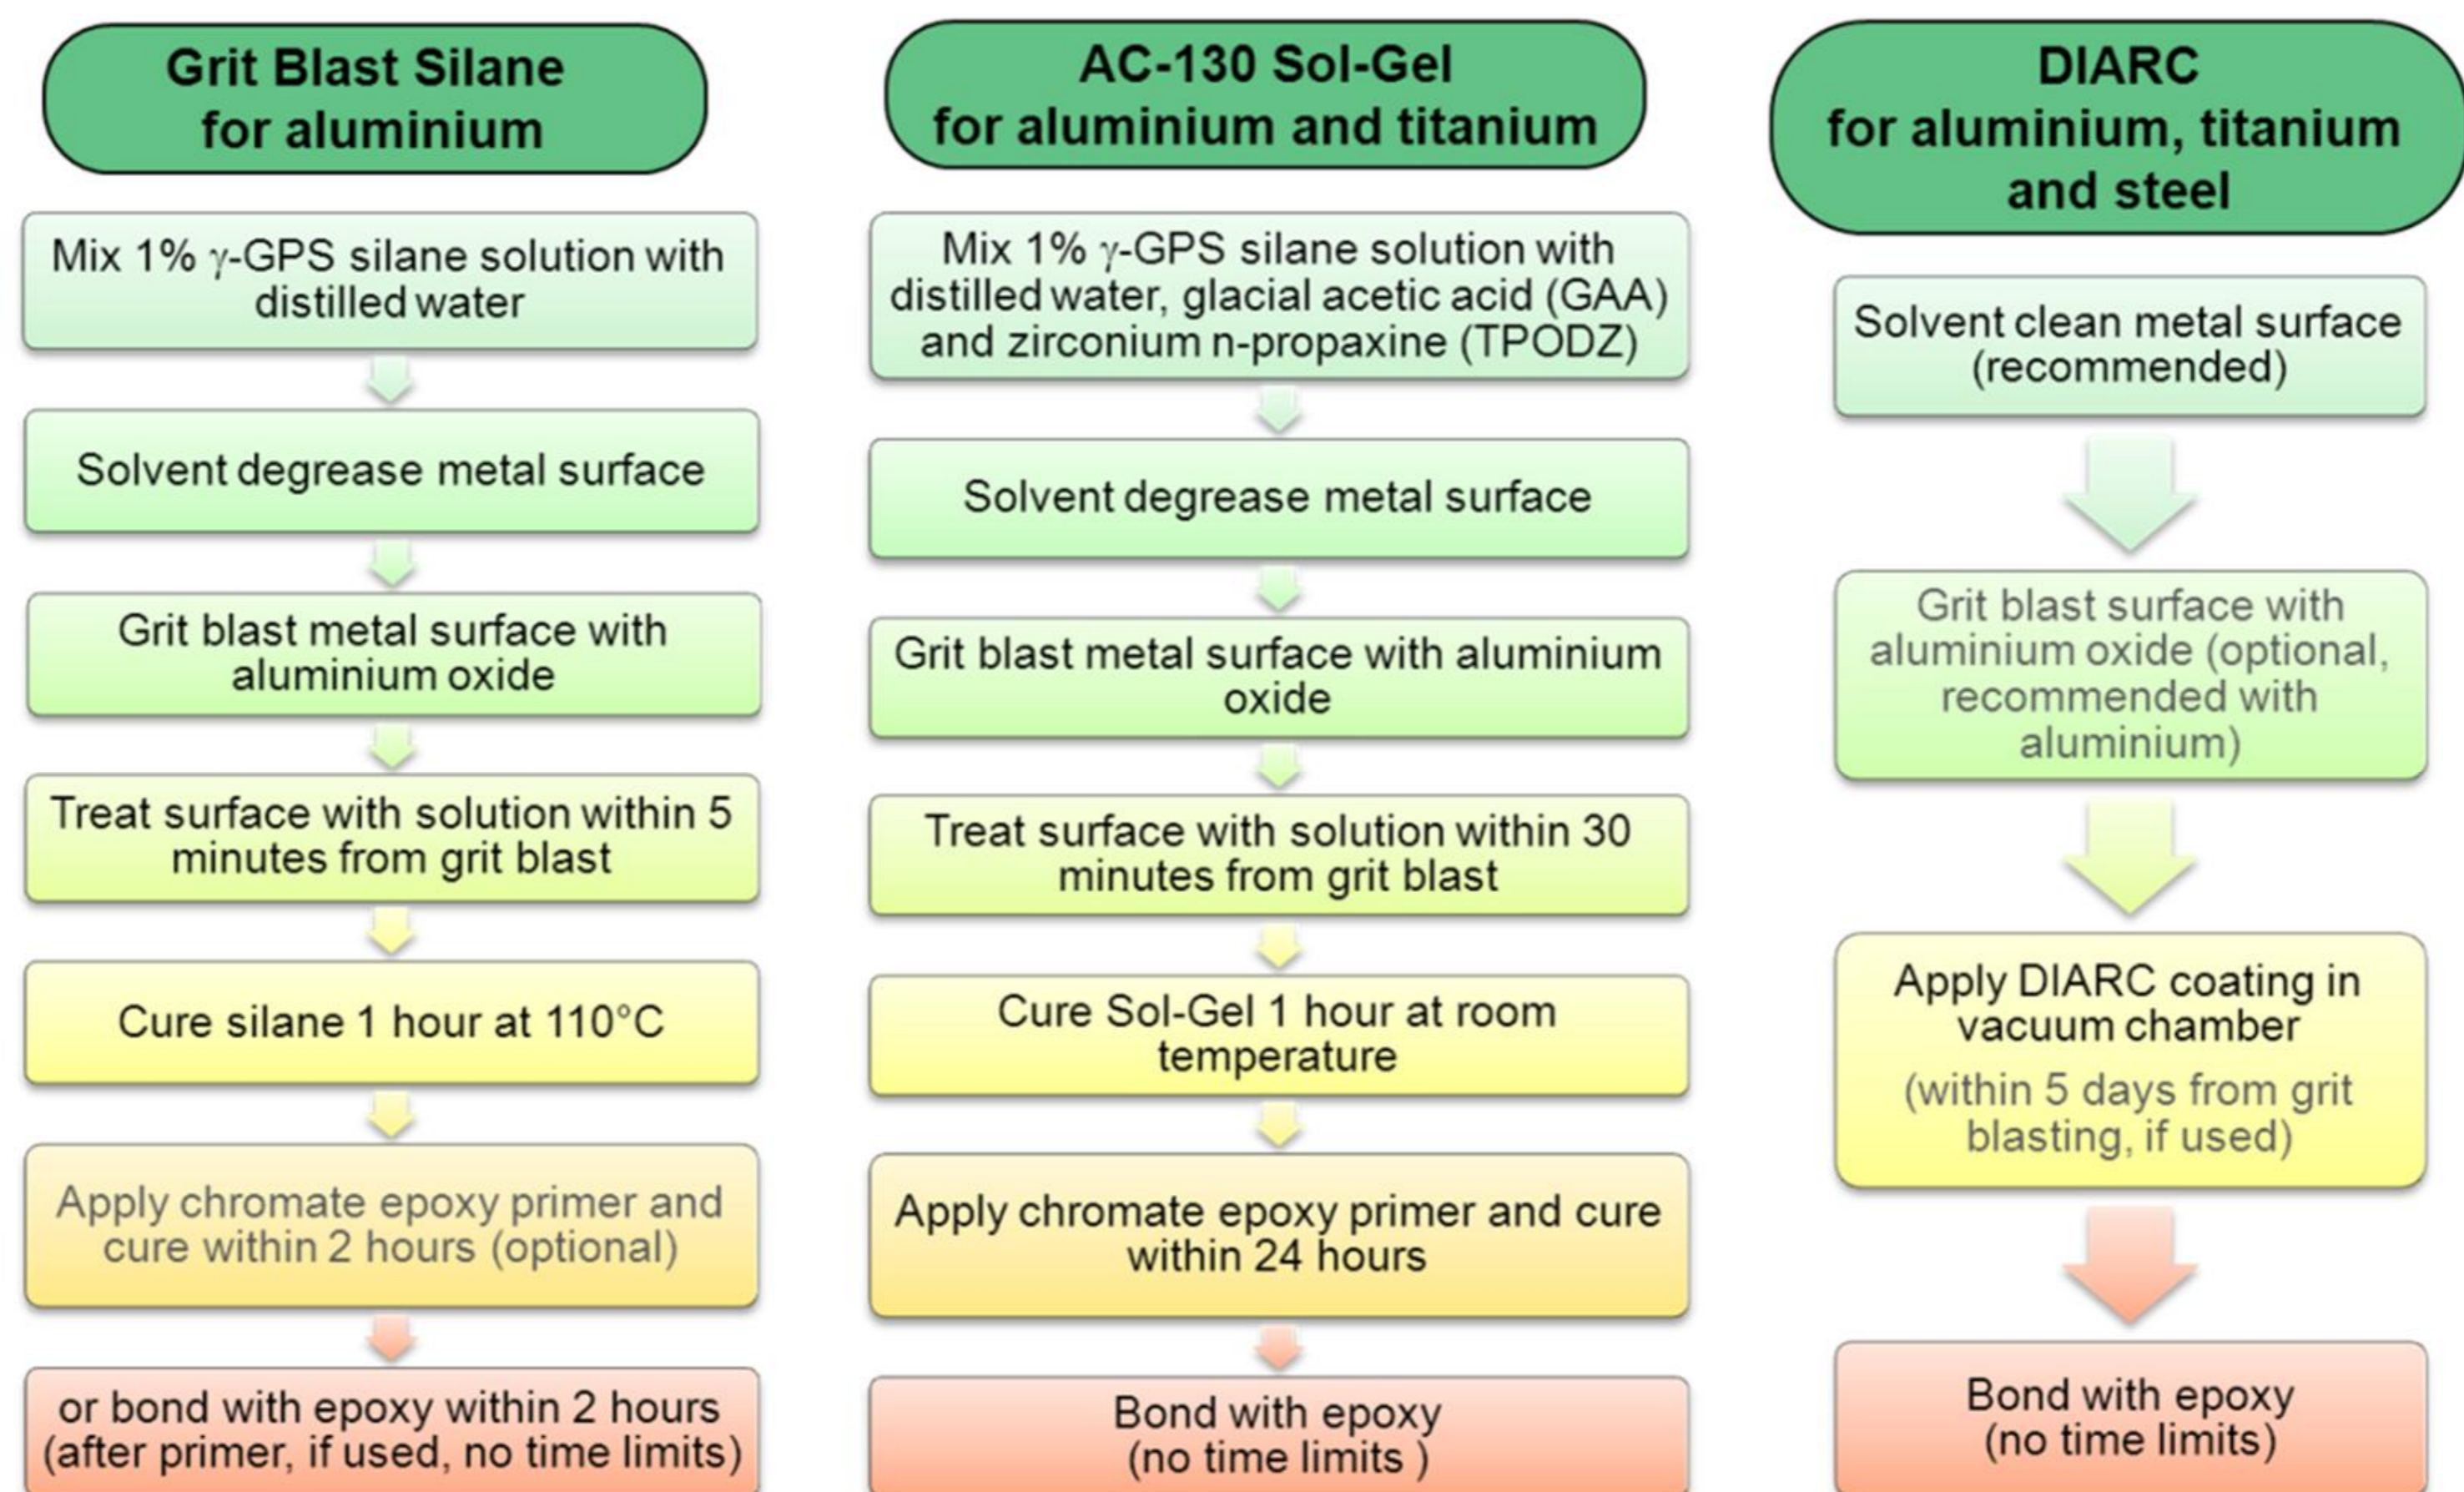
Figure 28: Surface treatment comparisons. Picture by courtesy of Aalto University.

The objective of this study [61] was to investigate the performance of new DIARC coating method for metal bonding. The results were compared to grit blast silane (GBS) and grit blast AC-130 Sol-Gel (SG) testing. **Fig. 28** summarizes the surface treatment comparisons.
