A review of aeronautical fatigue investigations in Finland April 2011 - February 2013

A REVIEW OF AERONAUTICAL FATIGUE INVESTIGATIONS IN FINLAND APRIL 2011 – FEBRUARY 2013

Presented at the 33rd Conference of the International Committee on Aeronautical Fatigue and Structural Integrity (ICAF), Jerusalem, Israel, 3-4 June 2013

Compiled by Aslak Siljander

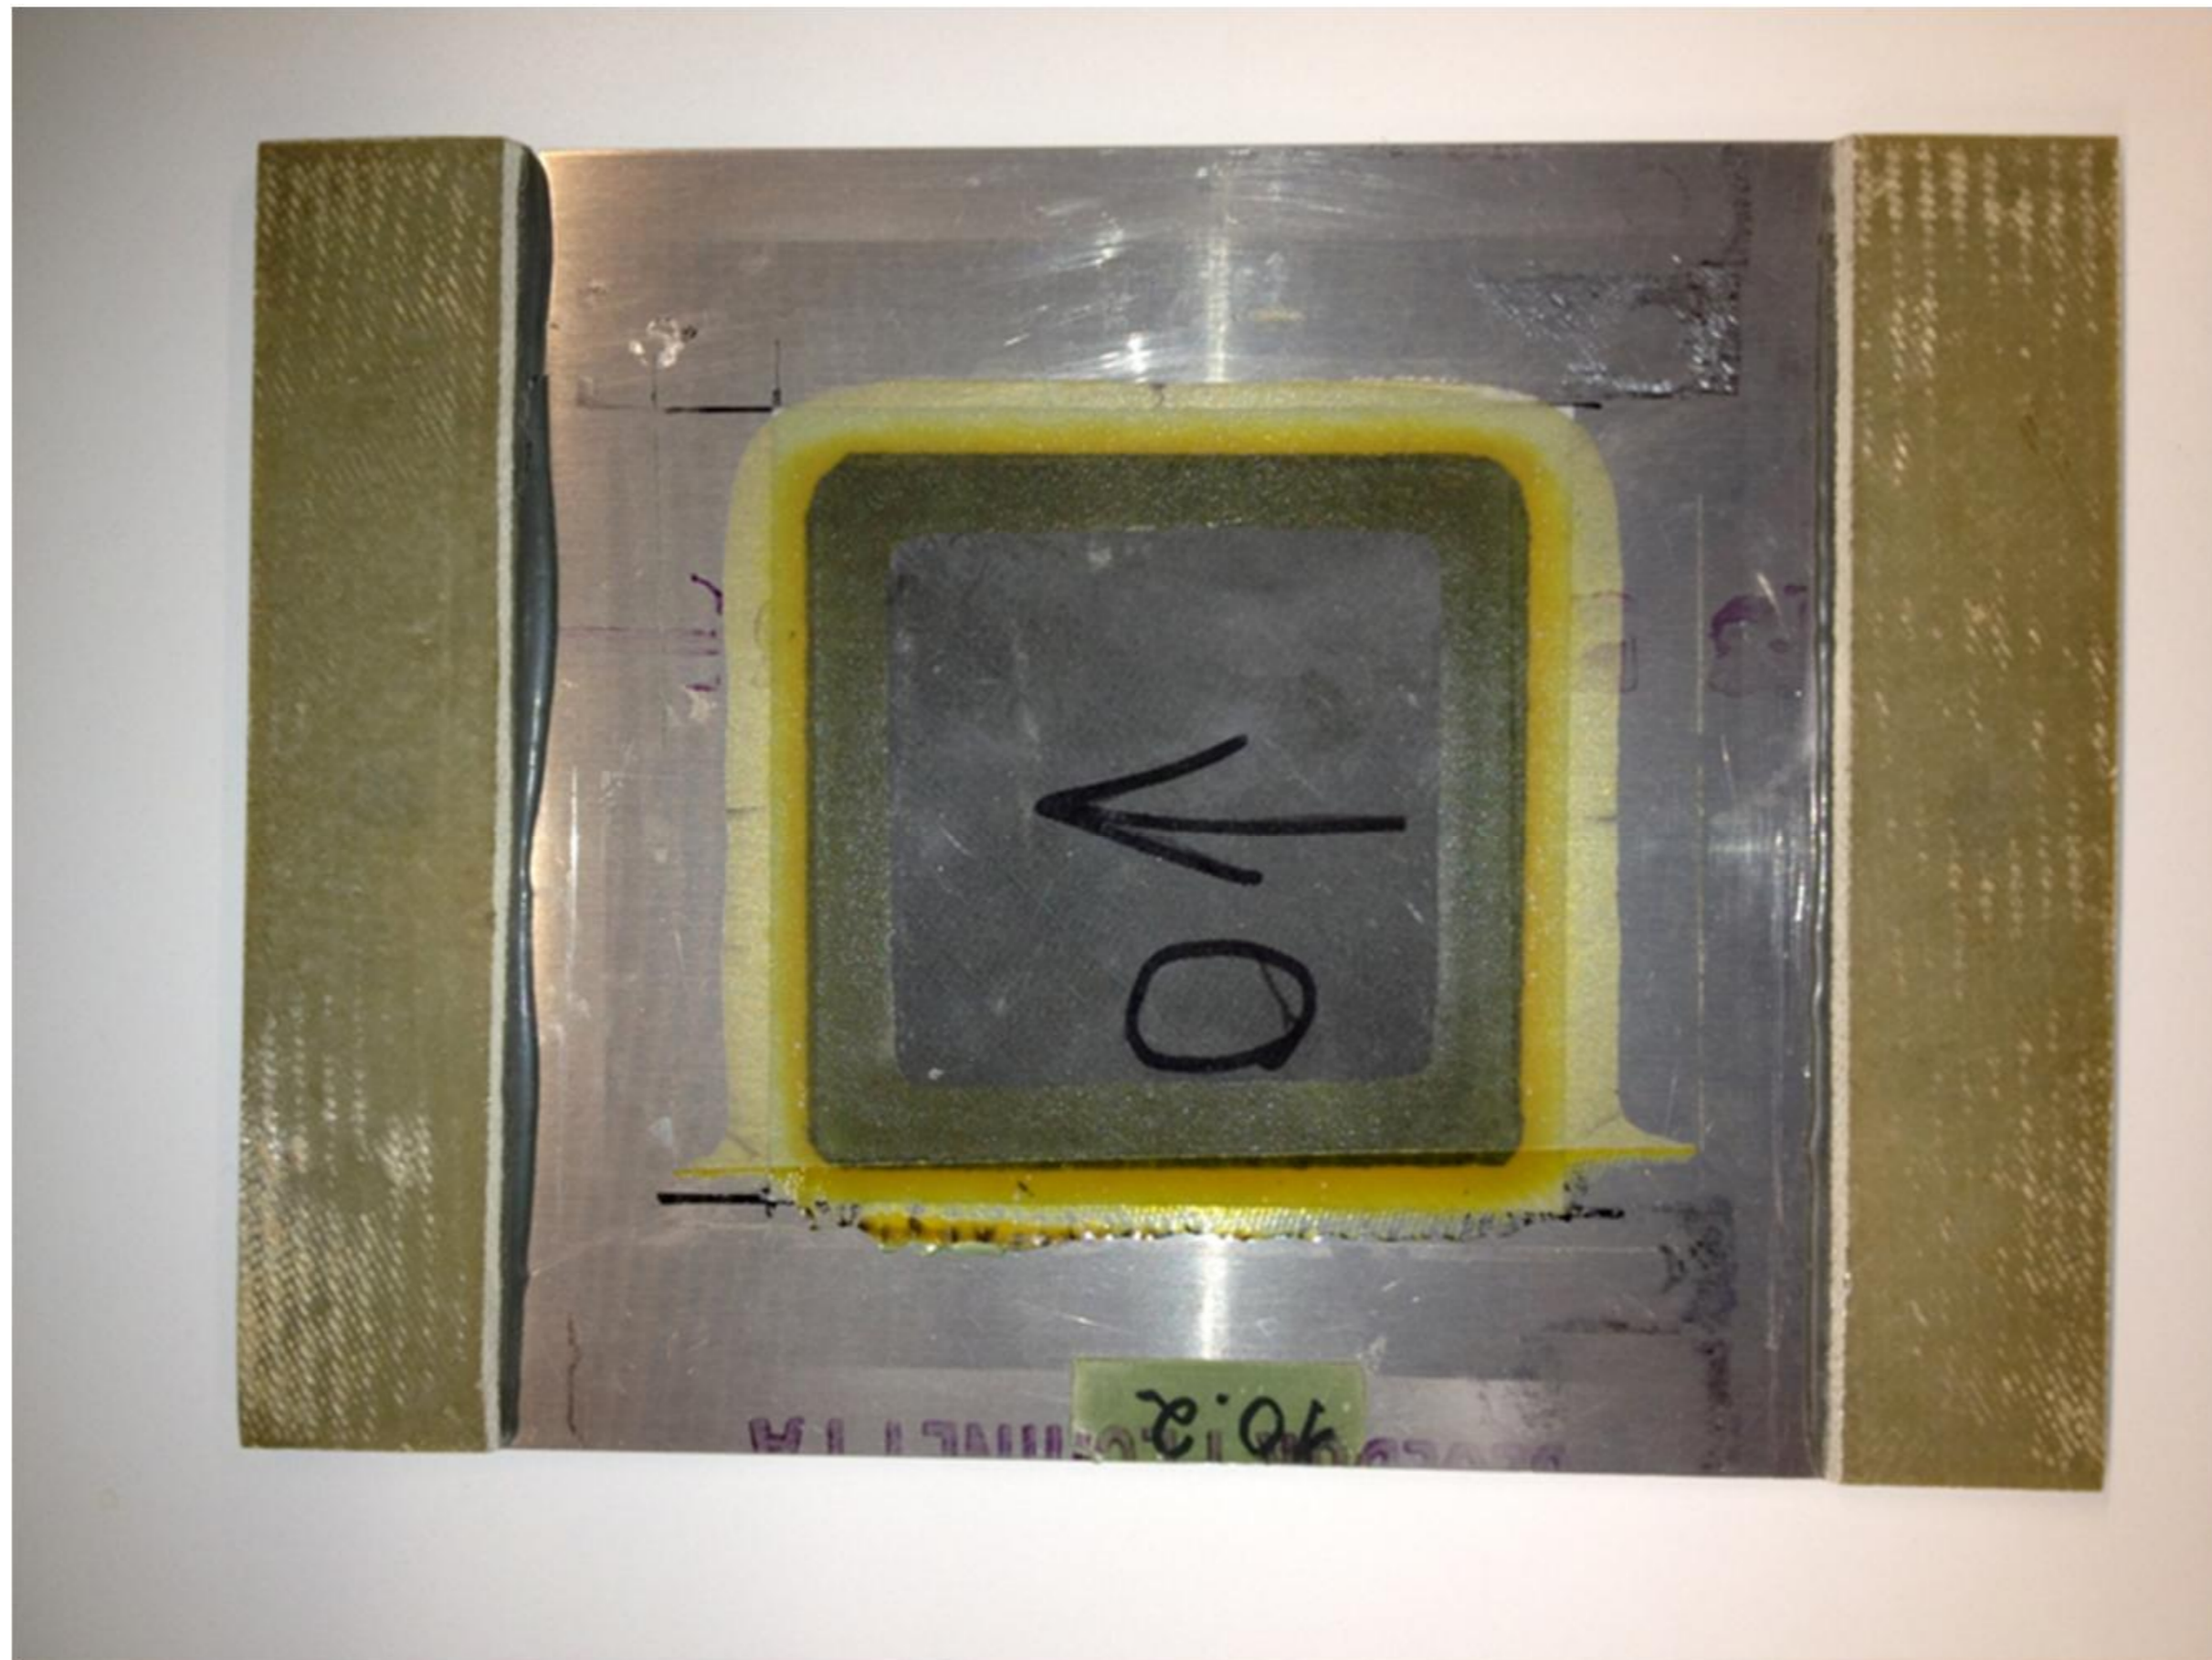
Figure 30: The examined structure; a 2024-T3 aluminum plate and a carbon/epoxy prepreg patch bonded with FM73M epoxy adhesive. Picture by courtesy of Aalto University.

limitations, which is why the results varied considerably [62]. An overview of the work is provided in *Fig. 30* and *Fig. 31*.

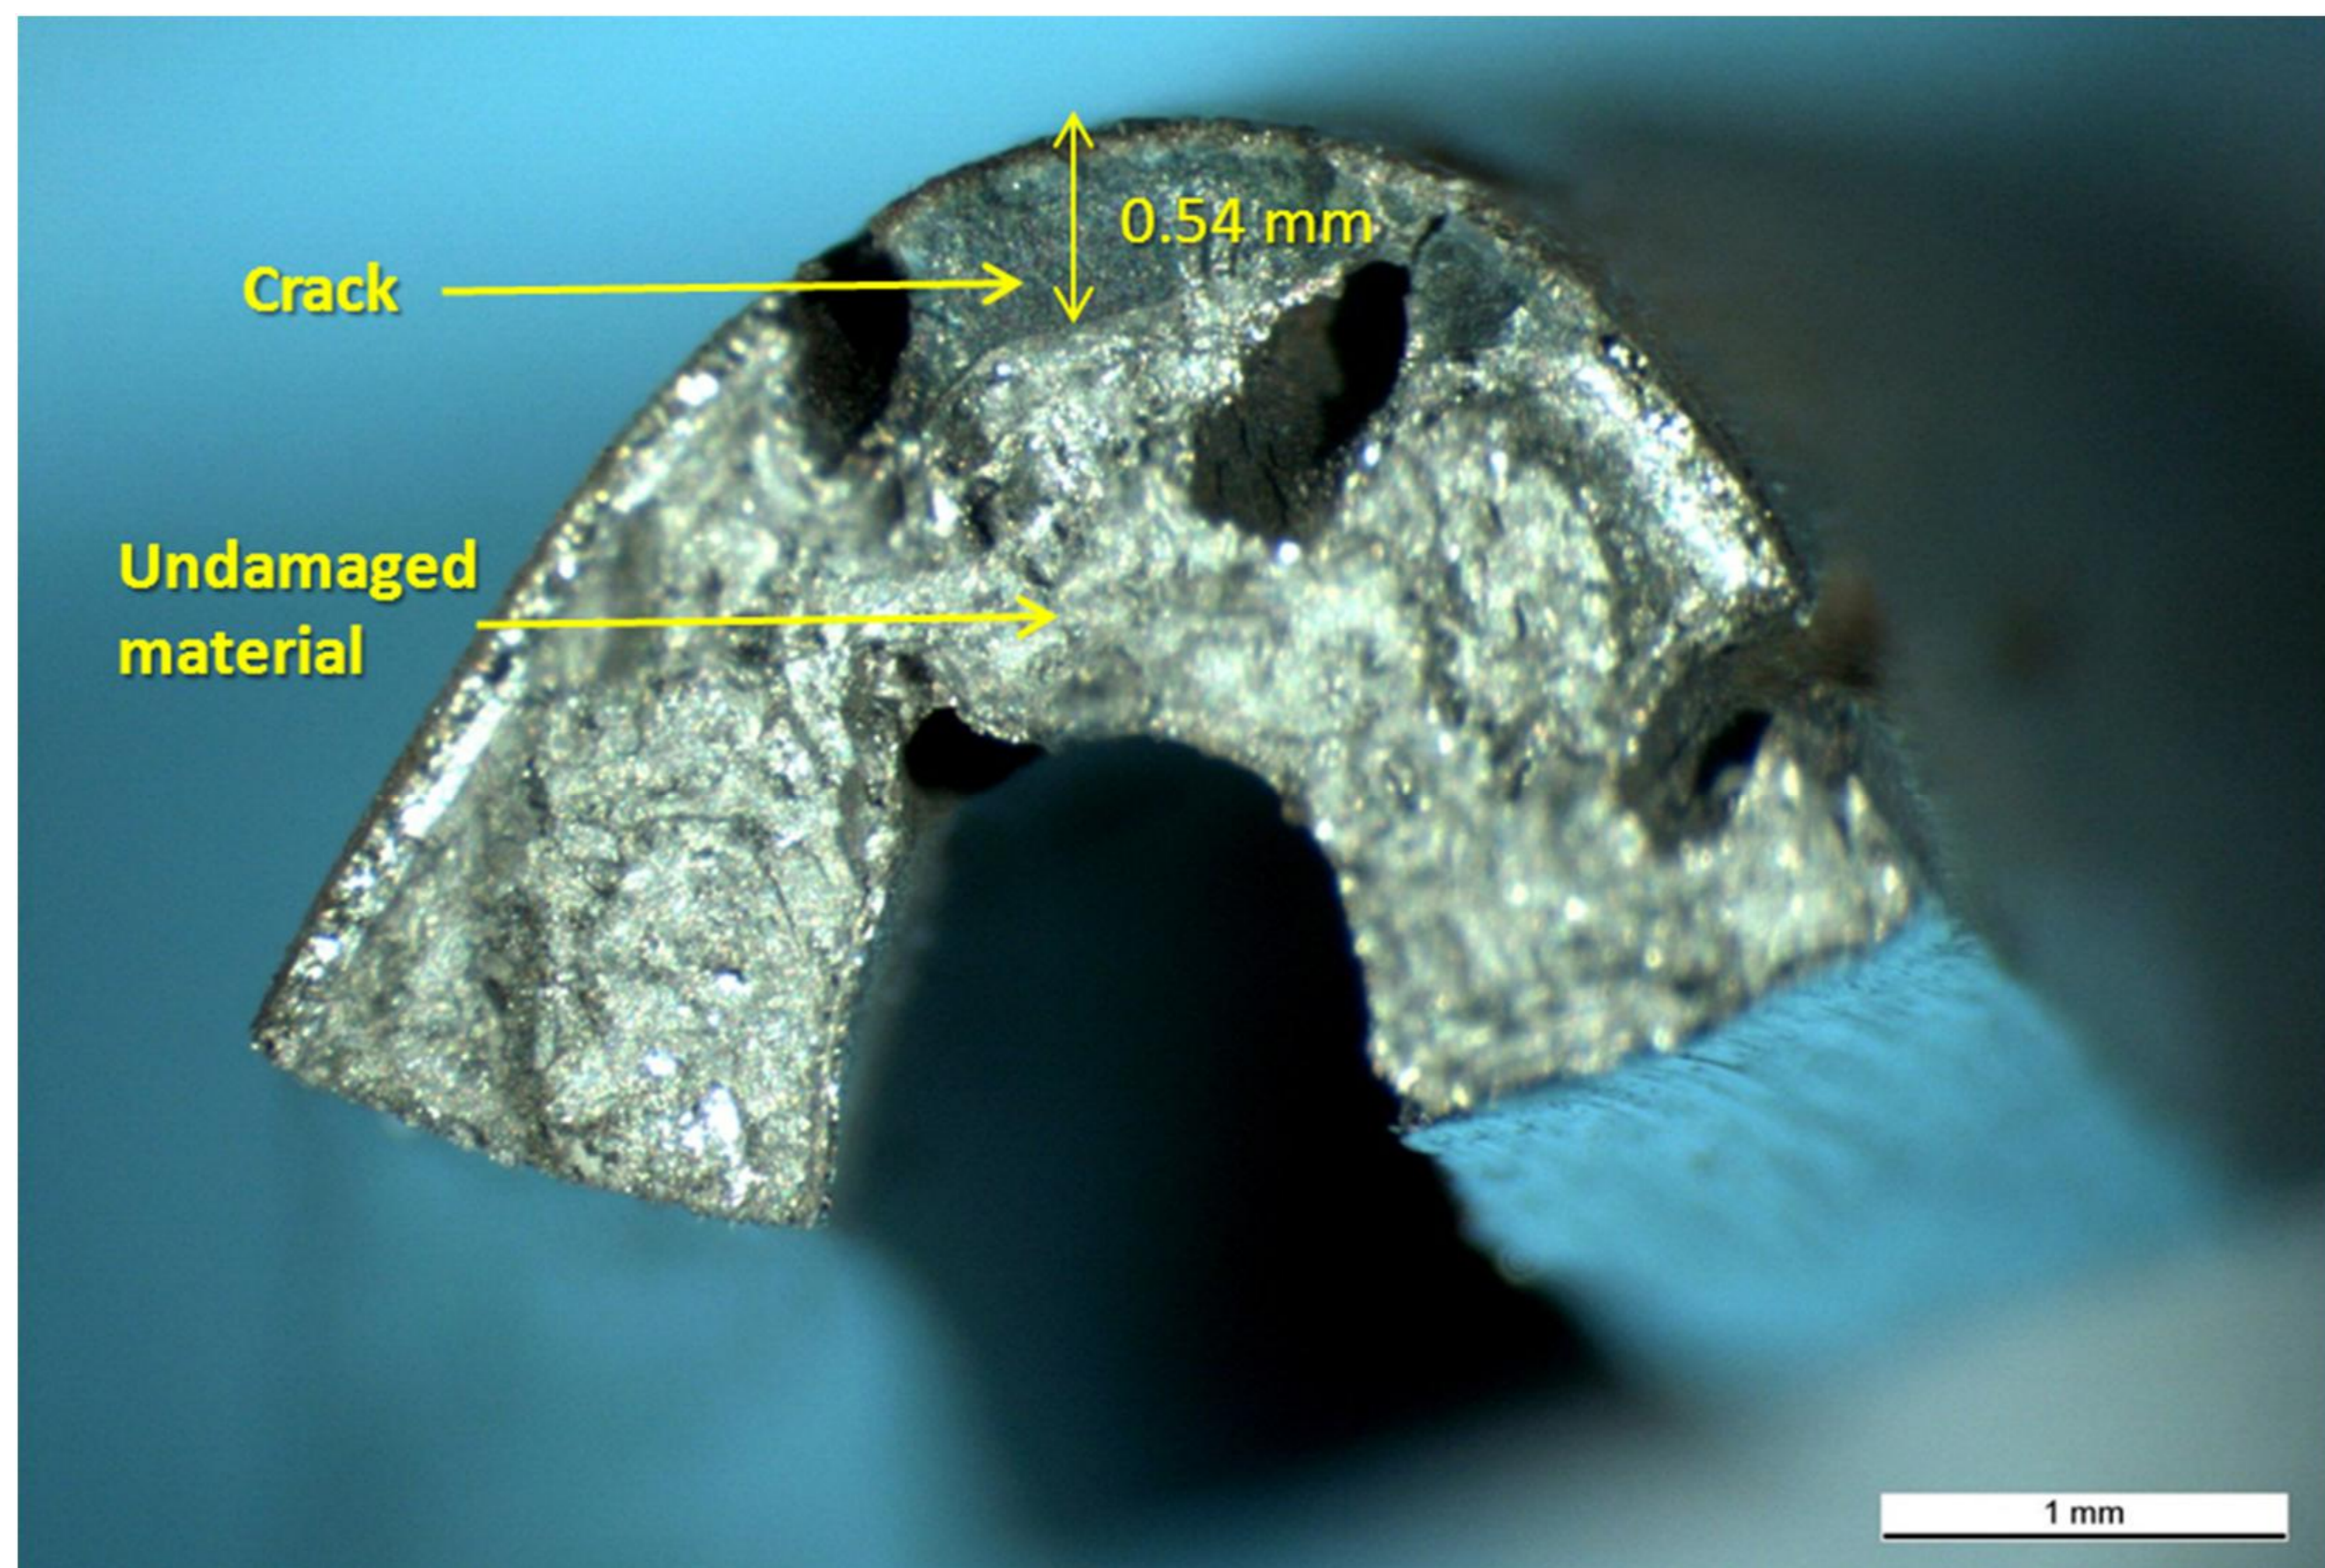
Figure 36: Opened crack from Fig. 35. Picture by courtesy of VTT.

Various different turbine blade cracks were collected for this report with the aim to produce a guideline for turbine blade failure inspection. The purpose of this handbook is to ease the visual inspection when analysing the severity of turbine blade cracks [68]. Examples of the turbine blade failures are shown in *Fig. 35* and *Fig. 36*.
