# Dry drilling of alloy Ti–6Al–4V

This work is focused on the combined study of the evolution of tool wear, quality of machined holes and surface integrity of work-piece, in the dry drilling of alloy Ti–6Al–4V. Tool wear was studied with optical microscope and SEM–EDS techniques. The quality of machined holes was estimated in terms of geometrical accuracy and burr formation. Surface integrity involves the study of surface roughness, metallurgical alterations and microhardness tests. The end of tool life was reached because of catastrophic failure of the drill, but no significant progressive wear in cutting zone was observed previously. High hole quality was observed even near tool catastrophic failure, evaluated from the point of view of dimensions, surface roughness and burr height. However, microhardness measurements and SEM–EDS analysis of work-piece showed important microstructural changes related with a loss of mechanical properties. Depending on the application of the machined component, the state of the work-piece could be more restrictive than the tool wear, and the end of tool life should be established from the point of view of controlled damage in a work-piece.

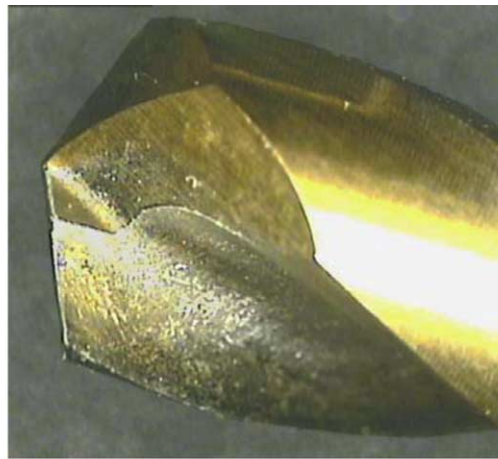
Fig. 2. Initial wear of drill I: (a) optical microscope view of drill I after machining eight holes (condition I, cutting time 0.4 min), and (b) SEM micrograph of rake face of drill I after machining 15 holes (condition I, cutting time 0.8 min).

Drill I presented slower wear evolution. Fig. 2(a), shows drill I after machining eight holes (condition I, cutting time 0.4 min). A smaller amount of material work-piece is adhered to the same zones that in the former case (drill point and clearance surface). No significant changes (flank wear, rounding of cutting edge, etc.) are observed in drill geometry.

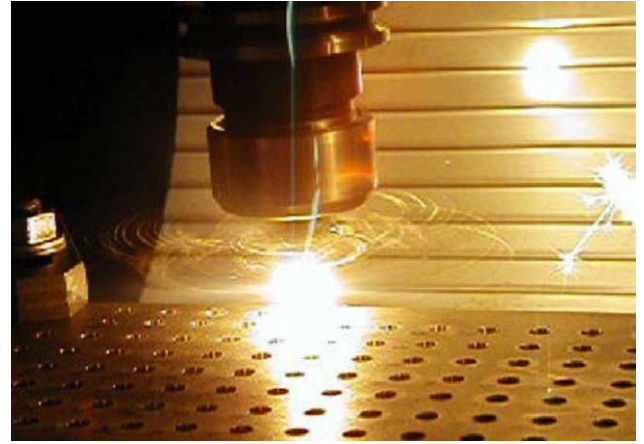
Fig. 5. Drilling test with combustion of the chip corresponding to 14th series with drill II (cutting time 6 min).

Cutting edge geometry does not change significantly up to the end of life of the tool. However, as cutting time increased, heat generated in the process increased, due to loss of coating, adhesion of work-piece material and small defects originated at the cutting edge. Tests were carried out in absence of cutting fluid, so high temperature is reached and combustion of chip was observed in some cases. In condition II, small sparks due to weak combustion of the chip appeared after the first series. This tendency increased as the number of holes increased. Since 10th series (cutting time 4 min) the chip began to burn, and since 14th series (cutting time 6 min) chip burned in a more intense way (see Fig. 5). During machining in condition I sparks appeared later (after 70th hole, cutting time 3.8 min). Complete combustion of the chip was observed firstly in hole number 395 (cutting time 21.2 min).

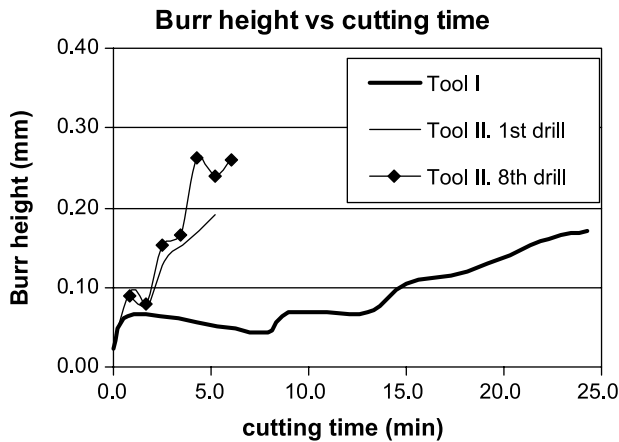
Fig. 8. Burr height versus cutting time for condition I and condition II (first and last hole of each series with tool II are presented).

Fig. 8 shows evolution of burr height versus cutting time, corresponding to both conditions I and II (burr height of first and last hole of each series are presented). Burr height increased as cutting time, and so tool wear, increased due to the higher temperatures. Holes machined in condition II (drill II), showed higher burr than those machined with drill I. Burr formation presented more sensibility to heat accumulation than resultant diameter. However, burr height presented moderate values up to tool failure, even in condition II.

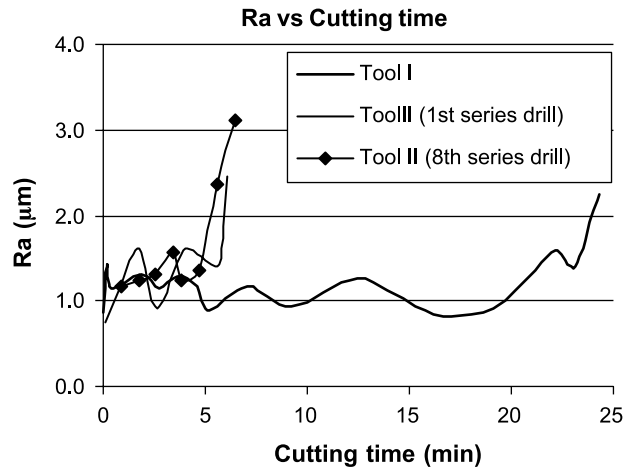
Fig. 9. Surface roughness versus cutting time for condition I and condition II (first and last hole of each series with tool II are presented).

Fig. 9 shows evolution of surface roughness of holes machined with drill I and drill II (roughness of first and last hole of each series are presented) versus cutting time.

In both condition I and II, average roughness ( $R_a$ ) was approximately 0.7  $\mu\text{m}$  in initial holes. Roughness increased at cutting time corresponding to medium wear of the tool, ranging from 1 to 1.5  $\mu\text{m}$ . Finally, close to tool failure, roughness increased up to 2.5  $\mu\text{m}$ . Roughness values recorded were unstable during the cutting tests (specially in
