INVESTIGATION OF EXPERIMENTAL RESEARCH ON THE LOW VELOCITY IMPACT DAMAGE BEHAVIOR OF NCF COMPOSITE PLATES – COMPLAS XII

I. AđIR[†], A. KURŞUN^{*}, AND N.B. BEKTAŞ[†]

Key words: Non-Crimp Fabric, Impact Response, Perforation, Load–Deflection Curves, Energy Profiling Method.

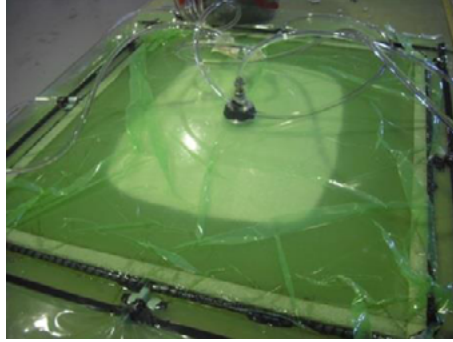
Figure 1: Manufacturing of composite plates.

As seen in the figure 1 that composite plates were manufactured by vacuum infusion process which is a technique that uses vacuum pressure to drive resin into a laminate. After manufacturing process, the composite specimens with dimensions of 100mm x 100mm were trimmed from the laminated plates. Instron-Dynatup 9250 HV are used for impact testing. The impactor has a hemispherical nose (12.5 mm diameter). The mass of the impactor is 6.32 kg. Impact tests are accomplished from 10J impact energy to perforation.

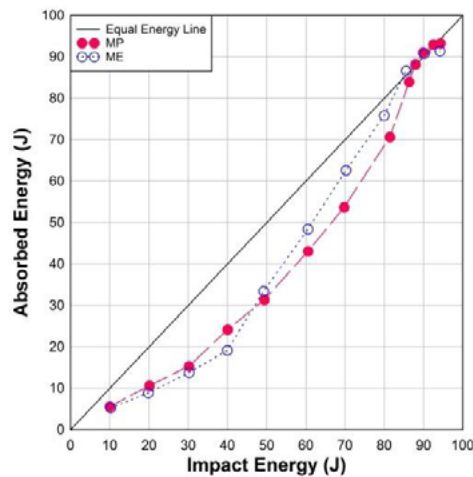
Figure 2: The energy profile diagram of MP and ME composites

Figure 2 shows the energy profile diagram, the relationship between impact and absorbed energy, of MP and ME composites. As seen, the penetration thresholds of MP and ME composites are obtained for 87.94J and 85.54J, respectively. The perforation thresholds are also obtained for 92.49J and 90.17J, respectively. The absorbed energies are almost the same up to 30J impact energy. For the next impact energies, the absorbed energies of ME composites are higher than MP composites.

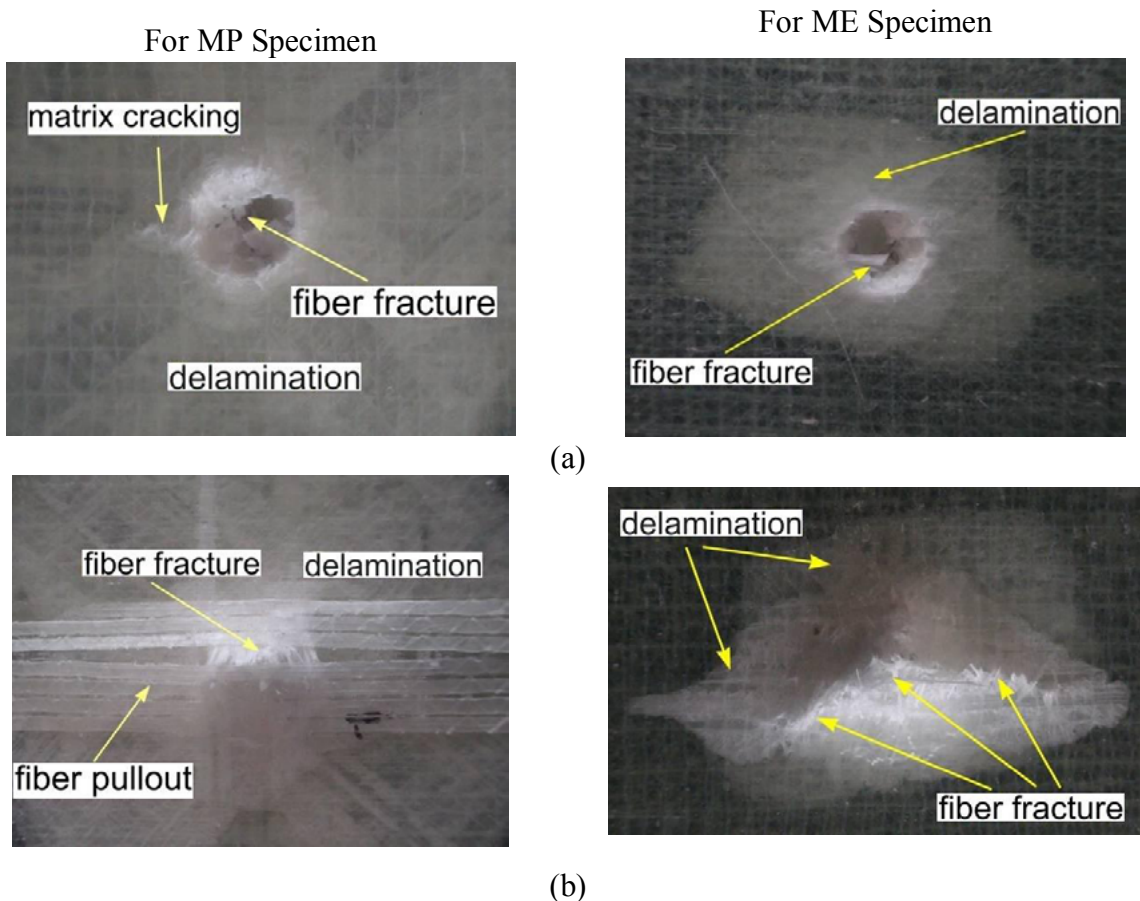
Figure 4: Damaged specimens of the MP and ME composites at penetration threshold a) impacted side and b) non-impacted side

The damage processes of impacted non-crimp fabric (NCF) composite specimens were evaluated for impacted side and non-impacted side by visual inspection, as seen in figures 4 and 5. As it can be seen from Figures 4 and 5, impact damage modes consist of matrix cracking, indentation, delaminations between adjacent layers, fiber breakages and fiber pullout. For 60J impact energy, damage modes are matrix cracking, fiber fracture and delamination. When some fibers of MP composite have fractured at impactor contact region, fibers of ME composite started to fracture in the through thickness. Shape of fiber accumulation is similar to a hill at the center of specimen, as seen figure 5(b) for MP specimen.

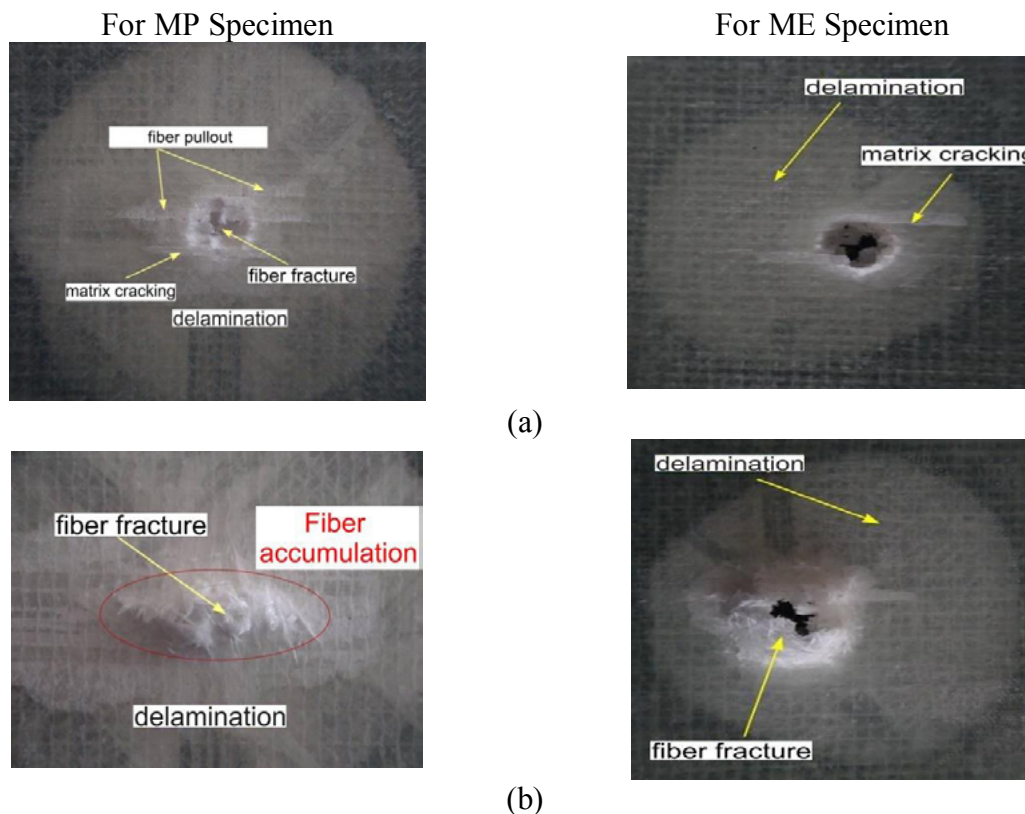
Figure 5: Damaged specimens of the MP and ME composites at penetration threshold a) impacted side and b) non-impacted side.
