Seismic Risk Analysis for Critical Infrastructure: The Case Study of a Medical Center and its Supporting Systems in Yangon, Myanmar

Abstract— Myanmar has a great strike-slip active fault called the “Sagaing Fault Zone” besides the Sumatra-Andaman Subduction Zone. Major cities (Yangon, Naypyitaw, Bago and Mandalay) are at risk along this fault. Recently, in 2012, Thabeikkyin earthquake with Magnitude of 6.8 caused collapse of many residential housings and ground failures near Mandalay. Therefore more attention should be paid for Yangon which has no large earthquakes since 1930 and is the largest not only in population but also in socio-economic activity. One of the most important concerns after an earthquake is to survive under any disastrous conditions. The medical care is requested not only for emergent injured people after an earthquake, but also for various types of patient and aged people from several weeks to longer periods. So medical center must be always functional before and after earthquake. For this purpose, medical buildings should be structurally resilient and also be functional for medical services by sustainable supply of electric power, water and any other delivery

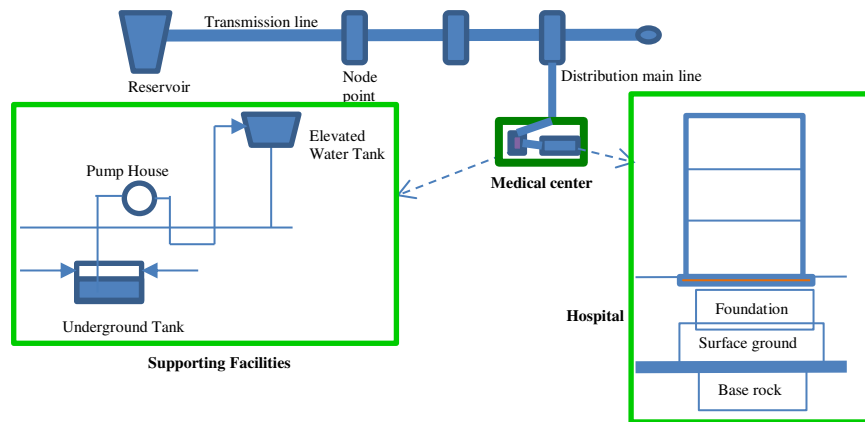
Figure 2. Schematic illustration of selected area of the study

This research is to investigate the structural vulnerability of hospital buildings and facilities, to assess the performance of urban lifeline systems and to check the operational capability of medical services. Schematic illustration of study area is shown in **Figure 2**.

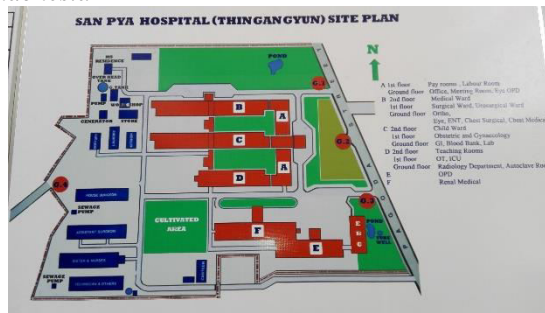
Figure 4. Site plan of Thingangyun (Sanpya) hospital

Thingangyun Township. Site plan of the hospital including water supply system is shown in **Figure 4**.

In main hospital building, A block is two-storeyed and B, C, D blocks are three-storeyed R.C building with brick walls (**Figure 4**). The 3D modeling of the building is shown in **Figure 6**. For assessment, the building is divided into four sections as described in **Table 2**.

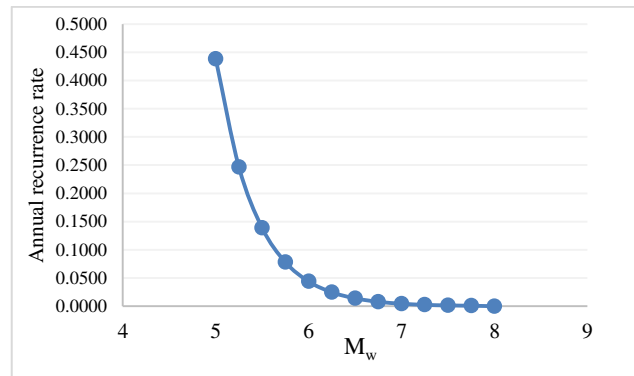
Figure 5. Illustrating the annual rate of exceedance of certain earthquake

The annual rate of exceedance curve as a function of corresponding moment magnitudes for Sagaing fault is presented in **Figure 5**.

Then, the probability of occurrence in any year for each earthquake level can be calculated by $T = \frac{1}{P}$. After that the associated magnitudes for three earthquake levels are estimated using **Figure 5**.

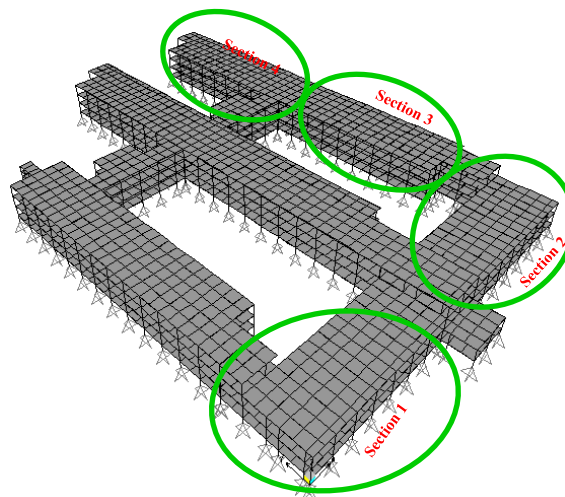
Figure 6. 3D View of Thingangyun Sanpya General Hospital

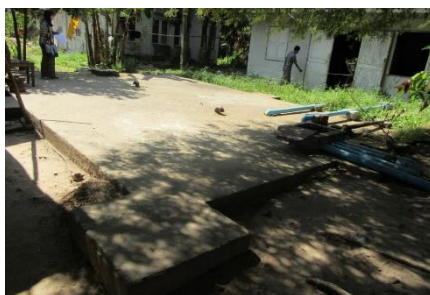
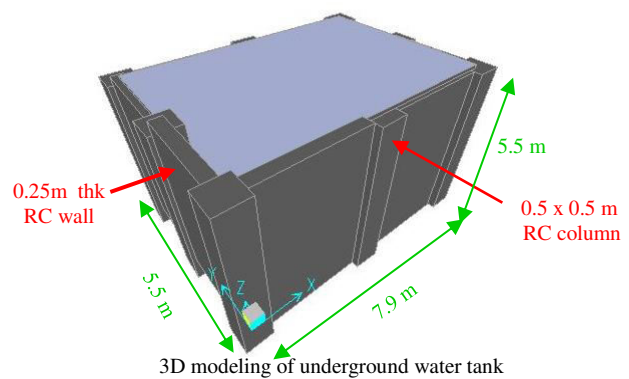
Existing structure

3D modeling of underground water tank

Figure 7. Modeling of underground water tank 1

The supporting buildings for water supply system include underground water tank, pump house, elevated water tank and ground tank. The configurations of these structures are different in terms of height, existing conditions, locations, function, and their seismic resiliency. Pump house, elevated water tank and ground tank are above-ground structures whereas underground tank is under-ground structure. All the supporting structures are assumed to be reinforced concrete structures. Modeling of these structures are shown in **Figure 7 to 11**.

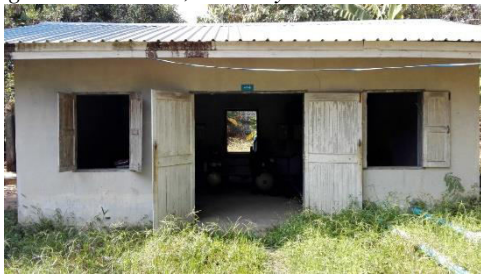
Existing structure

3D modeling of pump house

Figure 8. Modeling of pump house

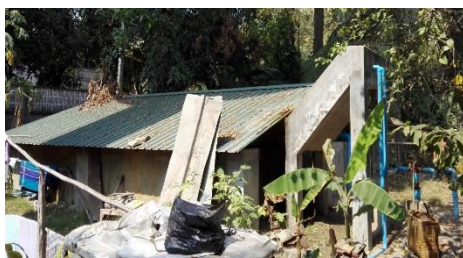
Existing structure

3D modeling of underground tank

Figure 10. Modeling of underground water tank 2

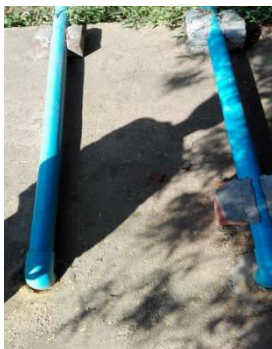
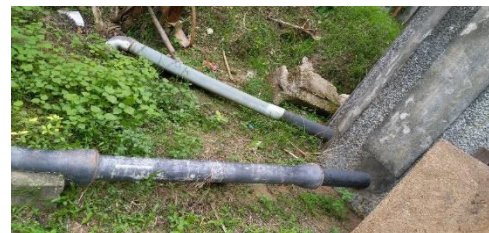
Figure 11. Existing Conditions of Some Pipe Segments and Pipe Joints

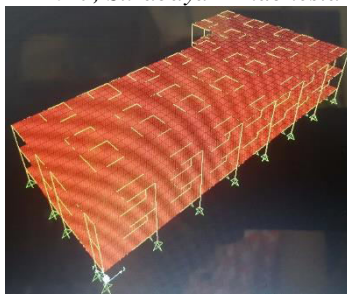
Figure 15. (a) Section 2 of main hospital building; (b) Fragility curves of section 2 for MOE, DBE and MCE levels

where, P_f is probability of failure; Z is demand – capacity; EQ is earthquakes; u_{cr}^{EQ} is critical displacement for a certain limit state; u_{max}^{EQ} is maximum displacement due to a certain earthquake; σ is standard deviation; μ is mean value and Φ is standard normal distribution. The fragility curves of hospital building and its supporting structures are shown in **Figure 14 to 21**.

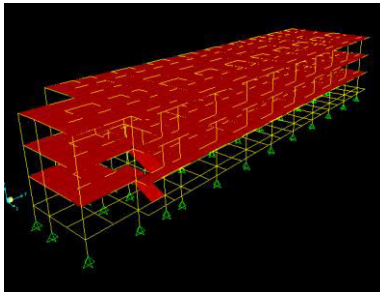
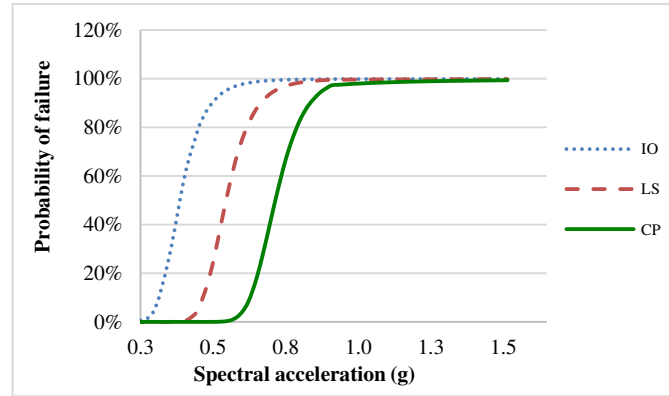
Figure 16. (a) Section 3 of main hospital building; (b) Fragility curves of section 3 for MOE, DBE and MCE levels

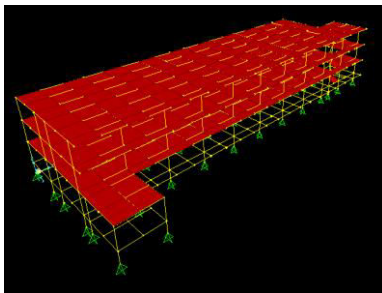
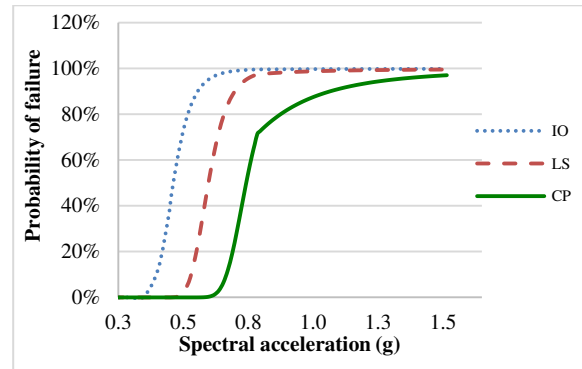
Figure 17. (a) Section 4 of main hospital building; (b) Fragility curves of section 4 for MOE, DBE and MCE levels

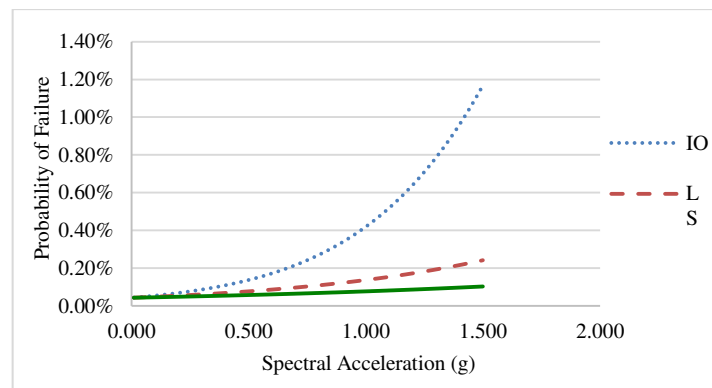
Figure 18. Fragility curves of underground water tank 1

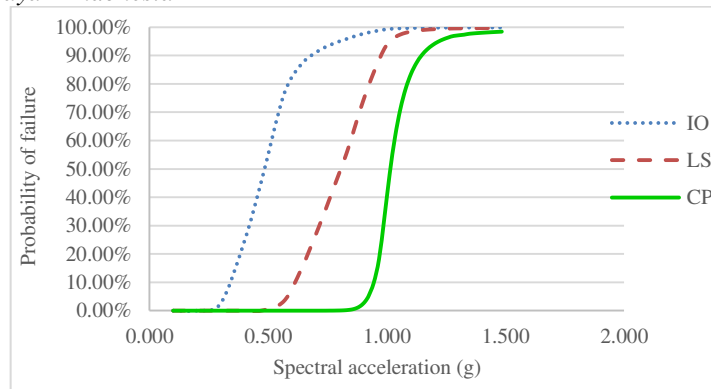
Figure 19. Fragility curves of pump house

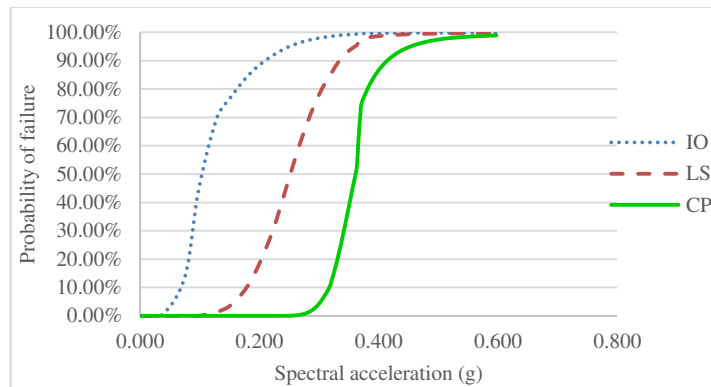
Figure 20. Fragility curves of elevated water tank

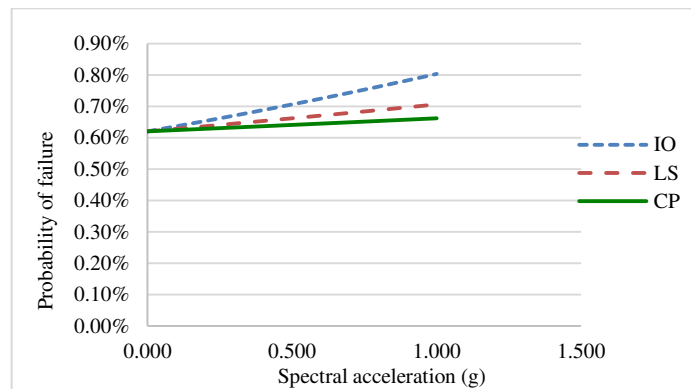
Figure 21. Fragility curves of underground water tank 2

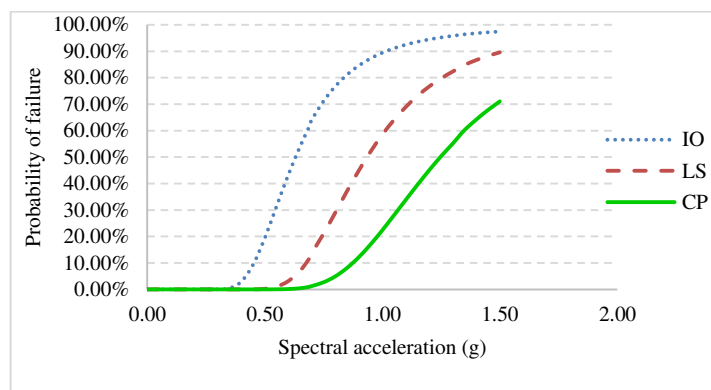
Figure 22. Fragility curves of pipe segment 1(PVC pipe) from internal water supply system

The developed fragility curves for water pipe lines are shown in **Figure 22** to **26**.

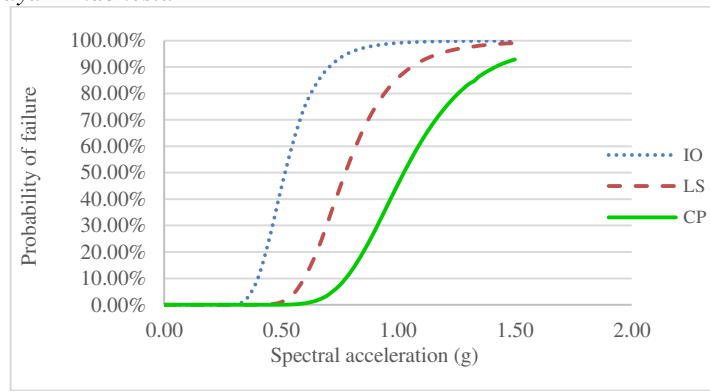
Figure 23. Fragility curves of pipe segment 3(CI pipe) from internal water supply system

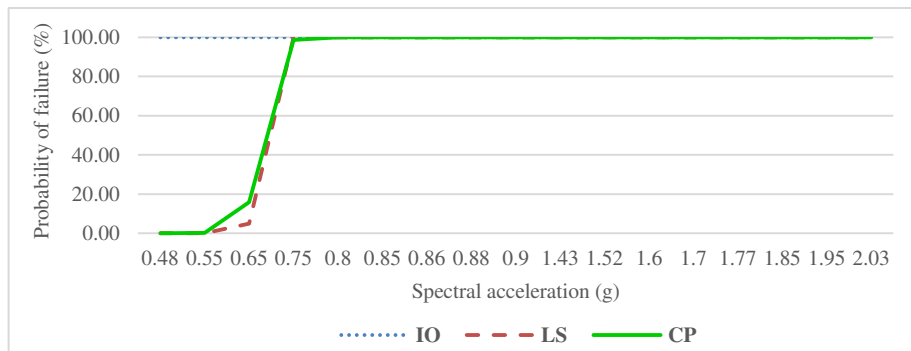
Figure 24. Fragility curves of 24" diameter PCP pipe at Thingangyun Township

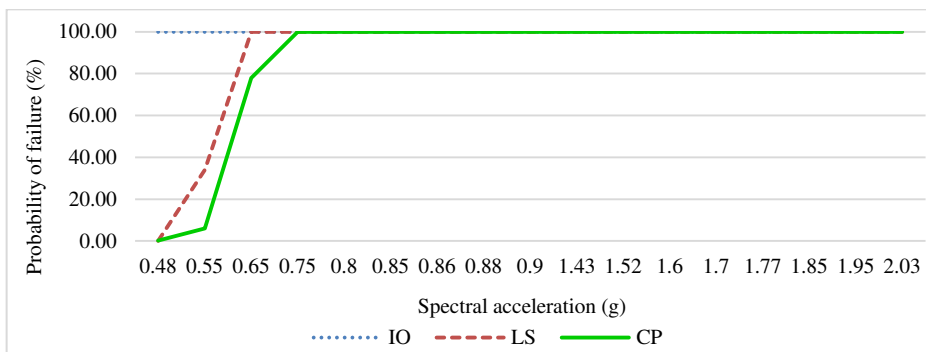
Figure 25. Fragility curves of 12" diameter CI pipe at Thingangyun Township

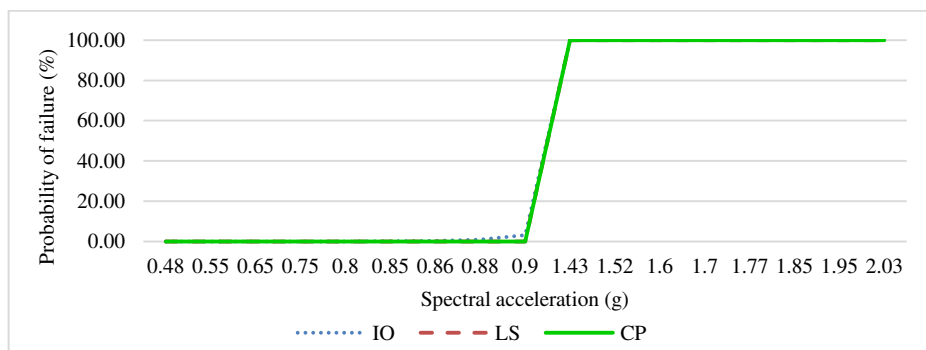
Figure 26. Fragility curves of 12" diameter HDPE pipe at Thingangyun Township
