Vibration-based health monitoring of lighting poles

P. Steinbauer^a, Z. Neusser^a, I. Bukovský^a

^a Faculty of Mechanical Engineering, Czech Technical University in Prague, Technická 4, 160 00, Praha 6, Czech Republic

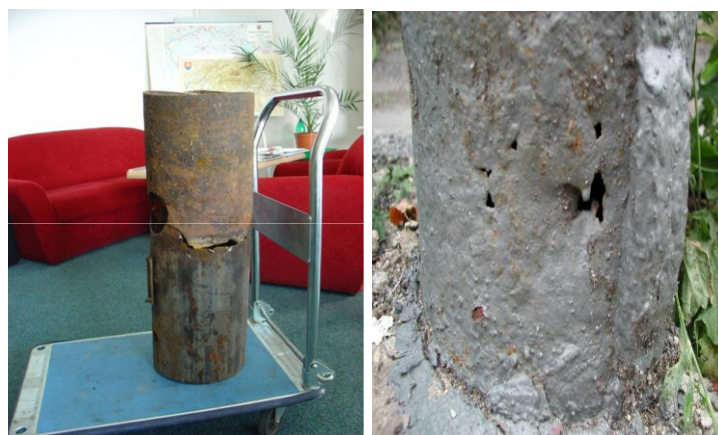
Fig. 1. Damaged lighting poles

The corrosive damage of the pole occurs usually at the pole base, often under the surface. The corrosion on the top of the pole is less frequent. In any case, the damage is not apparent and localizable (Fig. 1).

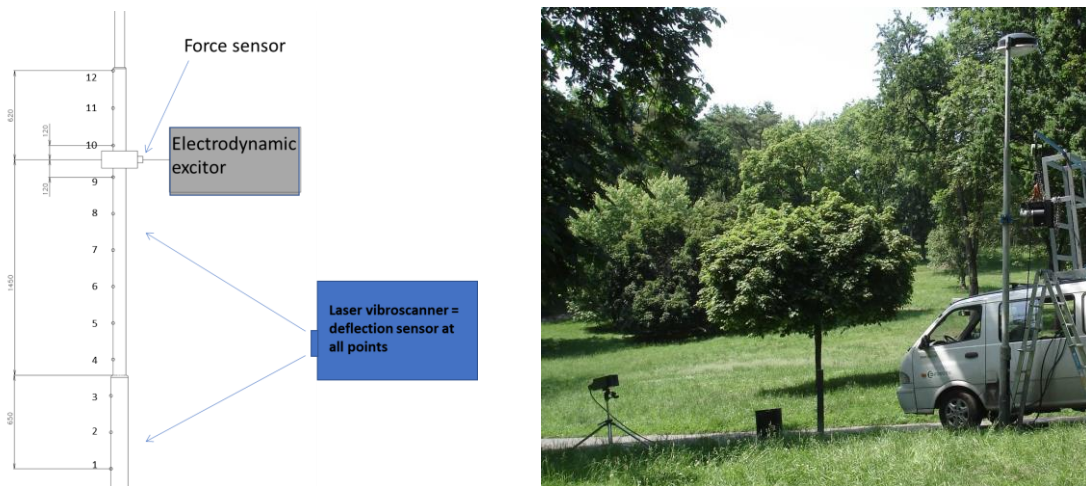
Fig. 2. Measurement setup for experimental modal analysis of lighting poles

The promising modelling results had to be verified experimentally. The two sets of existing, installed poles with same design, dimensions and arrangement, but quite different health, were selected. The complete experimental modal analyses were carried out for each pole in the investigated set. The first set was laboratory installation, fixed into the concrete bed, the second pole set consisted of regularly installed poles (same dimensions), i.e. in the sand bed. The excitation force was introduced by electromechanical shaker connected through load cell mounted on the pole in the height 3m. The pole response was measured by scanning laser vibrometer at several points on the pole (Fig. 2). The setup was same for all poles in the set.

The results in the form of frequency response functions (FRF) that were measured at the point 10 (see Fig. 2) are demonstrated in Fig. 4.
