Seismic behavior assessment of a Brazilian heritage construction

KEYWORDS. Seismic behavior; Heritage construction; Nossa Senhora das Dores Church; Numerical simulation; Sobral.

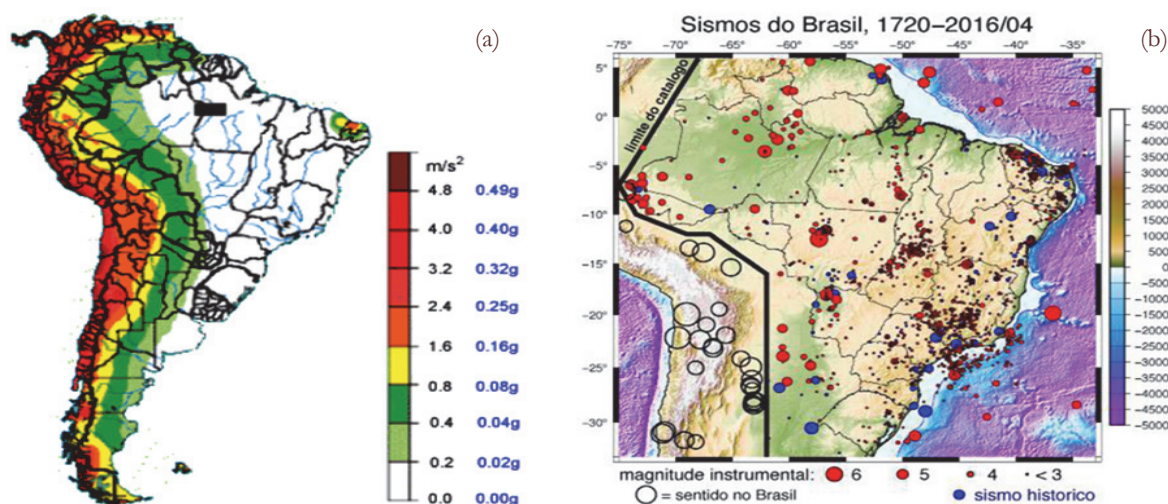
Figure 1: Brazilian seismicity: (a) map of the seismicity of South America [24] and (b) Brazilian Seismic Catalog [19].

A map of the South America seismic hazard, produced by United States Geological Survey (USGS), is shown in Fig. 1.(a): Peak Ground Accelerations (PGA) are reported both in m/s² and as a fraction of *g* (the acceleration due to gravity) with a 10% probability of being exceeded in 50 years [24]. This figure shows that there is a large part of Brazil where there is not seismic activity or it is practically null (white area), however, in the northeast region of the country is possible to observe a small area seismically active, more precisely, the area between the states of Ceará, Rio Grande do Norte and Paraíba, that have considerable values of PGA, ranging between 0.02 *g* and 0.25 *g*. Fig. 1.(b) shows the Brazilian seismic catalog which, according to [19] indicates all the earthquakes already cataloged in the country from 1720 to 2016. The map includes ancient and recent earthquakes, and only superficial earthquakes are shown (i.e. depth <50 km). The blue circles are epicentres of historical earthquakes with magnitude estimated from the macrosismic effects. The red circles are epicentres of earthquakes recorded by seismographic stations. The empty circles - in the Andes - are epicentres of earthquakes in which the seismic waves have caused the oscillation of tall buildings in some Brazilian cities. Fig. 1 confirms that the northern part of the Ceará State, where the city of Sobral is located, has been affected by an intense seismic activity.

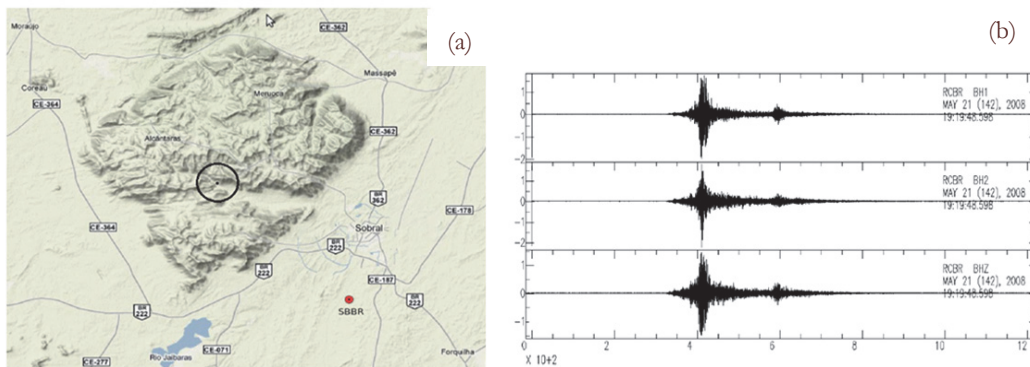
Figure 2: (a) geographical position of the earthquake of magnitude 4.2 m_b registered in 05/21/2008 (black circle) and (b) Seismogram of the event, where BH1 represents the component E-W, BH2 represents the component N-S and BHZ represents the vertical component (adapted from [25]).

mically active area, where in 1980 an earthquake of magnitude of 5.2 m_b was registered in the Pacajús city. The seismic activity in the northeast region of Ceará State, more precisely, in the Sobral region, is very old and it is the second most important in the Brazilian northeast, being preceded only by the region of the edge of the Bacia Potiguar, that includes a large part of the State of Rio Grande do Norte and the eastern part of the Ceará State. Since 2008 an intense seismic activity in the Sobral region has been observed, where several earthquakes have occurred and the big of these was occurred on 05/21/2008, of 4.2 m_b magnitude. The geographical position of the event and the seismogram recorded by the Riachuelo station (RCBR), located at Riachuelo-RN at approximately 572 km away from Sobral city, are shown in Fig. 2. These events have caused damage in some buildings.

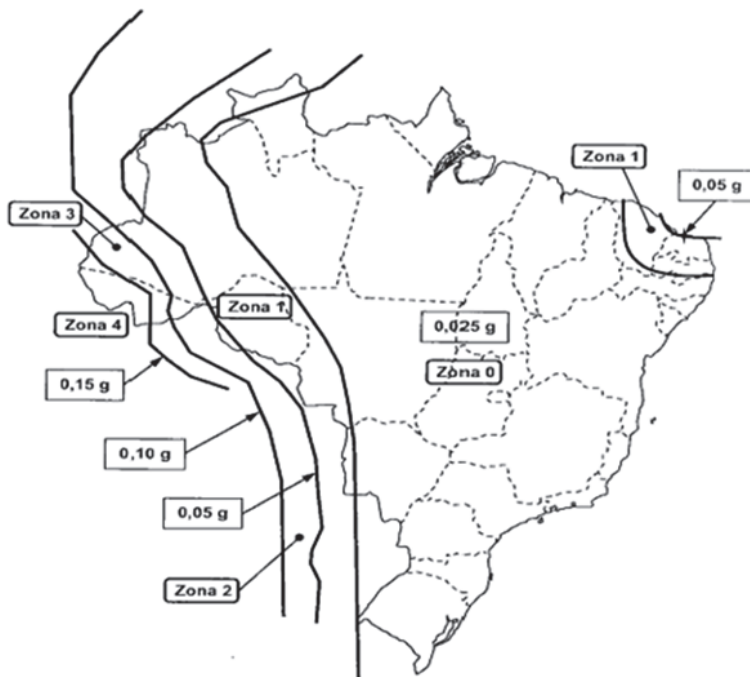
Figure 3: Seismic zones of Brazil [20].

fine the five Brazilian seismic zones presented in Fig. 3, with reference to the values of the ground accelerations for each zone as: Zone 0 – $a_g < 0.025 g$; Zone 1 – $0.025 g < a_g \leq 0.05 g$; Zone 2 – $0.05 g < a_g \leq 0.10 g$; Zone 3 – $0.10 g < a_g < 0.15 g$; and Zone 4 – $a_g > 0.15 g$.

Analyzing the seismic zones shown in Fig. 3, it is possible to observe that a large part of Brazil is covered by Zone 0, that causes a maximum ground acceleration of $0.025 g$, that is, the soil moves at a maximum speed of about 0.245 m/s^2 . However, in some North-Eastern states, such as Ceará, Rio Grande do Norte and Paraíba, most of their territories are located in Zone 1, that has the maximum ground acceleration of $0.05 g$ that corresponds to 0.490 m/s^2 .

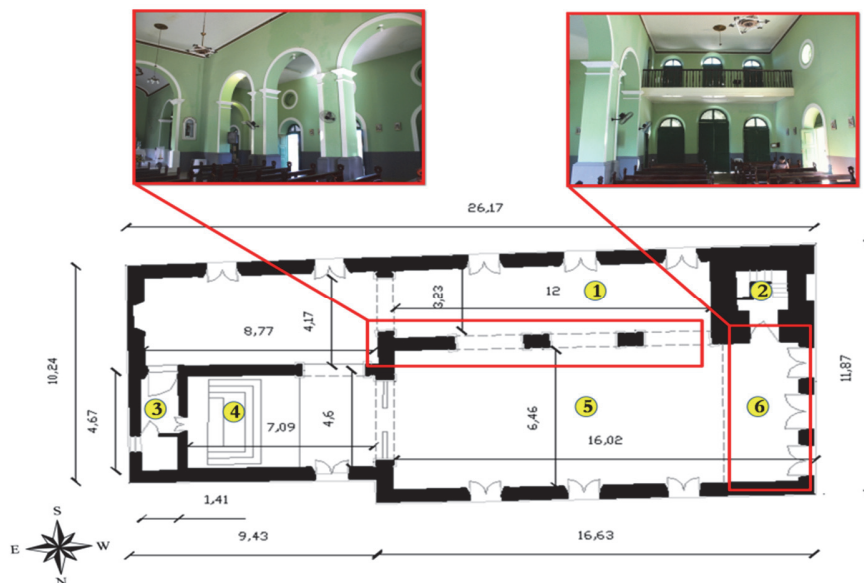
Figure 5: Schematic view of geometry of the Nossa Senhora das Dores Church, where (1) is the Lateral nave, (2) is the Lateral Tower, (3) is the office, (4) is the Altar-Mor, (5) is the Central Nave and (6) is the Coro-Alto.

The church dates back from the beginning of the 19th century and was built in a place where there was a small niche in the old Rio street, near the Acaraú River [27]. This church is very close to the Igreja da Sé of Sobral, and next to the urbanization of the near left of the Acaraú River. Its structure is composed of clay bricks masonry, and the church was built using local constructive techniques. The church's geometry, shown in Fig. 5, is almost regular with a length of about 26.2 m and a width of about 11.9 m; there is a lateral tower 20.50 m high. The structure is divided in a Central Nave (about 6.5 m × 16.0 m) and in a Lateral Nave (about 3.2 m × 12.0 m), separated by two columns and three arches. The Coro-Alto, the Altar-Mor and an office are located at the end of the building (Fig. 5).

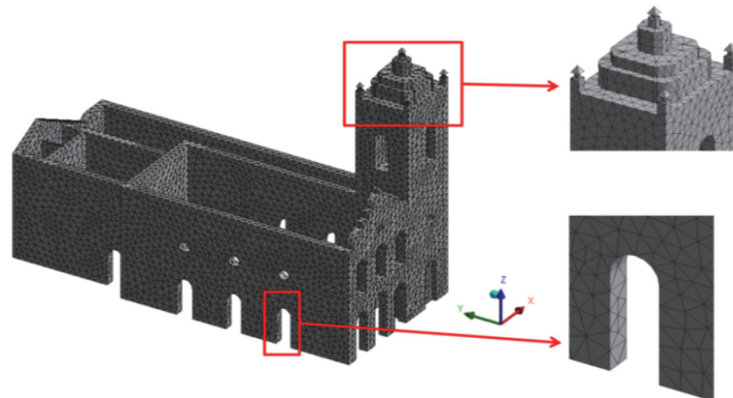
Figure 6: View of the 3D finite element numerical model of the Nossa Senhora das Dores Church.

Based on a geometric survey, provided by IPHAN-CE, and on the geometric characteristics observed by visual inspection, a 3D numerical model of the Nossa Senhora das Dores Church was built (Fig. 6). To build the 3D FE model some simplifications were done, aimed to reduce possible discontinuities in the finite element mesh. The architectural details of the main façade, the reinforced-concrete (RC) stair, the roofs and the Coro-Alto were not included in the model, but their respective loads and masses were applied on the corresponding walls.

The FE model was built with the commercial code ANSYS; SOLID187 tetrahedral elements with quadratic displacement behavior were employed (the finite element is defined by 10 nodes having three degrees of freedom at each node). A mesh-size of about 500 mm was adopted and the final FE model, shown in Fig. 6, was built with 53,889 elements and 93,380 nodes.

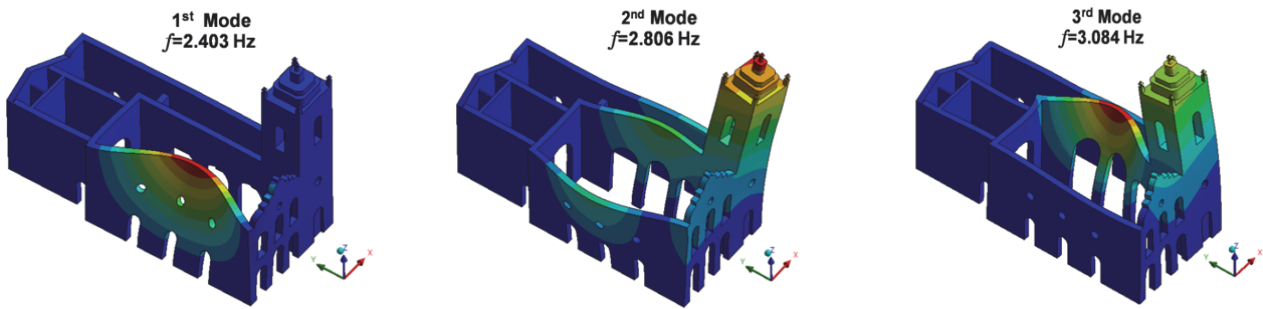
Figure 8: First three modal shapes of the Nossa Senhora das Dores Church.

The elastic parameters of the FE model were hence calibrated in order to fit the natural frequencies obtained by the EVT, assuming as starting values the ones estimated in accordance with the Italian recommendation [31]. The specific weight and the masses have been keeping constant, and the Young's Modulus has been iteratively updated (within the range from 1.50 GPa to 1.75 GPa) in order to fit the experimental values. The first three natural frequencies were assumed sufficient for the calibration. It is worth noting that, after calibrating the Young's Modulus in order to reproduce the first numerical natural frequency, a good adherence between experimental and numerical results was also obtained for the second and third frequency, denoting that the numerical model reproduces correctly stiffness and masses of the church. The final identified Young's Modulus was equal to 1.70 GPa. With this fitting, based only on the first frequency, the results and the errors associated with each frequency are shown in Tab. 3, while the first three numerical modal shapes are shown in Fig. 8.

Analyzing the numerical modal shapes of the church (Fig. 8), it is possible to observe that the first mode shape involves the translation in the weakest transversal direction (X direction) of the wall of the North lateral façade, with significant out-of-plane deformation (out-of-plane mode of the longitudinal wall). The second and third modal shapes are still local modes, involving out-of-plane deformation of the façade, of the lateral walls and the central arches and the lateral tower. The distribution of the mode shapes demonstrates that the church displays low transversal and torsional stiffness, with significant out-of-plane deformations of the elements. This demonstrates that the dynamic response of the Church is strongly affected by the local behavior of elementary macro-elements. It is possible to observe that the participating masses of each mode of vibration are affected by high dispersion: the distribution of the first 100 vibration modes (in the longitudinal and transversal direction) is reported in Figure 9.(a).

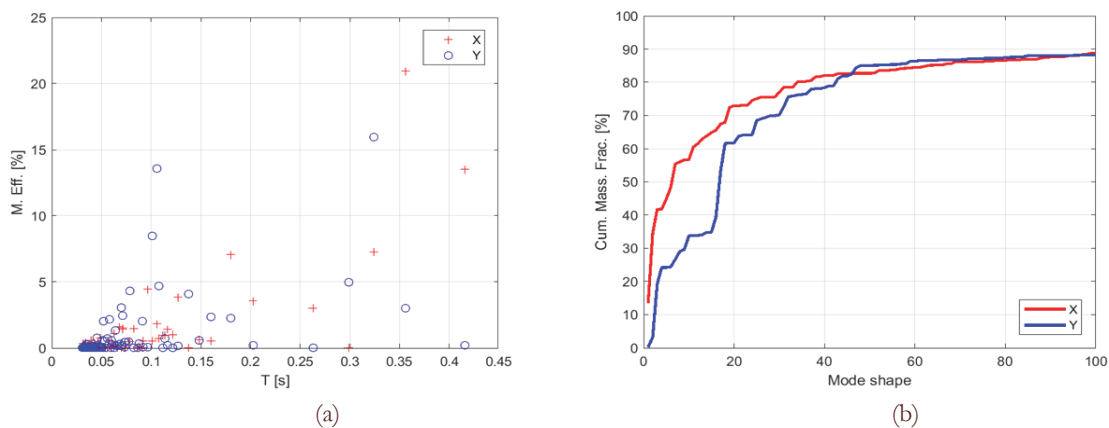
Figure 9: (a) Modal participating mass ratios vs. main periods and (b) cumulative modal mass ratio (CMF).

The modal participating mass ratios (ME) is plotted as a function of the corresponding period (T), and it is possible to observe that almost all vibration modes have modal participating mass ratio less than 10-15%. As the participating mass ratio

of each vibration mode is small, it is necessary to take into account about the first 100 modes to describe the dynamic behavior of the Church: the cumulative modal mass ratio is reported in Figure 9.(b).

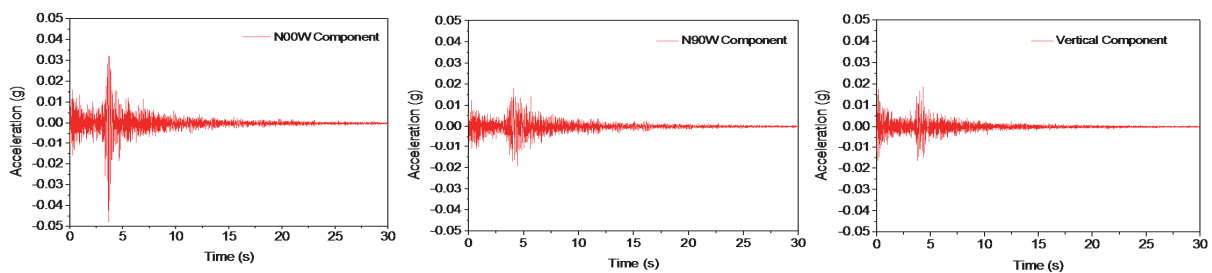
Figure 11: Accelerograms of the Earthquake 1- *San Juan de los Llanos*.

To analyze the seismic behavior of the church, linear time-history analyses of the structure were performed. Due to the absence of natural records of Brazilian earthquakes, records of real earthquakes occurred in other countries were used. The church was subjected to two earthquakes of different magnitudes with time-length of 30 s each one. As Earthquake 1, obtained by [49], the three components of the accelerogram of the *San Juan de los Llanos* earthquake (Fig. 11) occurred on 06/15/2014, 36 km from Ometepec, Guerrero, Mexico, of magnitude 4.1 with peak ground acceleration of 0.048 g on the component N00W was used. This earthquake was selected because its peak ground acceleration is very close to the value of the soil acceleration of the Sobral city which, according to the seismic zoning of [20], is located in Zone 1 with a maximum acceleration of 0.05 g. In addition, the magnitude of this earthquake is consistent with the seismic hazard of Sobral city, because the biggest earthquake recorded in this region had a magnitude of 4.2 m_b.

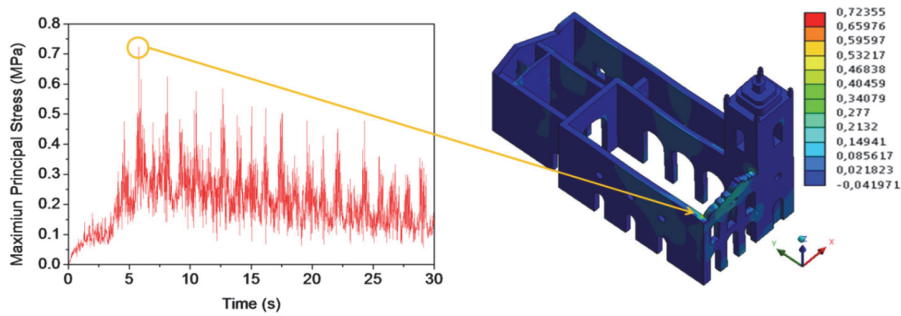
Figure 16: Peak of the maximum principal stress during Earthquake 1. Unit in MPa.

A peak of tensile stress (Fig. 16) equal to 0.72 MPa at $t=5.78$ s was observed in correspondence of the connection between the wall of the north lateral façade with the wall of the west main façade. The peak of tensile stress is due to the motion of the upper part of the wall of the west main façade out of the XZ plane. This value is higher than the assumed tensile strength, and it highlights a vulnerability of the pediment of the church (its overturning).

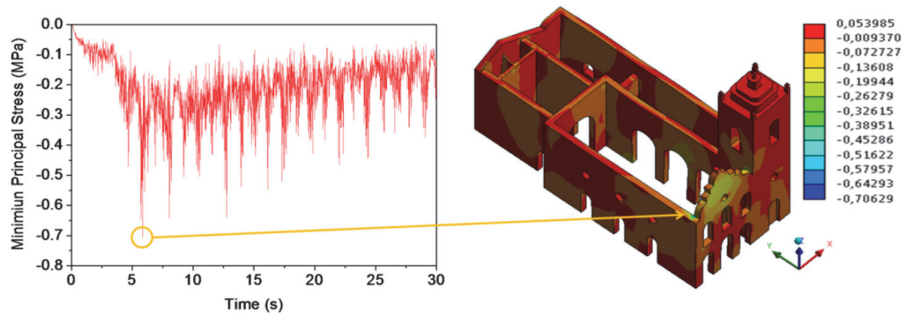
Figure 17: Peak of minimum principal stress during Earthquake 1. Unit in MPa.

Concerning the minimum principal stress, a peak of compression (Fig. 17) was also observed. In this case, this peak was evidenced at $t=5.92$ s and had a value of 0.71 MPa. A similar value was also found in the connection between the wall of the north lateral façade with the wall of the west main façade. This value is lower than the assumed compression strength (3.20 MPa), but is interesting since it confirms a vulnerability of the church: the overturning of the main façade during the Earthquake 1.

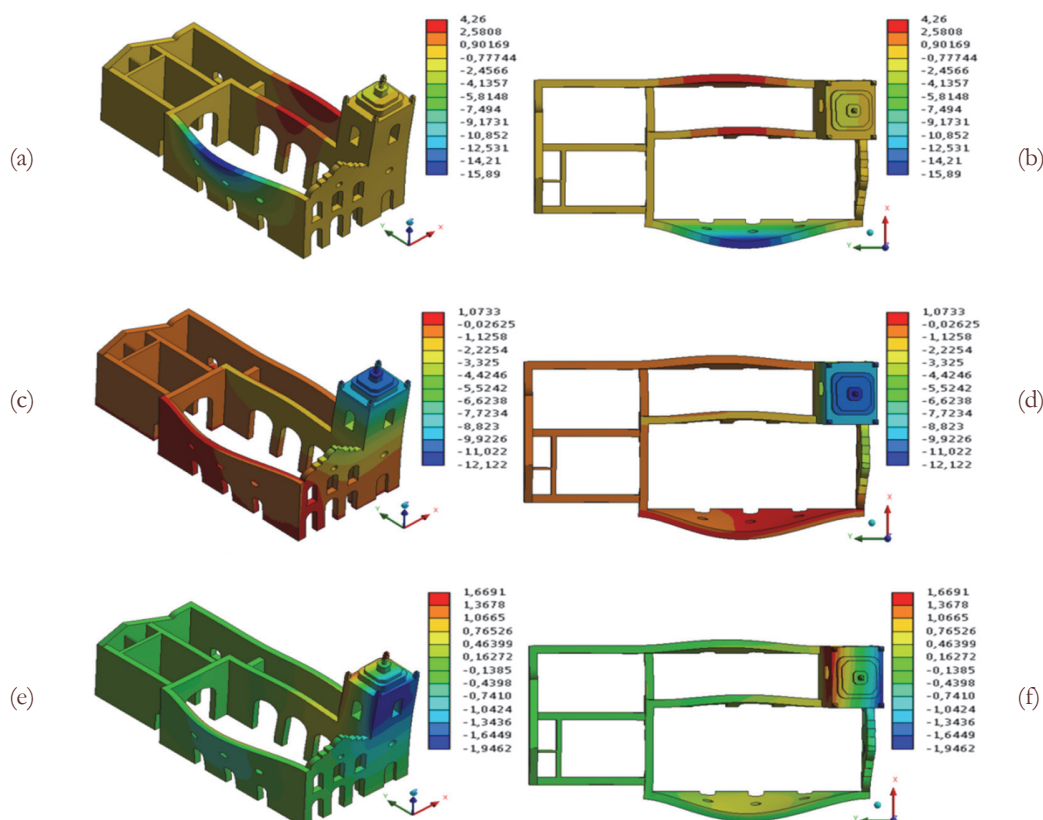
Figure 18: Directional displacements after Earthquake 2: (a) and (b) direction X; (c) and (d) direction Y; (e) and (f) direction Z. Unit in mm.

The displacements obtained using the Earthquake 2 are shown in Fig. 18; the maximum displacements in the X direction, Figs. 18.(a) and 18.(b), are about 4.30 mm and are located at the top of the central region of the wall of the south lateral façade (and also in correspondence of the wall of the central arches that separates the two naves). The biggest displacement, however, occurs in the wall of the north lateral façade along the negative X direction and has a value of about 15.90 mm. The displacements in the Y direction are shown in Fig. 18.(c) and 18.(d). It can be observed that the biggest value along the positive Y direction (the longitudinal one) is equal to 1.10 mm and is recorded on the wall of the north lateral façade and on the wall of the west main façade. The biggest displacement occurs in the negative Y direction, is located at the top of the lateral tower and corresponding to about 12.10 mm. In the region of the central arcs, displacements of approximately 2.2 mm in negative Y direction are also evidenced.

With respect to the vertical displacements, represented in Fig. 18.(e) and 18.(f), the back side of the lateral tower near the top, presents displacements of about 1.70 mm in the positive Z direction. The front side of the lateral tower also presents displacement of 1.95 mm, in module, along the negative Z direction. In addition, the wall of the region of the central arches connected to the side tower exhibits displacement of approximately 1.10 mm in the positive Z direction. As a general comment, analyzing the displacements exhibited by the church during the earthquake, it is possible to observe the absence of a box-behavior: the church behaves as a combination of independent macro-elements with first and second mode potential failures.

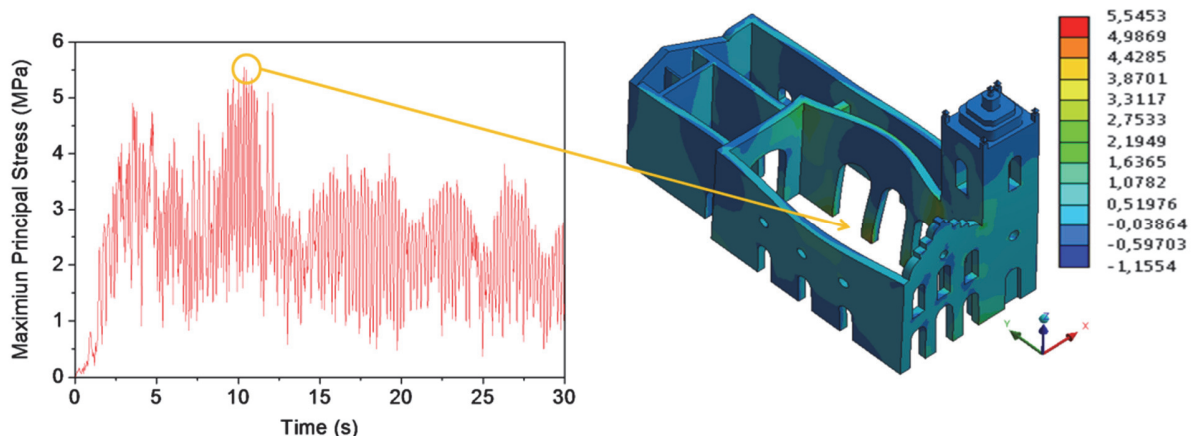
Figure 20: Peak of maximum principal stress during the Earthquake 2. Unit in MPa.

During the Earthquake 2, a maximum principal stress peak was observed as reported in Fig. 20. The peak is a tensile stress of about 5.54 MPa at $t=10.34$ s and is obtained at the base section of a column of the central wall of the structure. The high value denotes a potential collapse of the column due to overturning. Other critical zones can be identified, namely: i) the region of connection of the wall of the central arches with the wall of the triumphal arch in front of the altar (which is subjected to a tensile stress of about 2.19 MPa); ii) the region of connection of the wall of central arches with the lateral tower, just above the first arch (with a peak of tensile stress of about 3.30 MPa); iii) the region of connection of the wall of the west main façade with the lateral tower (with a tensile stress of about 1.64 MPa); iv) the upper region of the central arches and the inferior region of the smaller arc, located at the end of the smaller nave (about 2.19 MPa and 3.30 MPa, respectively). In all these regions cracks and/or local collapses are potentially expected during the seismic loading.

Both the maximum principal stress peak (5.54 MPa at $t=10.34$ s) and the minimum principal stress peak (5.67 MPa at $t=10.66$ s) over the structure were not close to the peak ground acceleration of the Earthquake 2 accelerograms (the S00E component was 0.348 g at $t=2.12$ s, the Vertical component was 0.21 g at $t=0.98$ s; however the S90W component was 0.214 g at $t=11.44$ s).

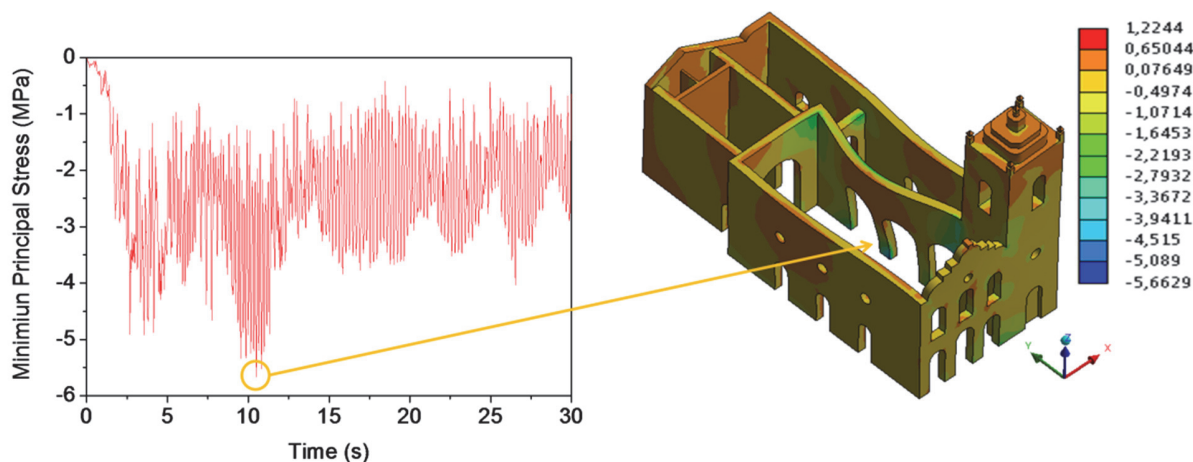
Figure 21: Peak of minimum principal stress during the Earthquake 2. Unit in MPa.

The time-history of the minimum principal stress is reported in Fig. 21. It is possible to observe a peak of stress of about 5.66 MPa at $t = 10.66$ s at the base of the column of the central arch. This region is the same that presented a peak of traction (see Fig. 20), and this result is a confirmation of the potential overturning of this central wall during the earthquake. Other regions present high compressive stresses, namely: i) the upper part of the first arc in contact with the lateral tower (a compression of about 3.94 MPa is recorded); ii) the region of connection between the upper part of the wall of the central arches with the wall of the arch in front of the altar and iii) the internal wall of the south lateral façade in

contact with the smaller arch located at the end of the smaller nave (for all these regions, the compressive stresses are about 3.37 MPa). The analysis of the stresses confirms the tendency of the church, over the whole time-history, to behave as a combination of macro-elements that are activated after the potential collapse of the connection between the walls.

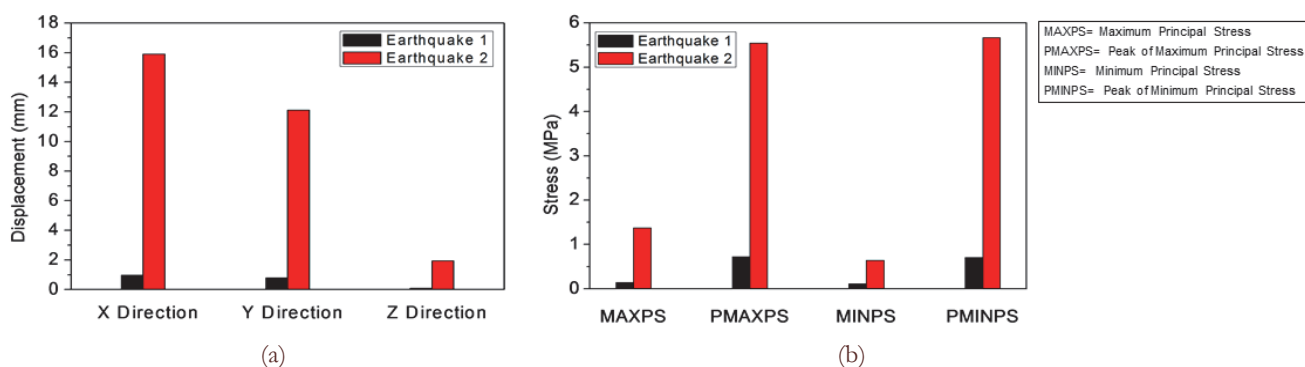
Figure 22: Comparison between (a) the directional displacements and (b) the principal stresses obtained in the seismic analyzes.

During the application of Earthquake 1 and Earthquake 2 to the Nossa Senhora das Dores Church, directional displacements in the X, Y and Z directions and principal stresses are obtained, as well as the peaks of stress during the 30 s of seismic loading. Because the two earthquakes have different magnitude, different frequency content, different peak ground acceleration and because the peaks are also different between the three components of each earthquake, the results obtained in the two analyzes show significant differences. In Fig. 22.(a) the maximum value of the directional displacements obtained in the two analyzes is reported while Fig. 22.(b) reports and compares the maximum and minimum principal stresses obtained during the two time-histories. The Earthquake 2, as expected, was the one that caused greater displacements and higher stresses. It can be interesting, anyway, to observe that in both cases the biggest displacements over the time-histories are obtained in the X direction (the transversal one), thus confirming the potential overturning of the main nave of the church.
