**USING INCLINED PLANE TEST TO COMPARE
TRACKING ON SILICON RUBBER UNDER HVAC
AND HVDC**

**IN FULFILMENT OF MASTER OF SCIENCE DEGREE IN
ELECTRICAL ENGINEERING
COLLEGE OF AGRICULTURE, ENGINEERING AND SCIENCE
UNIVERSITY OF KWAZULU-NATAL**

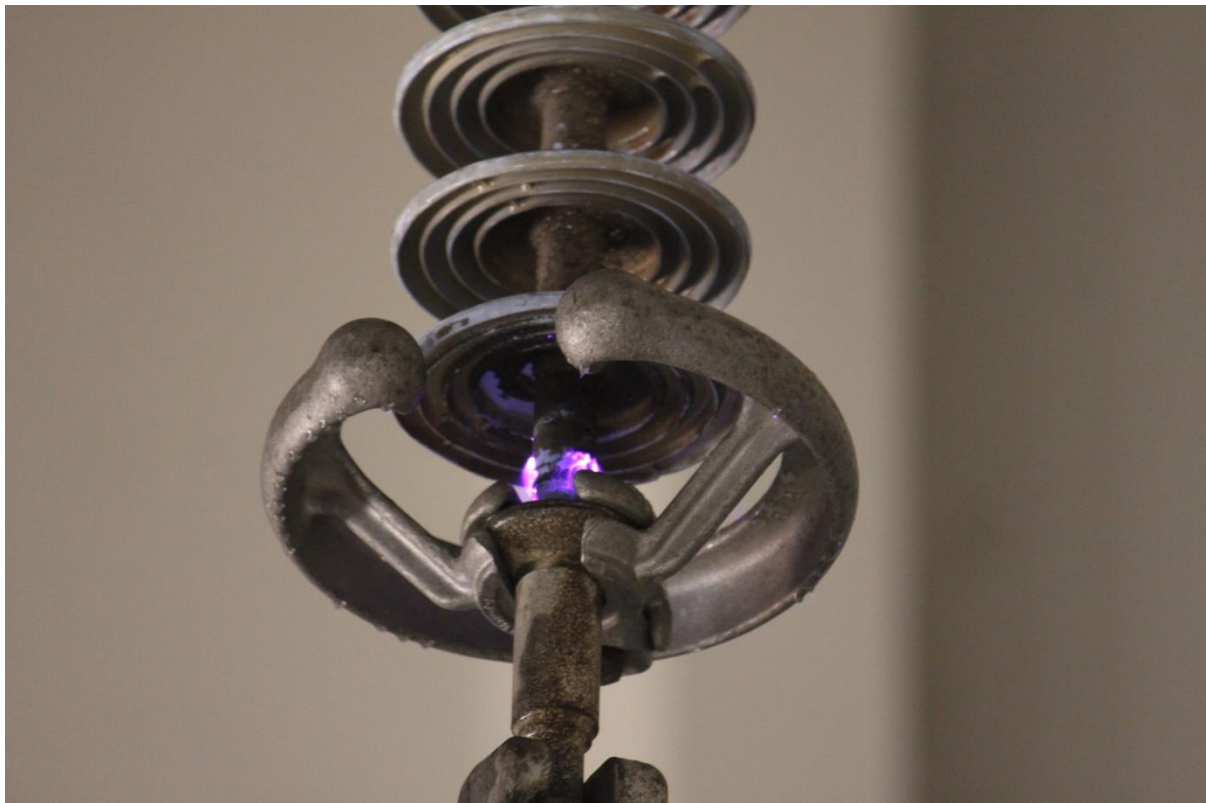
Figure 2-1: Composite insulator, HV Lab (HC) UKZN

A typical composite insulator consists of a central rod made of fibre reinforced plastic (FRP) and an outer weather-shed made of silicone rubber or EPDM. It has a fibre rod structure covered with weather resistant rubbers, fillers and fitted with end fittings. These fibres reinforced plastics are mechanically very strong but are not able to bear the outdoor environmental effects. The presence of dirt and moisture in combination with electrical stress causes the material to degrade by tracking and erosion. So, the rod is covered by a coating that protects it from outside stresses such as rain, salt, fog and pollution. This coating is referred to as housing. A composite insulator can be easily transported and assembled because of its low weight. It allows construction of lighter towers [6]. The early types of housing material had an epoxy bonded glass fibre core covered with a thin room temperature vulcanized (RTV) silicon rubber housing. The early housing material was replaced with ATH- filled high temperature vulcanized (HTV) silicon rubber because of changing production technology [7]. Composite insulators have a wide range of applications in overhead transmission lines. Figure 2-1 shows a polluted and wet silicon rubber insulator under high voltage conditions. It can be seen that there is discharge activity on the surface of the insulator near the end fitting.

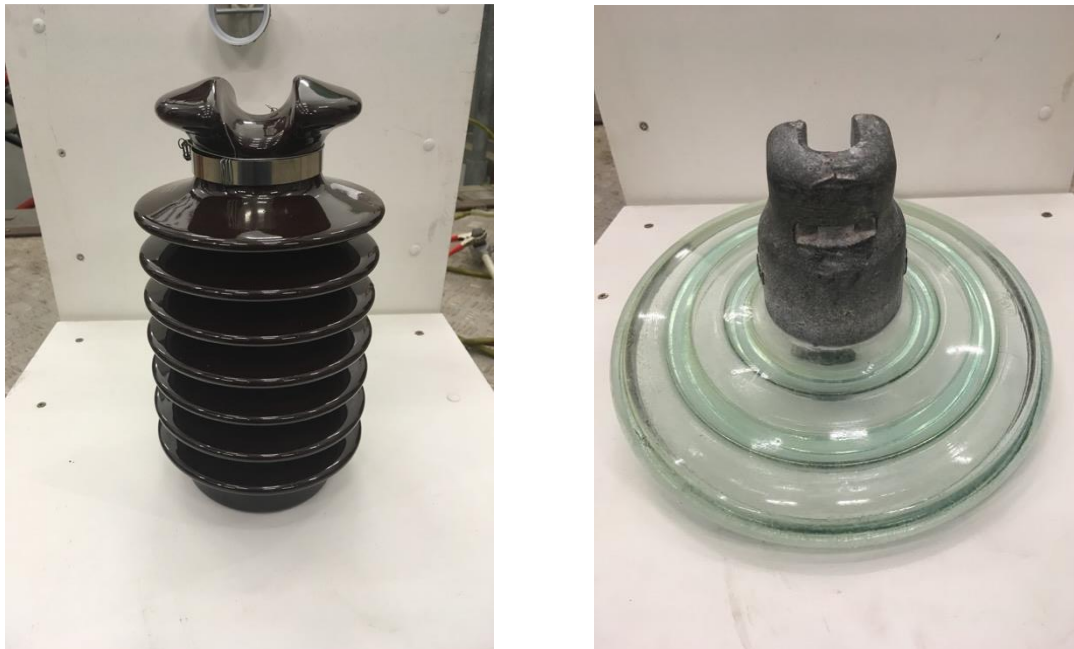
Figure 2-3: Ceramic (left) and Glass Cap and Pin (right) insulators, HV Lab (HC) UKZN

Ceramic insulators are usually composed of inorganic materials such as clay, glass and porcelain. Ceramic insulators have properties such as mechanical strength, poor heat and electrical conductivity. In areas such as industrial or coastal, ceramics are ideal insulators. Porcelain insulators are made up of plastic kaolin, fespap and quartz. The tensile strength is about 70 000 kg/cm² and 500 kg/cm² and the dielectric strength is about 60 kV/cm of its thickness. Glass insulator material are also used over porcelain because of low co-efficient thermal expansion and because it is easy to detect cracks or impurities as it is transparent. It has a high dielectric strength of about 140 kV/cm of its thickness and a high resistivity [12]. Whereas in polluted areas these ceramic performances are poor because pollutants can easily form conductive layers which causes great leakage currents. Figure 2-3 shows a picture of a ceramic insulator and a glass insulator.

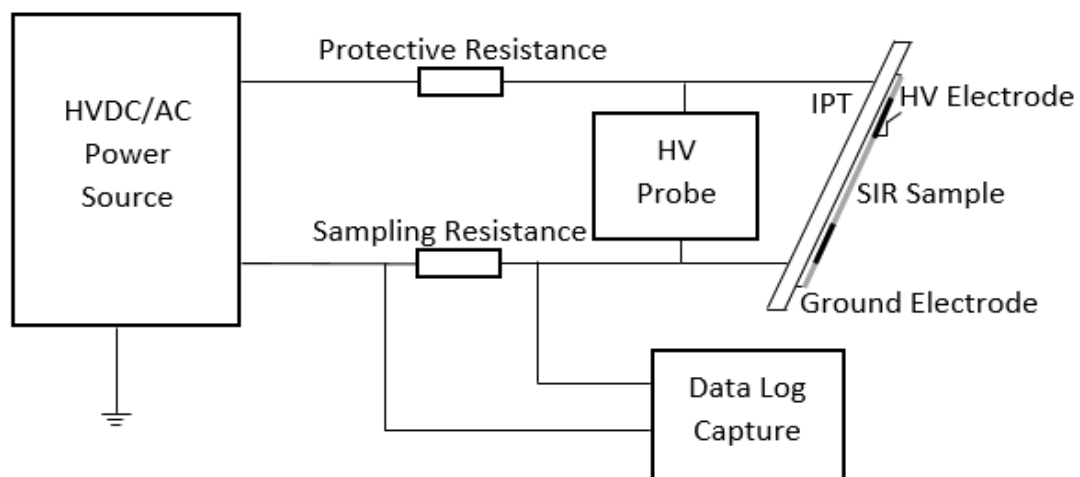
Figure 2-4: Layout of IPT Test [14]

The inclined plane test method, outlined in the IEC 60587 [1] standard, is used to evaluate the resistance of polymeric housing insulators to tracking and erosion under AC voltage. The inclined plane test schematic is shown in figure 2-4 with a sample having a dimension of 118 x 50 x 6 mm. The sample is suspended at an angle of 45°. This was done to allow ammonium chloride liquid contaminant to flow from the filter paper compartment on the high voltage electrode down to the lower ground electrode. A gap of 50 mm should be measured between the electrodes. The applied voltages have corresponding rates of contaminant flow. The flow rate must maintain a continuous spark of light on the surface of the sample. This helps to suppress interchange cycles of wetting and sparks on hydrophobic surfaces. Tracking of a material usually starts at the lower ground electrode due to the continuous sparks and progresses towards the high voltage electrode. Erosion usually follows on a defined area on the sample surface. The leakage current will flow on the contaminant path, causing discharges and with time, after 6 hours, failure of the material may happen due to tracking and erosion [1].

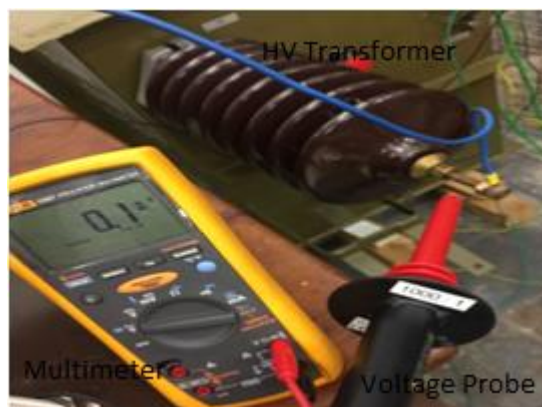
Figure 3-7: Voltage Probe 1:1000

The applied voltage was measured using a 1:1000 AC/DC high voltage probe connected to a True RMS multimeter (Digital Multimeter - Fluke 117 - True RMS multimeter).

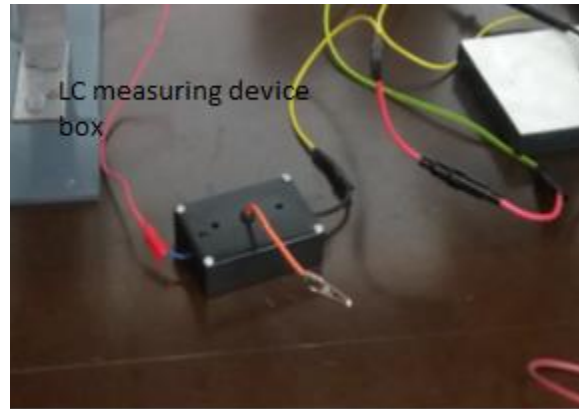
Figure 3-9: Leakage current measuring device

The Pico-log CM3 is normally used with a current clamp to measure an AC waveform and not normally used to measure intermittent AC and DC signals. It takes a number of samples from the input signal and converts this to an AC root mean square value, this is not the true root mean square value as it does not contain the DC component of the signal. Note: The sampling rate (e.g. 100 ms) refers to the rate of the rms value of the signal transmitted to the PC.

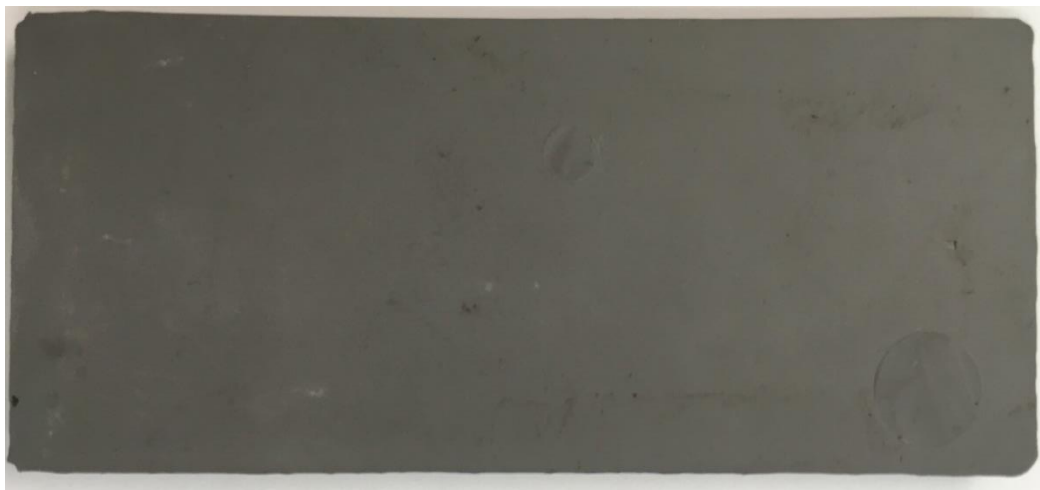
Figure 3-10: HTV Silicone Rubber Sample HV Lab (HC) UKZN

High temperature vulcanized (HTV) silicon rubber test samples were used for the experiments. The approximate dimensions of a samples were 118 x 50 x 6 mm and weighed approximately 56.00 g. The weight for the samples were measured using an accurate weighing balance (Mettler Toledo). Three SIR samples were selected for the test of each voltage type. In total 9 samples were tested for the AC and DC tests, a number of these samples were used in setting up the tests and were not included in the analysis.

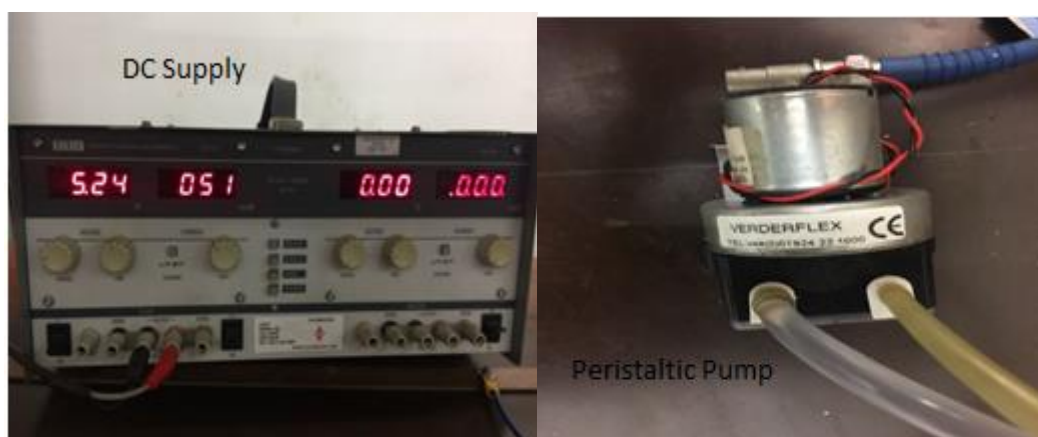
Figure 3-11: DC supply for Peristaltic Motor Pump

An electric peristaltic pump was used for the contaminant supply in the IPT setup in order to achieve desired controllable flow rates. Figure 3-10 show the peristaltic pump system. The motor pump was rated at 5000 RPM; 24 V. A DC supply of 5.24 V was used to provide the required contaminant flow rate of up to 0.6 ml/min. The peristaltic pump accommodated testing of one sample.
