# Dependence of damage to the running surface of the railway rail on the vibroacoustic signal of a passing passenger train

**Abstract.** The article presents an extended summary regarding the impact of rail damage on vibration waveforms and vibroacoustic spectrum images of vibrations. The analyzed example is based on the passage of the train depot – passenger train on a selected railway line. A short summary of the analyzed research problem is also presented.

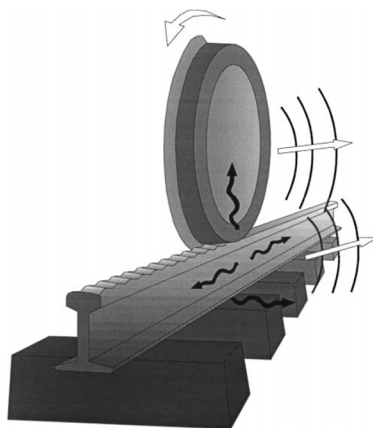
**Fig. 1.** Schematic diagram of how rolling noise is generated by the wheel/rail interaction and radiated by the wheel, the rail and the sleepers [9]

There are two basic types of structural vibration: steady-state vibration caused by continually running machines such as engines, and transient vibration caused by a short-duration disturbance such as train passing over an expansion joint in a rail. The major source of railway rolling vibration is the structural vibration of the wheel and rail which is generated by the combination of small-scale undulations on the wheel and rail contact surfaces.

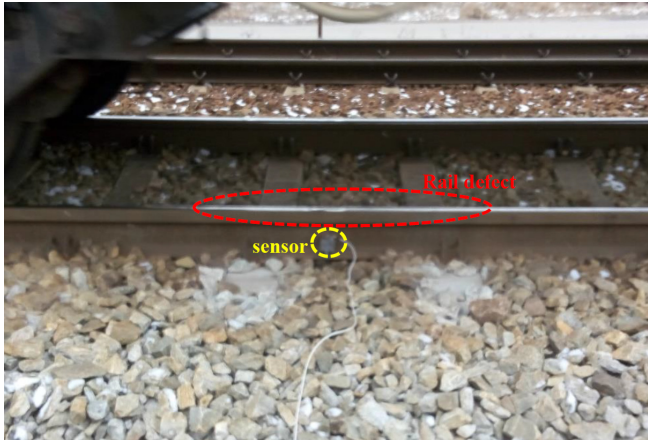
Fig. 2. Area of Rail damage – damage to the running surface and sensor assembly

In the case of this research phenomenon, two measuring points were analyzed and located in Silesia region. Weather conditions prevailing on a given day were  $-5$  degrees Celsius. Sampling with a single-axis sensor mounted was 42000 Hz. A characteristic feature of the selected measurement points was the finding of damage on the rail as shown in the below photograph (Fig. 2), differences in the waveform and vibration spectra in comparison to a healthy rail section – in this case the second sensor was located 5.4 m from the damage.

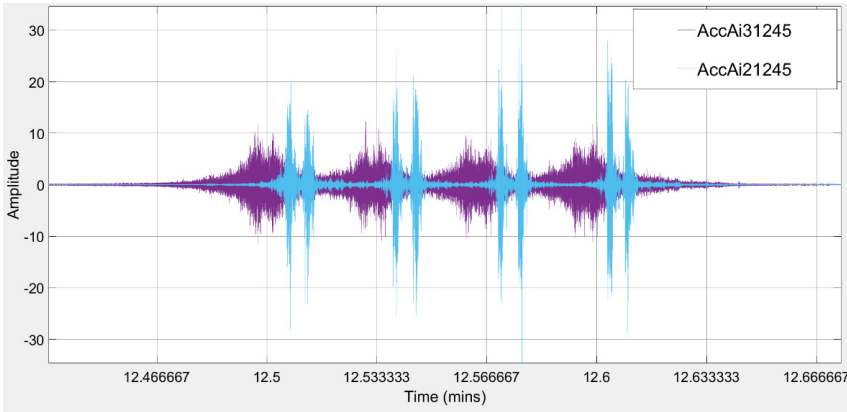
**Fig. 3.** Vibration waveforms – blue color sensor Ai3, violet color sensor Ai2

Fig. 3. A comparison of two waveforms for the sensor Ai2 (blue color) and Ai3 (purple color) is presented. Differences in amplitude for the two signals can be seen. In contrast, Fig. 4 and Fig. 5 show FFT Spectrum Estimate and for the signal from the sensor Ai2 a gain for frequencies from 50 Hz can be observed, decreasing until reaching 500 Hz. In the case of the signal from the Ai3 sensor the situation is different, and the amplification of the signal takes place around the frequency of 4000 Hz.

The results, despite the slight damage to the rail, indicate a large difference in signal waveforms as well as in the image of the signal spectrum. It notices the amplification of the signal from the Ai3 sensor located near damaged place where the frequency oscillated around 4000 Hz, while the spectral analysis of the signal for the Ai2 sensor located 5.4 m away to the damage indicates oscillating values in the range from 50 to 500 Hz.

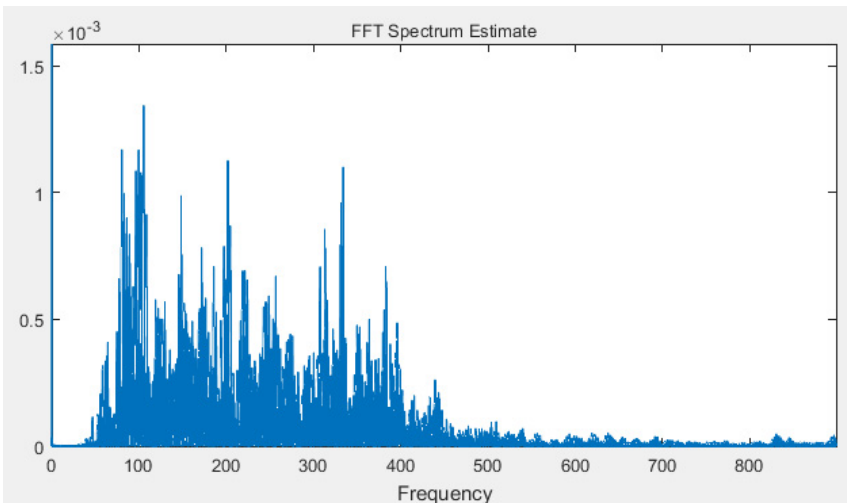
**Fig. 4.** Spectral analysis of signals – signal from sensor Ai2

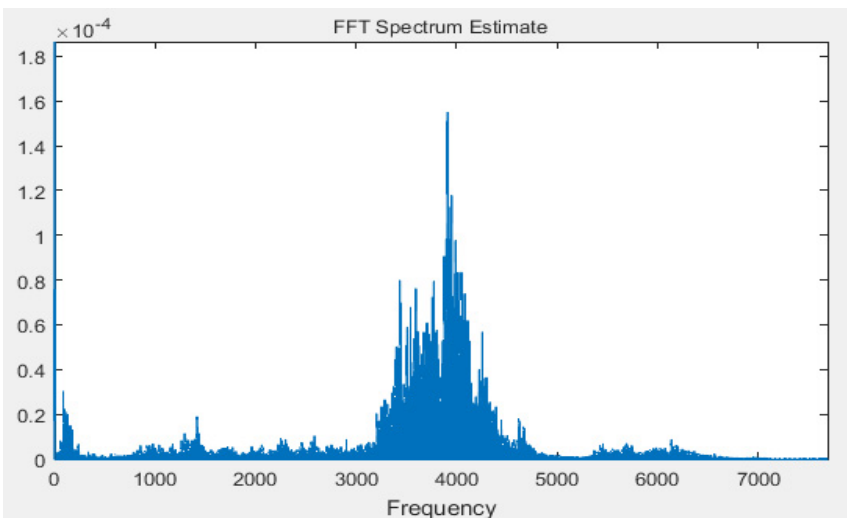
**Fig. 5.** Spectral analysis of signals – signal from sensor Ai3
