**Experimental Seismic Evaluation of Ceiling-Piping-Partition
Nonstructural Systems**

A thesis submitted in partial fulfillment of the
requirements for the degree of Master of Science in
Civil and Environmental Engineering

Craig K. Jenkins

December, 2015

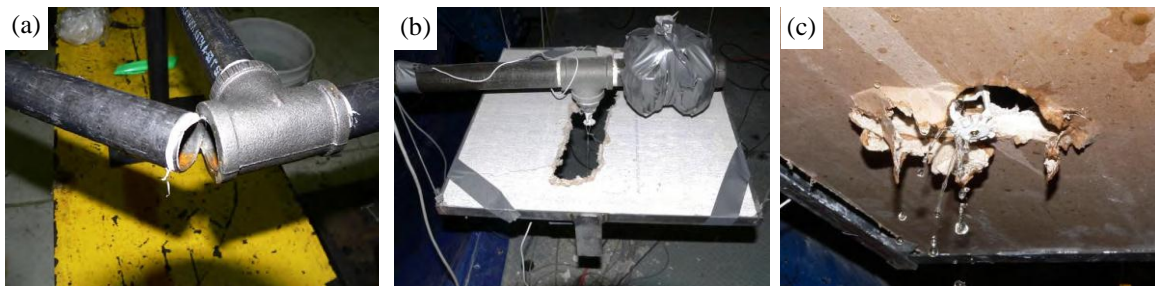
Figure 8: UB Piping Experiment: (a) tee joint rupture, (b) ceiling-piping damage, (c) activated sprinkler head, Source: (Tian et al., 2013)

A subsystem-level fire sprinkler piping system experiment was conducted at UB as part of the NEESR-GC: Simulation of the Seismic Performance of Nonstructural Systems project. This experiment investigated the behavior of tee joint connections and fire sprinkler piping systems under seismic loading. Two test series were carried out for this experiment. The first tested 48 piping tee joints under cyclic loading to determine the

rotational capacity at which leakage and/or fracture would occur (Figure 8a). Results show that the rotational capacities at first leakage for all joint types ranged from 0.005 rad. to 0.405 rad. From the observed failure mechanisms, component fragility curves were developed for sprinkler piping joints. The second test series evaluated the overall performance of a piping subsystem by testing three specimens with varying materials, joint arrangements, and bracing systems. Common damage observed during this series was failure of vertical hangers, branch line failure, and sprinkler head damage (Figure 8b). Results conclude that the unbraced specimens experienced extensive damage to vertical hangers, ceiling tiles, sprinkler heads, and pipe joints; however, braced systems suffered no damage. In addition, it was observed that for a number of fire sprinkler piping systems, there was little damage to the supporting elements, but some sprinkler heads were activated due to the interaction between ceiling tiles (Figure 8c).

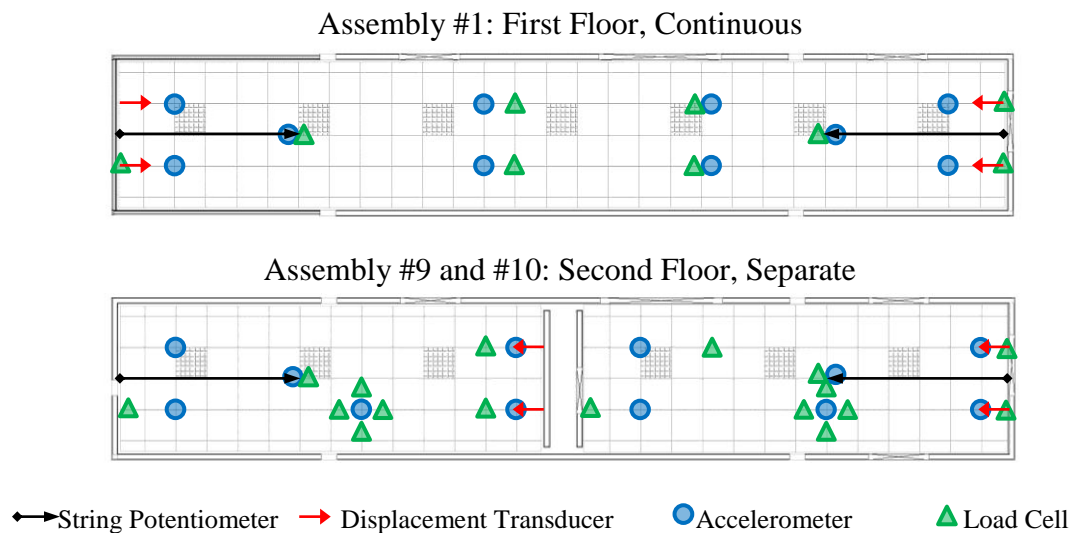
Fig. 5. Ceiling Instrument Location for Assemblies #1, #9, and #10

The ceiling system response was measured by string potentiometers, displacement transducers, accelerometers, and load cells. The number and orientation/layout of these instruments were dependent on the assembly configuration. An example of instrument location for Assembly #1 and Assembly #9-10 is show in Fig. 5.

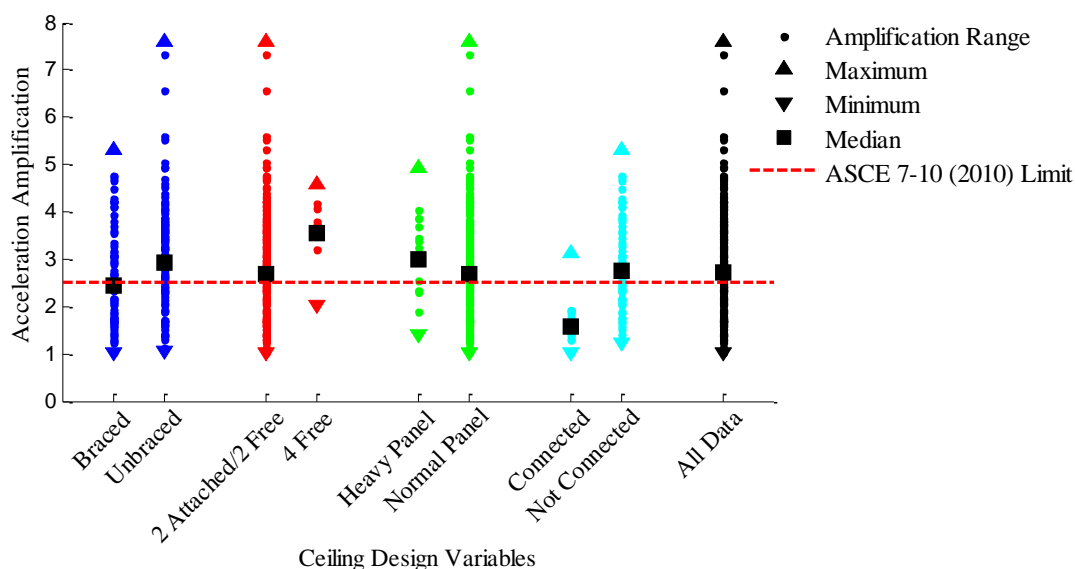
Fig. 8. Graphical Representation of Amplification Factors

Acceleration amplification (a_p) factors for suspended ceiling systems were calculated by taking the ratio of the peak ceiling acceleration over the peak floor acceleration (PFA). The ceiling design variables chosen to be compared were braced/unbraced, number of attached walls, panel weight, and partition wall height. The statistical parameters (max, min, and median) for the different design variables are shown in Table 7. The ASCE 7-10 (2010) recommends an amplification of 2.5 for flexible components. A graphical representation of the max, min, median, and ranges of amplifications calculated for each design variable along with the prescribed value from ASCE 7-10 is shown in Fig. 8. As shown, the maximum and minimum amplifications are 1.03 and 7.61, respectively, while the median amplifications range from 1.57 to 3.56. The two design variables that have the most effect on ceiling amplification are number of attached walls and partition wall height. The lowest median (1.57) occurred in assemblies that had ceilings connected to additional partition walls (content rooms). The additional connection increased the rigidity, causing the amplification to be more comparable to the rigid amplification value (1.0) suggested by ASCE 7-10. The highest median (3.56) was observed when the four ceiling perimeters were free (unattached). Due to the added flexibility from the unattached perimeters, the amplification exceeded the prescribed limit.

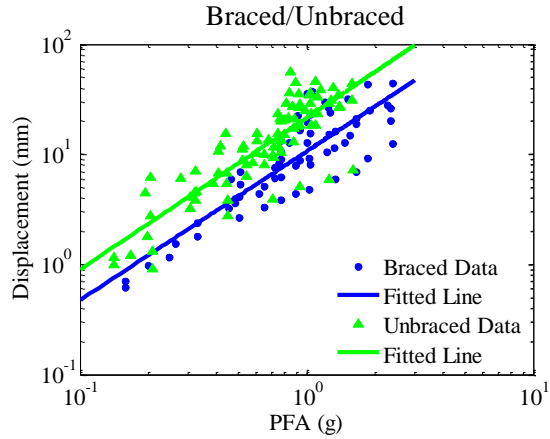
Fig. 9. Regression Plot for Braced/Unbraced Assemblies

In this study, a pounding gap of 19.1 mm (3/4 in.) was installed at all free sides of ceiling configurations. The effects of the pounding gap were compared through six design variables: bracing, boundary condition, number of attached walls, seismic separation joint, panel weight, and partition wall height. The recorded maximum perimeter displacements at the free ends from each ground motion were plotted against the corresponding PFA on a log-log scale to attain the regression plots for each design variable (example shown in Fig. 9). Then, from the regression line coefficients the demand parameters (S_d and $\beta_{d|PFA}$) were determined using Eq. (2) and Eq. (3) above for each of the design variables. The fragility curves shown in Fig. 10 were developed (using Eq. (1) from the demand and capacity parameters (Table 8). As previously mentioned, β_c is considered to be zero. From the median and dispersion fragility parameters, also shown in Table 8, the design variable with the highest probability of failure is four free perimeter walls. On the other hand, the smallest probability of failure is when the ceiling is connected to additional partition walls (content rooms).

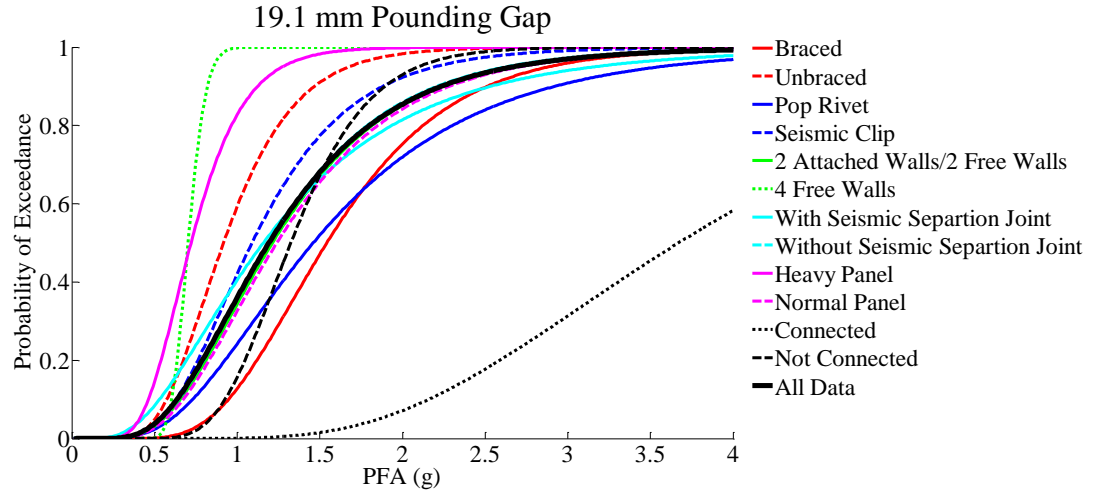
Fig. 10. Perimeter Displacement Fragility Curves (19.1 mm Pounding Gap)

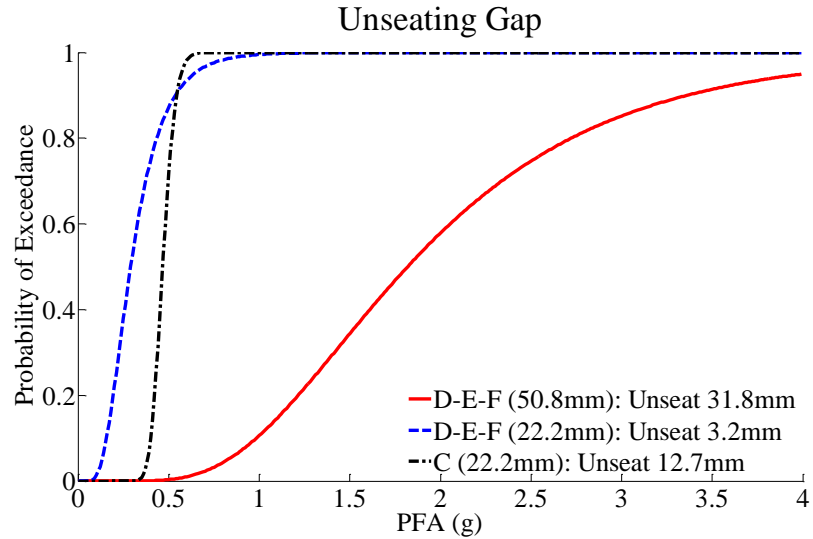
Fig. 11. Perimeter Displacement Fragility Curves (Unseating Gap)

A similar process was used to determine the demand and capacity parameters for the unseating gap damage state (Table 9). However, the only design variable considered was the number of attached walls. The capacity limit is dependent on the seismic design category and the size of wall angle. The recommended unseating displacements, per ASTM E580/E580M (2011), are shown in Table 9. Similarly, fragilities based on the unseating gap (Fig. 11) for each seismic design category were determined from Eq. (1). The seismic design category D-E-F governs the failure probability compared to category C. The probability is highest for the unseating of 22.2 mm (7/8 in.) wall angles and the lowest for unseating of 50.8 mm (2 in.) wall angles. A summary of the unseating fragility parameters is presented in Table 9.

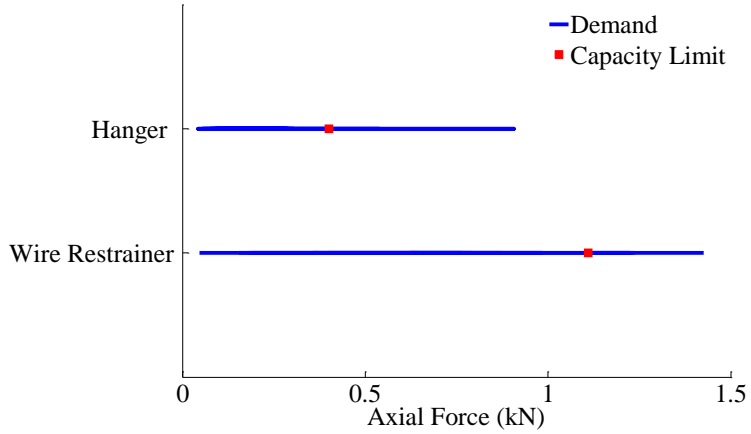
Fig. 12. Comparison of Demand Axial Force to Capacity Limit

The capacity limits for hangers and wire restrainers were taken from ASTM E580/E580M (2011) as 0.40 kN (0.09 kips) and 1.11 kN (0.25 kips), respectively. The demand axial force observed during testing was higher than the capacity limit suggested by ASTM in hangers and wire restrainer specimens. However, there were no occurrences of complete hanger or wire restrainer failure. A graphical representation of the demand axial force compared to the suggested capacity limit for all the data is shown in Fig. 12. As shown, axial forces recorded in hangers and wire restrainers were 0.91 kN (0.21 kips) and 1.43 kN (0.32 kips), respectively. These values suggest that the ASTM capacity limit underestimates the actual capacity limits. Nevertheless, the damage state considered for this study is the capacity (failure) limit of 0.40 kN (0.09 kips) for hangers and 1.11 kN (0.25 kips) for wire restrainers. The fragility curves (Fig. 13) were developed from the demand and capacity parameters by using Eq. (1). The median and dispersion fragility parameters are presented in Table 11. As shown from the fragility curves, hangers supporting heavy panels, 0.12 kPa (2.62 psf), have the highest failure probability. Wire restrainers in braced and with additional partition connection configurations also have the

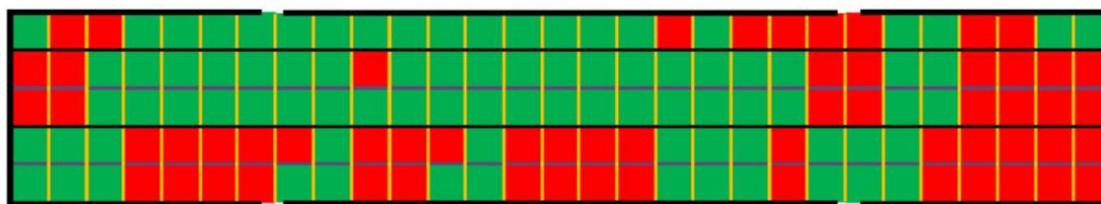
a) Ground Motion 7: Measured PFA= 1.56g, 28.3% Failed Area

b) Ground Motion 9: Measured PFA= 2.35g, 41.4% Failed Area

0.6 m (2 ft.) Cross Tee
 1.2 m (4 ft.) Cross Tee
 3.7 m (12 ft.) Main Run
 Non Damaged Panel
 Damaged

(Assembly #4, Test L-2, Second Floor, Config. #4, Ceiling Size 17.7 x 3.0 m, PFA_{achieved} 2.35g, Panel Weight 0.06 kPa, Braced, 22.2 mm wall angle and seismic clip)

Fig. 14. Example of Cumulative Ceiling Area Loss in Terms of Percentage

The last set of fragility functions were developed for the overall performance of ceiling systems. From the specifications outlined by FEMA P-58 (2011), three damage states were defined for this study (Table 12). The damage states were developed based on the percentage of fallen ceiling panels to the total ceiling panel area. As shown in Table 12, the thresholds of fallen ceiling panel percentages of the total ceiling area for the three damage states are 5%, 30%, and 50%, respectively. In order to find the percentage of fallen area, a determination process (as shown in Table 13) was used to equate the damage observed to an amount of fallen panels. This process was used to determine the cumulative percentage of ceiling area loss for each of the ground motions. A visual representation of the cumulative damage (with respect to percentage loss) that occurred in one of the ceiling assemblies is shown in Fig. 14. For brevity, only a few of the ground motions are shown. The percentages of ceiling loss and the PFA at which the loss occurred for each ground motion, was used as the data to formulate fragility curves.

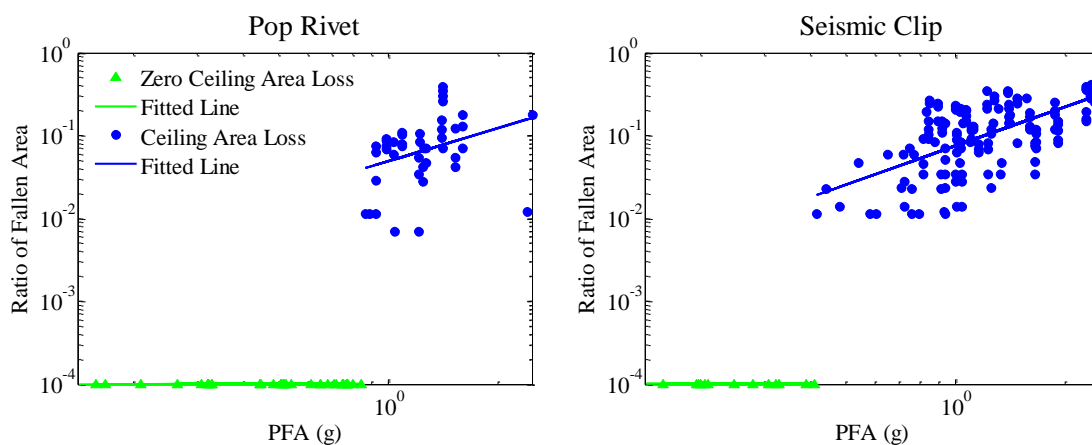
Fig. 15. Separate Regression Analysis for Assemblies with Pop Rivets or Seismic Clips

Three design variables were selected in order to compare the performance of ceiling assemblies: 1) bracing, 2) boundary condition, and 3) partition wall height. The demand parameters were determined through the power-law regression analysis (as previously described). However, a segmental analysis approach was used to fit the data because at low intensity ground motions, the ceiling systems may not have encountered any damage (zero percent ceiling area loss). An example of separate regression lines used to fit the data for assemblies with pop rivet or seismic clip connections are shown in Fig. 15. Table 14 shows the demand parameters for the selected design variables and all the data, labeled “All Data”. It should be mentioned that only the parameters for the data with a percentage area loss are given because the parameters for the data with zero percent area loss are zero.

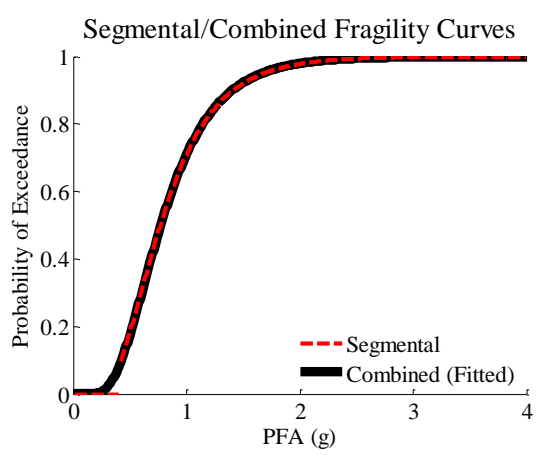
Fig. 16. Segmental and Combined Fragility Curves for Assemblies with Seismic Clips

From the demand parameters, segmental fragility functions (example shown in Fig. 16) were developed using Eq. (1) above. Then, a least squares curve fitting process was used to combine (or fit) the two separate fragility functions. For clarity, only the segmental and combined fragility curves for the seismic clip design variable that correlate to DS1 are shown (Fig. 16). The combined fragility curves for all three damage states are shown in Fig. 17. As depicted from the fragility curves, design variables under DS1 have a concentrated probability of failure. However, as the damage state increases (to DS2 and DS3), the difference in the performance variation of the design variables also increases. Additionally, there becomes a clear difference in trend between design variables. Assemblies that were unbraced, included seismic clips, or were not connected had a higher failure probability than assemblies that were braced, included pop rivets, or were connected. These results suggest that systems that are more susceptible to movement have a higher chance of exceeding their capacity limits under DS2 or DS3. The fragility curves also show that assemblies that use pop rivets have the lowest probability of failure compared to other design variables for all three damage states. The median and dispersion fragility parameters for each design variable are shown in Table 15. As shown,

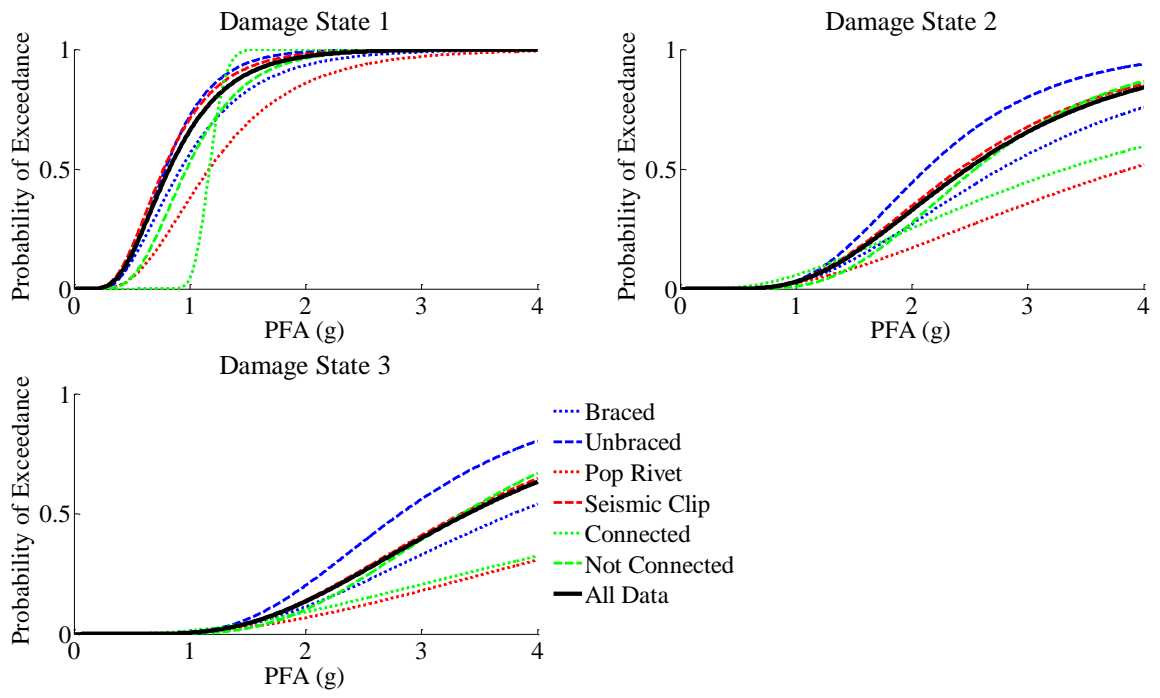
Fig. 17. Overall Performance Fragility Curves

the median for all the combined data is 0.82g, 2.47g, 3.39g for the three damage states, respectively.

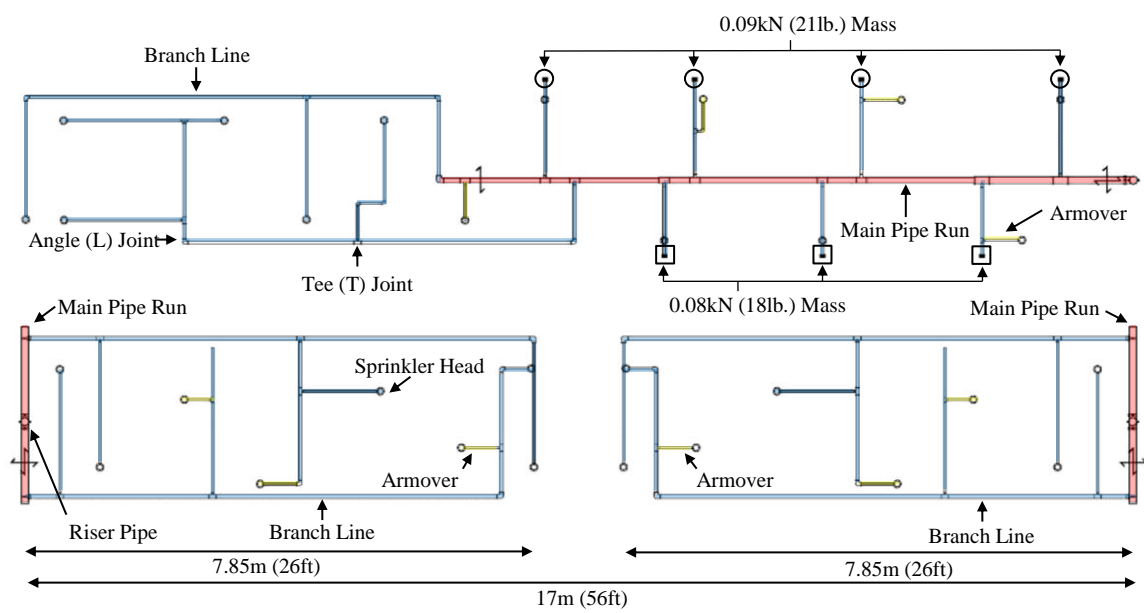
Figure 4. Plan View of Piping Configurations: (top) continuous, (bottom) separate

The pipe configurations were composed of different pipe segments, varying from 25 to 100 mm (1.0 to 4.0in.) diameter, and were categorized as riser pipes, main pipes, branch lines, armovers, and drops (see Figure 4). The riser pipe, typically 100 mm (4.0in.) diameter, connected the pressurized water tank to the horizontal assembly, made of main pipe runs and branch lines, on the two floors. The horizontal assembly suspended 457 mm (18.0in.) below the floor above. The main pipe run supplied water to the branch lines which expanded to other areas of the floor plan. Due to test-bed limitations, an additional mass 0.08 or 0.09 kN (21.0lb. or 18.0lb.) was attached to the ends of some branch lines to simulate a longer branch length. Branch lines supplied water to armovers and drops with typical diameters of 25 mm (1.0in.).

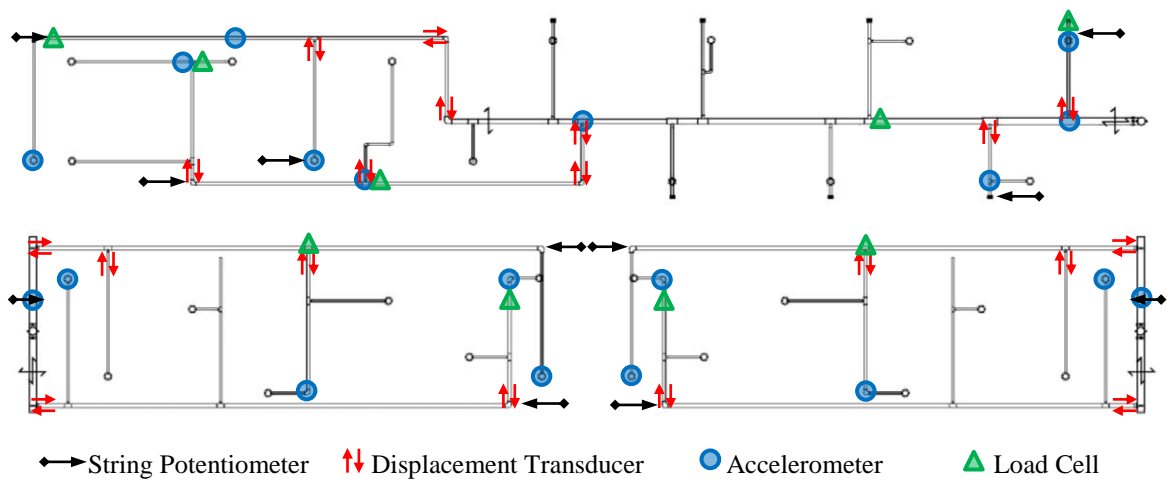
Figure 8. Typical Piping Instrument Location

The piping system response was measured by string potentiometers, displacement transducers, accelerometers, and load cells. The locations of these instruments for the two piping configurations are shown in Figure 8. String potentiometers extended from structural members to the ends of pipe segments in order to measure pipe displacements (Figure 9a), while displacement transducers were used to measure the rotation of joints (Figure 9b). Accelerometers, located on various pipe segments including main pipe runs, branch lines, and sprinkler heads (Figure 9c), captured accelerations experienced by different pipe segments. Load cells (Figure 9d) were used to record the axial force in hangers and wire restrainers.

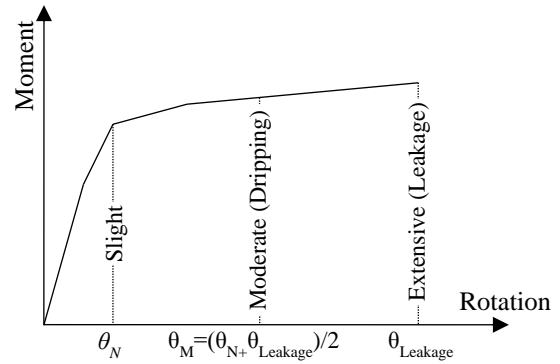
Figure 15. Pipe Joint Limit States
[Graph courtesy of Soroushian et al., 2013]

Three limit (damage) states, defined by Soroushian et al. [2013], for fire sprinkler pipe components were used in this study (Figure 15). The first is named “Slight” and is assumed to be the start of nonlinear behavior within the joint. The second, named “Moderate”, includes dripping or spraying of the threaded joints. The last limit state, named “Extensive”, corresponds to the first significant leakage of the joint. In addition to limit states, Soroushian et al. [2013] produced capacity parameters (median and dispersion) for each limit state based on analytical studies (Table 5). It should be noted that this study borrowed the capacity parameters produced by Soroushian et al. [2013] because specimen capacities were not exceeded in the experiments.

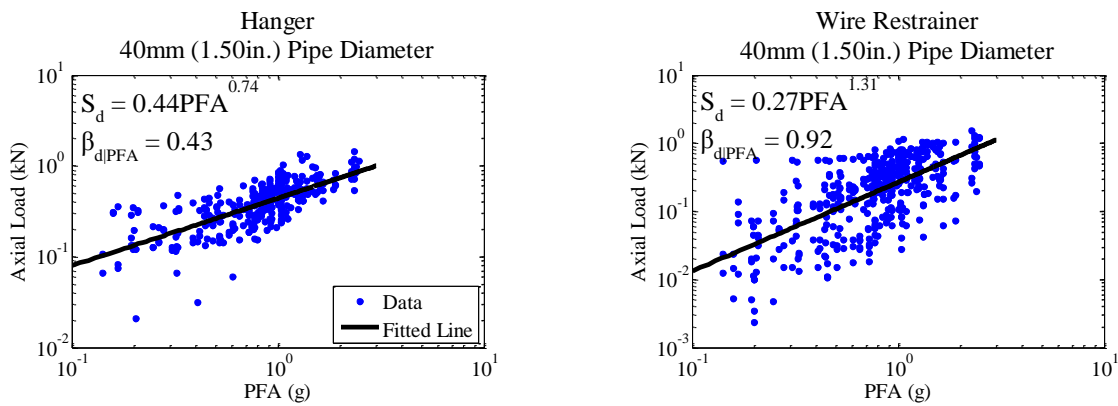
Figure 17. Example Regression Parameters for Hangers and Wire Restrainers

Similar to the previously defined methodology, the demand parameters were determined using the regression analysis (Eqs. (2) and (3). Figure 17 presents an example

of the regression parameters for hangers and wire restrainers that supported 40 mm (1.50in.) diameter pipes. The capacity requirements for the hanger and wire restrainer components were taken from the NFPA 13 [2011] and USG [2010], respectively. Hangers shall be designed to carry five times the dead load of the pipe (filled with water) plus an additional 1.11 kN (250lbs.). Wire restrainers shall be designed to carry 1.78 kN (400lbs.). The median capacity calculations for hangers and wire restrainers are shown by Eqs. (5 and (6, respectively. The dispersion capacity parameter, β_c , was defined as 0.4 as suggested from ATC-58 [2013] as a typical value for nonstructural systems. The demand and capacity parameters for support axial forces are presented in Table 7.

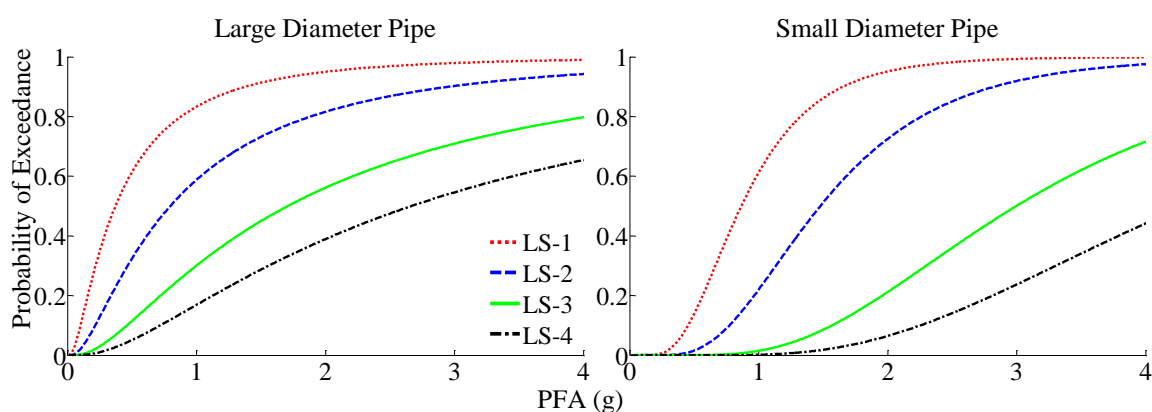
Figure 21. Displacement Fragilities for Large and Small Diameter Pipes

The demand and capacity parameters were then used in Eq. (1) to calculate the displacement fragilities as presented in Figure 21. The experimental fragility parameters are compared with a combination of analytical and experimental values (Table 9) produced by Soroushian et al. [2014d]. Results show that the experimental median values

are higher than the analytical/experimental for the large and small pipe diameter categories. Experimental fragility parameters from the three EDP's considered show that pipe displacement is the governing EDP and has the greatest probability of failure compared to pipe joint rotation and support axial force. This effect was determined by comparing the minimum median fragility parameters for pipe joint rotation, support axial force, and pipe displacement which are 0.81, 1.36, and 0.37, respectively.
