Use of natural resins in repairing damaged timber beams – An experimental investigation

Key words: bending capacity, damaged timber beams, environmental impact, natural resins, repair material

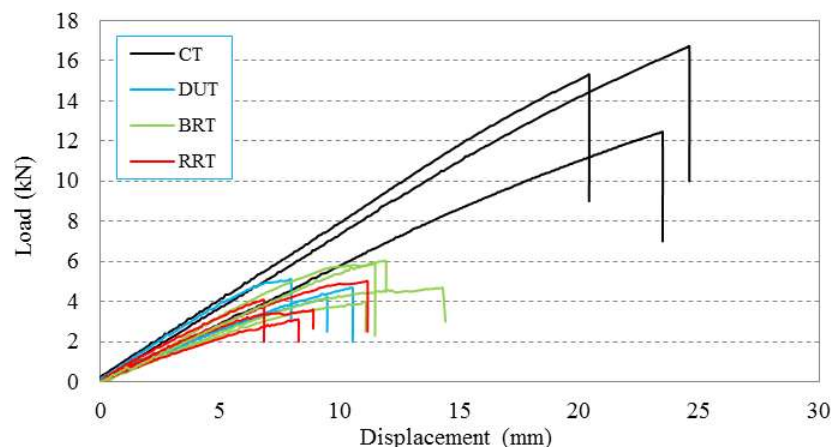
Figure 6. Load-displacement curves: CT (Control tests), DUT (Damaged and unrepaired beam tests), BRT (Bone glue repaired beam tests), RRT (Rosin repaired beam tests).

The tests were identified by an alphanumeric code, in which the letters indicate the specimen condition and resin type i.e. control (CT), damaged-unrepaired (DUT), Bone glue repaired (BRT) and Rosin repaired (RRT), while beams within the same test series are differentiated by the addition of numerals. All the beams were subjected to a four point bending test during which the load applied, and the mid-span displacement were measured and recorded. In this way, it was possible to plot, for each beam, the load-displacement curve, up to the point of failure. Figure 6 shows the load-displacement curves associated with all the tested beams.

The failure mode recorded for undamaged (control) beams was characterized by the opening of a lesion at the beam mid-span, which then spread along the beam in the direction of the grain (figure 7a). The load-displacement curves for these beams are presented in figure 6. In addition, the maximum load (P_{max}) and the corresponding maximum (d_{max}) at mid-span were obtained (table 2). Stiffnesses obtained at the

The load versus mid-span displacement curves for each test series is presented in figure 7. Average values for the maximum load (P_{max}), maximum displacement (d_{max}), stiffnesses (K and K') and of the linearity index (K'/K) for each test series are also presented in Table 4.

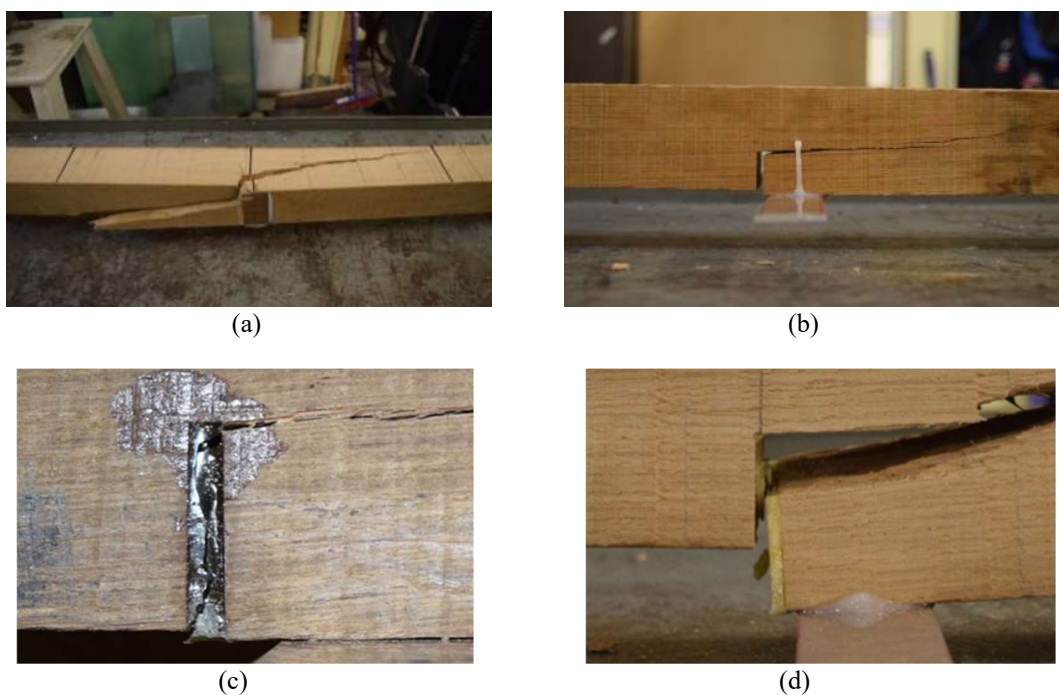
Figure 7. Specimens' failure modes: (a) CT series (control undamaged beams); (b) DUT series (damaged and unrepaired beams); (c) BRT series (damaged and bone glue repaired); (d) RRT series (damaged and rosin repaired).

The most common failure mode was the opening of a crack starting from the top corner of the cut, which was then propagated in the direction of the grain (figure 7b). An average linearity index of 1.3 was recorded showing significant reduction in the load – deflection slope as the load increases. This is probably due to the plasticization of the wood fibers in the compressed area of the beams.

Similar to the damaged un-repaired beams (DUT series), the beams repaired with natural resins, i.e. bone glue (BRT series) and rosin (RRT series), failed by the tensile rupture of the wood starting from the corner of the cut with consequent breaking of the resin present inside the cut (figures 7c and 7d). Same indices previously defined were also obtained and presented in table 2 for the BRT and RRT beams. It can be observed in table 2 that the use of bone glue results in higher load carrying capacity for the repaired beams when compared with rosin repaired beams. Results were unsatisfactory both in terms of bending capacity and stiffness: the application of the natural resins was unable to restore the continuity in the area of the cut. Failure occurred in the timber material on tension side inside the cut. At failure, natural resins only deformed (no failure) or detached from the timber. The main problem was the extremely low Young's modulus of the natural resins used.
