Stress Analysis of a Stepped-Lap Bonded Repair Joint in Composite Laminate under Compressive Loading

Abstract

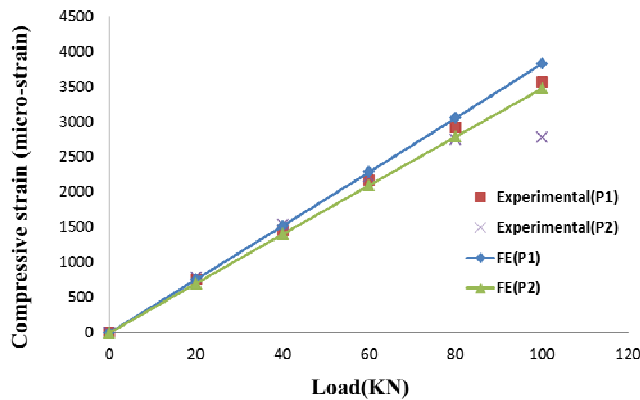
Fig. 9: Comparison of FE and experimental strain in repaired laminate at positions (1 and 2)

To establish and validate the FE-analysis methodology of stepped-lap repaired bonded joints, experimental studies also have been carried out on repaired laminates. For this, six different locations of strain gauge position are selected as shown in Fig. 8. Strain-gauge positions 1, 3 and 5 are on the patch (front) and strain-gauge positions 2, 4 and 6 are on the laminate (back). Directions of all strains gauge are in loading directions. Finite-element strains and experimental strains are plotted with the increasing the loads in the interval of 20 KN till the failure load (108KN) and strains are compared at all six locations. FE and experimental strains at location 1(front) and 2(back) are compared in Fig. 9 and it is found that both the strains are correlating well. Maximum variation in strain in this location is 5 %. FE and experimental strains at locations (3, 4) and locations (5, 6) are compared in Fig.10 and Fig. 11 respectively and it is observed that both the strains trends are correlating but variation in strains in these locations are 5 % at 20KN to 45 % at failure loads. Most probable reasons for increasing the variation in strains is local buckling in the test specimen or de-bonding in laminate in that area.

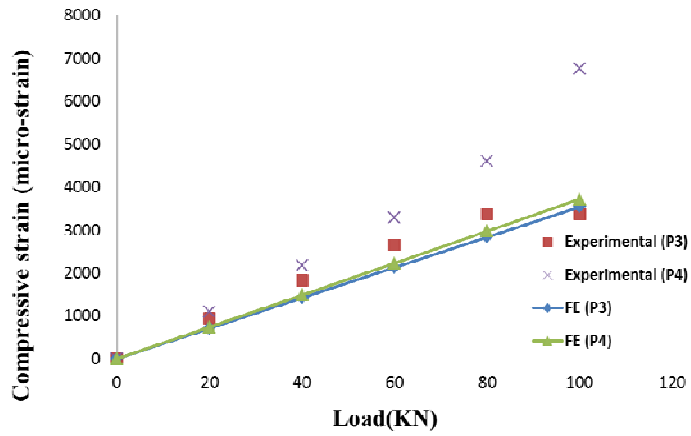
Fig. 10: Comparison of FE and experimental strain in repaired laminate at positions (3 and 4)
