Degradations of Incoloy 800 Steam Generator Tubing

Dumitra Lucan Department of Corrosion and Circuits Chemistry, Institute for Nuclear Research, POB 78, Pitesti Romania

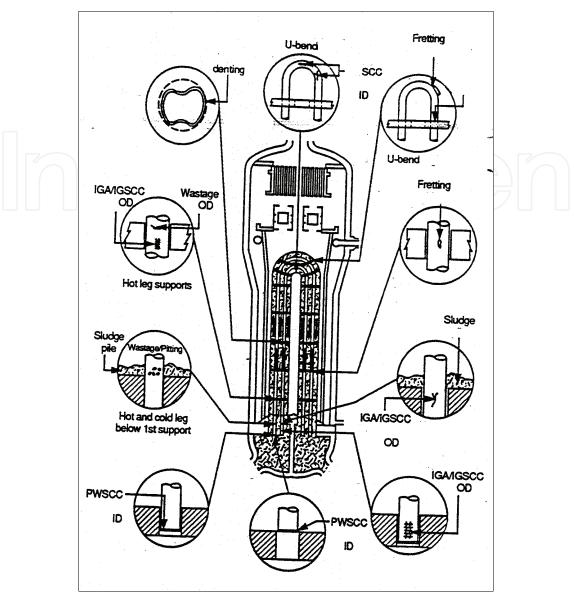
Fig. 1. is a schematic layout of corrosive attacks specific to Steam Generators.

Fig. 1. Types of corrosion specific to the steam generator, (IAEA, 1997)

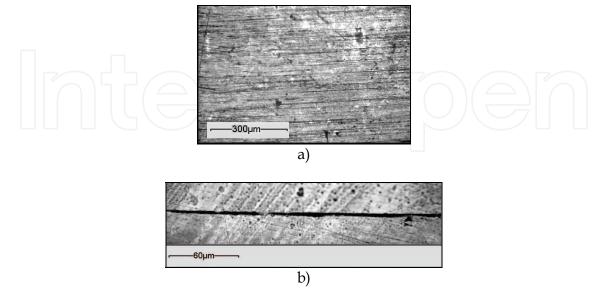
Fig. 2. Surface morphology (x200) (a) and aspect of the superficial layer (x1000) (b) for Incoloy-800 exposed for 1680h in demineralised water, pH=7.5, T=260 $^{\circ}$ C and p=5.1MPa

The chemical composition of Incoloy-800 in percent weight is: C=0.02%, Mn=0.64%, Si=0.49%, S=0.01%, Ni=33.40%, Cr=21.90%, Cu=0.01%, Al=0.24%, Ti=0.41% and Fe=42.88%. Some examples of experimental results for the testing of the Incoloy-800 samples for different times in demineralised water environments with pH=7.5, pH=8.5 and pH=9.5 (AVT) at secondary circuit steam generator specifically parameters (260°C and 5.1MPa) are presented in the Fig.2 ÷ Fig.4.

The aspect of the surface and film formed on the samples tested 1680h in demineralised water at a pH=7.5 are presented in Fig.2. The exposure times for the metallographic analysis of the samples tested at a pH=8.5 were: 240h, 720h, 1200h, 1416h, 1656h, 1824h, 2064h, and 3600h. On the Incoloy-800 samples, tested for 240h in demineralised water with a pH=8.5 adjusted with morpholine and cyclohexylamine, at 260°C and a pressure of 5.1MPa a uniform, continuous and adherent oxide layer is noticed, whose thickness is smaller than or equal to 1.9µm. The surface morphology for some samples exposed for 240h in demineralised water at a pH=8.5 (AVT) at parameters specific to the steam generator secondary circuit shows the presence of the oxide, its colour being brown-red. The samples surface is completely covered by oxide and there are no uncovered spots, while the visual aspect is almost identical for the entire surface. It is to be noticed that the oxide layer for the samples tested 720h in demineralised water with a pH=8.5 is in this case, uniform, continuous, adherent and its thickness ranges between 0.7µm and 0.8µm. The oxide is uniform, with brown-red shadows and formed in continuous film on the samples surface. For the Incoloy-800 samples tested for 1200h in demineralised water with a pH=8.5 the result of the exposure was the formation of an oxide layer with a uniform thickness of 1.2μm. In this case the oxide uniformity is noticed. The aspect of the oxide layer existing on the samples tested 1416h is shown that the film thickness on these samples is about 0.8µm. The surface morphology for the samples exposed for 1416h has a uniform aspect.

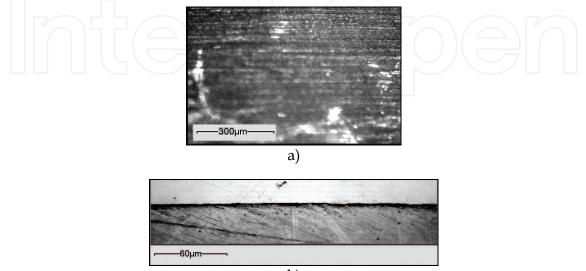
Fig. 3. Surface morphology (x200) (a) and aspect of the superficial layer (x1000) (b) for Incoloy-800 exposed for 3600h in demineralised water, pH=8.5, $T=260^{\circ}C$, p=5.1MPa

The aspect of the oxide layer on the surface of samples tested for 2064h in demineralised water with a pH=8.5 is uniform, continuous and adherent. The uniformity and continuity of the oxide layer can be noticed by the surface morphology of samples exposed for 3600h in demineralised water with a pH=8.5, Fig.3. The oxide layer is uniform, continuous and adherent and has a thickness smaller than 3.5µm. The aspect of the oxide layer and the surface morphology, respectively, for a sample exposed for 3192h in demineralised water at a pH=9.5 under operating conditions specific to the secondary circuit are presented in Fig.4.

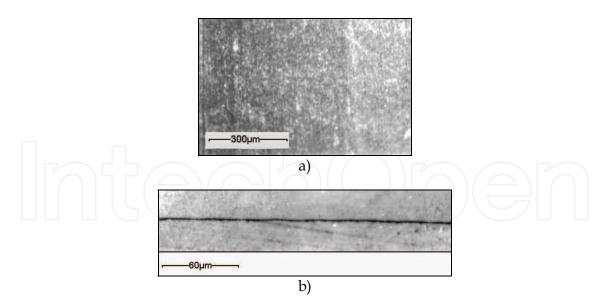
Fig. 4. Surface morphology (x200) (a) and aspect of the superficial layer (x1000) (b) for Incoloy-800 exposed for 3192h in demineralised water, pH=9.5, $T=260^{\circ}C$, p=5.1MPa

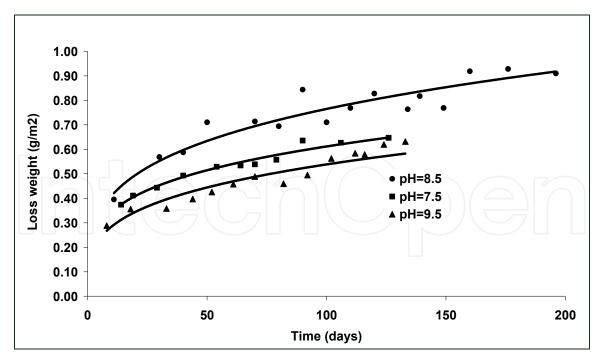
Fig. 5. Loss of metal by corrosion vs. time

After autoclaving operation the samples were descaled in two stage alkaline permanganate – citrox, (Taylor, 1977). Fig.5 ÷ Fig.11 comparatively present the corrosion kinetics for: metal loss by corrosion; corrosion rate; totally formed corrosion products; adherent corrosion products, released corrosion products; corrosion products release, and the release rate of

metal at a pH=7.5, pH=8.5 and pH=9.5, respectively. The Table 1 presents the equations for the corrosion kinetics. For the weight loss due to corrosion and corrosion rate it is noticed that, in the case of a pH=9.5 these have the smallest values (Fig.5 and Fig.6), (Lucan et al., 1998; Lucan et al., 2001; Lucan et al., 2003; Lucan et al., 2005; Cojan et al., 2008). The results are confirmed by the experiments presented in articles from specialty journals, (Taylor, 1977; Stellwag, 1998; Iglesias & Calderon, 2003).

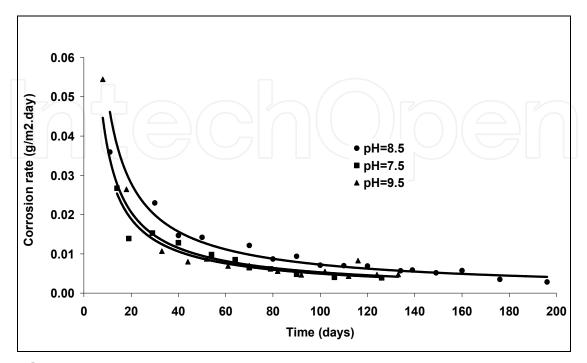
Fig. 6. Corrosion rate vs. time

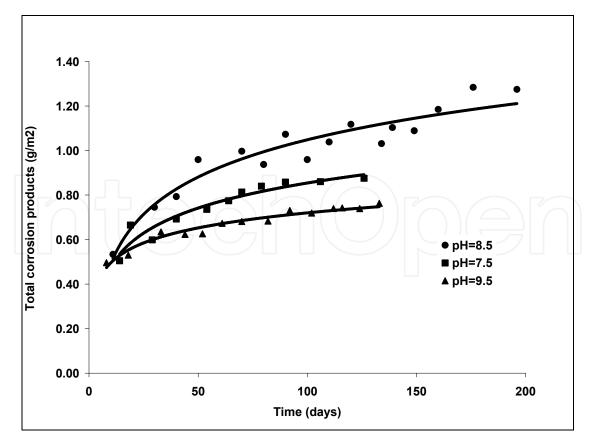
Fig. 7. Total corrosion products vs. time

Also, in the case of totally formed corrosion products the smallest values have been obtained in exposure in solution at a pH=9.5 (Fig.7). In the case of adherent corrosion products, the smallest values have been reached for the solution with a pH = 7.5 (Fig.8), but the values for

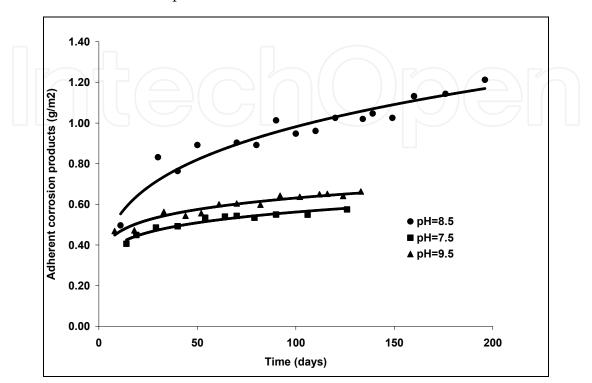
Fig. 8. Adherent corrosion products vs. time

the tests at pH = 9.5 solution are similar, without significant differences between the two cases.

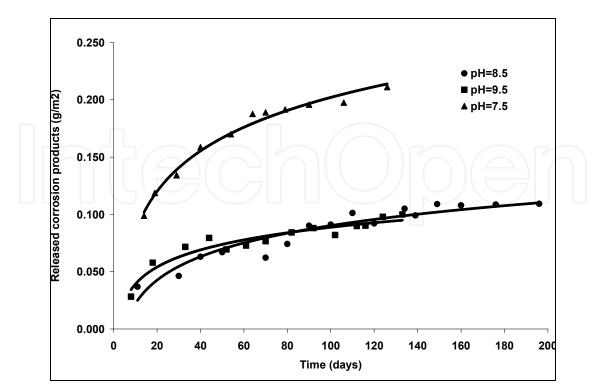
Fig. 9. Released corrosion products vs. time

In the case of released corrosion products, the release rate for products and metal the highest values are obtained for the samples tested in the solution with a pH=7.5 (Fig.9÷Fig.11). This can be explained by the fact that magnetite solubility has higher values for solutions with a smaller pH.

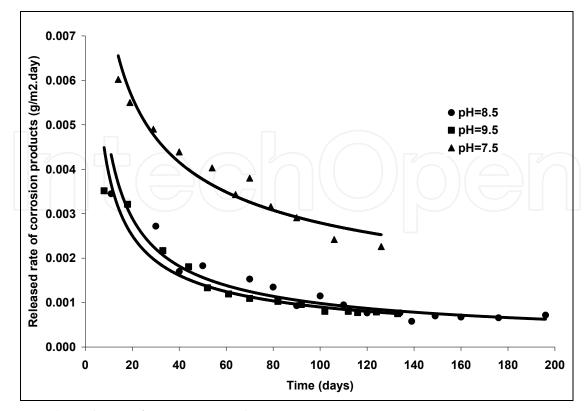
Fig. 10. Released rate of corrosion products vs. time

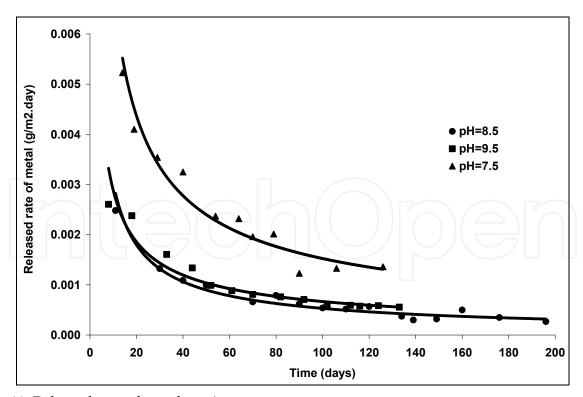
Fig. 11. Released rate of metal vs. time

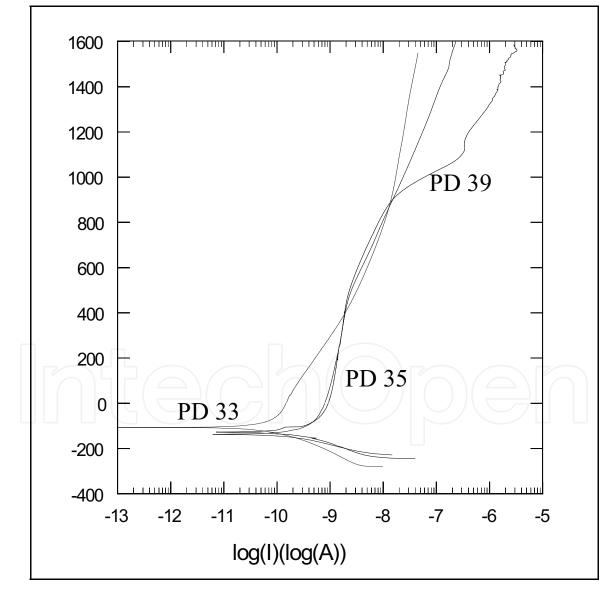
Fig. 12. Potentiodynamic curves Incoloy-800 tested pH=7.5: PD 33- as received; PD 35 – tested 10 days; PD 39 – tested 19 days

Fig.12 and Fig.13 show the results of electrochemical measurements performed by the potentiodynamic method. The electrochemical potential values measured in demineralised water at a pH=9.5 for samples tested by autoclaving at a pH=7.5: PD 35 – tested 10 days, PD 39 – tested 19 days and PD 33- initial status; and pH=8.5 for samples tested by autoclaving at a pH=8.5: PD 36 – tested 10 days, PD 37 – tested 47 days, PD 38 – tested 96 days and PD 34- initial status, show that the oxide films formed on the samples surface at higher exposure times provides them a relatively high corrosion resistance.

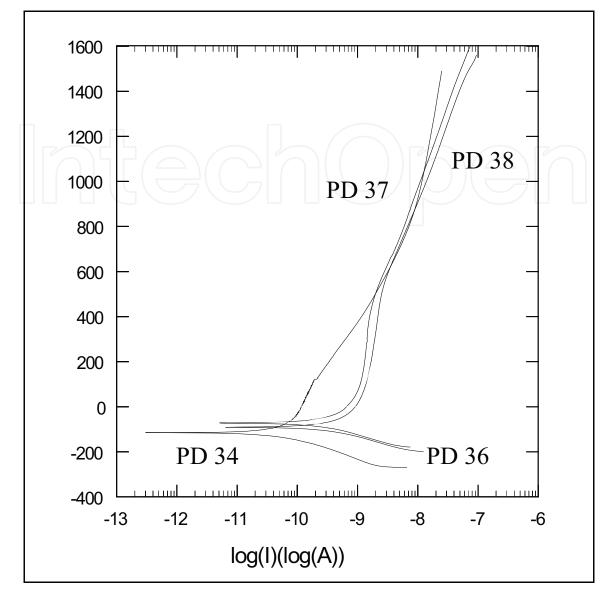
Fig. 13. Potentiodynamic curves Incoloy-800 tested pH=8.5: PD 34- as received; PD 36 – tested 10 days; PD 37 –tested 47days; PD 38 – tested 76 days
