Surface Modification of Mg Alloys AZ31 and ZK60-1Y by High Current Pulsed Electron Beam

Gao Bo, Hao Yi, Zhang Wenfeng and Tu Ganfeng School of materials and metallurgy, Northeastern University, Shenyang China

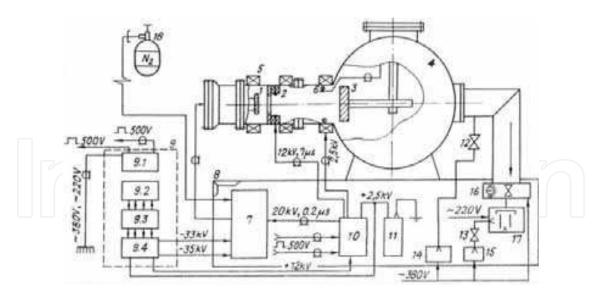
Fig. 2.1. Schematic diagram of high current pulsed electron beam (HCPEB) system

The Fig. 2.1 refers to "Nadezhda-2" type HCPEB device [27] made in Russia. It consists of four parts, such as electron gun, vacuum system, power supply control system and diagnostic system. Vacuum system includes vacuum pump set (a set of molecular pump & a set of mechanical pump), vacuum chamber, vacuum valve as well as pipes for inputting cooling water and waste gas emission. Power supply control system includes high-voltage pulse generator and magnet field triggering power supply, etc. Diagnostic system includes relevant instruments and meters, such as operating vacuum measurement, electron beam, cathode accelerating voltage and average energy density, etc. Electron gun includes cathode, anode, spark source, rogowski coil and magnetic coil, etc. The electron gun used for generating high current pulsed electron beam is the core part of the whole equipment.

1-cathod; 2-spark source; 3-collector; 4-vacuum chamber; 5-solenoid; 6-rokovsky coil; 7-pulsed high-voltage generator; 8-bracket; 9-electricity controller; 10-pulses trigger; 11-capcitor; 12, 13-manual vacuum valve 1, 2; 14, 15-pump 1, 2; 16-electromagnetism valve, 17-molecular pump, 18-nitrogen.

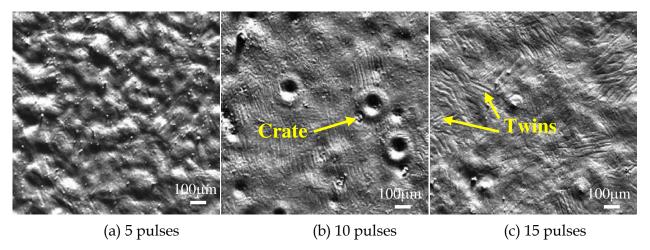
Fig. 3.1. Surface SEM morphologies of AZ31 Mg alloy after HCPEB irradiation with different pulses

Fig. 3.1 gives the surface SEM morphologies of Mg alloy AZ31 after HCPEB treatment with energy density of 3J/cm². Fig. 3.1 (a) refers to the surface morphology of Mg alloy AZ31 after HCPEB treatment of 5 pulses. It can be apparently observed that a typical morphology emerges on the AZ31 Mg alloy surface after HCPEB treatment, namely wavy morphology after complete melting. With the pulse number increasing to 10 pulses, the "crater" morphology and few twins are found on the treated surface shown in the Fig. 3.1 (b). Fig. 3.1 (c) shows surface morphology of Mg alloy AZ31after 15 pulse treatment, it is found that the "crater" morphology disappears after repeated melting and a large number of twins are formed. The 15-pulsed sample surface tends to be smooth. The formation of twins is possibly induced by a lot of residual stresses on the surface after HCPEB treatment [28].

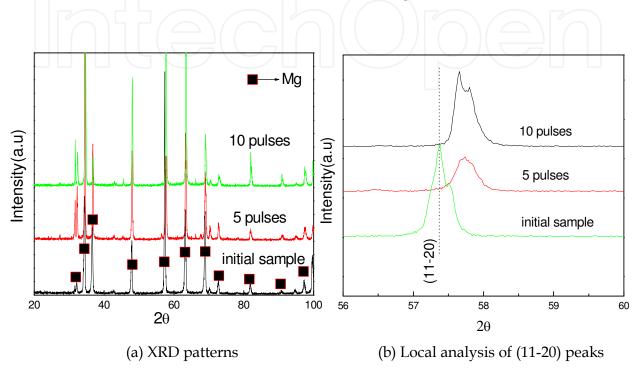
Fig. 3.2. XRD patterns of Mg alloy AZ31before and after HCPEB treatment

Fig. 3.2 indicates XRD patterns of Mg alloy AZ31 before and after HCPEB treatment and local analysis of (11-20) peaks. From the figure, it is found that the diffraction peaks of Mg

obviously move towards high-angle direction after 5 and 10 pulse treatments, as clearly shown in the enlarged figure. The moving of Mg diffraction peaks is more obvious with the increase of pulse number. This is generated by rapid heating and cooling process induced by HCPEB on the surface of Mg alloy. The substitutional solid solution of Al atoms replacing Mg atoms is formed in the Mg lattices, and the lattice constants are reduced as increasing solid solubility. To sum up, high-angle moving of Mg diffraction peaks is attributed to the formation of saturated solid solution of Mg [29].

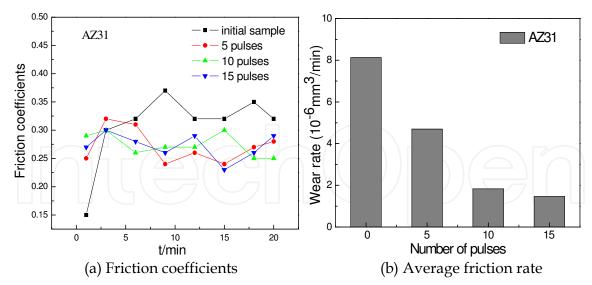
Fig. 3.3. Evolution of friction coefficients with friction time and change of average friction rate with the number of pulses for Mg alloy AZ31 before and after HCPEB treatment

Fig. 3.3 indicates the evolution of friction coefficients with friction time and change of average friction rate with the number of pulses for Mg alloy AZ31 before and after HCPEB treatment. It can be seen that the friction coefficients of initial samples are only about 0.15 at the beginning (as seen in Fig.3.3(a)). It is due to a layer of hard MgO film on the surface. The oxide film is worn away after 5 minutes and the wear enters into severe wear stage, thus, the friction coefficients suddenly rise to 0.32~0.37. But the friction coefficients of treated samples are relatively stable (between 0.25 and 0.27). On the one hand, the oxide film on the sample surface is damaged during HCPEB process, then MgO film can not rapidly formed in the vacuum. On the other hand, the higher roughness on the surface will also lead to the increase in the friction coefficients. Compared to initial samples, the friction coefficients of Mg alloy AZ31 are obviously reduced after HCPEB bombardment. Additionally, the wear rate is reduced by a factor of 6.7 after 15 pulse treatment (as seen in Fig.3.3 (b)), so the wear resistance of Mg alloy AZ31 is increased significantly. It is indicated that there is a large potential in the application of Mg alloy AZ31 after HCPEB treatment.

After HCPEB treatment, the friction coefficients of Mg alloy AZ31 are reduced and the wear resistance is greatly improved. The wear resistance of the 15-pulsed sample is enhanced by about a factor of 6. Besides, the wear form is the typical abrasive wear. Meanwhile, the result of polarization curve test in 5%NaCl indicates that the corrosion resistance of the sample after HCPEB treatment is enhanced because the content of Al on the alloy surface is increased, and a layer of compact oxide film is formed on the surface. As a result, the polarization resistance is increased and the corrosion current is reduced.

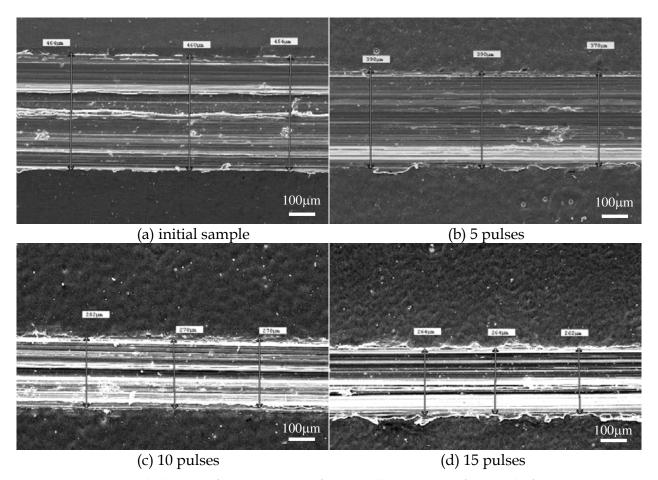
Fig. 3.4. SEM morphologies of wear grooves for Mg alloy AZ31 before and after HCPEB treatment with energy density of $\sim 3J/cm^2$

Fig. 3.4 gives SEM morphologies of wear grooves on the surface of Mg alloy AZ31before and after HCPEB treatment. Compared to wear groove morphology on the surface of initial

sample, the width of wear grooves on the surface of Mg alloy AZ31 is decreased obviously after HCPEB treatment, which is reduced from 460µm of initial sample to 280µm of 10-pulse

treated sample. The wear form is the typical abrasive wear for Mg alloy AZ31. The hardness of matrix is far smaller than that of WC grinding ball, so the cutting form is focused on the wear surface and the groove morphology is formed. After HCPEB treatment, the residual compressive stress is left on the surface, leading to the increase in hardness of HCPEB-treated Mg alloy. As a result, the wear rate and wear volume are reduced, and the width of wear grooves is also decreased. Meanwhile, the main composition of wear debris is the oxides of Mg and Al through EDS analysis of SEM. It is caused by oxidization resulting from the fact that the wear test is performed in the atmosphere, and a lot of heat is accumulated on the sample surface during the severe friction process.

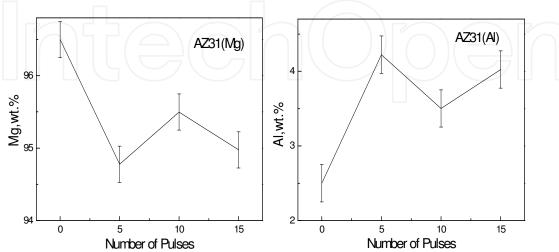
Fig. 3.5. Content of Mg and Al on the surface of Mg alloy AZ31 after HCPEB irradiation

The chemical composition of alloy surface plays an important role in corrosion process. The changes of Mg, Zn and Al elements are analyzed by SEM. It is found that the variation of Zn is very small after HCPEB treatment. The changes of Mg and Al are mainly given in Fig. 3.5. It can be seen that the content of Mg on the surface is reduced after HCPEB treatment and reaches maximum reduction after 5 pulse treatment, which is due to Mg evaporation in the molten state. As the number of pulse increases to 10 pulses, the melted layer is thickened. The Mg contained underneath new melting liquid will spread or evaporate to the upper layer, so the Mg content on the surface of Mg alloy AZ31 will rise again. With further increase in pulse number, the Mg at the surface layer loses balance as well as the Mg inside the equipment, and the Mg at the surface layer evaporates, so the content of Mg is reduced again. But, the change of Al content is on the contrary to that of Mg. The increased Al content at the surface layer will be undoubtedly favorable to the formation of compact oxide film and the enhancement of corrosion resistance on the alloy surface. Therefore, in order to acquire the surface that contains high content of Al, it is crucial to choose proper pulse number and energy density.

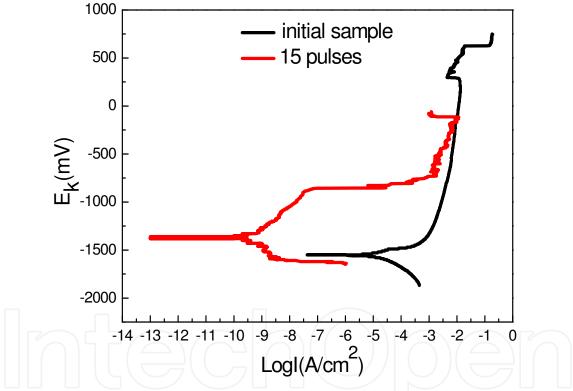
Fig. 3.6. Potentiodynamic polarization curves of Mg alloy AZ31 before and after HCPEB treatment (15 pulses)

Fig. 3.6 shows the potentiodynamic polarization curves of Mg alloy AZ31 before and after HCPEB treatment. From the measuring result, we can see that the Ecorr of modified sample is moved to -1360mV. Through Tafel straight line fitting of cathode and anode, it is discovered that the corrosion current is reduced but the polarization resistance is increased. The reason is that HCPEB treatment leads to rich Al on the AZ31 Mg alloy surface and the formation of compact oxide film. Compared to the initial sample, the corrosion resistance of HCPEB-treated sample is increased. It can be also discovered that the overpotential (the difference between applied potential and Ecorr) reaches about 300mV, namely breakthrough occurs. For one thing, the surface protective film is comparatively thin. For another thing, the applied etching solution is 5% NaCl, in which chloride ion has strong penetrability. Hence the protective film is punctured rapidly. It also illustrates that HCPEB treatment can not be solely applied as the final process of the sample treatment, but it should be applied practically together with other processes.

In the environment where the chloride ion exists, a sort of soluble magnesium salt forms in the boundary of metal and solution, as shown in the equation (2). This soluble magnesium salt ruins the protective film of magnesium hydroxide, and then the exposed metal generates self-solvent reaction with electrolyte in the damaged film and the corrosion speed is accelerated thereupon. The partial attack causes the pitting formed on the alloy surface. Once the pitting starts, it will expand at a very fast speed. Thinking over from the angle of kinetics, the pitting formation rate of the treated sample is smaller than that of the initial sample. It should be contributed to stability and compactness of oxide film formed on the surface of modified sample. It is equivalent that the anode dissolution speed is slowed down, thus Icorr is reduced remarkably.

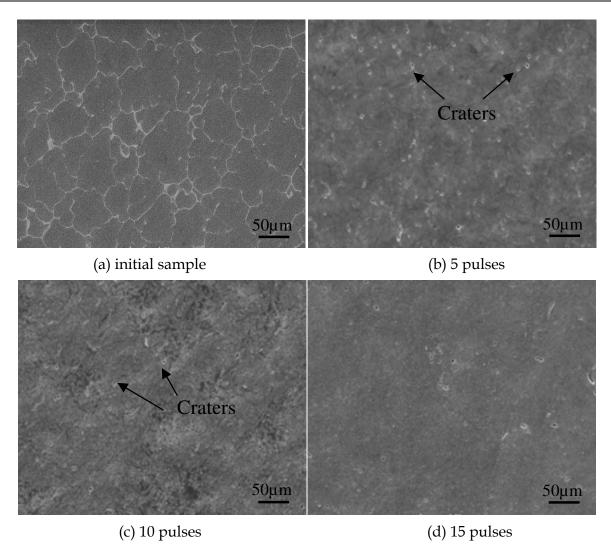
Fig. 3.7. Surface SEM morphologies of Mg alloy ZK60-1Y before and after HCPEB treatment

Fig. 3.7 refers to surface SEM morphologies of Mg alloy ZK60-1Y before and after HCPEB treatment. Before electron beam treatment, the original structure of Mg alloy ZK60-1Y is composed by eutectic structure and matrix $\alpha(Mg)$, and the eutectic structure shows discontinuous distribution (white contrast in the figure), as shown in the Fig. 3.7 (a). After HCPEB treatment, the crystal boundaries on the surface of Mg alloy ZK60-1Y become less obvious, and the composition tends to be uniform. It is because that the HCPEB bombardment results in melting of the alloy surface, and it is too late to be redistributed and solidified for the elements owing to subsequent rapid solidification. At the same time, the typical "crater" morphology is formed on the surface of Mg alloy (Fig. 3.7 (b)). It is due to the ZK60-1Y Mg alloy surface is under the action of pulsed beam current, the subsurface is melted first and liquid is erupted outwards from inside, which is similar to the volcanic eruption. It is one reason for the formation of "crater" morphology [31]. With increasing pulse number, more energy is absorbed by the surface of Mg alloy, as a result, the "crater" quantity is reduced and the surface becomes much smoother, as shown in the Fig. 3.7 (c-d).

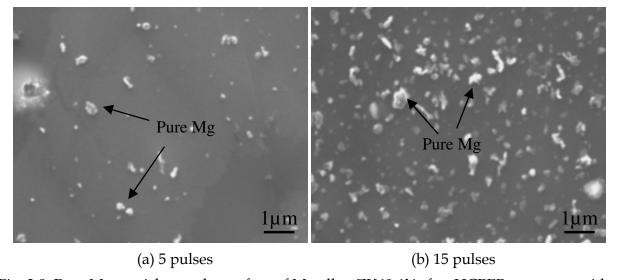
Fig. 3.8. Pure Mg particles on the surface of Mg alloy ZK60-1Y after HCPEB treatment with accelerating voltage of $27 \mathrm{kV}$

Fig. 3.8 shows pure Mg particles on the surface of Mg alloy ZK60-1Y after HCPEB treatment. From the figure, it can be seen that the pure Mg particles (the result of EDS analysis) are distributed on the surface of Mg alloy after HCPEB treatment and more pure Mg particles emerge on the alloy surface after 15 pulse treatment. The reason can be explained as follows: Mg belongs to the low melting point metal and its vapor pressure is also very low compared with Zr and Y elements. Under HCPEB bombardment, the temperature of matrix Mg rises swiftly due to the momentary energy deposition, resulting in melting of Mg at the surface layer. As the surface temperature reaches the boiling point, the vaporization goes ahead within a certain range at the surface layer and a lot of droplets sputter out. Because the target material surface parallels to the direction of gravity, the spilled droplets will not return to the surface under the action of gravity but will be charged with negative electricity under the action of electron beam current. As the target is the anode, the droplets with negative electricity will slow down and be drawn back to anode under the action of electric field force. Consequently, the droplets fall on the entire surface at certain speed. After solidification, we can see the pure Mg particles as shown in the Fig. 3.8.

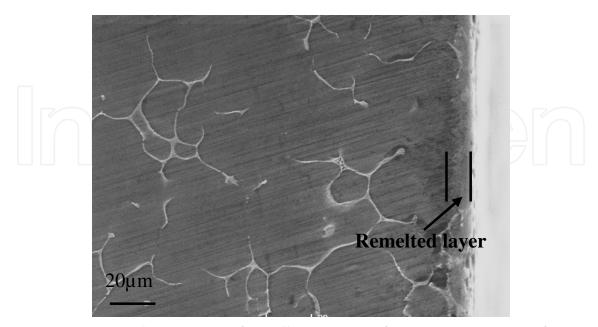
Fig. 3.9. Cross sectional SEM image of Mg alloy ZK60-1Y after HCPEB treatment after HCPEB treatment

Fig. 3.9 refers to cross sectional SEM image of Mg alloy ZK60-1Y after HCPEB treatment. From the figure, it can be observed that remelted layer with thickness of \sim 12 μ m is formed on the surface layer. Compared to the matrix, the remelted layer is more compact and the crystal boundary become less obvious. It can mainly be explained as follows: the second phase existing in crystal boundaries melts and diffuses due to the rapid melting process induced by HCPEB treatment, while the crystal boundaries disappear in the melting liquid. When the electron beam bombardment terminates, the rapid solidification occurs immediately on the surface owing to good thermal conductivity of the metal material. Under the action of high solidification rate (\sim 10 8 K/s), great temperature gradient is generated on the surface of the material and non-equilibrium freezing occurs in the melting

layer. For the solidification time is too short, the actual temperature of the liquid at the frontier of solid liquid interface is lower than the liquidus temperature, so there is no way to provide continuous driving force for the growth of crystal grains. The nucleation rate of crystal is greater than the growth rate, so the crystal grains in the surface layer are refined and the inter-grain boundaries of the refined crystal grains become indistinct. In addition, the segregation phenomenon of alloying elements existing in grain boundaries is improved, and Zn and Zr better dissolve into the Mg matrix and form supersaturated solid solution. As a result, the element is uniformly distributed on the modified surface of Mg alloy ZK60-1Y.

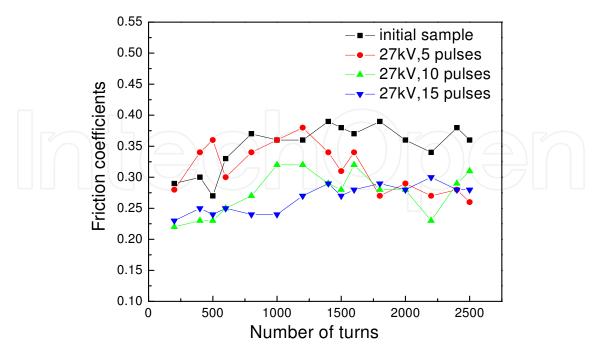
Fig. 3.10. Evolution of friction coefficients with the number of friction turns for Mg alloy ZK60-1Y before and after HCPEB treatment

Fig. 3.10 indicates the evolution of friction coefficients with the number of friction turns for Mg alloy ZK60-1Y before and after HCPEB treatment. From the figure, it can be seen that the friction coefficients of initial sample maintain around 0.28 at the initial friction stage. However, the friction coefficients of the sample are relatively high at the initial friction stage after 5 pulse treatment, around 0.35. It mainly because the sample surface is not even and the pure Mg particles are distributed on the modified surface, so the surface roughness is increased and the friction coefficients become higher. On the other hand, there is a layer of oxide film on the surface of the initial sample, and the surface roughness is smaller compared to that of the HCPEB-treated sample. Therefore, the friction coefficients of the initial sample are lower at the initial friction stage. With the increase in the number of friction turns, the friction coefficients of the initial sample present rising trend. Upon 1200 cycle friction, the friction coefficients maintain between 0.34 and 0.38. It is because that the oxide layer on the surface is worn away after a period of friction, therefore the matrix gradually touches stainless counterpart discs and shows high friction coefficients.

After 1400 cycle friction, the friction coefficients of the sample treated by HCPEB are lower than that of the initial sample, showing better wear resistance. The reason can be summarized as:1) the grain structure in the remelted layer after HCPEB treatment is refined, namely fine-grain strengthening effect; 2)the enrichment phenomenon of alloying elements is improved, and the chemical composition is distributed evenly and the mechanical property is further enhanced on the ZK60-1Y Mg alloy surface. With the progressing of wear test (after 1800 cycle friction), the friction coefficients of HCPEB treated sample are much lower. It is because the surface at the remelted layer has been worn away basically. Then the remelted layer in this layer has better wear resistance. In the whole friction test, the friction coefficients of the alloy don't fluctuate drastically and maintain between 0.23 and 0.30 after 15 pulse treatment under the accelerating voltage of 27kV. With the increase of pulse number, the times of rapid solidification occurred on the treated sample surface is increased accordingly, thus the alloying elements are distributed evenly and the mechanical property of the alloy surface is more stable. To sum up, compared to the initial sample, the surface of Mg alloy ZK60-1Y has better wear resistance after HCPEB treatment.

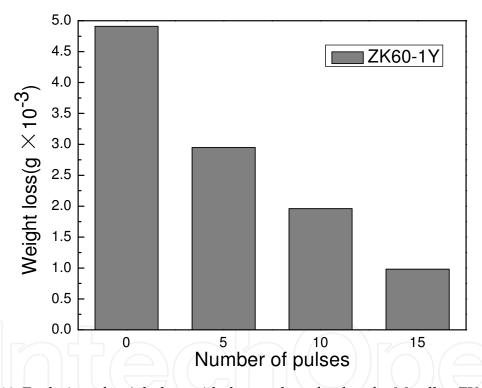
Fig. 3.11. Evolution of weight loss with the number of pulses for Mg alloy ZK60-1Y before and after HCPEB treatment

Fig. 3.11 refers to the evolution of weight loss with the number of pulses for Mg alloy before and after HCPEB treatment. From the figure, it can be seen that the weight loss of the sample is reduced from 4.91×10^{-3} g of initial sample to 0.98×10^{-3} g after 15 pulse treatment. It indicates that the wear resistance of the sample by HCPEB treatment is greatly improved under same friction condition. The weight loss of the sample by 5, 10 and 15 pulse treatments is reduced by 39.9%, 60.1%, 80% respectively compared to that of the initial sample. That means the wear resistance of the sample is the best after 15 pulse treatment under the accelerating voltage of 27kV and the relative wear resistance is improved by a factor of 5. It can be attributed to the changes in the microstructure of ZK60-1Y Mg alloy

During the HCPEB treatment, the rapid melting and solidification process is completed on the surface of Mg alloy ZK60-1Y, and the grain boundaries on the surface become less obvious. The chemical composition tends to uniform distribution and some pure Mg particles are distributed on the alloy surface. According to the analysis of cross sectional structure, it indicates that a remelted layer with the thickness of ~12µm is formed on the surface of Mg alloy ZK60-1Y, which possesses much compact and refined structure compared to the matrix. According to friction and wear test, the wear resistance of Mg alloy ZK60-1Y surface is obviously enhanced after HCPEB treatment and the friction coefficients and weight loss are reduced compared to that of the original sample. The wear resistance of Mg alloy ZK60-1Y by 15 pulse treatment is the best and the relative wear resistance is increased by a factor of 5.
