New Non-Destructive Methods of Diagnosing Health of Gas Turbine Blades

Józef Błachnio^{1,2}, Mariusz Bogdan² and Artur Kułaszka¹

¹*Air Force Institute of Technology, Warszawa,*

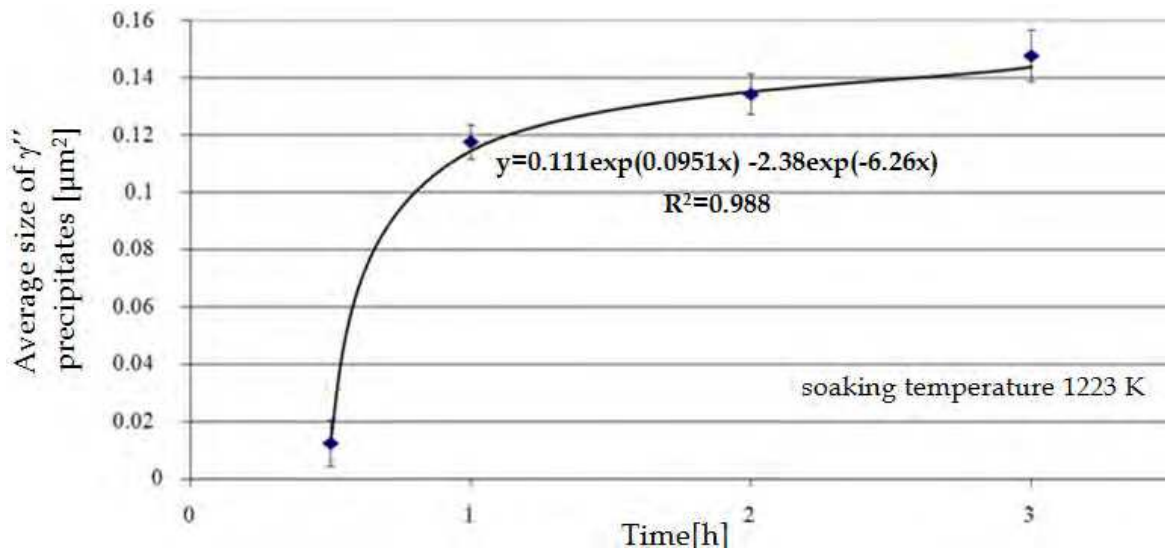
The dedicated software to analyze images of the material microstructures (Bogdan, 2009) in was used to determine alterations in size (surface area) of precipitates of the strengthening γ' phase against the soaking time (Fig. 3).

Fig. 3. Variations in the average size of γ' precipitates against time of soaking the specimens

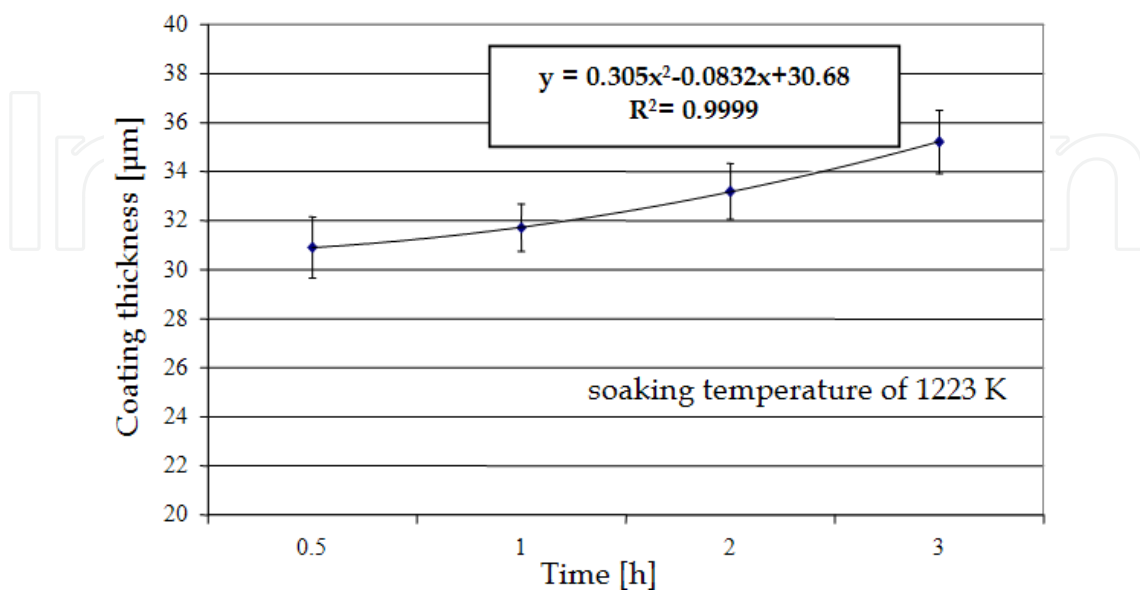
Fig. 6. Soaking-time dependent variation in thickness of the protective coating

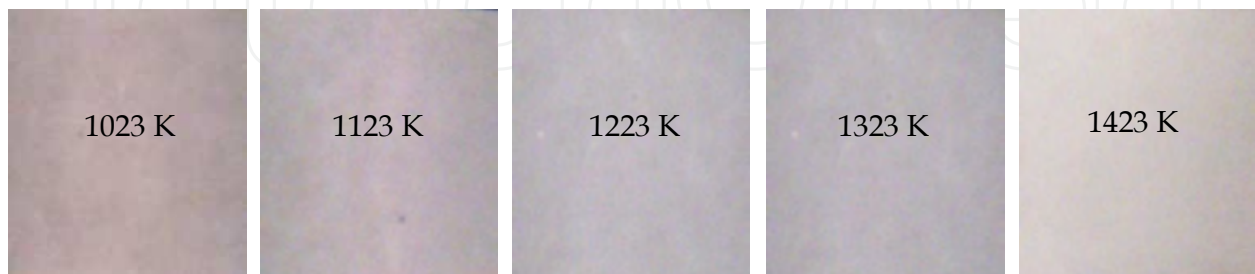
Images of surfaces of blade specimens were acquired both before and after specimens soaking in the furnace. The photos were taken on a purpose-built workbench (Bogdan & Błachnio, 2007; Błachnio & Bogdan, 2008;) with a digital photo camera, while the surfaces were illuminated with scattered white light. Repeatability of the obtained results was proved by taking multiple photos of the same specimens, under the same conditions with appropriate settings of parameter of the digital photo camera. The soaking of blade specimens in the furnace led to alterations in colour of the surfaces. An exemplary set of images is shown in Fig. 7.

Fig. 7. Images of surfaces of specimens soaked at various temperatures

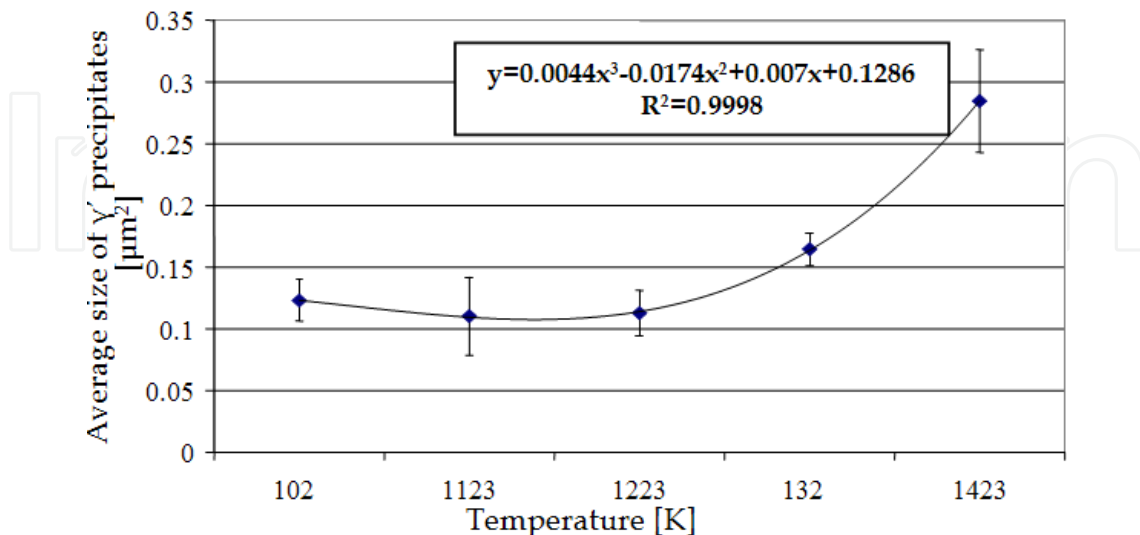
the graphic relationship between the average value of the γ' strain hardening phase emissions and the heating temperatures for the EI 867-WD alloy is plotted in Fig. 12 and demonstrates the exponential nature, but can be approximated with a polynomial.

Fig. 12. Variation in γ' particles of average size against temperature

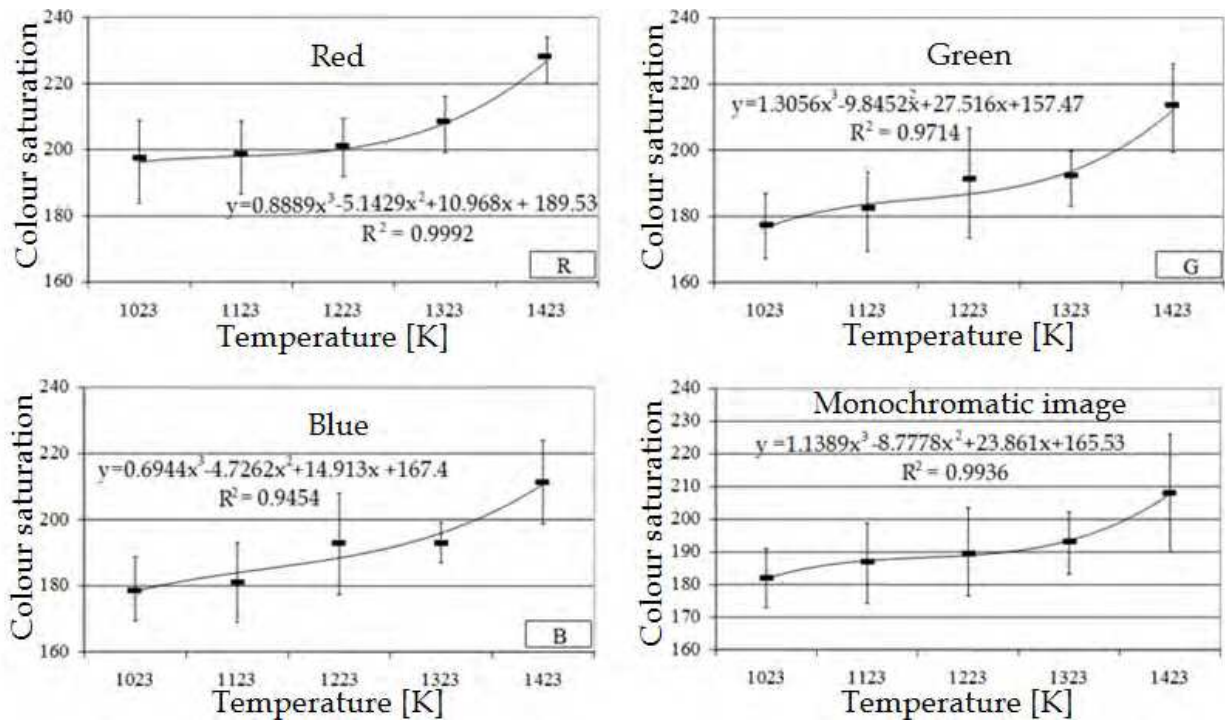
maximum saturation amplitudes (for individual histograms representing distributions of brightness of digital images (Bogdan, 2008) – Fig. 13.

Fig. 13. Changes in locations of maximum amplitudes of saturation with RGB colours and shades of grey for various temperatures of specimen soaking

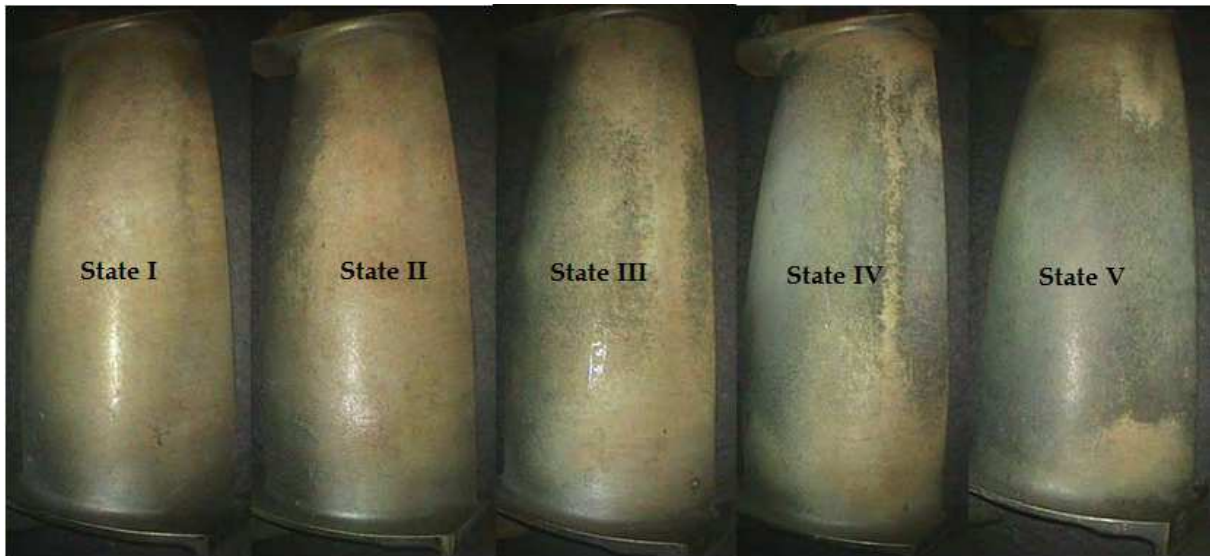
Fig. 17. Recording of vane surface images with a videoscope No. 2

Differences in colours of recorded images of turbine vanes surfaces result from properties of optoelectronic systems (chiefly, the CCD matrix) and variations in illumination (type of light) used in particular instruments. When images were taken with a photo camera, the illuminating light was uniformly scattered on entire surfaces of vanes, whilst the light emitted by videoguides was of focused nature.

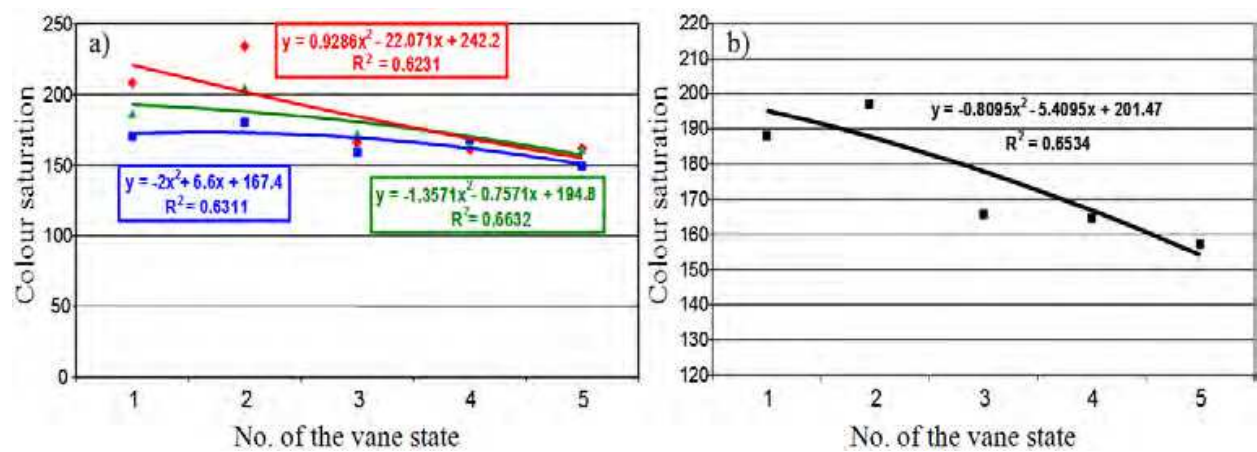
Fig. 18. Dislocation of the maximum saturation amplitudes of the image for various states of vanes: a) RGB components; b) grey shades

- for images recorded with the digital photo camera (Fig. 18):
- for images recorded with use of the videoscope No 1(Fig. 19):

The curves (trend lines) demonstrate correlation coefficients much worse than those obtained from laboratory tests. It has been caused by the forms of histograms (the colour range of images is wider). However, for images recorded with a digital photo camera the surface colour represents changes due to the exposure of the material to high temperature (Fig. 18). To recognise microstructures of vanes that had already been in operation further metallographic examination was carried out under laboratory conditions. As in the experiment with new blades subjected to soaking, the examination was carried out using metallographic microsections. Two microscopes were used: optical and scanning (SEM) ones. After long-time operation the vanes manufactured of the ZS6K alloy demonstrated different health conditions. On the basis of metallographic examination (Bogdan, 2009) it was found that initially, after some time of operation, the vane coating suffers no degradation and its thickness is nearly the same as that of a new vane. Later on, it starts to suffer swelling, which after a pretty short time may result in crack nucleation due to thermal fatigue. Since the working agent (exhaust gas) of high kinetic energy keeps affecting the vane material (the surface layer), successive changes in thickness of this layer follow. The coating is getting thinner and thinner and, therefore, loses its protective properties. Consequently, temperature of vane material grows by approx. 100 K and it is no longer protected against chemical effect of the exhaust gas. The vane becomes much more vulnerable to the exhaust gas, which results in complete deterioration of the protective coating or even the parent material. Furthermore, morphology of the γ phase has been found to prove that after critical temperature is exceeded the alloy becomes overheated. The turbine vane cannot be then considered serviceable (fit for use). Therefore, on the basis of findings of vane microstructure analysis it is possible to state that vane no. 1 (i.e. State I) exhibits correct microstructure, whilst the structure of vane no. 5 (i.e. State V) is overheated. When these results are compared to those of the analysis of blade surface images, it is possible to infer that vanes no. 1 and 2 are in sound condition, since parameters of image properties are comparable. On the other hand, vanes no. 4 and 5 are overheated, as values calculated from the histogram (as well as from the co-occurrence matrix) are much different from those for earlier discussed items. Thus, it is feasible to demonstrate correlation between

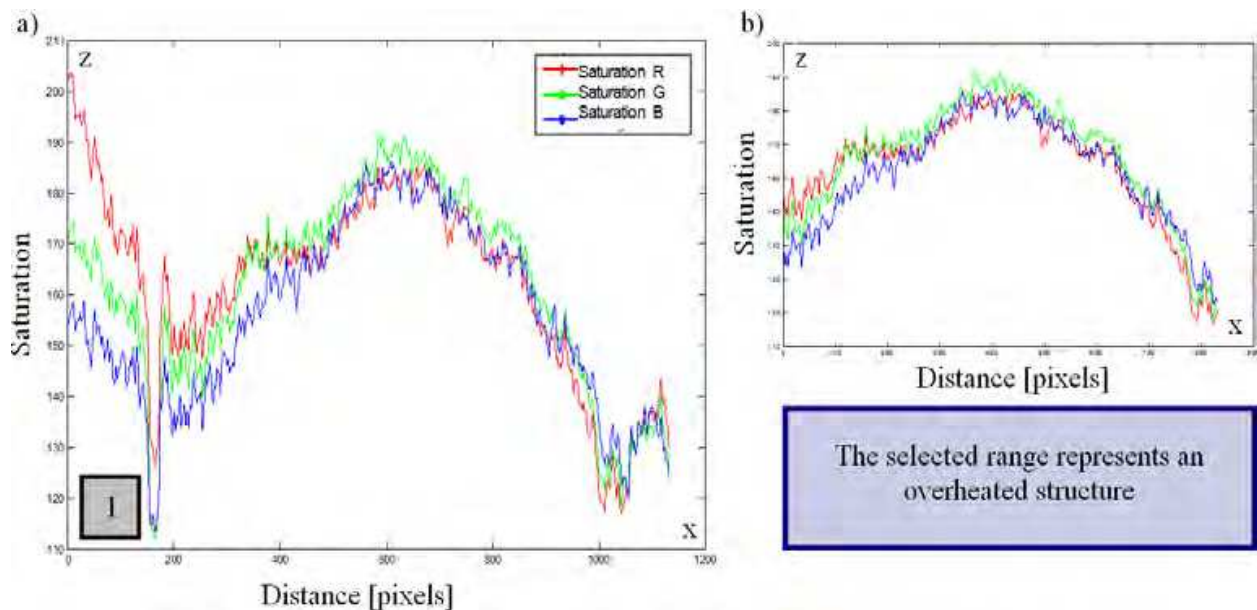
According to the already applied classification, the fifth condition (state) denotes an overheated vane. To verify this judgement, further metallographic examination was carried out along two cutting lines. The changes in the coating thickness (on the aluminium matrix) were measured and changes in size of precipitates and shape of the strengthening γ' phase (the scanning (SEM) microscope, the computer-aided analysis of metallographic images). Alterations in these two parameters are of crucial importance for the heat resistance and high-temperature creep resistance of turbine vanes. Thus, it was possible to plot an averaged colour profile (taking account of the width of cutting) that represents an overheated structure (the selected range along line 1 – Figs 21a, b, and a non-overheated structure (the selected range along line 2 – Figs 22 a, b).

Fig. 21. Averaged RGB profiles: a) along line no. 1 – parallel to the normal direction (KN); b) the selected range that represents an overheated structure

Next, on the basis of two ranges of colour profiles (Fig. 21b, Fig. 22b) each component (one pixel after another) of surfaces from states (I-V) of vanes was examined with regard to the occurrence of colour dots (RGB) that correspond to either overheated or non-overheated structure. Finally, the ratio of the overheated surface area to the overall surface area of the vane was obtained (Fig. 23).

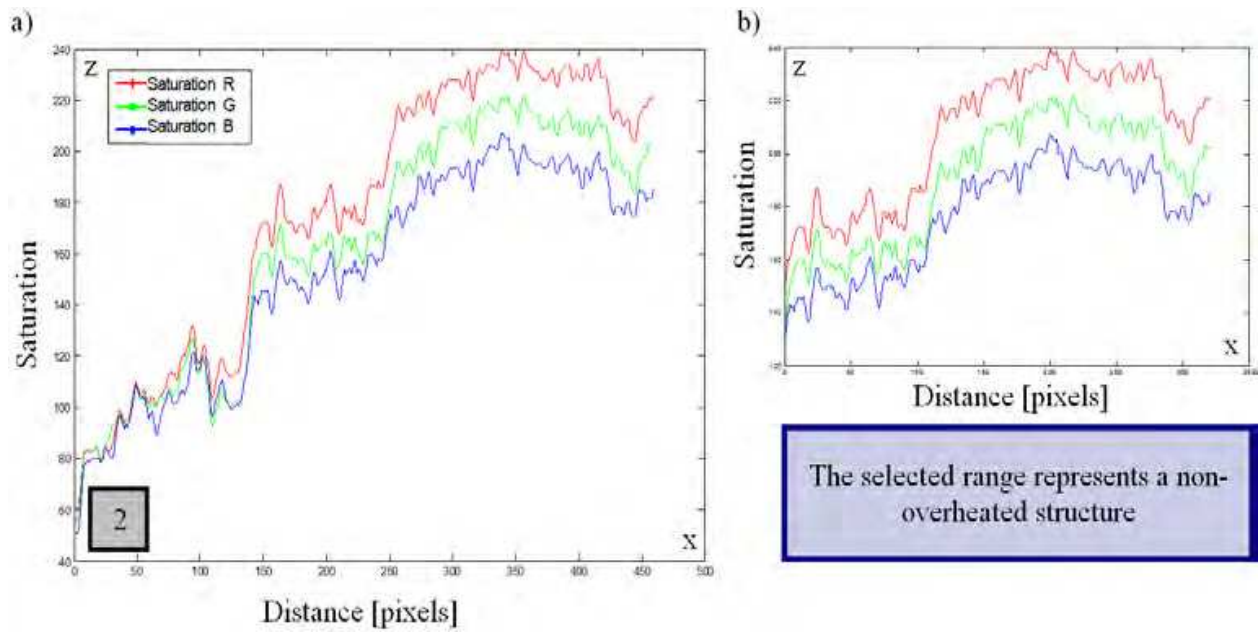
Fig. 22. Averaged RGB profiles: a) along the line no. 2 – perpendicular to the normal direction (KN); b) the selected range that represents a non-overheated structure

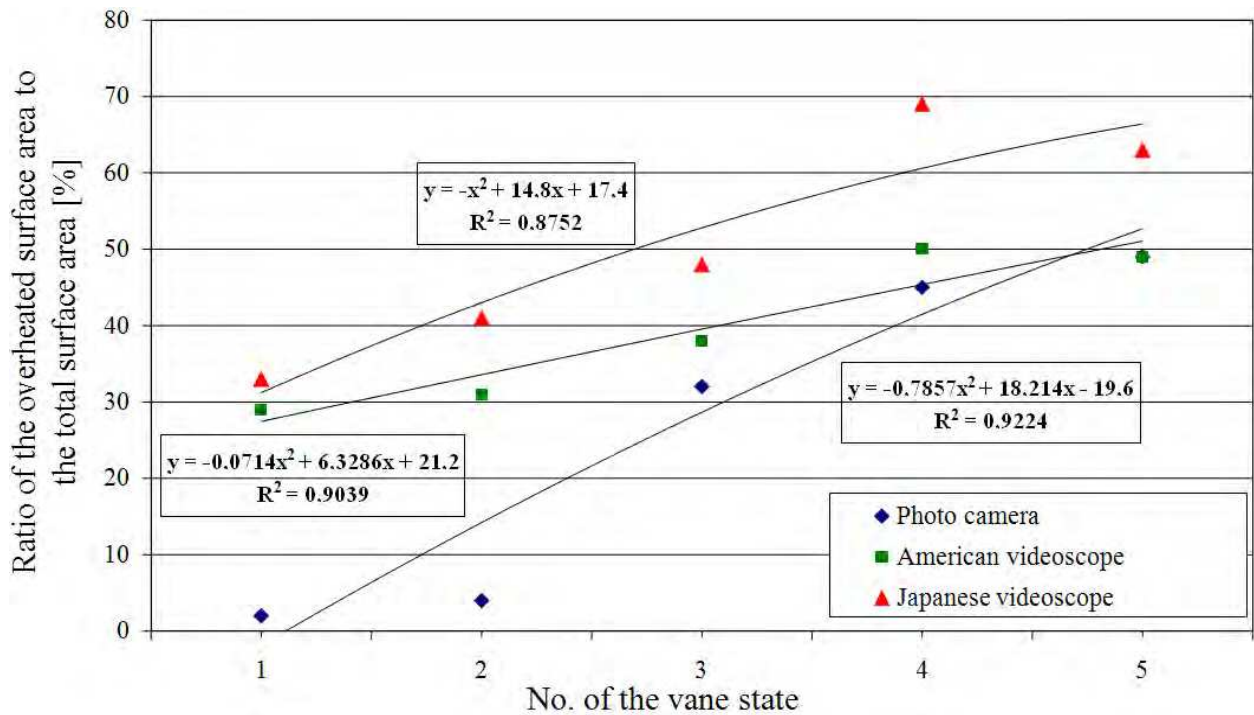
Fig. 23. Ratio of the overheated surface area to the total surface area for particular states of the vane – detection of images with a photo camera and two types of videoscopes

The best results were gained for images of vane surfaces recorded under laboratory conditions with the digital photo camera. On the basis of the plotted curves (Fig. 23, Fig. 26 and Fig. 27) one can conclude that changes in colours of vane surfaces reflect health/maintenance status of the examined turbine components. Application of one of the

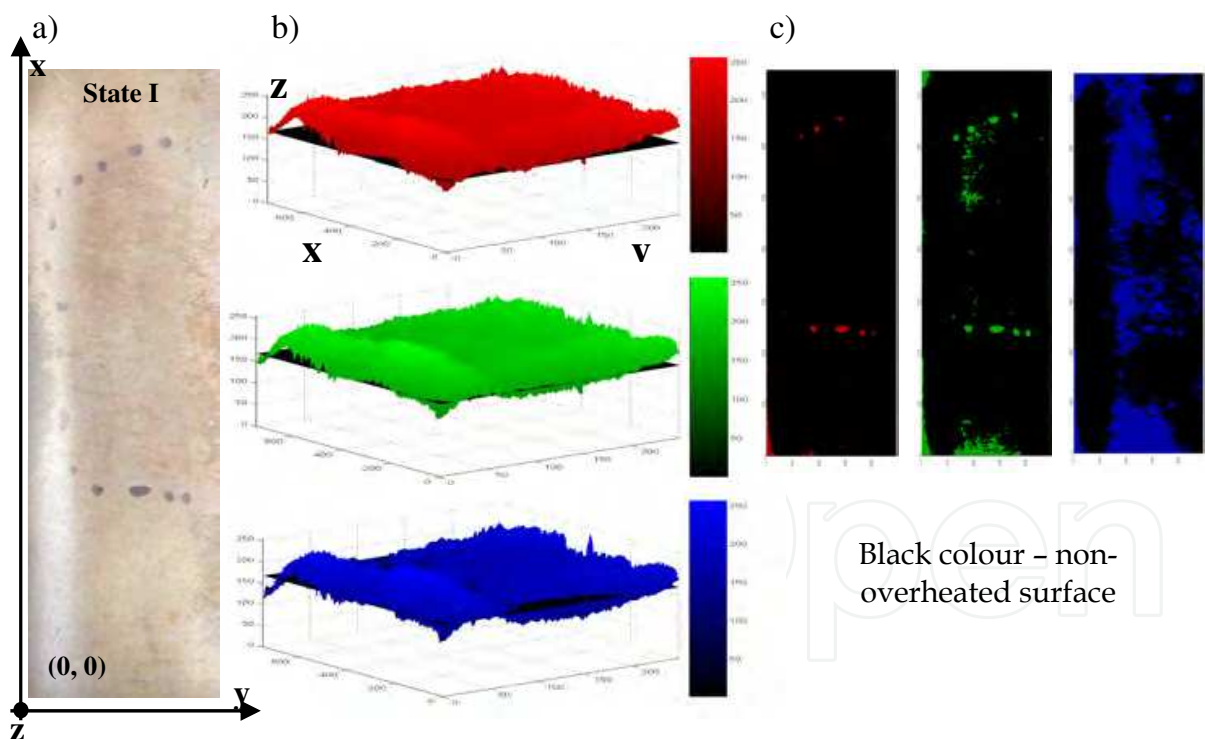
The dashed lines (Fig. 24a, Fig. 25a) represent the non-uniform effect of temperature on the vanes under examination, caused by faulty operation of injectors – irregularities in the combustion process inside the combustion chamber.

The area of overheated surface (the set of image points) extends as condition of vanes deteriorates - Fig. 24c, Fig. 25c. Introduction of the threshold plane (criterion of vane material overheating) in the 3-D charts of RGB distribution in images of surfaces of the turbine component under examination allows of the determination of the ratio of the overheated surface to the overall surface.(Fig. 26).

Fig. 24. Vane representing State I: a) surface image; b) 3-D distribution of RGB primary colours; c) vane surface viewed from below – the result of introduction of the criterion plane

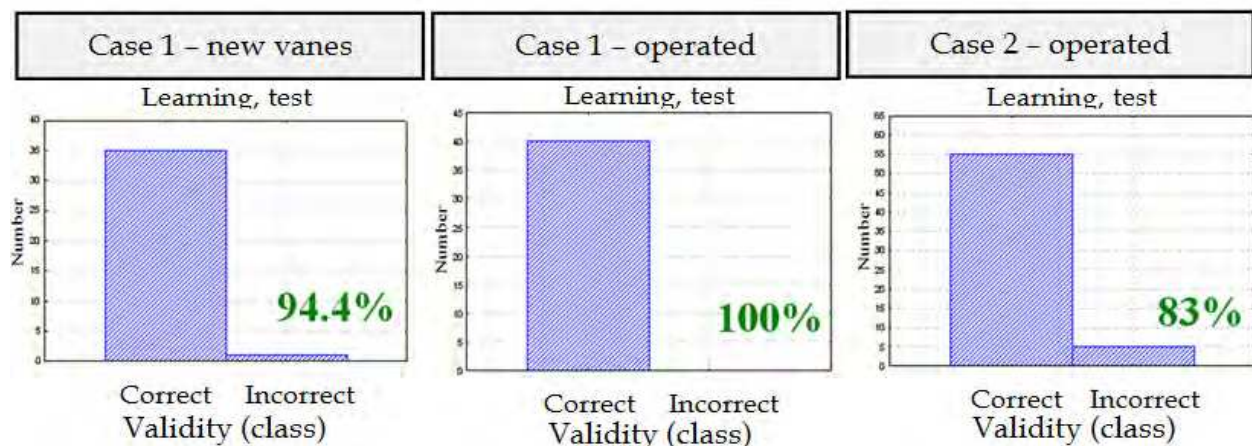
Fig. 30. Comparison between validity of classification

The network was subjected to the learning process with use of the set of input data. As a result of the simulation process, both in the learning and the test modes, the optimum models of neuronal networks were developed for each case (two-state and three-state classifications). It was confirmed that neuronal networks offer a useful tool to assess status of vanes, both new ones (after heating) and those that have already been in operation (Fig. 30).

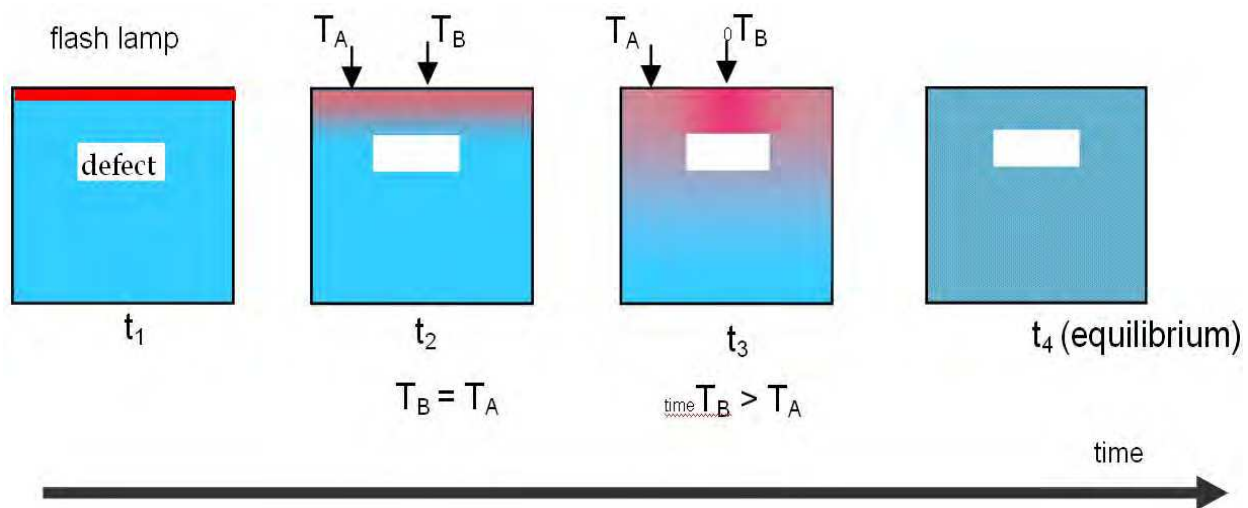
Fig. 32. Change in temperature of the specimen's surface after stimulation with an external heat pulse (Thermal Wave Imaging, Inc., 2009)

Thus, the monitoring of the temperature field on the surface of a specimen subjected to cooling provides capability to show locations of defects. The simplest method of processing the signal recorded with an infrared thermograph while cooling the examined surface down consists in calculating the temperature contrast. The contrast is defined by the following relationship (Oliferuk, 2008):

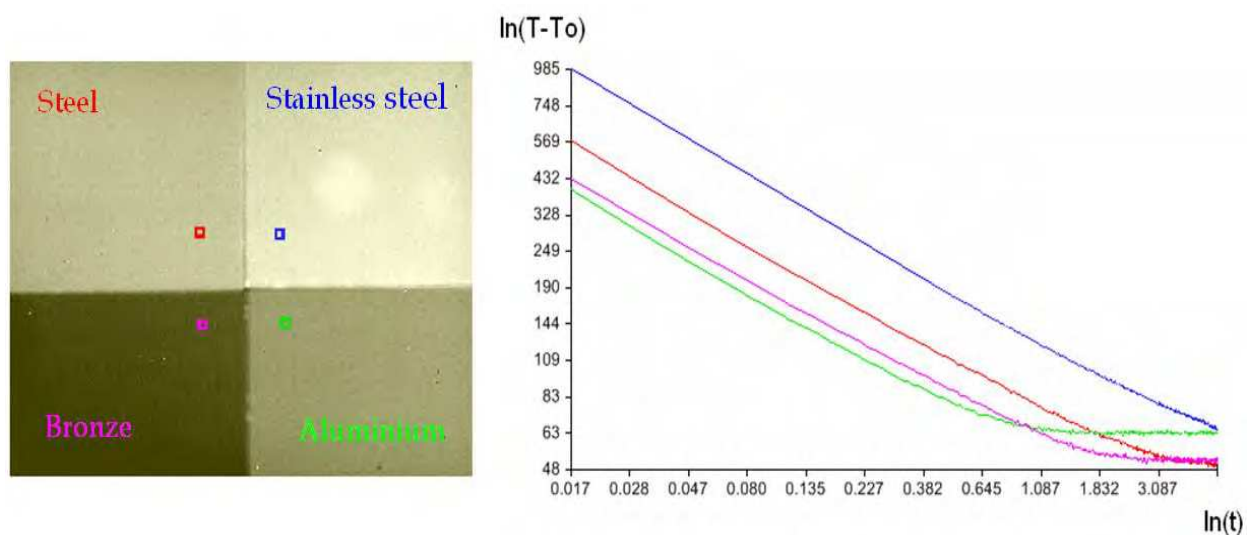
Fig. 34. Thermal response to a thermal pulse for selected grades of materials (Thermal Wave Imaging, Inc., 2009)

preliminary treatment with a thermal pulse. The acquired information contained in thermal response from the examined surfaces enables detection of other types or grades of materials present in the specimen (Fig. 34)

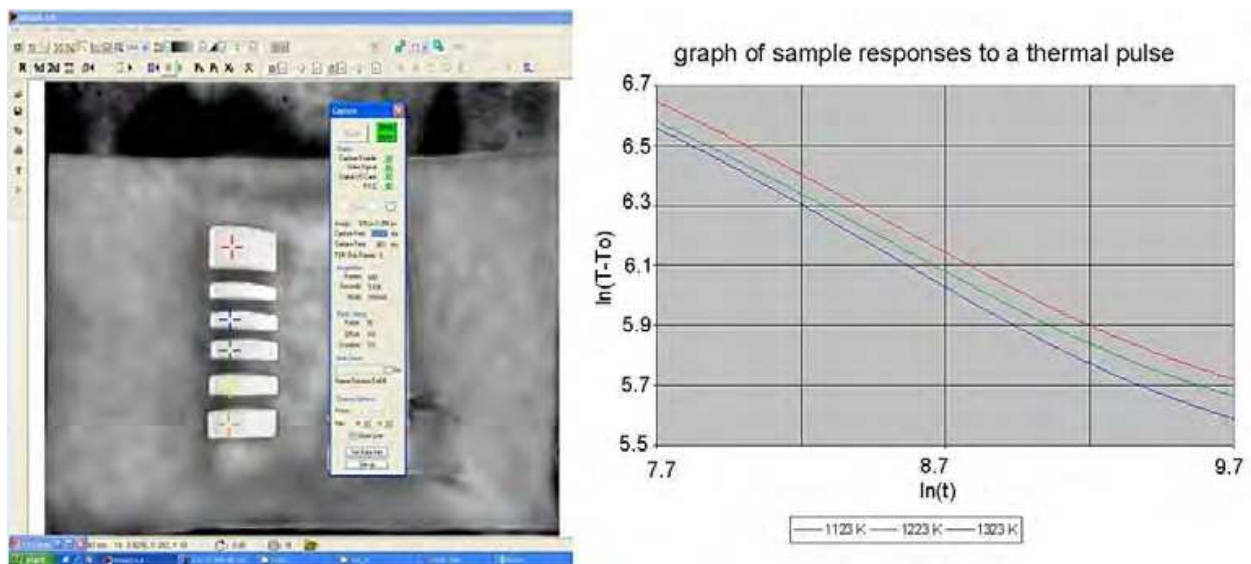
Fig. 36. Images of specimens cut out from blades (EI 867-WD alloy) subjected to soaking at 1123 K, 1223 K, 1323 K; graph of their responses to a thermal pulse

Results of examining turbine vanes and blades with the pulsed thermography methods while investigating into discontinuities in the subsurface layer of the material became the inspiration to embark upon further research on the feasibility of this thermographic technique to assess alterations in microstructures of gas turbine blades and vanes using available devices and instruments. The examination involved specimens from new blades made of the EI 867-WD alloy and subjected to thermal ageing in a furnace at various temperatures. What resulted were distinct changes in the relationships between parameters of the thermal response from specimen materials and stimulation by a thermal pulse (Fig. 36).

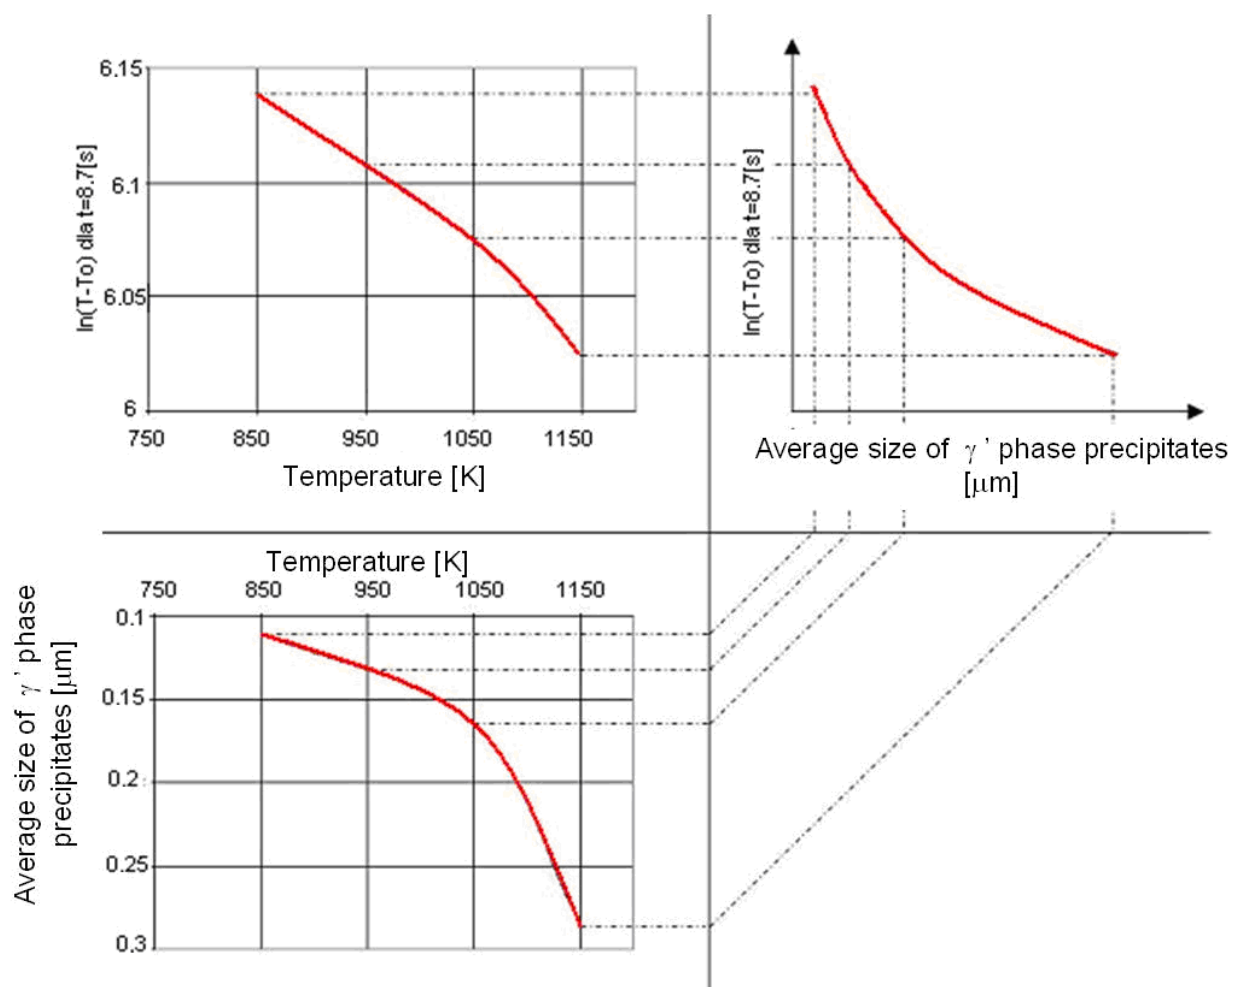
Fig. 37. Nomogram for the assessment of microstructures of specimens from gas turbine blades made of EI 867-WD alloy on the basis of relationship between change in $\ln(T-T_0)$ parameter and that in size of γ' precipitates at different soaking temperatures

$\text{Ni}_3(\text{Al,Ti})$. Findings of this examination are presented in Fig. 37 as a nomogram. The relationship between the thermal response of the specimen's material, represented as the value of $\ln(T-T_0)$ against the average size of the γ' precipitates allows of the assessment condition/health of the specimen material. This relationship, in conjunction with the knowledge on permissible changes in the microstructure, serves as a basis to judge whether the specimen's material remains fit for further service, or not.
