# **A Structural Health Monitoring of a Pitch Catch Active Sensing of PZT Sensors on CFRP Panels: A Preliminary Approach**

K.D. Mohd Aris, F. Mustapha, S.M. Sapuan and D.L. Majid

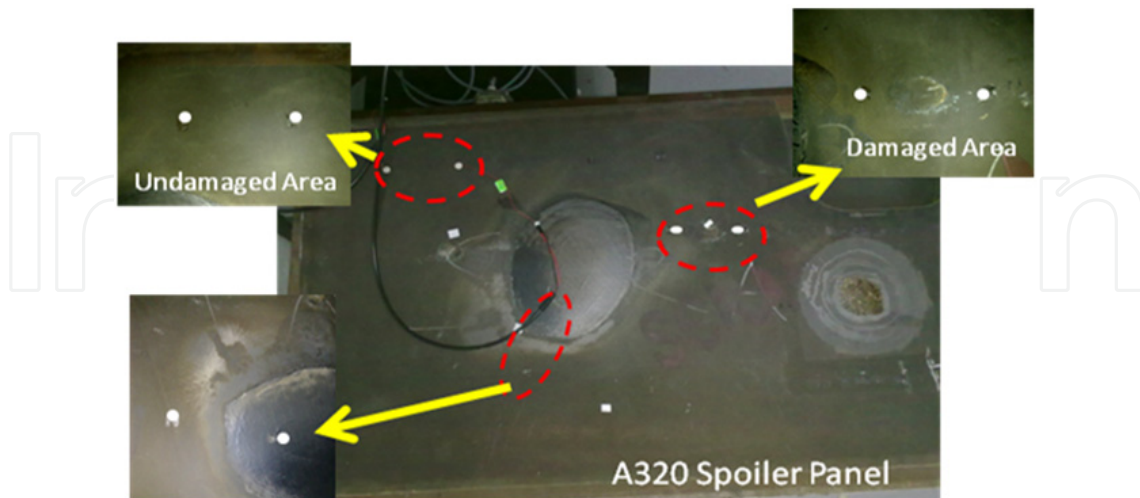
An aircraft spoiler was used for this research. The use of the structure is only arbitrary at this stage. It is use to seek the workability of the sensor upon trial on several flat panels. Three conditions were introduced to the panel which is the undamaged/ parent, damaged and repaired area. The undamaged/ parent was the area free from any defects. The undamaged area is the original conditions or controlled area. The damaged area was damage caused by impact that removes the top laminate. It was made by impacting the faced planes with a blunt object and creating damage less than 40mm diameter fracture. The level of impact is not an interest in this particular testing due to the studied conditions is only applicable to small surface damage due to impact. The repaired area was where the

damage plies were removed and replaced in accordance with the SRM [23]. The damaged area was repaired by scarfing method.

**Figure 1.** Locations of the structural conditions and PZT sensor placements

The PZT sensors were placed at 100mm apart for the three studied conditions. For damaged condition, the sensors were placed in between the damage area and for the repaired area, the sensors were replace across the actual and the repair doubler surface. This is to ensure

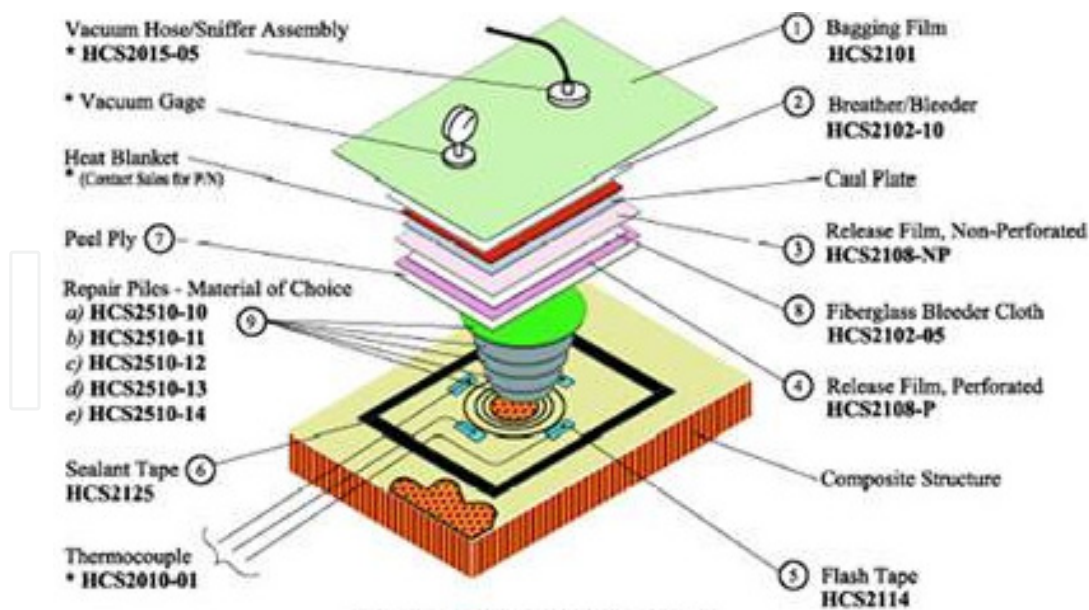
The repair was conducted by using hot bonder from Heatcon Inc. The Hexply® M10/38%/UD300/CHS/460mm CFRP pre-preg system from Hexcel Corp was used for the repair process. Care and take were observed to ensure similar procedures as per SRM recommendation. All plies were cut according to the sizes required and laid up accordingly. The affected area were vacuum bag as per Figure 2 and cured at 120°C at atmospheric pressure for 120 minutes. All vacuum bag materials were removed once the cycle ended.

**Figure 2.** Hot bonder materials sequence for repairing aircraft composite parts. [24]

bonding was cured in accordance with Aircraft Structural Repair Manual (SRM). A scarf cutting technique was used to remove the damage and replaced the affected its areas. Curing was achieved by using the Heatcon HCS4000 hot bonder with assisted consolidation from vacuum bag as per Figure 2. The parameters were ramp rate at  $3^{\circ}\text{C}/\text{min}$ , dwell time at 120 minutes, dwell temperature at  $121^{\circ}\text{C}$ , cooling rate at  $3^{\circ}\text{C}/\text{min}$  and vacuum pressure attained at 22 in mg/ 1 bar.

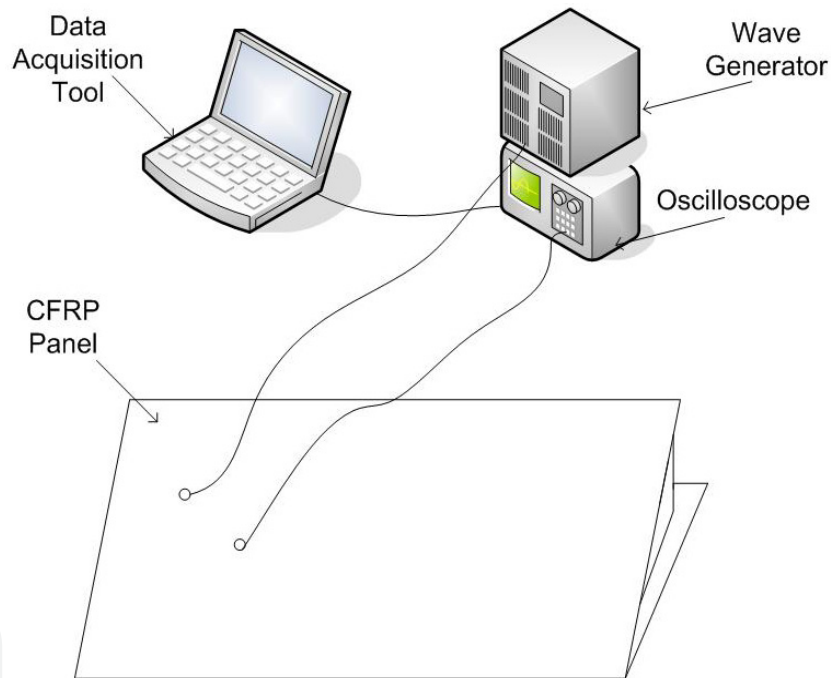
The receiving sensor modulated as the guided wave reached and transmit the energy to electrical signal. The received signals were saved for post processing by using oscilloscope. The arrangement of the equipment is shown in Figure 4.

**Figure 3.** Aircraft spoiler with PZT sensor on specimens set-up.

distance consistency of 100mm between the sensors. One of the sensors acted as an actuator. The actuator controls the surface guided in the form of elastic perturbation through the surface guided wave across the panel. The wave was controlled by a function generator with the setup as per Table 2.

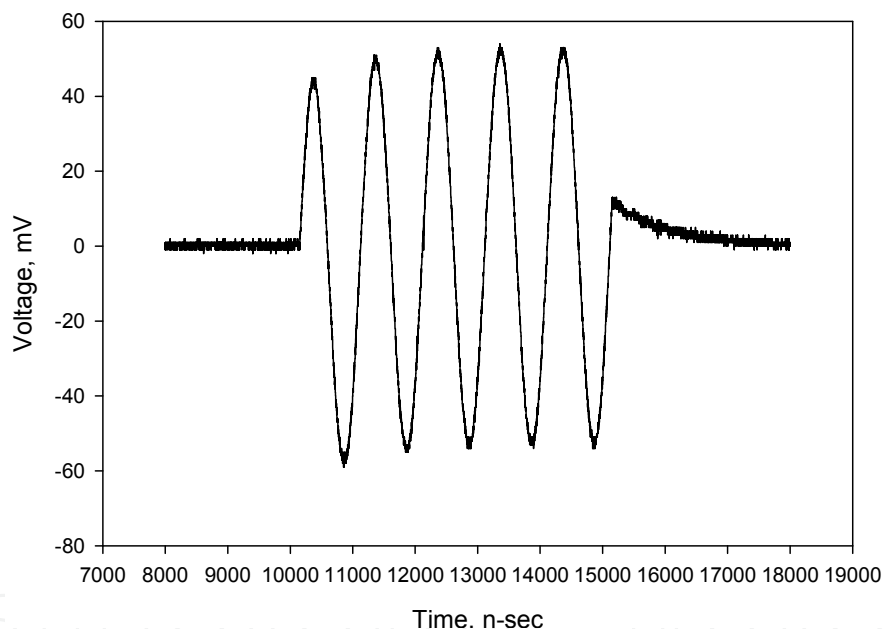
Statistical pattern recognition was used to analyze the lamb wave generated by the PZT actuator. [15] A total of 100 wave packets were taken for each conditions stated. Each wave packets consisted of 25000 points by default from the oscilloscope. From the 25000 points, it was then grouped to 1000 intervals data set for analysis. There were two significant spike occurred each at point 12000 ~ 13000 and 18000 ~ 19000 as shown in Figure 4. The reduction of data intervals were applied in order to assist the further analyze the distributions. By judgment, the first group of the spike was concerned and the data packet was zoomed again in 500 data intervals. Figure 6 shows the actuating signals for each of the testing. Consistence settings are required to ensure the wavelet generates similar wave perturbation throughout the experiment.

**Figure 5.** Actuating signals

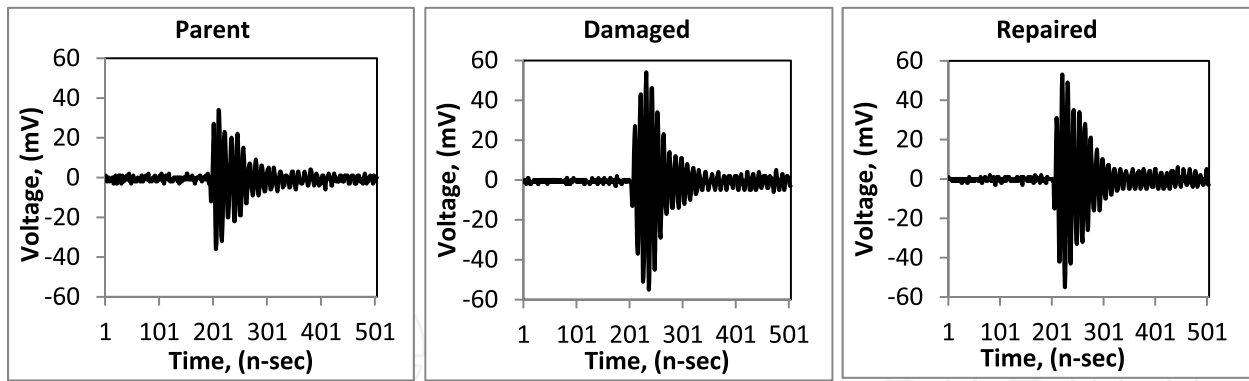
Figure 7 shows the results of the receiving wave packet upon synthesized by the points for each condition. Different behavior from the voltage ( $V_{pp}$ ) and complete time of flight cycle are shown which characterized the evaluated conditions.

**Figure 6.** Wave packet samples from a) undamaged, b) damaged and c) repaired structural conditions after synthesized.

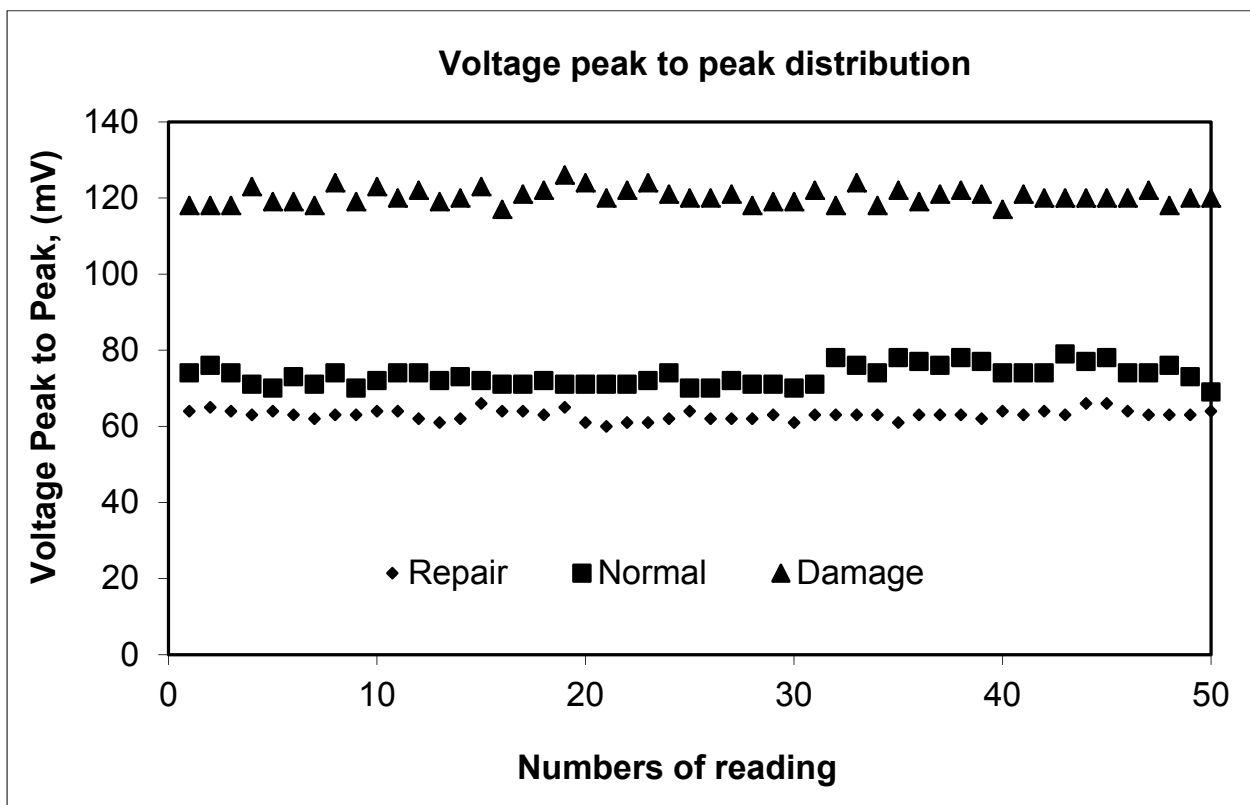
The  $V_{pp}$  showed similar values for the undamaged and damaged structure condition. It was assumed that the wave travel without discontinuity due to partial damage at that particular area. However several other types of damage need to be examined before any conclusive evidence can be finalized.

**Figure 7.**  $V_{pp}$  distribution among the structural conditions

Then, each of the receiving structural conditions wavelet data were compared between to ensure the signals was homogeneous to each other on the timeline basis. Since this is the unsupervised learning process the clusters were assigned to separate three conditions as stated in the methodology. The  $V_{pp}$  or voltage peak to peak is the attribute to distinguish the conditions. More than 50  $V_{pp}$  values were collected and tabulated. The scattering of the  $V_{pp}$  for the three conditions were examined and is shown in Figure 8.

1. The  $V_{pp}$  value for all tested condition showed a significant different due to the signal intensity once it passed the tested conditions. Although the undamaged and damaged signals are almost identical, the repair area shows a higher  $V_{pp}$  values. This might due to the additional plies of the repair and the bouncing of the intensification of the signal to travel the tested structure. The time of flight for the repaired reading was found to be delayed from the two conditions. The additional ply or doubler may contribute to the delay. This can promote detection of hidden repair area. The outlier behavior of the  $V_{pp}$  is an initial indications that PZT sensors can be used to detect interested conditions.

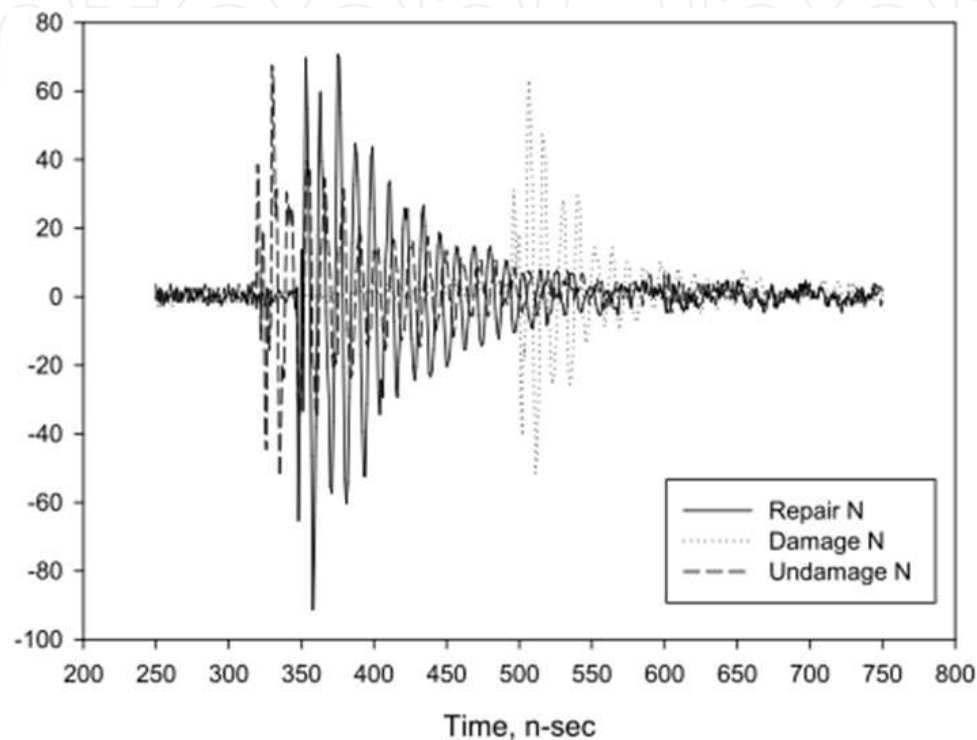
However, when all three data was overlapped, a significant different can be seen as shown in Figure 9. The undamaged signals appear at the initial time frame indicated that there was a clean surface wave traveling from the actuator to the receiver. However, once the partial damage was introduced, the spike appear later about 200nsec due to the discontinuity of the spoiler surface. The unaffected wave bifurcated to the receiver with delay. For the repair condition, since the surface integrity has been restored by the flush repair, the continuity of the surface wave was preserved again with delay about 50 nsec .

**Figure 8.** Overlay Outlier Pattern for different structural condition

A further post processing was carried out by overlapping the three conditions in one graph with similar time-domain comparison. The most common interest point lies within points 12250 ~ 12750. This was the first spike seen in the wave packet. In the earlier  $V_{pp}$  comparison, the distribution data between the damage and undamaged were identical. Therefore it was difficult to interpret the data for the latter machine learning process.

2. The overlay patten analysis show a promising results as it can bifurcate each of the conditions. The outlier analysis can be applied to differentiate the condition of the surface integrity. Due to separation of the fibers, the time for the Lamb wave to travel from the actuator to the receiver has been delayed and takes a longer time with the reduction of the  $V_{pp}$  value when compared to the repaired area.

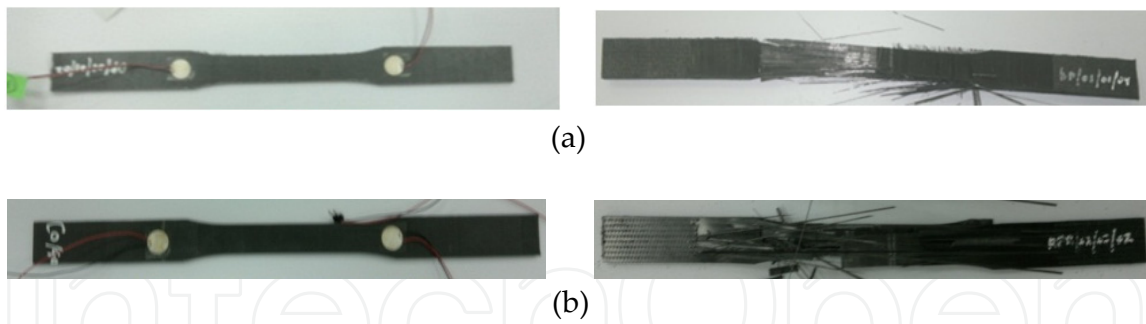
The tensile test results showed a similar behavior towards a brittle stress-strain curve. Below are the results of the tensile test on normal and repaired specimens. All specimens were found to have breakage at center. The fiber breakage for parent specimens occurred at arbitrary layer. However, for the repaired specimens, the breakage occurred at the intermediate bonding layer between the original layers and repair plies. This is due to the fiber discontinuity and the matrix is the only medium to transfer the stress from the parent surface to the repair surface.

**Figure 9.** CFRP result before and after tensile test for parent specimens for a) normal and b) repaired specimens

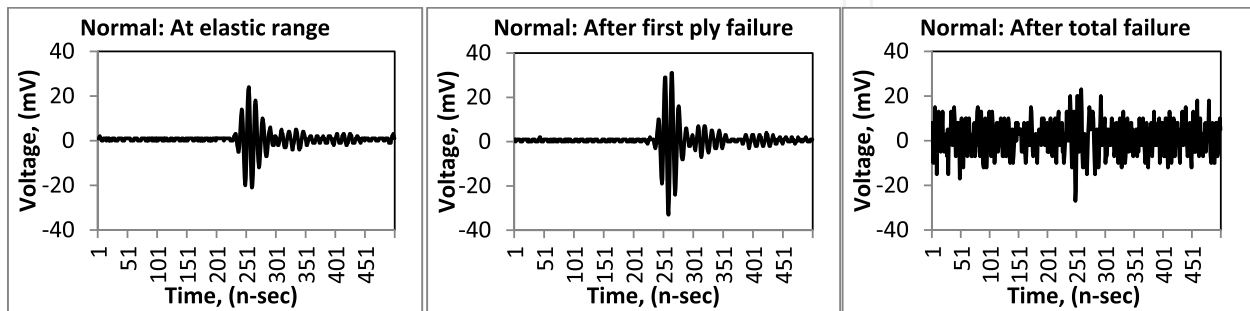
Based of the wavelet analysis from the Sigmaplot software, both conditions showed a significant changes at the investigated stages. At the elastic range, the wavelet shows a significant solid wave at the respective time of flight. However a slight change appeared after the first ply failure occurred. The  $V_{pp}$  values were found to be higher and there are also a distinct echo developed after the main wave packets. At the end of the testing, the signal lost its signature due to damage upon breakage of the panels. An online monitoring during the course of the test shown a good unique characteristics for anomalies to be identified.

**Figure 10.** Receiving signals for parent panel with a) at elastic range, b) after first ply failure and c) at failure.

3. The tensile test indicates that the materials behave in accordance with typical brittle materials. The breakage at the center indicates a good distribution of the load during the testing. The wavelet signals at the elastic area, within the first ply failure and total failure shows good indications of how the Lamb wave behaves before the specimen fails. However, the method of taking the PZT sensor receiver reading need to be improved as the fluctuation of the signals is unbearable.

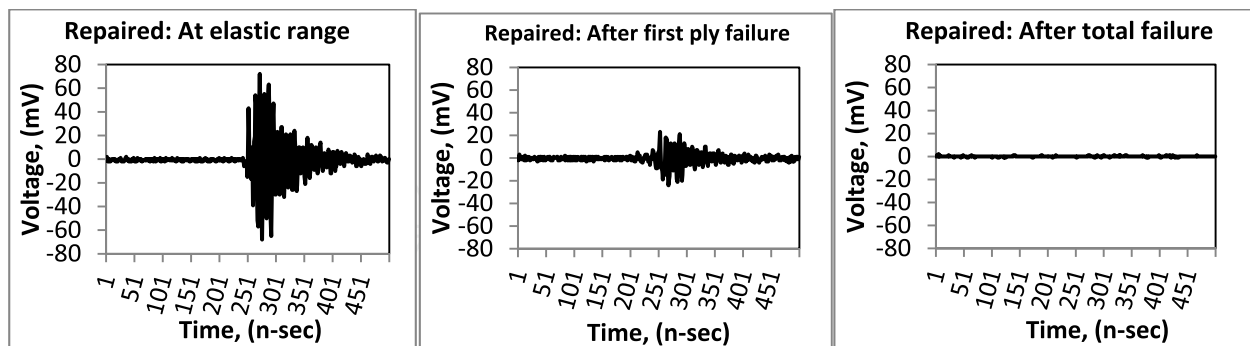
Figure 11 shows the behavior of the full repair panel throughout the testing. The degradation of the signal indicates the lamb wave attenuation has lost due to separation of the repair plies. This can be seen by 50% reduction of the  $V_{pp}$  at the initial of the testing. The significant reduction of the signal strength correlates with the structural integrity lost as the test reached the total fractured. Towards the end of the testing, all the specimen failed at the center and disintegration of the sensor due to the failure of the panels.

**Figure 11.** Receiving signals for parent panel with a) at elastic range, b) after first ply failure and c) at failure.
