Neutron Irradiation Effects in 5xxx and 6xxx Series Aluminum Alloys: A Literature Review

Murthy Kolluri

Abstract

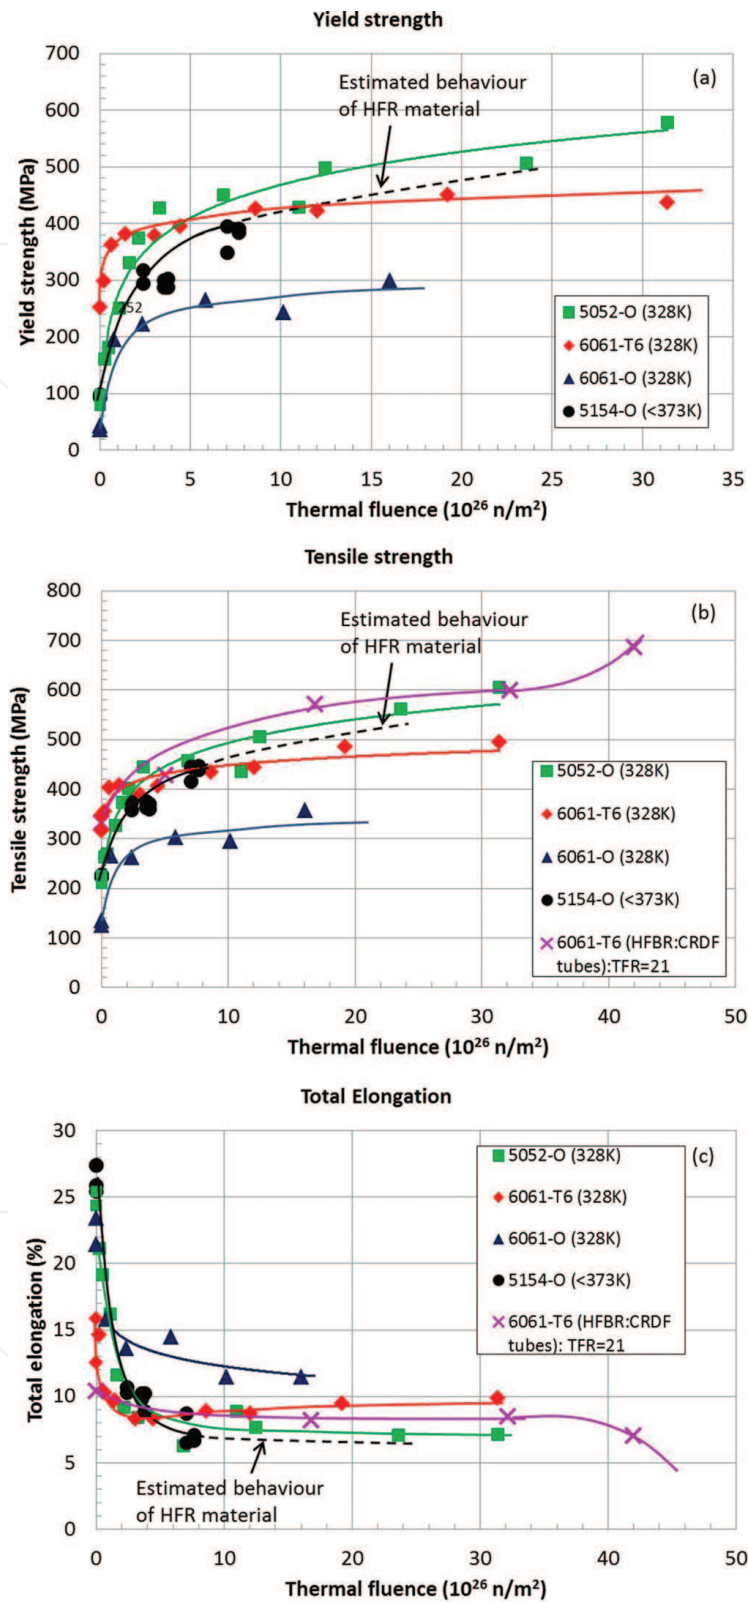
Figure 1. Literature tensile data of irradiated Al alloys in comparison with HFR SURP data. (a) Yield strength versus thermal fluence, (b) tensile strength versus thermal fluence and (c) total elongation versus thermal fluence.

Farrell et al. [3] published data on tensile behavior of 5052-O aluminum alloy (Al-2.2% Mg) heavily irradiated in HFIR to fluences greater than 10^{27} n/m^2 in contact with cooling water at 328 K (see **Figure 1**). HFIR is predominantly a thermal reactor with a strong fast neutron component. The thermal neutron fluence ($E < 0.0025 \text{ eV}$) of the samples ranged up to $\sim 31 \times 10^{26} \text{ n/m}^2$ to produce 7.15 wt.% Si. The fast neutron fluence ($E > 0.1 \text{ MeV}$) is a factor of 1.7 (=TFR)

lower than the thermal fluence, and results in a damage value of 260 displacements per atom (dpa). Associated gas generation due to fast neutrons was estimated to be 8.5×10^{-5} atomic fraction He and 5×10^{-4} atomic fraction H. It is important to notice that this data is very relevant to the HFR SURP program because of the (i) similar chemical composition of 5052 and 5154 alloys, except that Mg in 5154-HFR alloy is 3.2% instead of 2.2% in 5052 and (ii) similar irradiation conditions, including temperature, TFR, and high fluence values. Farrell et al. [2] also published tensile data on heavily irradiated 6061-O and 6061-T6 alloys irradiated at 328 K up to $\sim 31 \times 10^{26}$ n/m² and tested at three different temperatures (323, 373 and 423 K). **Figure 1** shows only results at 323 K due to their relevance to HFR operating conditions. Additionally, tensile strength data from a 6061-T6 type alloy tested from CRDF A-2 tubes of HFBR, published by Weeks et al. [5] are also shown in **Figure 1**.

Comparison of yield and tensile strength properties of all these alloys including HFR-SURP tensile data, shown with added trend lines in **Figure 1 (a, b)**, reveals specific trends in irradiation hardening and embrittlement behavior. Each of these alloys showed a rapid hardening regime (and corresponding drop in ductility) at the beginning, followed by a transition regime toward a relatively slow hardening (and stable ductility) regime. A brittle regime is observed in some alloys at the end, as shown schematically in **Figure 2**. Depending on whether an alloy is of 5xxx or 6xxx series, a single or multiple irradiation damage mechanism can be active, determining the hardening rates in each of these regimes.

In case of 6xxx series Al alloys, rapid hardening observed at the onset of irradiation (regime 1), for example, curves of 6061-O and 6061-T6 alloys (**Figure 1 (a, b)**), can be attributed to irradiation-induced dislocation damage. It is known that the irradiation-induced dislocation density rapidly increases at the beginning and reaches a saturation value (see Section 3.1) at relatively low fluence values. For steels irradiated at 603 K ($\sim 0.35T_m$), this saturation dislocation density is expected to reach around a fast fluence of $\sim 2 \times 10^{26}$ n/m² [15]. For Al alloys irradiated at temperatures about 323 K ($\sim 0.35T_m$), it is expected that saturation is reached at lower fluences due to the low effective displacement energy of Al (~ 25 eV) compared to Fe (~ 40 eV) [9].

The differences in irradiation hardening trends in all four regimes of 5xxx and 6xxx series alloys are depicted schematically in **Figure 2**. Both 5052-O and 5154-O alloys show similar irradiation hardening and embrittlement behavior (**Figure 1**) due to similar alloy microstructure and irradiation conditions. The unirradiated strength values of 5052-O and 5154-O alloys are lower, and ductility is higher than 6061-T6 alloy (**Figure 1**) due to the absence of Mg_2Si precipitates before irradiation. In the rapid hardening regime, the magnitude of irradiation hardening and embrittlement in 5xxx series alloys is observed to be much higher than 6xxx series, because both dislocation hardening (due to displacement damage) and precipitation hardening (due to the formation of Mg_2Si precipitates from transmutation Si) occur simultaneously in 5xxx alloys (see Section 3.1).

Similar to 6xxx alloys, a rough estimation of the total irradiation hardening contribution is performed for 5052-O and 5154-O alloys using Eq. (2) for the dislocation-hardening contribution and Eq. (3) for contribution from precipitation hardening. An average precipitate size of 10 nm and linear planar spacing between precipitates of 10 nm is used from the microstructure data presented in [3] on 5052-O alloy irradiated to a thermal fluence of 31×10^{26} n/m². This resulted in a total yield strength of 547 MPa (including unirradiated yield strength value of 85 MPa) for 5052-O, matching very well with the data presented in **Figure 1 (a)**. Similar analysis for 5154-O at a thermal fluence of 9.81×10^{26} n/m², with an average precipitate size of 8 nm and linear planar spacing between precipitates of 20 nm (obtained from **Figure 5**) [13] resulted in a total yield strength of 410 MPa, again matching with the trends seen in **Figure 1 (a)**.

In the rapid hardening regime (regime 1), the fracture toughness value drops rapidly in line with the observed hardening and ductility behavior of 5xxx alloys (**Figure 3** vs. **Figure 1 (c)**).
