# On the Fractography of Impact-Tested Samples of Al-Si Alloys for Automotive Alloys

Zheyuan Ma, Agnes M. Samuel,  
Herbert W. Doty and Fawzy H. Samuel

Castings were prepared from both industrial and experimental 319.2, B319.2 and A356.2 alloy melts, containing Fe levels of 0.2–1.0 wt%. Strontium-modified (~200 ppm) melts were also prepared for each alloy/Fe level. Impact testing of heat-treated samples was carried out using an instrumented Charpy impact testing machine. At low Fe levels and high cooling rates (0.4% Fe, dendrite arm spacing (DAS) of 23  $\mu\text{m}$ ), crack initiation and propagation in unmodified 319 alloys occur through the cleavage of  $\beta\text{-Al}_3\text{FeSi}$  platelets (rather than by their decohesion from the matrix). The morphology of the platelets (individual or branched) is important in determining the direction of crack propagation. Cracks also propagate through the fracture of undissolved  $\text{CuAl}_2$  or other Cu intermetallics, as well as through fragmented Si particles. In Sr-modified 319 alloys, cracks are mostly initiated by the fragmentation or cleavage of perforated  $\beta$ -phase platelets, in addition to that of coarse Si particle

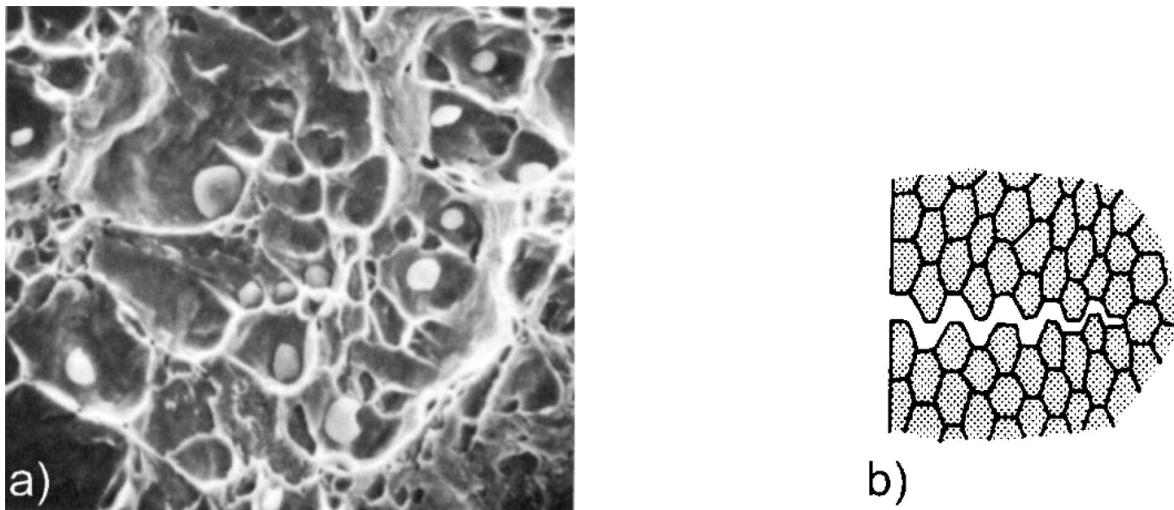
**Figure 1** shows two main types of fracture observed in the Al-Si alloy under tensile overloading. **Figure 1(a)** illustrates an example of the simple rupture mode of fracture, where the particles are observed at the bottom of the dimples. These particles are seen to have decohered from the surrounding matrix. In such cases, where decohesion of the particles takes place, the resultant fracture surface attains the dimpled appearance as seen in the figure. The alloy is said to have failed by the process of microvoid coalescence. The microvoids nucleate at regions of localized strain discontinuity, such as that associated with second-phase constituents, inclusions, grain boundaries, or dislocation pileups [4].

**Figure 1.** Two main types of fracture observed in Al-Si alloys under tensile overloading: (a) dimple rupture and (b) cleavage fracture of intermetallics [4].

**Figure 1(b)** represents an example of the cleavage fracture of intermetallics. Cleavage is a low-energy fracture that propagates along well-defined low-index crystallographic planes known as cleavage planes. Theoretically, a cleavage fracture should have perfectly matching faces and a completely flat and featureless surface. However, as the Al-Si alloys used are polycrystalline and contain grain boundaries, inclusions, and dislocations, these imperfections affect the propagating cleavage and alter the perfectly flat characteristics to a certain extent. Sometimes, the microconstituents present in the path of the propagating crack can result in the alloy sample exhibiting a mixed fracture mode, as was observed in the present study.

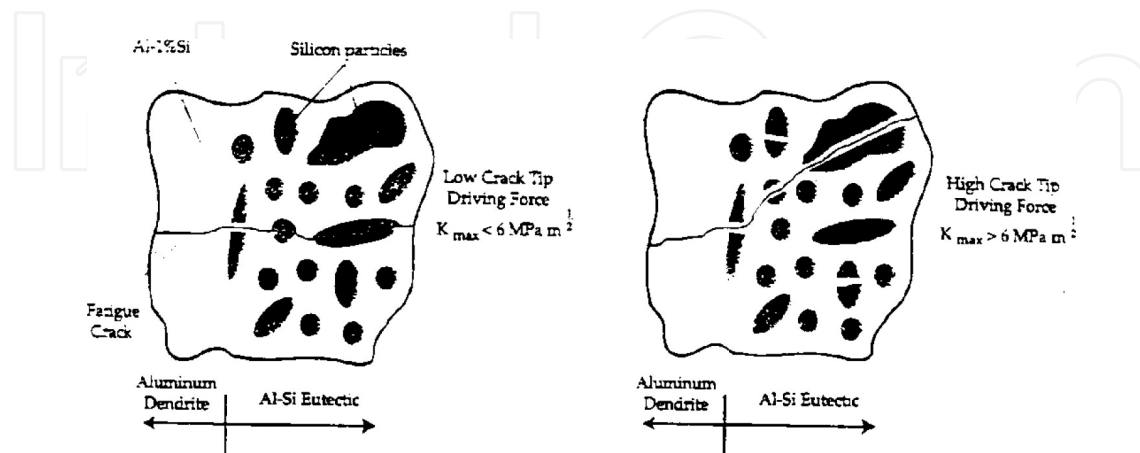
Ammar et al. [6] described the microstructure of A356 alloys consisting of primary Al-1% Si dendrites and a eutectic with silicon particles (12 pct volume) embedded in the Al-1% Si matrix. Room temperature constant amplitude fatigue tests revealed that for a low crack-tip driving force, the surface fatigue crack propagated primarily through the Al-1% Si dendrite cells. The silicon particles in the eutectic remained intact and served as barriers at low-fatigue crack propagation rates. When the fatigue crack crossed the three-dimensional Al-Si eutectic network, it propagated mainly along the interface between the silicon particles and the Al-1% Si matrix. Therefore, nearly all of the silicon particles were progressively debonded by fatigue cracks propagating at low rates, with the exception of elongated particles with a major axis perpendicular to the crack plane, which were fractured. For a high crack tip driving force, silicon particles ahead of the crack tip were fractured, and the crack subsequently propagated through the weakest distribution of prefractured particles in the Al-Si eutectic. Only small rounded silicon particles were observed to debond at high crack propagation rates. The crack process in the two cases is schematically depicted in **Figure 2**.

**Figure 2.** Schematic of the fatigue crack process through the silicon particle-rich eutectic regions at low and high crack-tip driving forces [7].

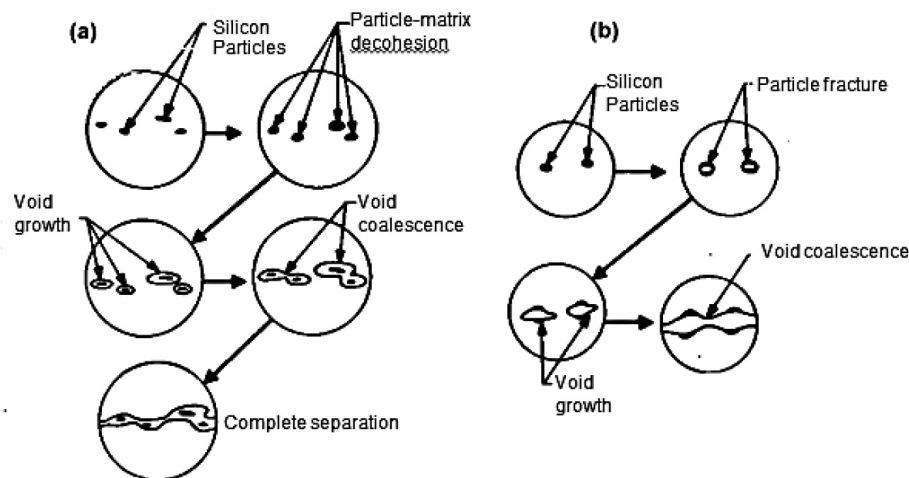
Figure 3 shows a schematic representation of the process.

Figure 3. Schematic illustration of fracture mechanisms based on Si particles. (a) Initiation by Si particle-Al matrix interface decohesion and (b) initiation by Si particle fracture [11].

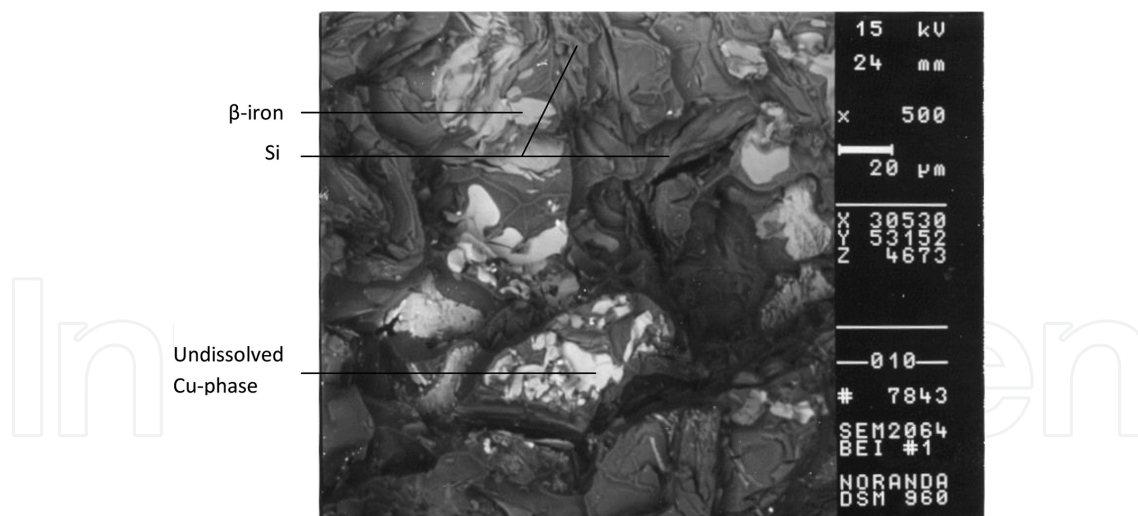
**Figure 4.** SEM micrograph showing fracture surface of alloy 319.2 (0.4% Fe, DAS 23 μm, unmodified, edge).

The features exhibited in **Figure 4** are typical of cleavage fracture, as is expected to be the case at high deformation rates during impact loading. The fracture plane changes orientation from grain to grain. A certain amount of intergranular cleavage is also observed in the form of secondary cracks. The fracture surface reveals the presence of  $\beta$ - $\text{Al}_5\text{FeSi}$  iron intermetallic platelets, undissolved  $\text{CuAl}_2$  or  $\text{Al}_7\text{Cu}_2\text{Fe}$  (insoluble phase) particles (since all alloy samples

were T6-heat treated), and acicular Si particles surrounding them. The fragmentation of all three particle types indicates that possibly all three could have acted as crack initiation sites. The microstructural constituents of interest in **Figure 4** and those that follow have been marked in each case.

The SEM fractographs of the 319.2 alloy sample corresponding to the 0.4% iron level and highest cooling rate are presented in **Figures 4** and **5**, taken respectively from the sample edge where the sample was hit during impact testing and the center of the sample surface.

Comparing the much higher magnification image of **Figure 8** (2000X) with that of **Figure 4** (500X), one may also estimate the much smaller sizes of the  $\beta$ -platelets obtained in the modified alloy. **Figure 9** shows fractured  $\alpha$ -iron script and Cu-containing phase (bright) particles. Due to the surrounding eutectic structure, the fracture surface is more reminiscent of ductile, rather than brittle fracture, in spite of the cracks observed in the  $\text{CuAl}_2$  particles.

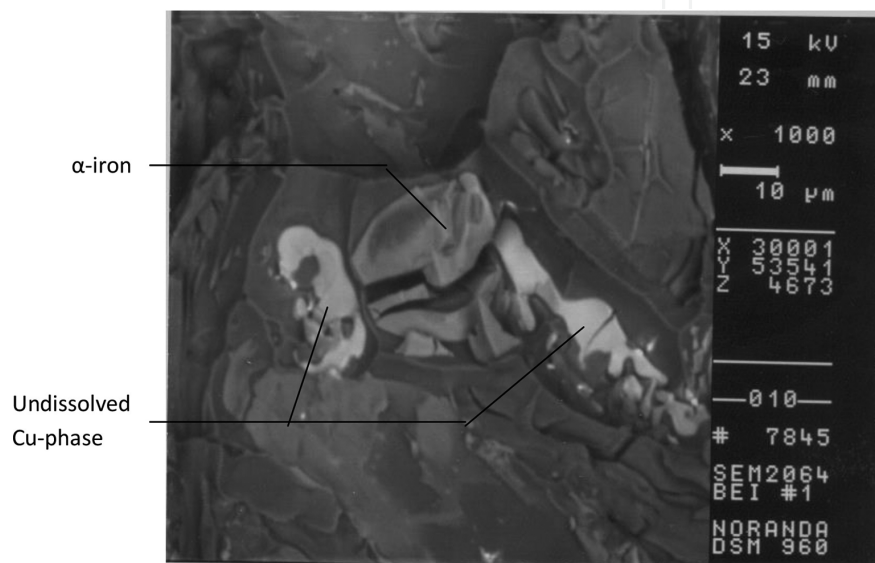
**Figure 5**, taken from the central region of the fracture surface of the same sample, shows a cracked  $\alpha$ -iron script particle, surrounded by brighter Cu-containing phase particles on either side. The presence of cracks within these particles confirms how crack formation is facilitated when such intermetallics are present in the microstructure.

**Figure 5.** SEM micrograph showing fracture surface of alloy 319.2 (0.4% Fe, DAS 23  $\mu$ m, unmodified, center).

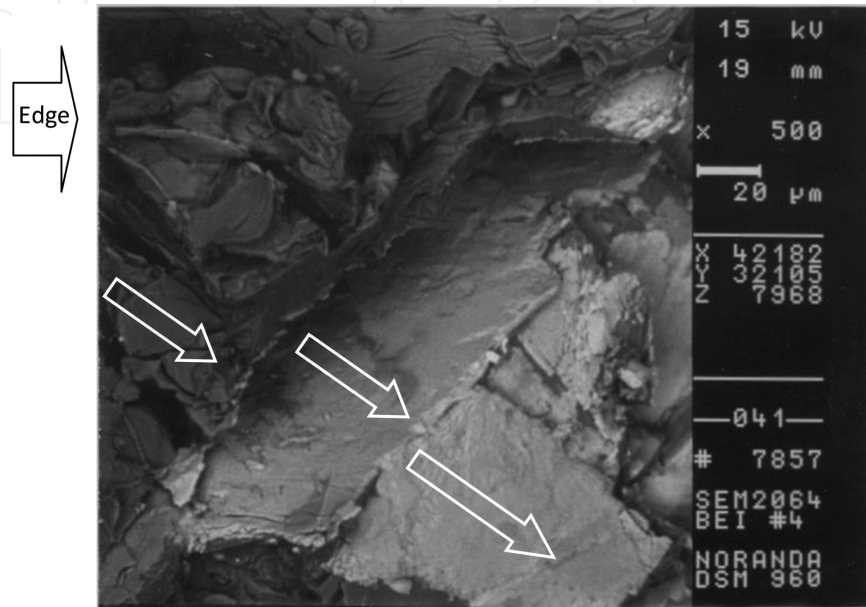
At the highest iron level (0.8%) and lowest cooling rate, the SEM fractograph of **Figure 6** reveals that crack initiation occurs by massive cleavage of the brittle  $\beta$ - $\text{Al}_5\text{FeSi}$  phase. A profusion of  $\beta$ -platelets is expected to be observed in the alloy microstructure at such Fe levels and, as can be seen, the crack propagates from one  $\beta$ -platelet across the other, along the direction delineated by the open arrows. In an ordinary two-dimensional optical micrograph, these  $\beta$ -platelets would appear in the form of branched needles. The much larger dimensions of the plate-like  $\beta$ - $\text{Al}_5\text{FeSi}$  phase would make it more susceptible to crack initiation compared to the Si particles, even if the latter occurs in brittle, acicular form in the unmodified alloy.

In cleavage fracture, the fracture path follows a transgranular plane that is usually a well-defined crystallographic plane, as is judged to be the case by the relatively smooth surfaces of the  $\beta$ -platelets seen in **Figure 6**. The central area of the fracture surface of the same sample, **Figure 7**, shows instances of the Cu-containing (brighter) phase, precipitated on the  $\beta$ -platelets, amplifying the likelihood for crack propagation through these locations. The crack propagates in the direction denoted by the open arrows, along the cleaved intermetallic particles. A number of secondary cracks are also observed in the vicinity. In keeping with the brittle fracture features observed in **Figures 6** and **7**, this sample exhibited a low impact energy of 1.90 J.

**Figure 6.** SEM micrograph showing fracture surface of alloy 319.2 (0.8% Fe, DAS 83  $\mu\text{m}$ , unmodified, edge).

**Figures 10** and **11** show SEM fractographs taken from the modified 319.2 alloy sample containing 0.8% Fe and obtained at the lowest cooling rate. Comparing **Figure 10** with **Figure 6** corresponding to the same alloy in the unmodified condition, the effect of Sr on the  $\beta\text{-Al}_5\text{FeSi}$  phase is evidenced, in the deteriorated appearance of the latter (see medium gray regions all over the fracture surface). The small bright spots in **Figure 10** correspond to particles of undissolved  $\text{CuAl}_2$ . In **Figure 11**, however, the bright regions (marked C) viewed on top of the  $\beta$ -platelets are Cu-containing phases, most likely  $\text{Al}_7\text{Cu}_2\text{Fe}$ . As observed by Li et al. [10, 33], this phase is insoluble even after 100 h solution heat treatment at  $500^\circ\text{C}$ . Compared to the flat surface of the  $\beta$ -platelet marked B, the perforated nature of those marked A is quite clear. Due to the high Fe content of the alloy, the volume fraction of  $\beta\text{-Al}_5\text{FeSi}$  phase, although considerable, appears distributed as smaller platelets all over the microstructure. It is interesting to note from the smooth surface of the  $\beta$ -platelet at B (and that at C below) that the  $\beta$ -platelets

A comparison with the fractograph shown in **Figure 6** (same Fe level, but lowest cooling rate) shows how a high cooling rate is more effective than the Fe content in determining the size of the  $\beta$ -platelets that result and, hence, the nature of the fracture, i.e., fragmentation or cleavage (this point is further brought out in the context of **Figure 16**). The corresponding  $E_V$ ,  $E_P$ , and  $E_T$  values of this sample are 6.18, 1.40, and 7.58 J, respectively. However, as **Figure 15** shows, the  $\beta$ -platelet can still fracture by cleavage, particularly in regions where several platelets have precipitated together. The smooth surface of the various  $\beta$  layers in the figure clearly indicate that fracture in this part of the specimen occurred by cleavage. It is not hard to imagine the branched appearance of these several platelets in a two-dimensional optical micrograph.

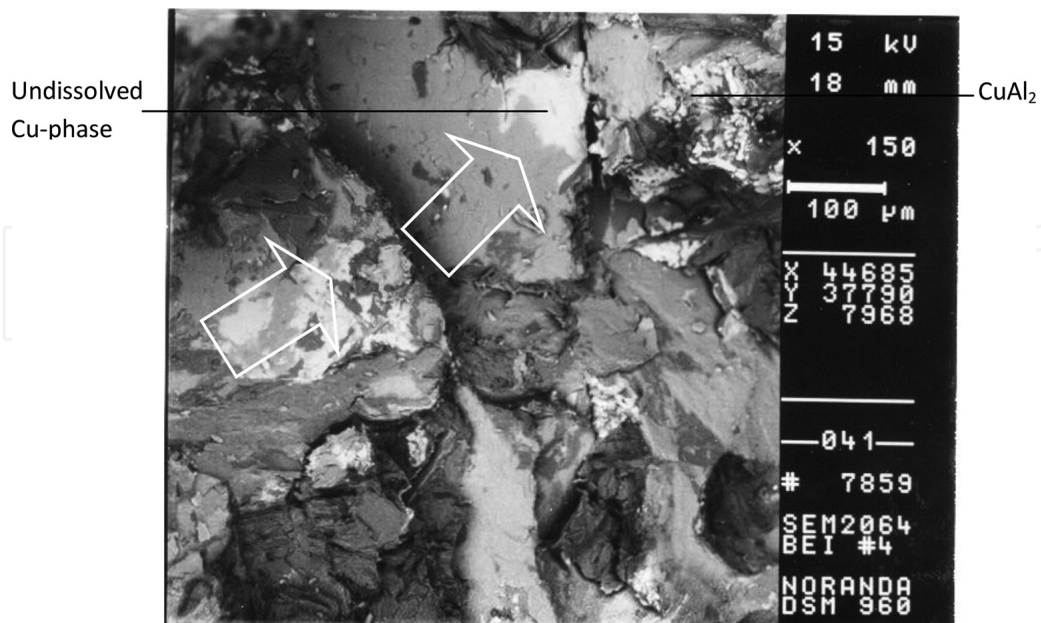
**Figure 7.** SEM micrograph showing fracture surface of alloy 319.2 (0.8% Fe, DAS 83  $\mu\text{m}$ , unmodified, center).

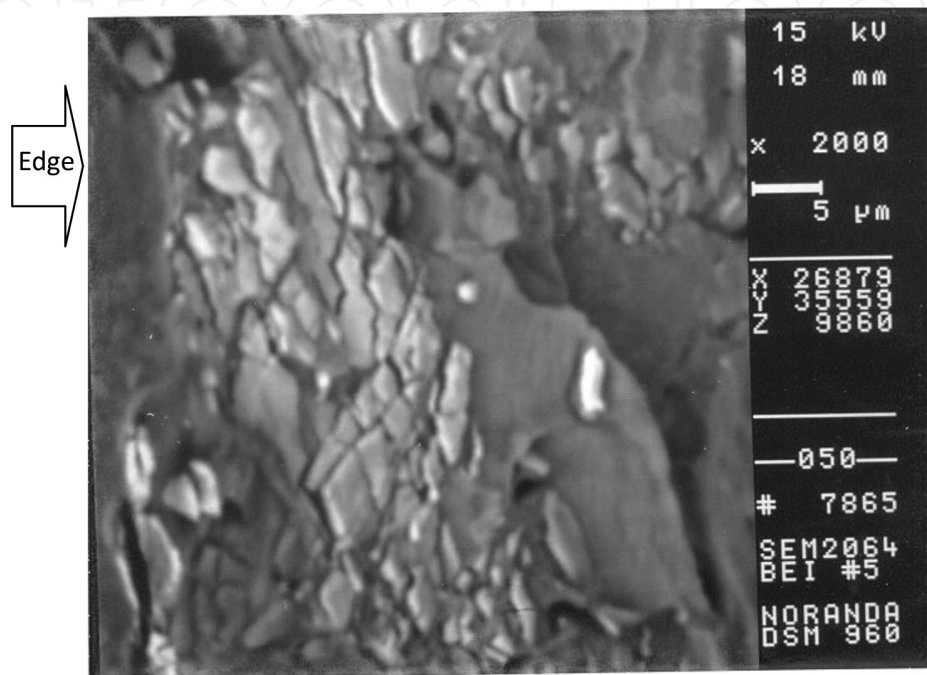
In the case of the modified 319.2 alloy containing 0.4% Fe and obtained at the highest cooling rate, the SEM fractographs, **Figures 8** and **9**, revealed considerably different characteristics. Upon application of a high deformation rate during impact loading, **Figure 8**, the  $\beta$ -platelet at the edge of the sample fragmented into several smaller segments, rather than undergoing cleavage as was observed in **Figure 4** for the unmodified alloy. Keeping in mind the effect of Sr (in the modified alloy) on the dissolution and fragmentation of the  $\beta$ - $\text{Al}_5\text{FeSi}$  phase, the

deterioration of the  $\beta$ -phase caused by Sr addition would more likely result in the fragmentation of the  $\beta$ -platelets rather than their cleavage (as observed in the case of solid  $\beta$ -platelets in the unmodified alloy). Consequently, crack propagation would proceed at a slower rate, leading to higher impact energy, as indicated by the  $E_V$ ,  $E_P$ , and  $E_T$  values of 16.39, 14.57, and 30.96 J, respectively. In addition, the transformation of the eutectic Si particles from acicular to fibrous form would also result in a more ductile fracture mode.

Figure 8. SEM micrograph showing fracture surface of alloy 319.2 (0.4% Fe, DAS 23  $\mu\text{m}$ , modified, edge).

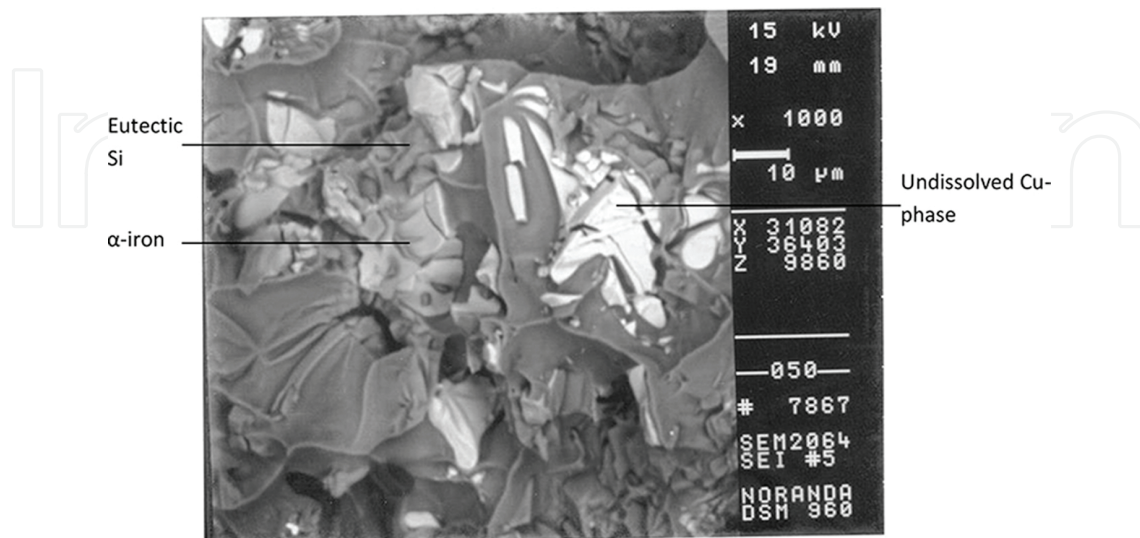
Figure 9. SEM micrograph showing fracture surface of alloy 319.2 (0.4% Fe, DAS 23  $\mu\text{m}$ , modified, center).

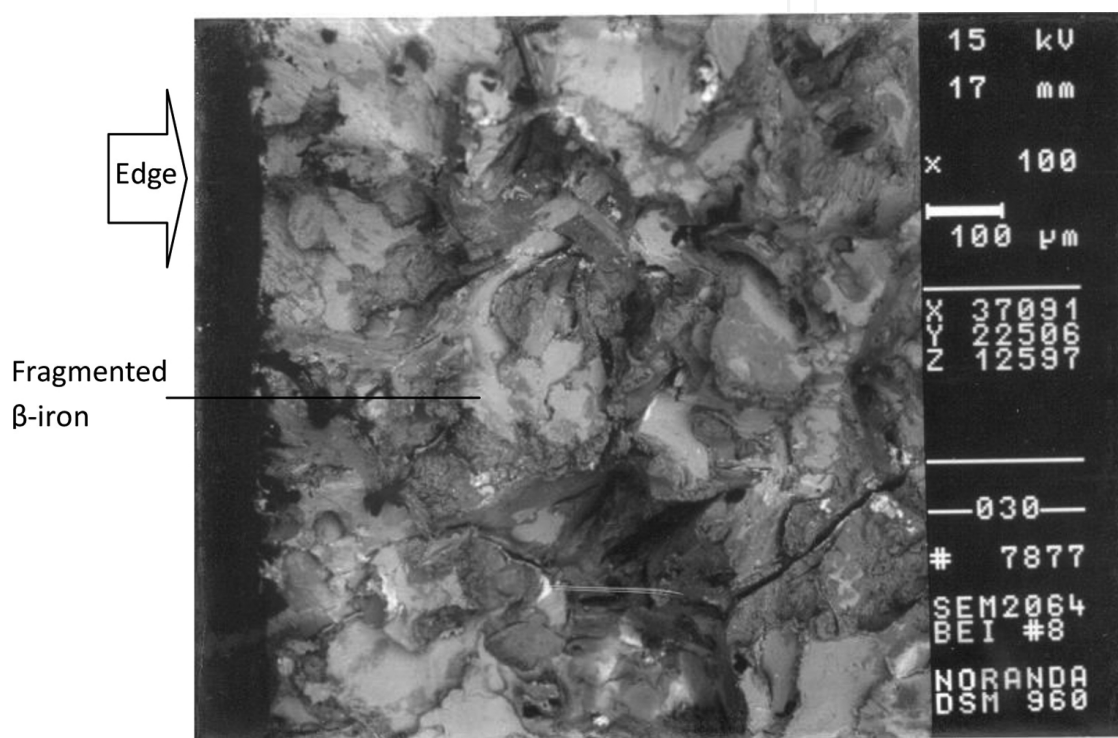
**Figure 10.** SEM micrograph showing fracture surface of alloy 319.2 (0.8% Fe, DAS 83  $\mu\text{m}$ , modified, edge).

not modified by Sr cracked by cleavage quite easily, whereas elsewhere, the crack passed through other regions (e.g., eutectic Si) as well, as evidenced by the intergranular cracking.

From the overall mode of fracture observed in **Figures 10** and **11**, the modified alloy exhibits more resistance to crack propagation than that offered by the unmodified alloy (cf.  $E_I$  and  $E_P$  of 1.30 and 0.60 J with 1.63 and 1.43 J in the unmodified and modified alloys, respectively) where the brittle fracture/cleave features reflect the ease of crack propagation in that sample.

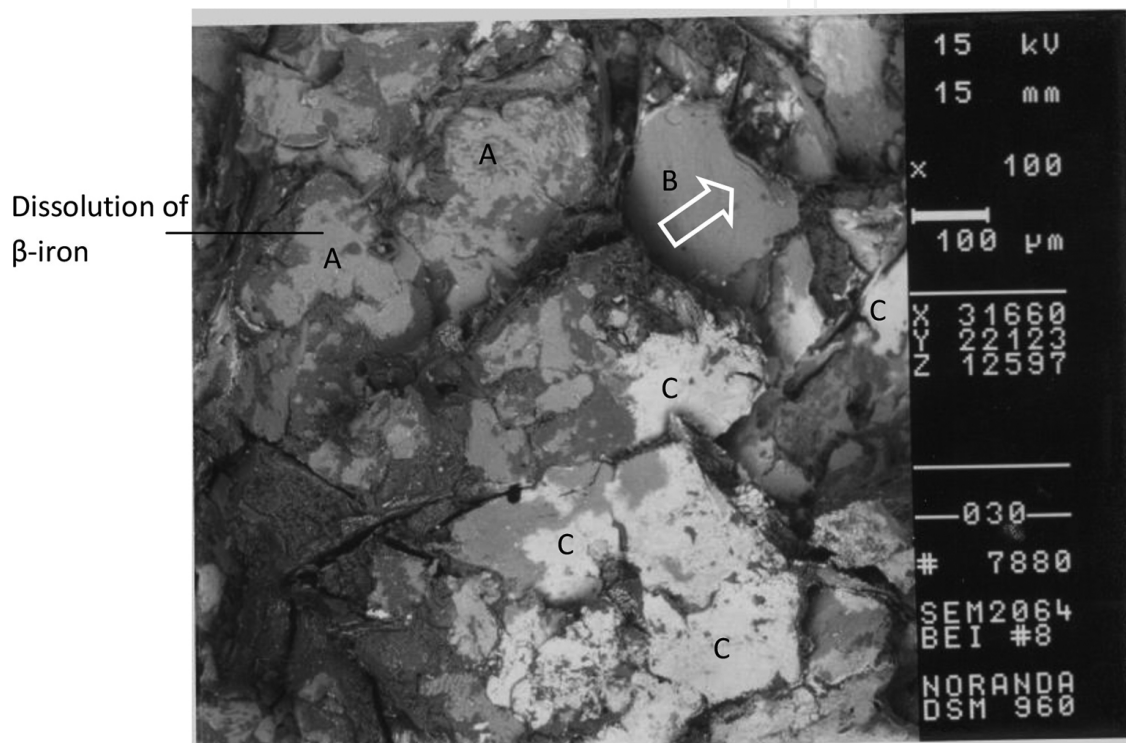
Both cleavage fracture and intergranular fracture are characteristically low-energy mechanisms, and the simultaneous operation of both can occur when the resolved stresses for transgranular cleavage are approximately equal. Also, if the preferred grain boundary fracture path is not continuous, and if the cleavage stress is relatively low, the regions that do not fracture intergranularly can fracture by cleavage. **Figure 11** shows an example of this type of fracture.

**Figure 11.** SEM micrograph showing fracture surface of alloy 319.2 (0.8% Fe, DAS 83  $\mu$ m, modified, center).

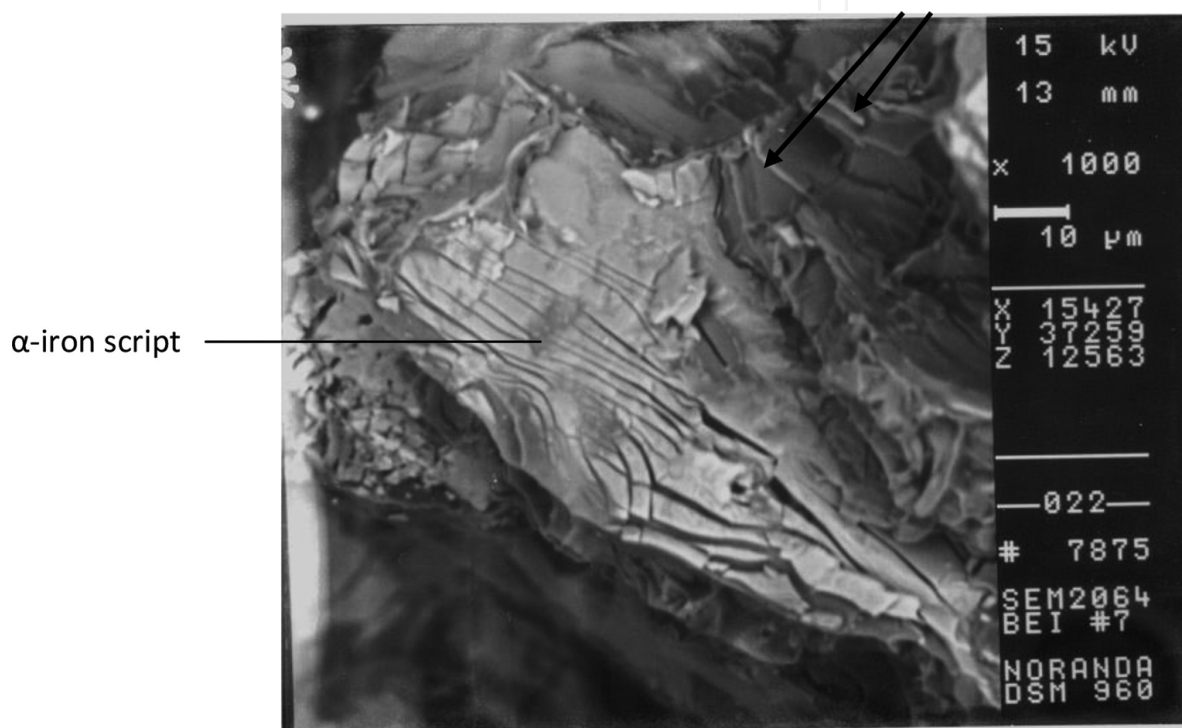
The SEM micrograph of **Figure 12** shows the cleavage fracture of an  $\alpha$ -AlFeSi intermetallic particle in the modified 319.2 alloy sample containing 0.8% Fe and obtained at the highest cooling rate. The fracture consists of several cleavage steps that provide an indication of the

local direction of crack growth. Further above, the cleavage planes followed by the crack show various alignments, as influenced by the orientations of individual grains.

Another feature of cleavage fracture, the “tongue” appears on cleavage facets as very fine slivers (see arrows marked T) that result from cleavage across micro-turns formed by plastic deformation at the tip of the main propagating crack. Around the  $\alpha$ -AlFeSi particle, the surrounding eutectic Si regions are identified by the small microvoids and dimpled nature of the fracture surface, indicating the mixed fracture mode of the sample. The  $E_I$ ,  $E_P$ , and  $E_T$  in this case are 8.71, 1.31, and 10.02 J, respectively.

**Figure 12.** SEM micrograph showing fracture of  $\alpha$ -AlFeSi intermetallics in alloy 319.2 (0.8% Fe, DAS 23  $\mu\text{m}$ , modified).

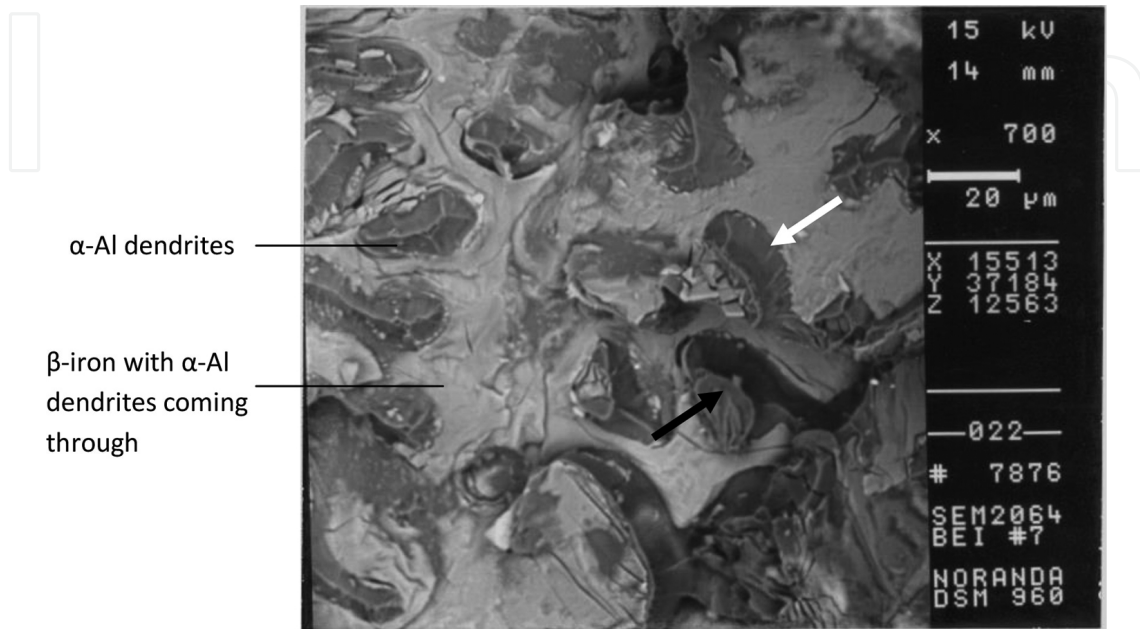
**Figure 13** shows another fractograph of the same sample, where the fracture surface consists of interlinked  $\beta$ -phase regions that would probably correspond to more than one branched  $\beta$ -platelets. Alpha-Al dendrites appear through parts of the  $\beta$ -phase where dissolution of the platelets has occurred. Dimpled rupture of the eutectic Si regions interspersed in between is also observed. The shallow, depressed nature of the dendrite observed near the white arrow,

together with the darker void region below (black arrow), indicate the existence of a pore in this area, which would have facilitated crack propagation. The smooth interface between the  $\beta$ -phase and the  $\alpha$ -Al dendrite and the pore linked to them affirms the feedability-related characteristics of the  $\beta$ -platelet phase, aiding in the formation of porosity.

Figure 13. SEM micrograph showing fracture of  $\beta$ -AlFeSi intermetallics in alloy 319.2 (0.8% Fe, DAS 23  $\mu\text{m}$ , modified).

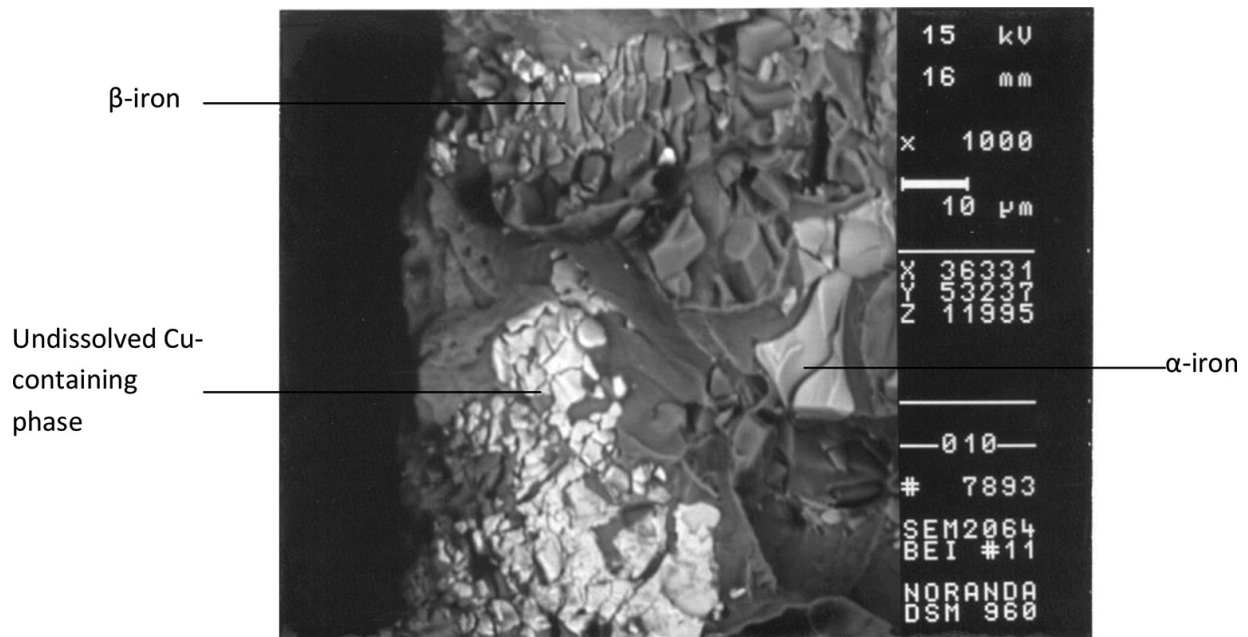
Figure 14. SEM micrograph showing fracture of both iron and copper intermetallics in alloy B319.2 (0.8% Fe, DAS 23  $\mu\text{m}$ , unmodified).

**Figure 14** shows the fractograph taken from the unmodified B319.2 alloy sample containing 0.8% Fe, obtained at the highest cooling rate. Transgranular fracture of all intermetallics viz., the  $\alpha$ -Fe,  $\beta$ -Fe, and Cu-containing phases is observed. In this alloy, containing a higher level of Mg, the Cu-phase would include  $\text{Al}_5\text{Mg}_8\text{Cu}_2\text{Si}_6$  and  $\text{Al}_{15}(\text{Mn,Fe,Cu})_3\text{Si}_2$ , in addition to the  $\text{CuAl}_2$  phase. The presence of cracked Si particles and associated microvoids are also seen.

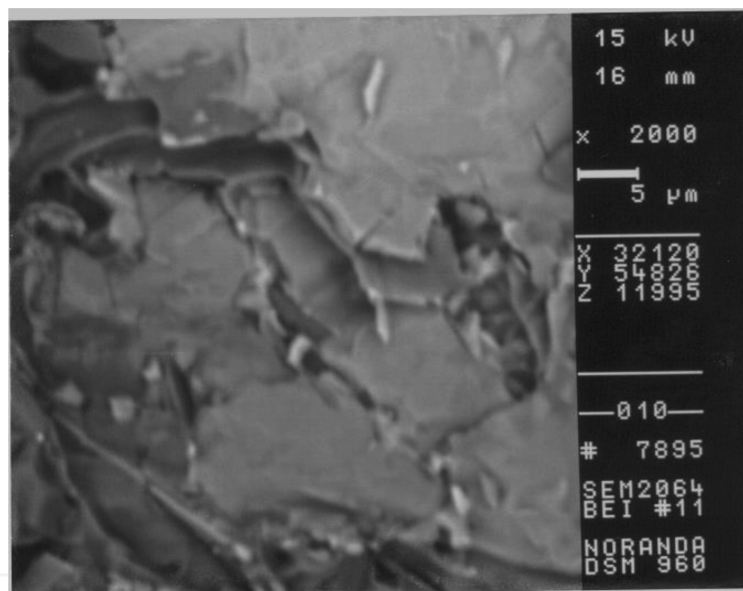
**Figure 15.** SEM micrograph showing fracture of  $\beta$ -platelets in alloy B319.2 (0.8% Fe, DAS 23  $\mu\text{m}$ , unmodified).

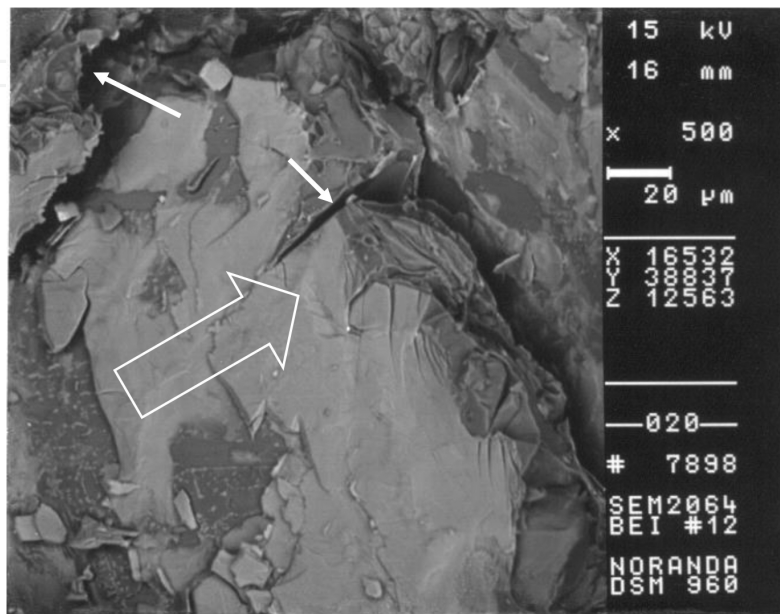
The SEM fractograph, shown in **Figure 16**, of the same 0.8% Fe-containing unmodified B319.2 alloy obtained, however, at the lowest cooling rate shows clearly the massive dimensions that the  $\beta$ - $\text{Al}_5\text{FeSi}$  platelets can attain at the same 0.8% Fe level, depending upon the solidification conditions. Again, the platelet fractures by cleavage, the open arrow indicating the cleavage direction. Secondary cracks (white arrows) are also observed when the crack propagates through the eutectic Si regions.

**Figure 16.** SEM micrograph showing fracture of  $\beta$ -AlFeSi intermetallics in alloy B319.2 (0.8% Fe, DAS 83  $\mu\text{m}$ , unmodified).

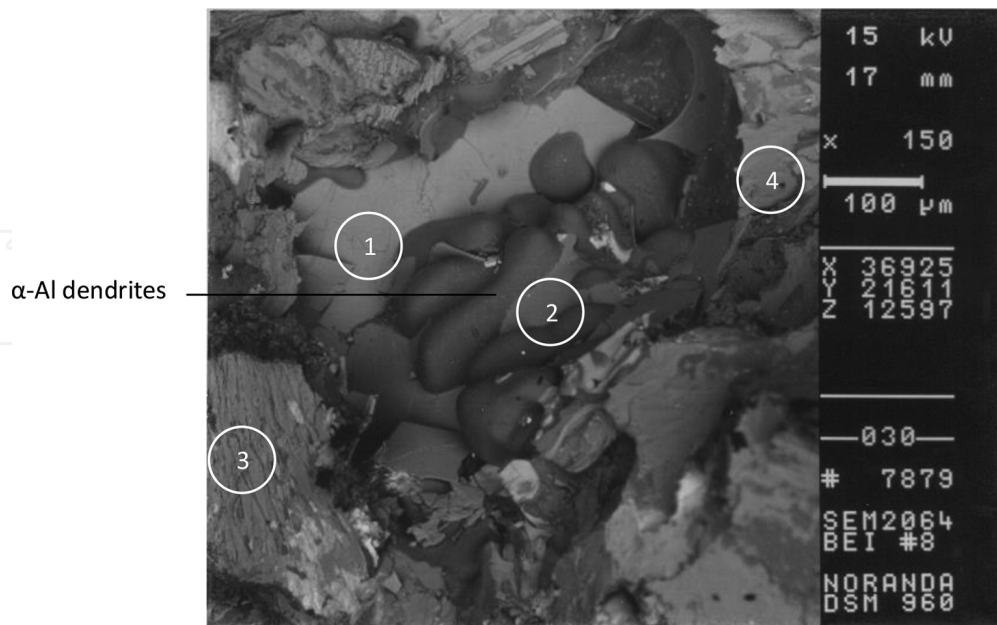
**Figure 17.** SEM micrograph showing the effect of porosity participating in the fracture behavior of alloy 319.2 (0.8% Fe, DAS 83  $\mu\text{m}$ , modified).

**Figures 17** and **18** are SEM fractographs obtained from modified 319.2 and B319.2 alloys, respectively, under the same Fe and solidification conditions (0.8% Fe, lowest cooling rate). The rather large dimensions of the pore observed in **Figure 17**, as evidenced by the untouched  $\alpha$ -Al dendrites sitting inside, show how the  $\beta$ -phase platelets lodged beside (1) and between

(2) the dendrites restrict the flow of the liquid metal in the surrounding region and hence lead to the formation of porosity. The presence of the pore facilitates fracture. In contrast to the fractured  $\beta$ -platelets (e.g., 3 and 4) around the pore area, the  $\beta$ -platelets within the pore did not participate in the fracture process and remained quite intact.

Similarly, **Figure 18** shows an example of a pore observed on the fracture surface of the modified B319.2 alloy. In this instance, the pore appears to be much smaller in dimension and more shallow than the one depicted in **Figure 17** with fragments of cleaved  $\beta$ -phase platelets on the surrounding fracture surface. The dissolution of the  $\beta$ -platelets due to the effect of Sr is more evident in this fractograph.

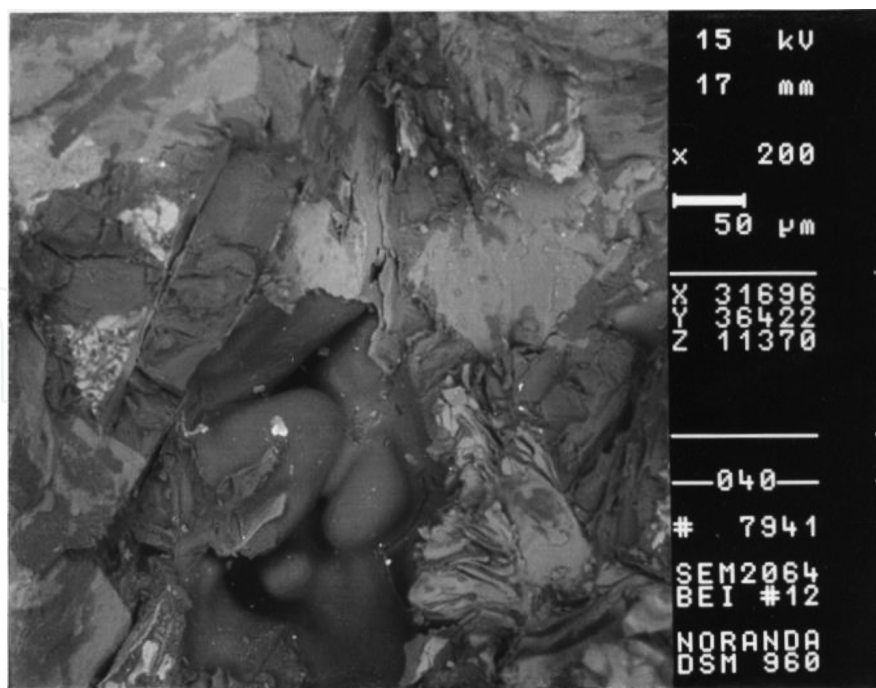
**Figure 18.** SEM micrograph showing the effect of porosity participating in the fracture of alloy B319.2 (0.8% Fe, DAS 83  $\mu\text{m}$ , unmodified).

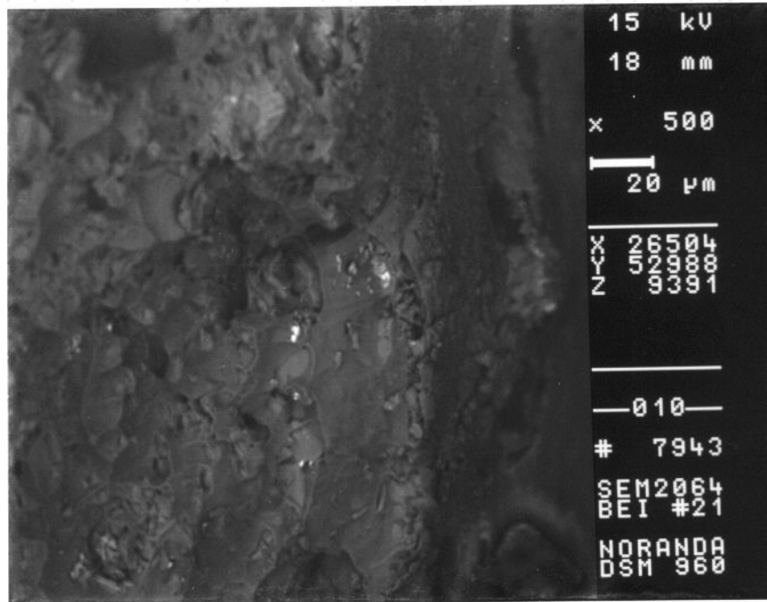
**Figure 19.** SEM micrograph showing fracture surface of alloy A356.2 (0.1% Fe, DAS 23 μm, modified, edge).

**Figures 19** and **20** are the SEM fractographs taken from the modified A356.2 alloy sample containing 0.1% Fe and obtained at the highest cooling rate. **Figure 19** shows the fracture to be of the transgranular dimpled rupture type. As mentioned before, the BEI image does not provide a good phase contrast.

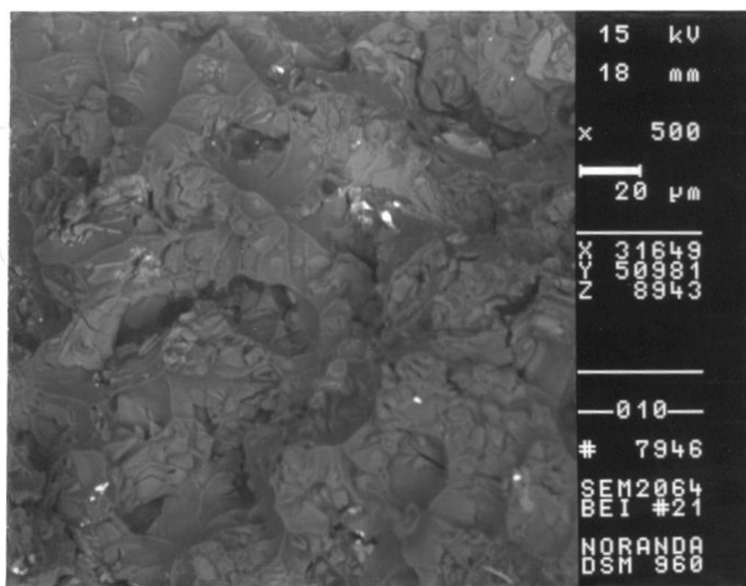
**Figure 20.** SEM micrograph showing fracture surface of alloy A356.2 (0.1% Fe, DAS 23 μm, modified, center).

The fractograph of **Figure 20** taken from the center of the sample shows these features more clearly. Note the fine Si particles in the structure. The absence of intermetallics, due to the low Fe content, together with the fine Si particles obtained under the optimum alloy conditions of a high cooling rate and Sr modification, results in the sample exhibiting the highest impact energy (80.88 J).

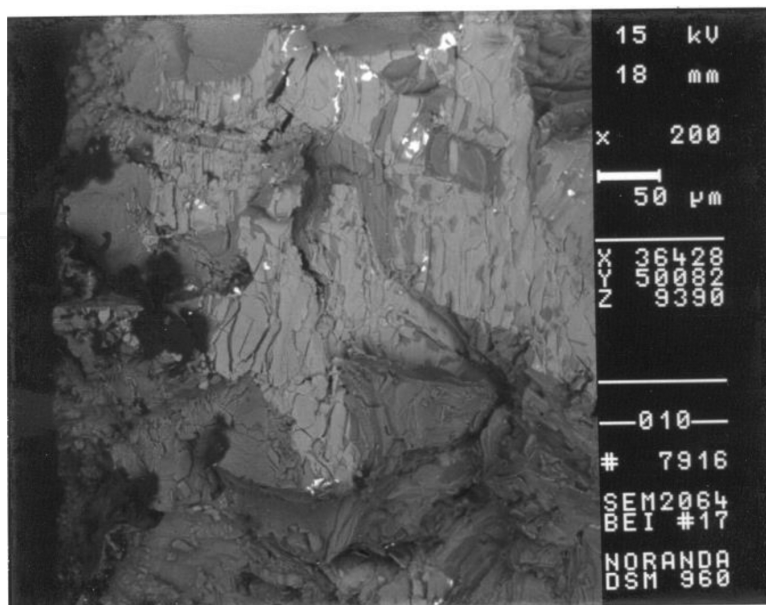
**Figure 21.** SEM micrograph showing the role of  $\beta$ -Al<sub>3</sub>FeSi intermetallics in initiating fracture in alloy A356.2 (0.6% Fe, DAS 75 $\mu$ m, unmodified).

**Figures 21** and **22** depict the SEM fractographs of the unmodified A356.2 alloy sample containing a high Fe level (0.6%) and obtained at the lowest cooling rate. The presence of massive  $\beta$ -Al<sub>3</sub>FeSi platelets in the alloy microstructure under these conditions results in the brittle fracture of the sample. As **Figure 21** shows, crack initiation takes place by the fragmentation of the  $\beta$ -phase at the edge of the sample and some amount of transgranular fracture, as well, whereas the crack propagates by cleavage fracture, as evidenced by the relatively smooth surfaces of the  $\beta$ -platelets observed in **Figure 22**, as also by intergranular fracture. Accordingly, the impact energy of this sample was 2.45 J.

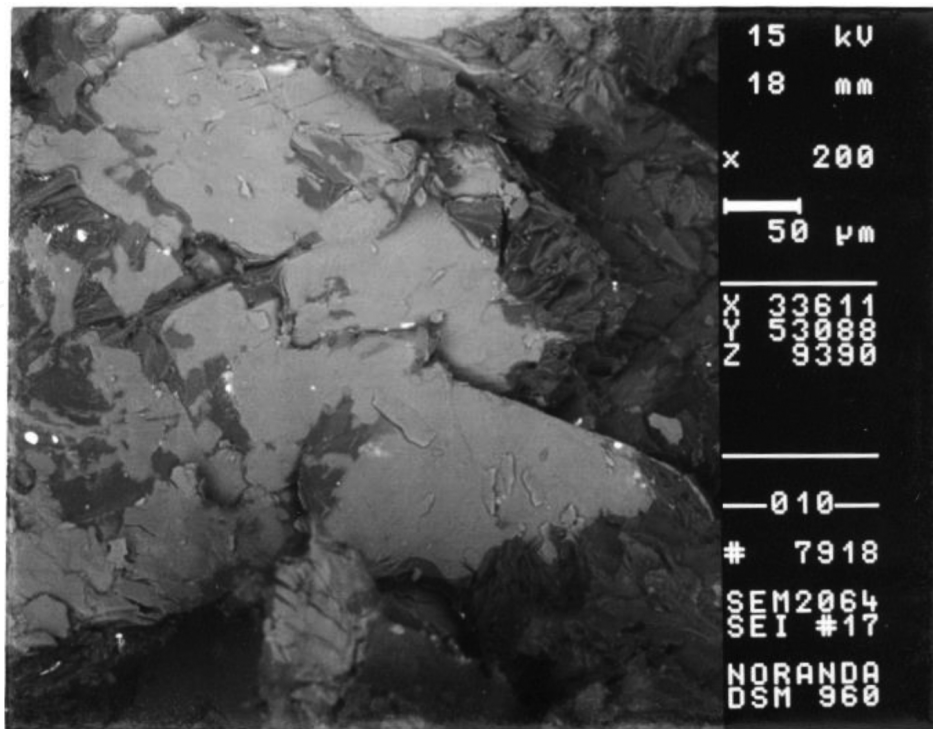
Figure 22. SEM micrograph showing crack propagation in alloy A356.2 (0.6% Fe, DAS 75  $\mu$ m, unmodified).

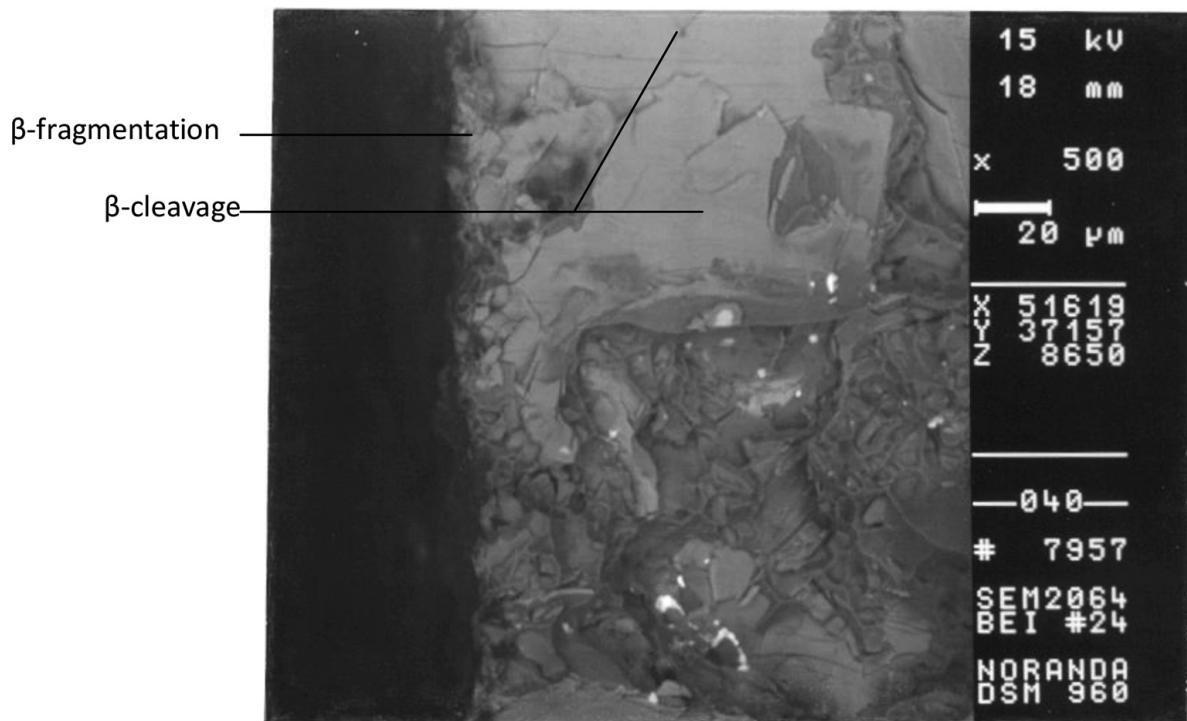
Figure 23. SEM micrograph showing fracture surface of alloy A356.2 (0.6% Fe, DAS 75  $\mu$ m, modified, edge).

When the same alloy is modified, crack initiation occurs by fragmentation of the  $\beta$ -Al<sub>3</sub>FeSi platelet, followed by cleavage, as seen in **Figure 23**. Modified silicon eutectic regions around the  $\beta$ -platelet can also be distinguished. **Figure 24** shows that the fracture mode is a mixture of cleavage and intergranular fracture.

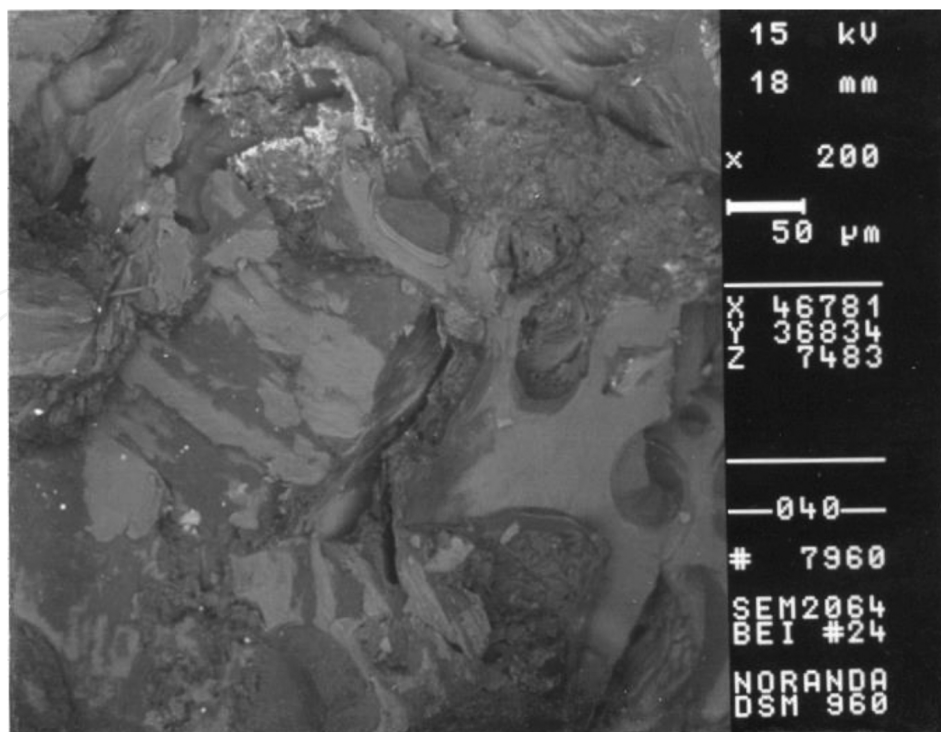
Figure 24. SEM micrograph showing fracture surface of alloy A356.2 (0.6% Fe, DAS 75 μm, modified, center).

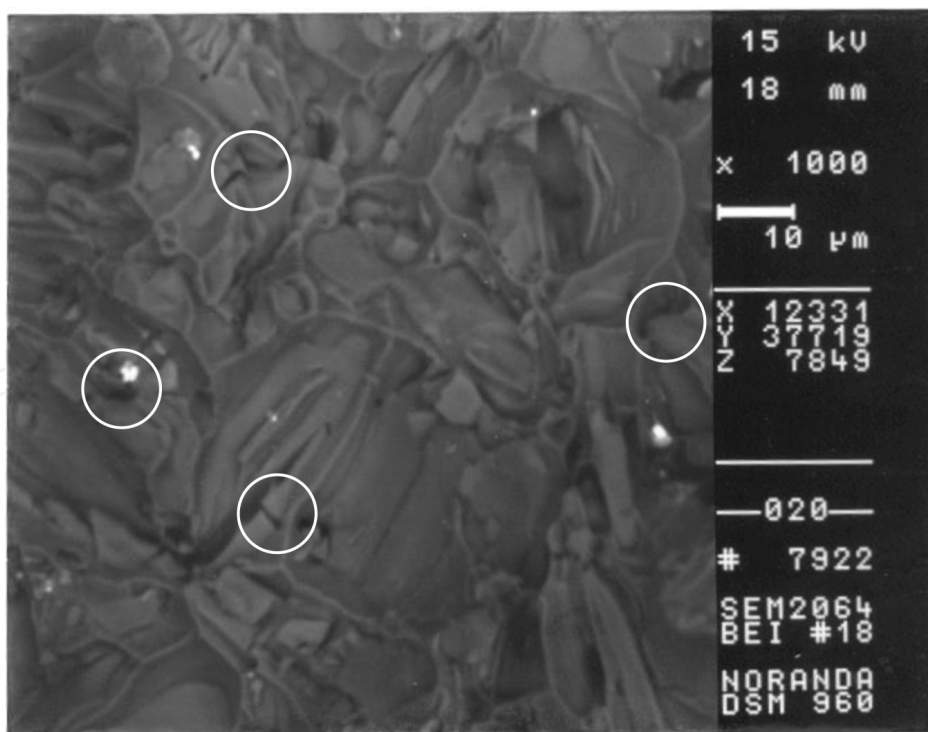
Figure 25. SEM micrograph showing fracture of eutectic Si particles in alloy A356.2 (0.1% Fe, DAS 75 μm, unmodified).

The high magnification SEM fractograph of an unmodified A356.2 alloy sample containing 0.1% Fe and obtained at the lowest cooling rate, **Figure 25**, reveals the eutectic Si regions much more clearly, where the fracture is seen to occur by the transgranular brittle fracture of the acicular Si particles (see circled areas).
