# On the Fractography of Impact-Tested Samples of Al-Si Alloys for Automotive Alloys

Zheyuan Ma, Agnes M. Samuel,  
Herbert W. Doty and Fawzy H. Samuel

Castings were prepared from both industrial and experimental 319.2, B319.2 and A356.2 alloy melts, containing Fe levels of 0.2–1.0 wt%. Strontium-modified (~200 ppm) melts were also prepared for each alloy/Fe level. Impact testing of heat-treated samples was carried out using an instrumented Charpy impact testing machine. At low Fe levels and high cooling rates (0.4% Fe, dendrite arm spacing (DAS) of 23  $\mu\text{m}$ ), crack initiation and propagation in unmodified 319 alloys occur through the cleavage of  $\beta\text{-Al}_3\text{FeSi}$  platelets (rather than by their decohesion from the matrix). The morphology of the platelets (individual or branched) is important in determining the direction of crack propagation. Cracks also propagate through the fracture of undissolved  $\text{CuAl}_2$  or other Cu intermetallics, as well as through fragmented Si particles. In Sr-modified 319 alloys, cracks are mostly initiated by the fragmentation or cleavage of perforated  $\beta$ -phase platelets, in addition to that of coarse Si particle

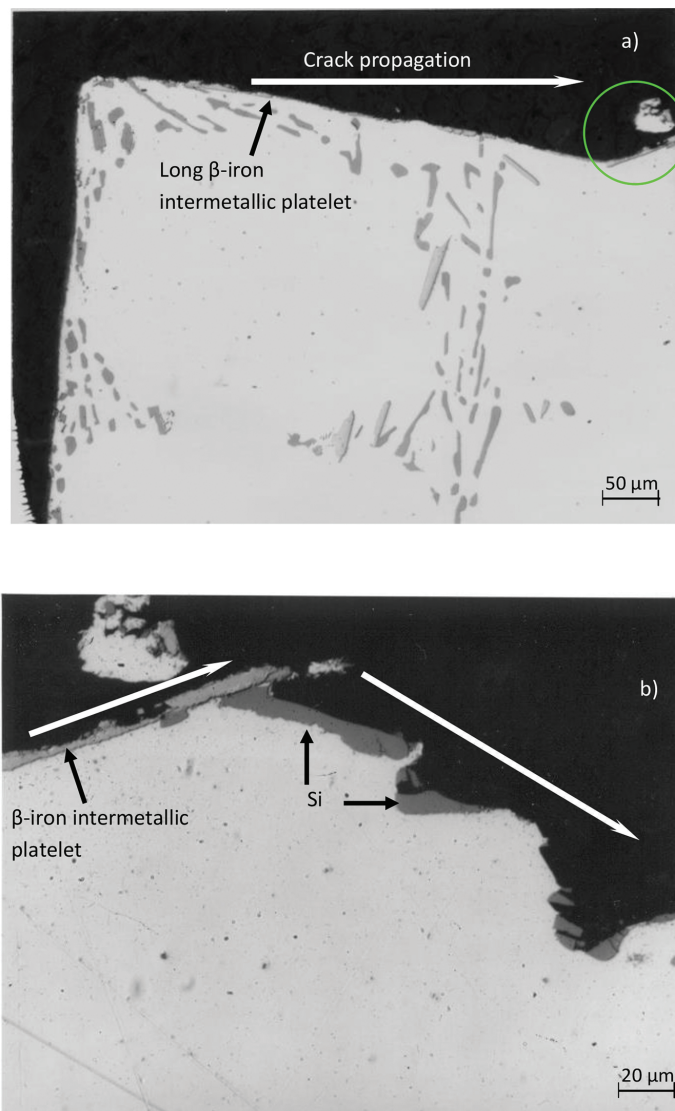
**Figure 26.** Optical micrographs showing fracture behavior of alloy A356.2 (0.6% Fe, DAS 75 $\mu\text{m}$ , unmodified, edge). A high magnification micrograph of the circled area in (a) is shown in (b).

The optical micrographs presented in **Figure 26** show the polished longitudinal section of the fractured A356.2 unmodified alloy sample containing 0.6% Fe, obtained at the lowest cooling rate. In **Figure 26(a)**, the edge of the sample on the left shows how crack initiation occurs by cleavage and/or transgranular fracture of the Si particles and  $\beta$ -Al<sub>5</sub>FeSi platelets. The sample edge corner is relatively straight, indicating that cracking occurred almost immediately, i.e., by brittle fracture mode, and the crack propagated along the direction shown.

A higher magnification micrograph, **Figure 26(b)**, of the fracture surface corresponding to the circled area in **Figure 26(a)** shows how the crack propagates further along the fracture surface by cleavage of the  $\beta$ -iron intermetallic and coarse Si particles. The persistence of such coarse Si particles, even after solution heat treatment at 540°C/8 h, aids in inducing the brittle fracture of the sample. Correspondingly, under such alloy conditions, the sample exhibited the lowest impact energy (2.45 J). **Figure 26** provides a good example of how optical microscopy can aid

in providing a clearer interpretation of the crack initiation and propagation in A356 type Al-Si-Mg alloys.

Compared to the micrographs shown in **Figure 26**, those obtained from the A356.2 alloy sample corresponding to optimum energy conditions (viz., 0.1% Fe, lowest cooling rate, Sr-modified alloy), **Figure 28(a)** shows how the sample edge is more curved or rounded, rather than flat as was observed in the case of the unmodified alloy sample of **Figure 26**. The curvature of the fracture surface, also clearly observed in **Figure 28(b)**, indicates a ductile mode of rupture as the crack propagates through the well-modified Si eutectic regions. The  $E_V$ ,  $E_P$ , and  $E_T$  values in this case are 60.44, 20.44, and 80.88 J, respectively, compared to 1.41, 1.31, and 2.45 J in the case of the sample shown in **Figure 26**.

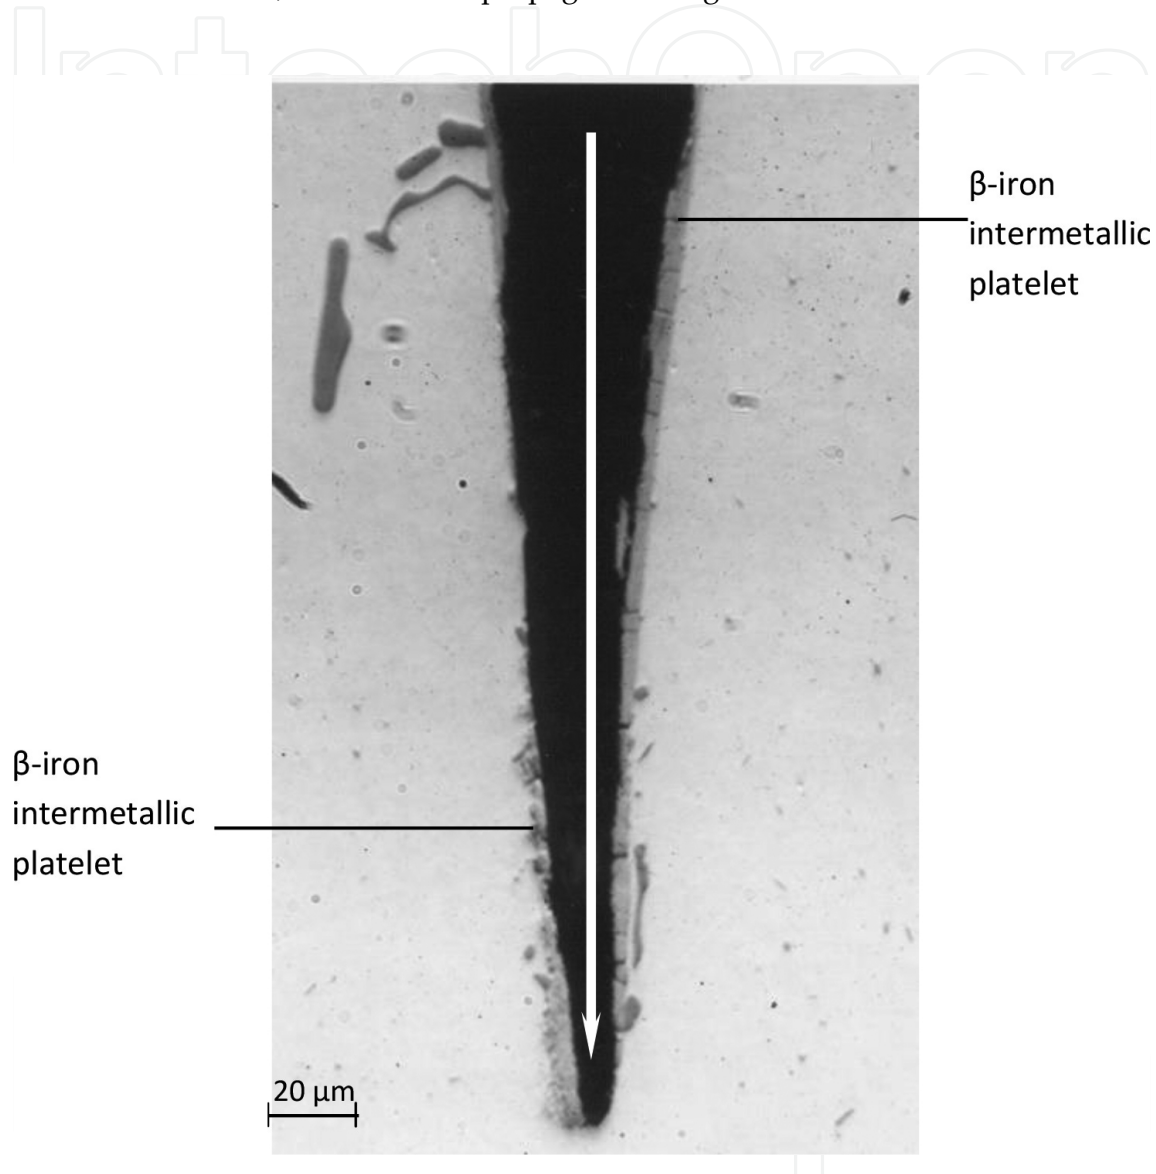
**Figure 27.** Optical micrograph showing fracture behavior of alloy A356.2 (0.4% Fe, DAS 23 μm, unmodified, edge, 500×).

The optical micrograph in **Figure 27**, taken from an A356.2 unmodified alloy sample containing 0.4% Fe and obtained at the highest cooling rate, shows the propagation of a secondary crack (see white arrow) that splits a  $\beta$ - $\text{Al}_5\text{FeSi}$  platelet right through the middle. The crack propagates to the end of the platelet, till it reaches the aluminum matrix which, being ductile, allows for stress relaxation at the crack tip by local plastic flow.

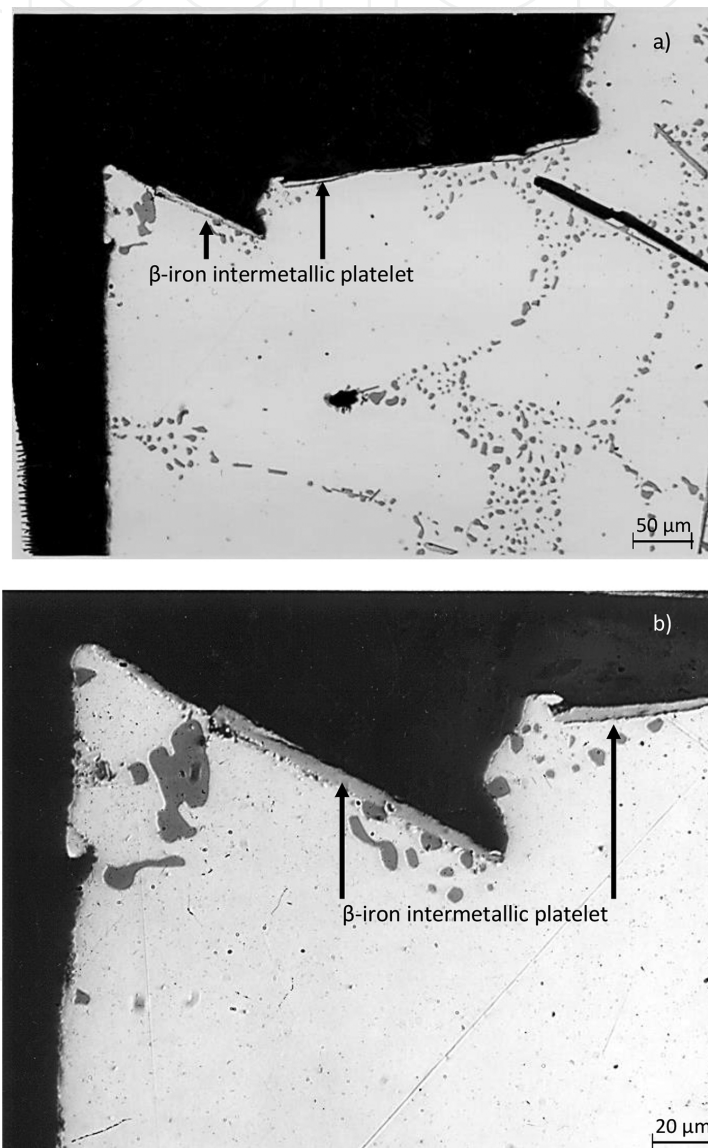
**Figure 29.** Optical micrographs showing fracture behavior of alloy A356.2 (0.6% Fe, DAS 75  $\mu\text{m}$ , Sr-modified, edge).

However, when the alloy Fe level is increased and the cooling rate decreased to its lowest value, even in the Sr-modified alloy, the fracture still occurs mainly by cleavage of the brittle  $\beta\text{-Al}_3\text{FeSi}$  platelets, as seen in **Figure 29(a)**. Note the sharp edge of the sample fracture surface in this

case, compared to **Figure 28**. **Figure 29(b)** shows these features much more clearly at a high magnification. In instances when the crack propagates through the more ductile Al-Si regions, the fracture surface is more rounded than sharp. The corresponding  $E_V$ ,  $E_P$ , and  $E_T$  values are 3.41, 1.46, and 4.87 J, respectively.
