Self-healing of Structural Composites Containing Dendrimers as Healing Agent

Vassilis Kostopoulos and Athanasios Kotrotsos

Abstract

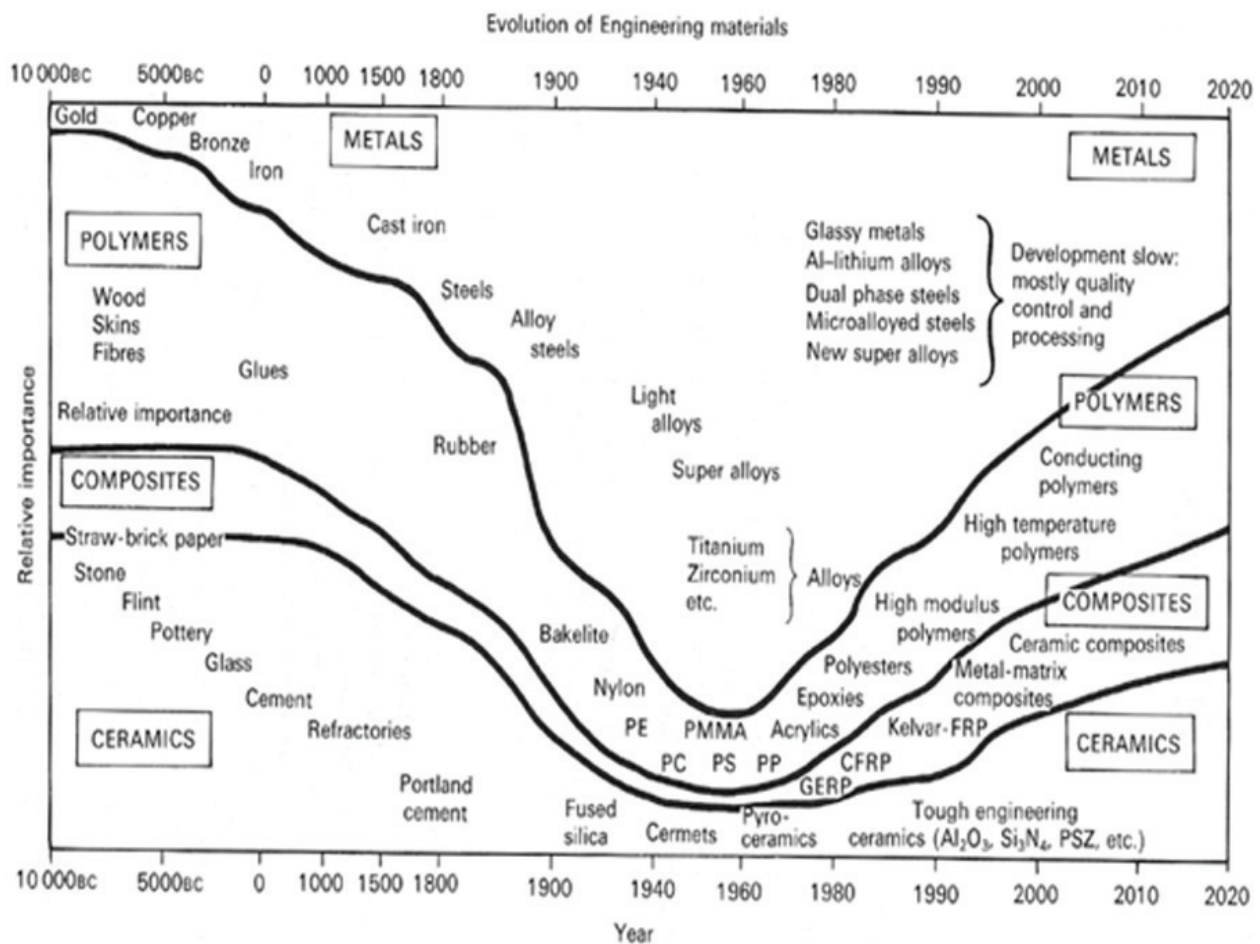
Figure 1. Schematic representation of the importance of four classes of materials (ceramics, composites, polymers, and metals) in mechanical and civil engineering as function of time [1].

with the necessity for greener operation of structures, was the main driver for intensive research and application of polymer-matrix-fiber-reinforced composites in many fields as structural materials. **Figure 1** shows the evolution in use of materials versus time. In this picture, the rapid increase in the use of polymers and composite materials, during the last decades is evident [1].
