Mechanical performance of composite bonded joints in the presence of localised process-induced zero-thickness defects

Conference Paper · November 2018

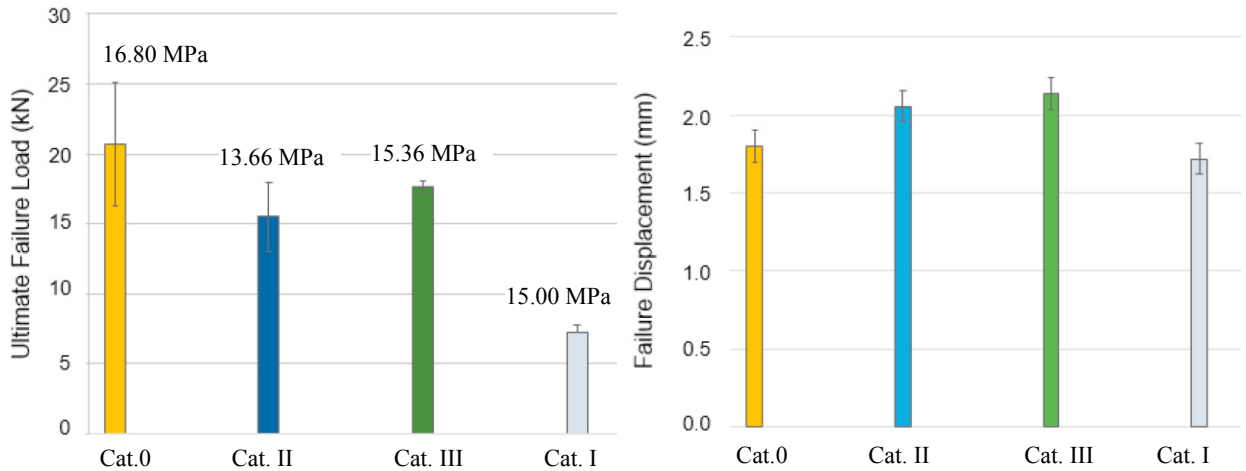
Figure 5: Ultimate failure loads for the bonded categories Figure 6: Failure displacements for the bond categories

The failure load for the four categories are presented in Figure 5, and the failure displacement in Figure 6. Figure 5 also includes the ultimate average shear stress levels (equaling the ultimate failure load divided by the effective bond area) at top of each category. For no-defect joints (Cat. 0), the ultimate failure load for wide joints was 20.7kN and for narrow joints (Cat. I) was 7.8kN. Failure loads for Categories II and III fall between these two levels. Therefore, the average shear stress was 13.66MPa and 15.36MPa respectively. It can be noticed that there was a big difference in the shear stress. This is attributed to the fact that there is a high stress gradient through the bond with stresses being high at the bond edges [11, 16] and low at the bond centre, and thus an average stress level cannot be representative of the bond strength. Also, the joints exhibited a 30% and 48% reduction from the shear stress, which is attributed to surface treatment. Surface treatment such as grit blasting and plasma treatment are more effective in creating better adhesion than that provided by peel ply. Better performance can be achieved by utilising these techniques [25]. Also, peel ply was not followed by mechanical ablation. According to the findings in [26], this is highly recommended for creating chemically active surfaces. Also, the secondary bending occurring in composite joints is significant for single-lap joints due to their asymmetric nature. This introduced mixed-mode failure.

Category 0 seemed to exhibit the highest failure load as expected for a wide joint with no defect. This category had the most scattered data attributed to the introduction of higher out-of-plane mechanical fluctuations associated with

wide joints during tension testing. Category III (cohesion defect initiator) had a higher failure load than Category II (adhesion defect initiator), which was expected. This was because a joint with cohesive failure should fail at higher load as the failure is progressive in cohesion. In adhesion failure, the joint fails instantaneously (i.e. less progressive) and then lower load is reached. Category I (narrow joints) exhibited the lowest failure load because these specimens had smaller width (25mm). There is difference in failure response between the thumb-nail and through-the-width (Cat. I) defects. Thus, additional investigation is required in order to understand, better, the impact of these defects on the performance of the joints. Also, the failure displacement for Category 0 (no-defect) was found surprisingly lower than that in joints with defects (Figure 6). This can be attributed to the introduction of deformation mechanisms to the joints with defects where strain energy could have been dissipated more gradually around defects e.g. for blunting. This will be discussed further in section 6.2 where microscopy images from the damage sites are presented.

pre-existing cohesion defect (cohesive failure). The failure mode was mainly a mixed-mode failure (adhesion and cohesive failure initiated by cohesion failure). It was also observed that although delamination occurred in Cat. III, the integrity of the bond did not degrade as much, according to Figures 5 and 6.
