## Aircraft Rescue and Fire Fighting Capabilities: Are Today's Standards Protecting Passenger's Futures?

Graduate Capstone Project

For the Degree of  
Master of Science in Safety Science

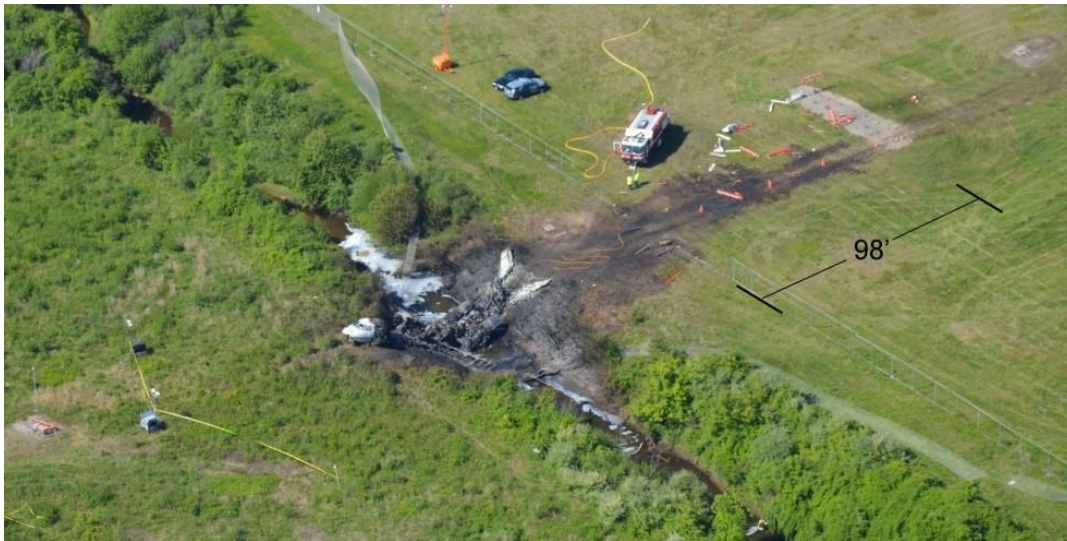
**Figure 2.** N121JM Runway over run showing distance from ALS/localizer to perimeter fence

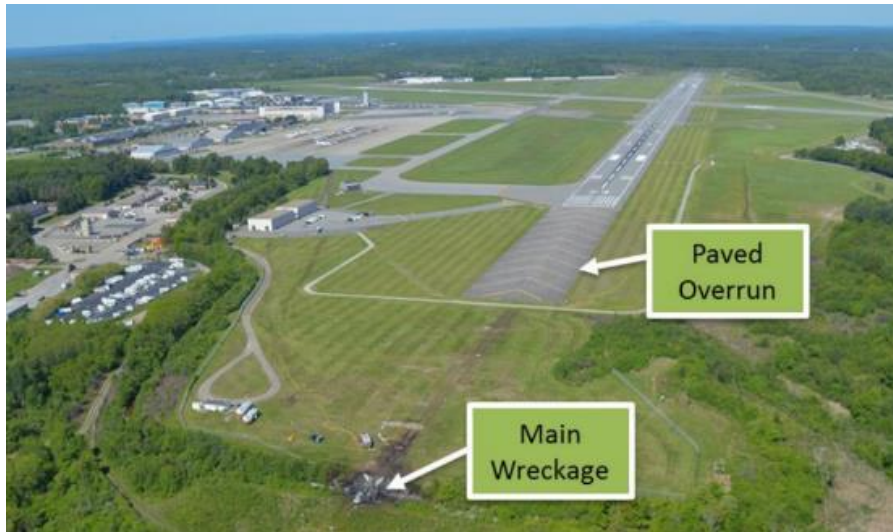
**Figure 3.** *N121JM Runway over run, Aerial image (From NTSB (2014) Aircraft Accident Report No. AAR-15-03)*

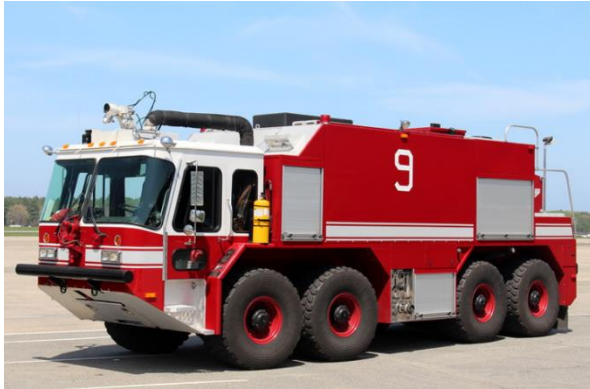
**Figure 7.** (Left) Variation of Crash 9

According to the Department of Defense (2012) memorandum, Crash 9, which was Hanscom AFB-FD’s largest firefighting vehicle, was a 2006 Pierce P-23 and was capable of holding 3,300 gallons of water, 500 gallons of AFFF, and 500 pounds of potassium-based dry chemical with the maximum primary turret discharge rate of 1,200 gallons per min (gpm). Crash 10 was a 1985 Oshkosh P-19 and was capable of holding 1,000 gallons of water, 130 gallons of AFFF, and 500 gallons of potassium-based dry chemical with the maximum primary turret discharge rate of 1,000 gallons per min (gpm). (Department of Defense, 2012). Tanker 7 was 1994 International capable of holding 5,000 gallons of water with a primary turret discharge rate

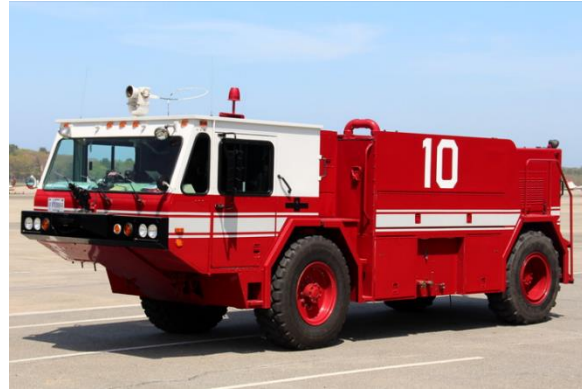
**Figure 8.** (Right) Variations of Crash 10

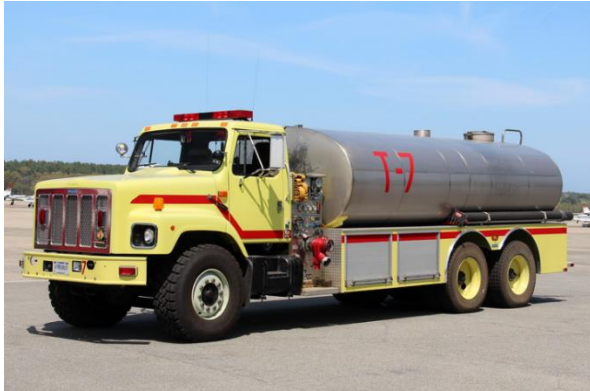
**Figure 11.** (Left) *Variation of Tanker 7*

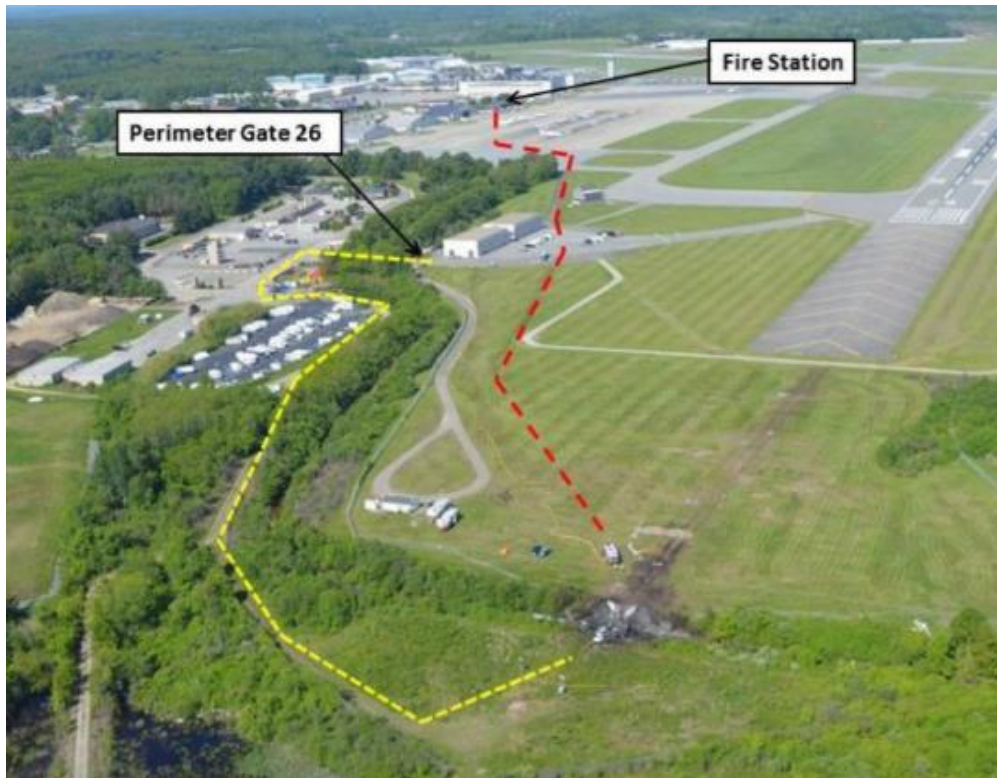
**Figure 13.** Aerial image of N121JM impact, ARFF routes to accident scene (From NTSB (2014) Aircraft Accident Report No. AAR-15-03).

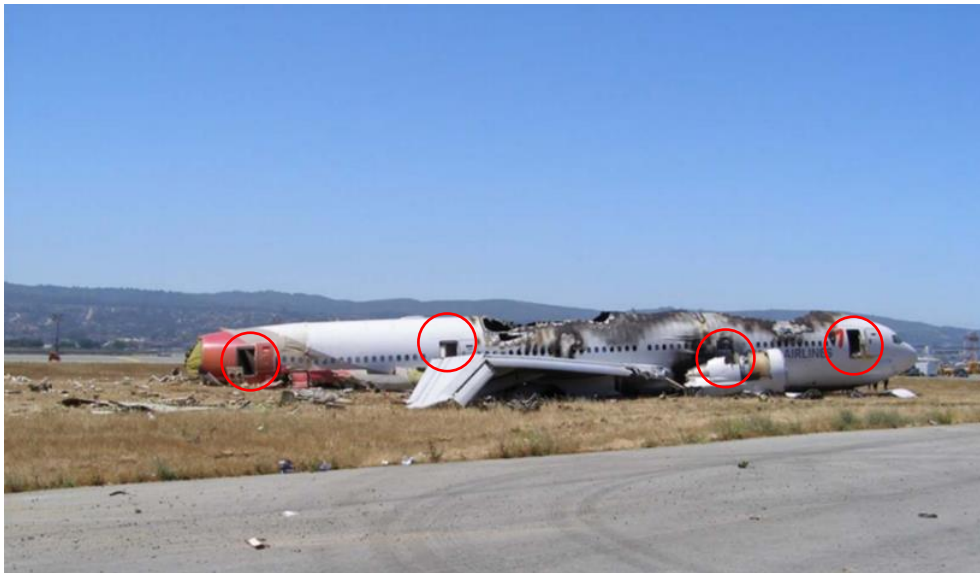
**Figure 16.** Right side of Flight 214 from the 3 o'clock position depicting doors 1R, 2R, 3R, 4R.

Flight attendants, R1 and R2A, that were seated adjacent to door 1 right and door 2 right reported to investigators that on the second impact the slides pertaining to door 1 right and door 2 right, were dislodged and became inflated inside the cabin pinning them into their respective seats (National Transportation Safety Board, 2013a). This was confirmed by investigators who discovered that door one right was open; however, the slide was found deployed and deflated inside the aircraft. Door 2 Right, however, was closed and exhibited fire damage but also had a slide deployed and deflated inside the aircraft. As a result, neither doors were operational in the evacuation process.

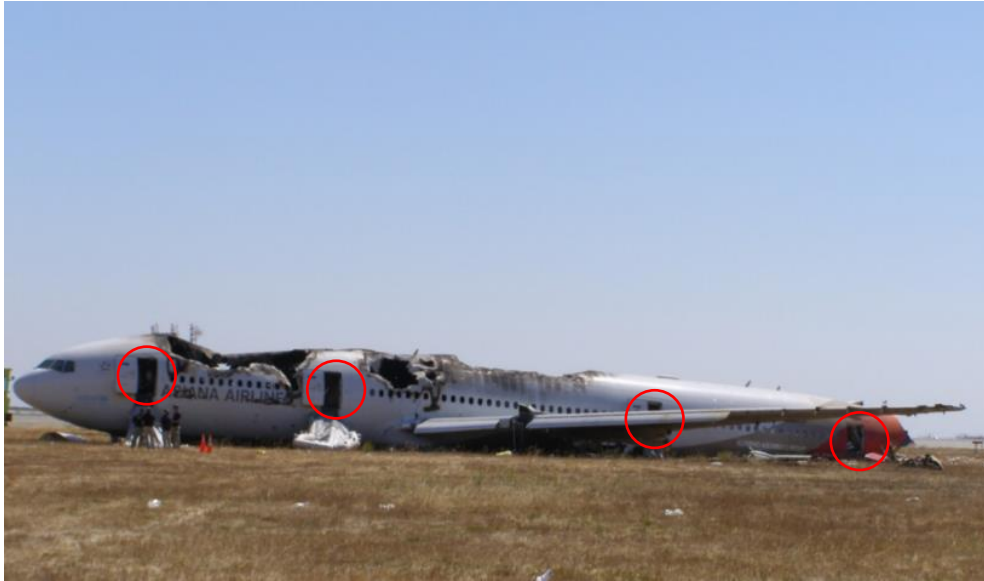
**Image 17.** Left side of Flight 214 from the 9 o'clock position depicting doors 1L, 2L, 3L, 4L.

Flight attendant L3, who was stationed at door 3 left, indicated that she attempted to open door 3 left after regaining consciousness, however it was jammed, and she could not do so. The accident report stated that door 3 left remained closed for the entire duration of the evacuation process, but it was later opened from the inside by an emergency responder. Video footage shows the slide falling to the ground but not inflating. Flight attendant L3 reported seeing light emitting from the direction of door three right, and this was further confirmed to investigators by Passenger 30K, who reported that he quickly opened door three right; however, the slide had only partially deployed and was not inflated. The flight attendant stationed at door 3 Right was severely injured and subsequently unable to assist in directing evacuation as she was carried out by other passengers.

Door 4 Left was found to be detached from the aircraft lying some distance away, however the slide was found to be lying inside the aircraft. The National Transportation Safety Board (2013a) accident report indicated that the slides aspirators had ingested towels and blankets preventing its inflation, which was consistent with the slide attempting inflation during the impact sequence. Lastly, door 4 right was found to be in the open position, however the slide's girt was torn at the bar rendering the slide useless. In summary, the accident report concluded that the evacuation process was accomplished by only 5 of the 12 flight attendants utilizing only 3 of the 8 doors (1L, 2L, and 3R) (National Transportation Safety Board, 2013a).

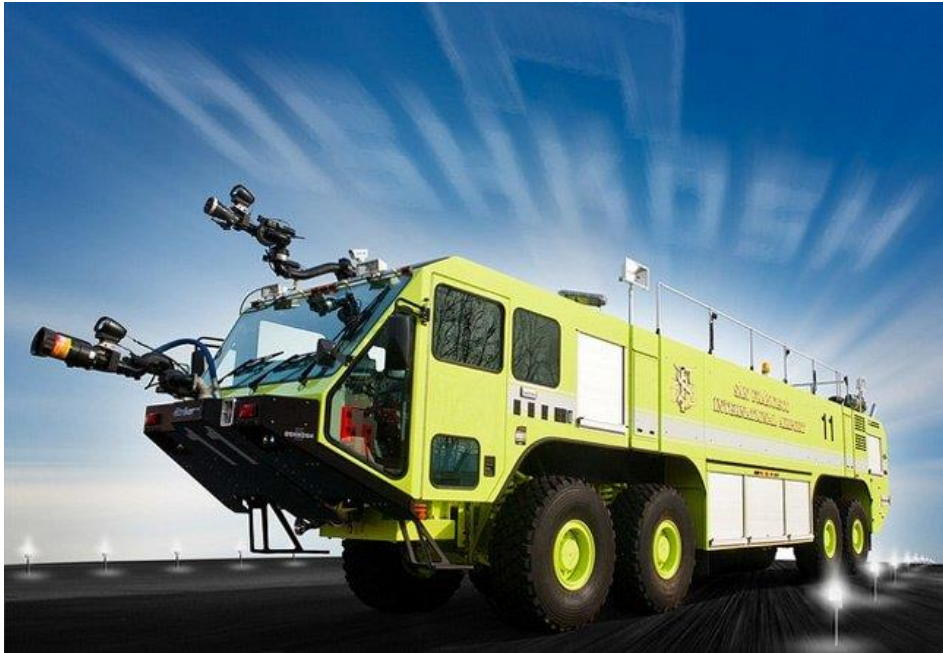
**Figure 19.** *Oshkosh Striker 4500 (Rescue 11) Exhibit Photos. Source, Oshkosh Corporation*

Three of the SFFD ARFF vehicles were Oshkosh Striker 4500's (Figures 18 and 19), each with the capacity of 4,500 gallons of water, 630 gallons of foam, 460 pounds of dry chemical, and 500 pounds of Halotron, and each striker is staffed with two firefighters (National Transportation Safety Board, 2013a). Rescue 9 and Rescue 10 were both equipped with 65-ft high-reach extendable turrets (HRET) with piercing nozzles (Figure 21). The fourth ARFF vehicle (Figure 20), Rescue 88, was an Oshkosh T3000, which had the capacity of 3,000 gallons

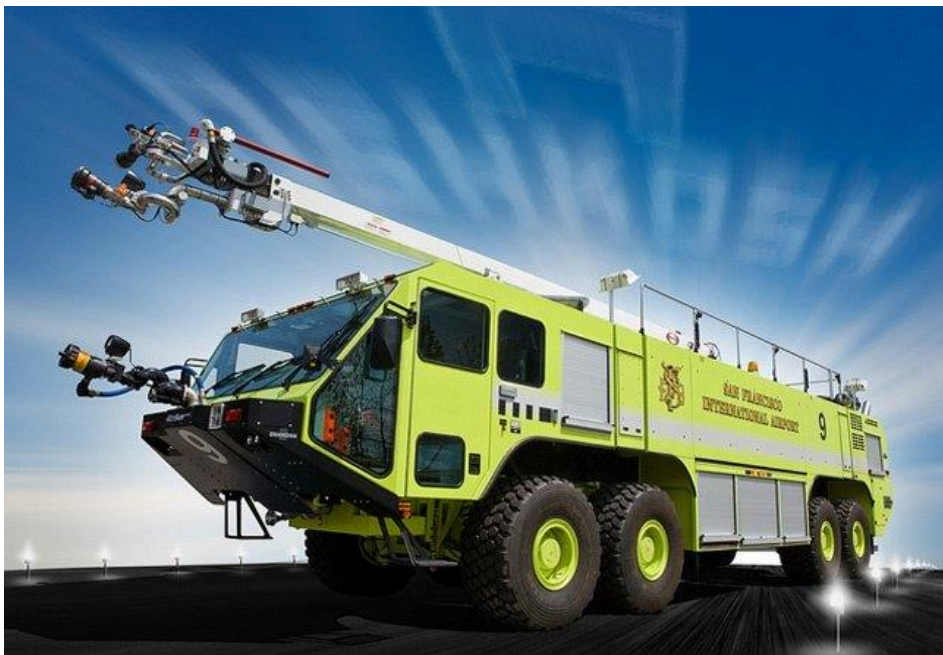
**Figure 20.** *Oshkosh Striker 4500 (Rescue 9) Exhibit Photos. Equipped with the high-reach extendable turret (HRET) and piercing nozzle. Source, Oshkosh Corporation.*

Another significant issue recognized in hindsight to Asiana Flight 214 was the problems involving the use of the high-reach extendable turret’s (HRET), which were equipped on the two most sophisticated ARFF vehicles, Crash 9 and Crash 10. The National Transportation Safety Board determined that, while the vast majority of firefighting operations were successful and greatly improved passenger survivability, ARFF operations could have been improved in that the HRET-equipped vehicles were not effectively used in the initial response. This is reflected in the timeline (Figure 22), which displays numerous situations where ARFF vehicles repositioned. The accident report explained that in several situations, the repositioning of the ARFF vehicles was neither effective nor safe. Crash 9 specifically was maneuvered into an area where there were still passengers evacuating, increasing the risk of a strike or rollover occurrence. Both vehicles were at one point positioned in locations that could not effectively fight the growing fire to protect evacuation routes. Additionally, it was whole 20 minutes after each vehicle arrived on the scene before either used the HRET to penetrate the fuselage and dispense agent inside.

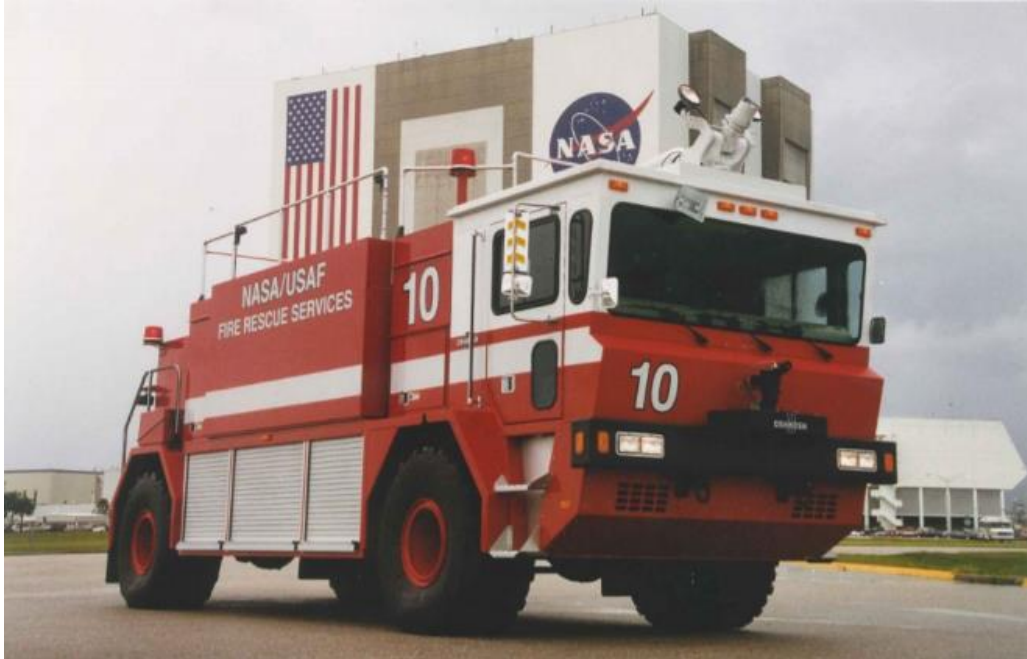
**Figure 21.** Oshkosh T3000 variant, Exhibit Photos. Source, Oshkosh Corporation

of water, 420 gallons of foam, and 460 pounds of dry chemical, and it was staffed with two firefighters and one lieutenant.

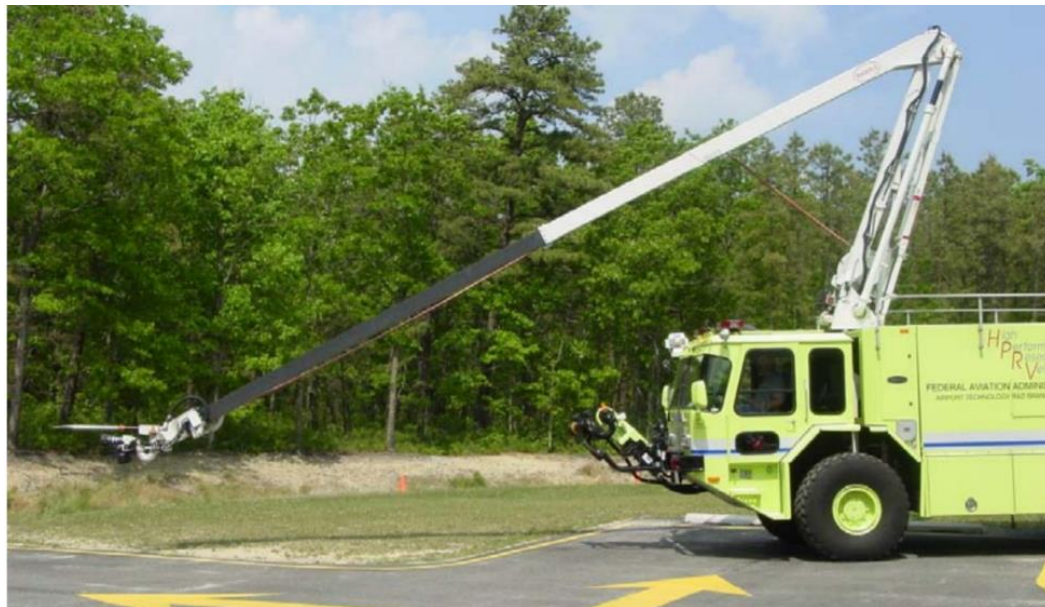
**Figure 22.**

*Exhibit T- High Reach Extendable Turret with Skin-Penetrating Nozzle. The HPRV with HRET in a Down-in-front attack mode. Source, Department of Transportation, Federal Aviation Administration, Office of Aviation Research and Development.*
