## Investigation into end-on collisions at sea

Ali Moftah Belhag Ahmed  
*World Maritime University*

# An Investigation into End-on Collisions at Sea

MASTER OF SCIENCE DEGREE  
in  
MARITIME EDUCATION AND TRAINING (NAUTICAL).

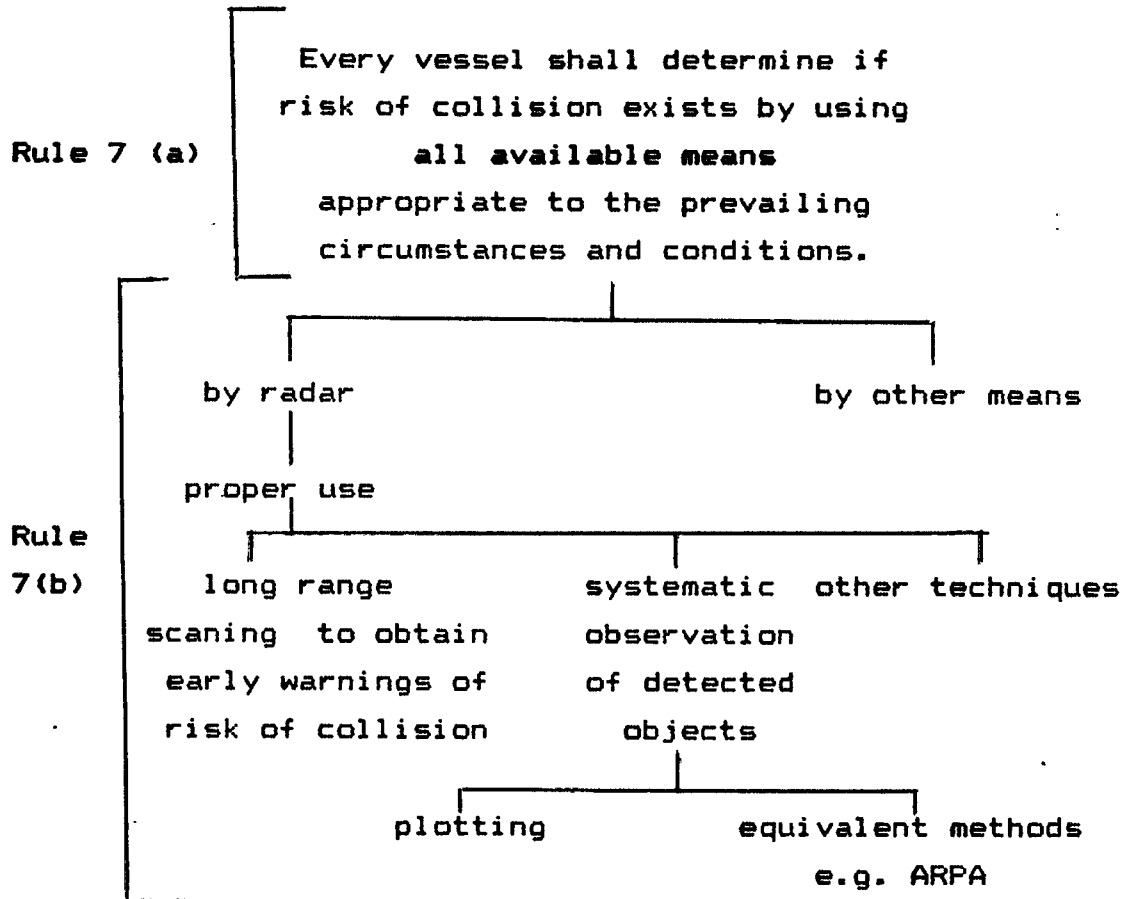
RISK OF COLLISION

Rule 7(b) plotting = a systematic observation of detected objects with the aim to determine if risk of collision exists.

to plot = to mark (or to take the bearing and distance of) a target at regular time-intervals and, by graphic or computing method, to determine the CPA and/or to determine if risk of collision exists.

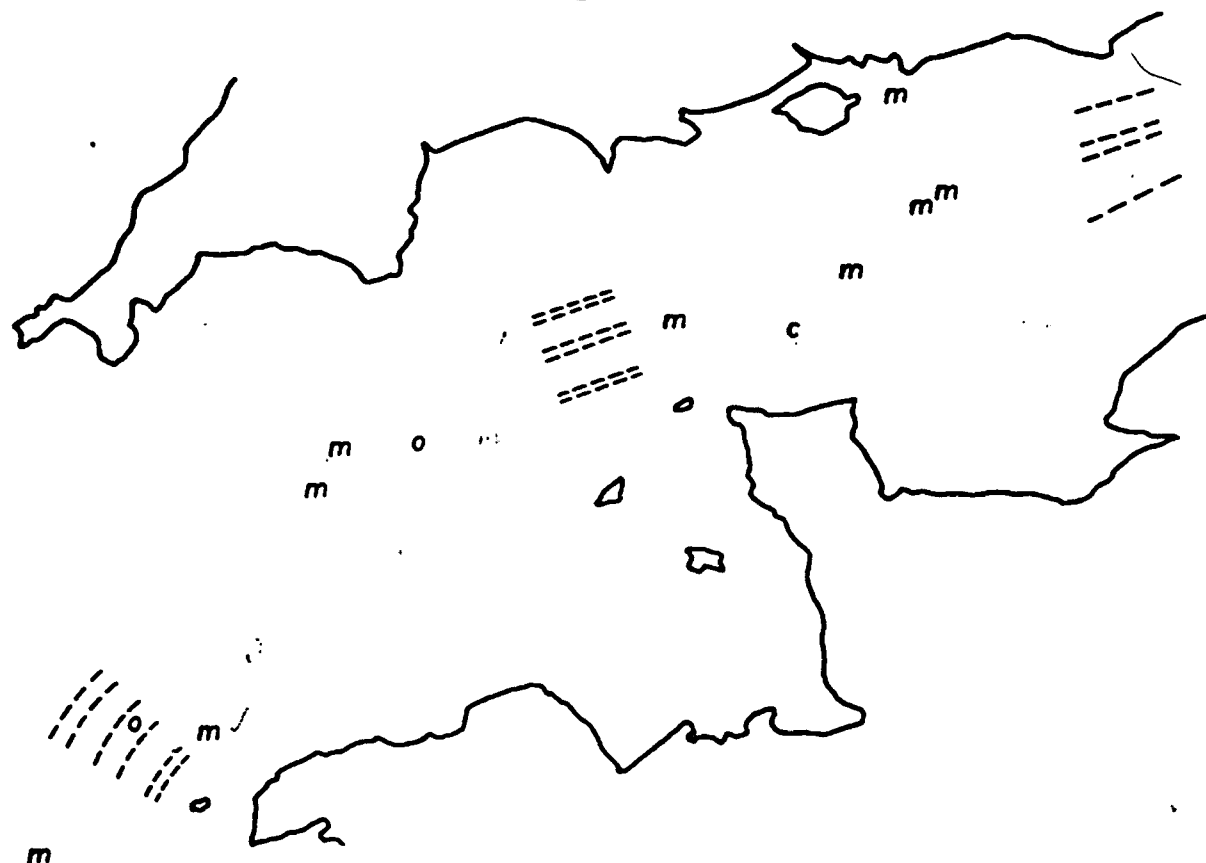
Fig. 3. Location and type of collisions in the English Channel 1977-81

Figure 3 shows the location and type of collisions which have occurred in the region in the last five years. The precise location of two collisions between vessels proceeding in opposite directions has not been determined. Since January 1979 there has been an additional eastbound lane in the outer part of the Ushant TSS with a recommended direction of traffic flow extending to the north-east for use by tankers and other ships fitted with appropriate electronic position-fixing equipment. This arrangement has been criticized as being likely to cause problems with crossing traffic west of the Casquets scheme, but so far there has been no report of a collision which could be attributed to the revised routing scheme.
