# Epifluorescent microscopy of edge-trimmed carbon fibre-reinforced polymers: An alternative to computed tomography scanning

## Abstract

X-Ray computed tomography (XCT) can be used to detect edge-milled carbon fibre-reinforced polymer (CFRP) defects. Significantly this method is able to show subsurface defects that cannot be captured by traditional methods such as stylus-based or more novel areal methods of surface quality measurement. While useful, this method can be prohibitive due to high equipment cost, scanning time and image resolution. XCT can often produce artefacts which falsely predict damage or obscure damage and depending on machine X-ray power often cannot resolve damage to fibre diameter which is critical when observing milled quality of the surface/subsurface. This study utilises epifluorescent (EF) optical microscopy to provide high-quality optical images as an alternative to XCT to observe through-depth damage of CFRP materials. The method of computing the novel damage criteria is presented, as well as the validation of the method which compares EF to XCT. Subsurface damage of fabric and unidirectional (UD) materials in 0°, 45°, 90° and –45° orientations to the c

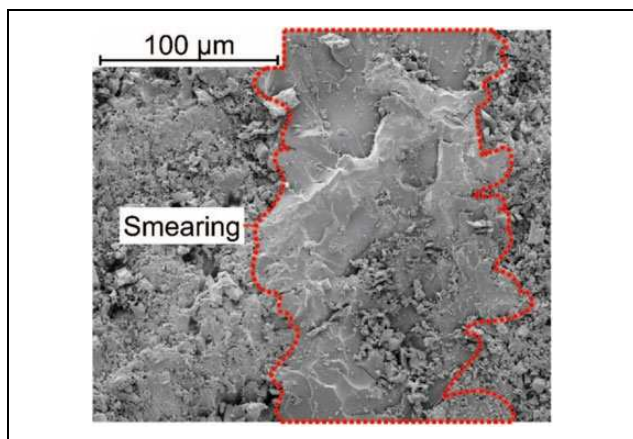
**Figure 1.** Smearing matrix observed on the trimmed surface by SEM for fibres oriented at  $90^\circ$  to cutting edge. SEM: scanning electron microscopy.

While improvements have been made to characterise the surface of the machined part quality, the full extent of damage may not be captured. Scanning electron microscopy (SEM) has confirmed that matrix smearing during edge-trimming operations can occur and occurs most predominantly in fibres oriented at  $90^\circ$  to the cutting edge<sup>9</sup>. Smearing occurs across the surface of edge-trimmed samples due to high cutting temperatures generated through the abrasive nature of cutting. This temperature exceeds the glass transition temperature ( $T_g$ ) of the CFRP reinforcement material, where  $T_g$  is the state at which the polymer becomes rubbery before its melting point.<sup>10</sup> The trochoidal motion of the tool during milling smears the rubbery polymer across the surface, potentially hiding defects. An example of this smearing is shown in Figure 1. This smearing may limit the results of areal methods of depth of damage recorded by authors<sup>7,8</sup> as the true depth of damage may be obscured and for some fibre directions ( $90^\circ$ ), the damage may be obscured entirely.

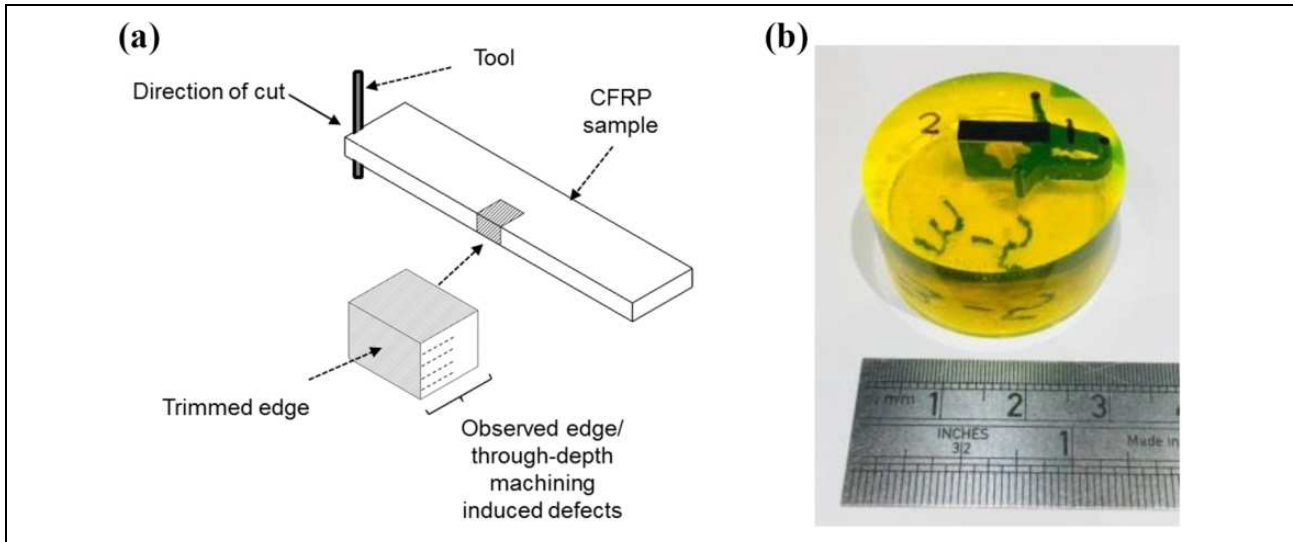
**Figure 2.** (a) Area of epifluorescent inspection of edge trimmed CFRP coupon and (b) CFRP sample mounted in fluorescent resin. CFRP: carbon fibre-reinforced polymer.

The proposed alternative to XCT requires through-depth observation of the edge-trimmed material as shown in Figure 2(a). Samples are trimmed to fit in a 30mm mounting cup using a water cooled tile saw (Erbauer) with a 1.6-mm-thick diamond disc cutter.

Following sectioning, the samples are mounted in Epo-fix which was mixed with Epo-dye (Struers, UK), an epoxy resin infused with fluorescent dye as shown in Figure 2(b). EF material has been used because of its ability to clearly show defects in damaged CFRP materials by providing extremely high contrast.<sup>13</sup> Cold mounting ensures that the damage caused by milling is not removed by heat which could potentially damage the CFRP material and change the specimen from its original machined condition. The mounted samples are placed in a vacuum of  $0.1 \text{ N mm}^{-2}$  for 5 min to ensure that the resin penetrates any cracks present in the CFRP. The samples are then cured for 24 h at room temperature. Samples were abrasively polished to remove the face of the material which may have been damaged by the Erbauer tile saw and finally polished to provide a smooth surface for optical observation using the polishing regime noted in Ashworth et al.<sup>14</sup>

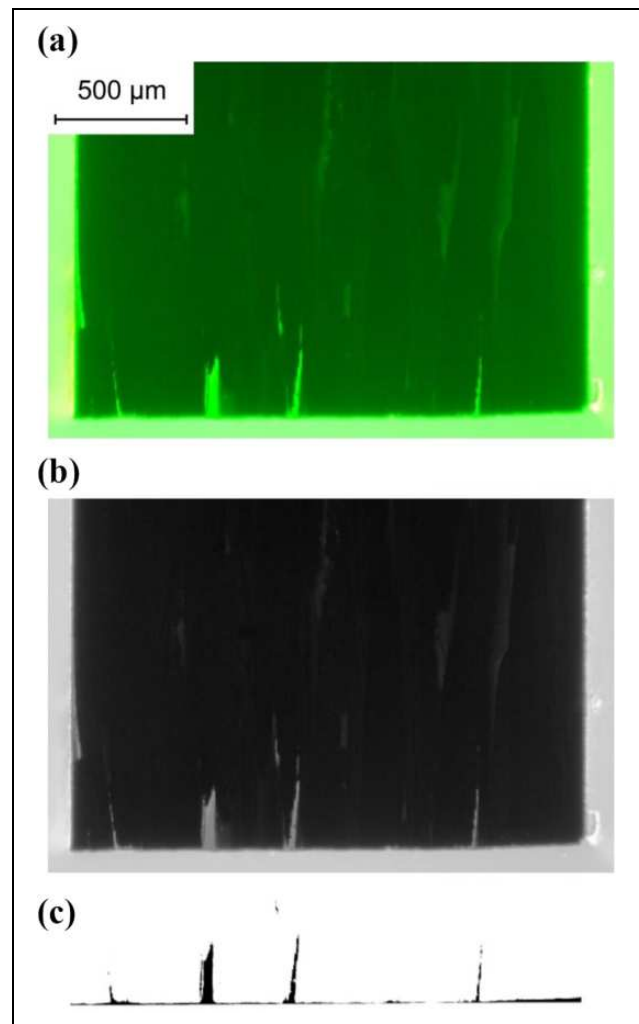
**Figure 3.** (a) Epifluorescent image showing through-depth damage, (b) Matlab processed greyscale image and (c) Matlab/Otsu processed binary image showing damage.

An X-Cite ultraviolet light box (Excelitas, Best Scientific, UK), a 5-MP digital camera (Pax-it, Best Scientific, UK) and microscope at  $2\times$  magnification were used to capture the EF sample, an example is shown in Figure 3(a).

The EF material has allowed a high contrast between the damaged and the un-damaged CFRP. To determine the amount of damage shown in Figure 3, the digital image can be subject to pixel thresholding. Thresholding of colour images is possible, however the image was changed to a greyscale for simplicity of Matlab (Mathworks). A Matlab script changes the colour image to a greyscale image as shown in Figure 3(b).

A further Matlab subroutine allows the user to define a straight edge which can be drawn across the edge of the image to represent a theoretical straight cutting line. Deviations from this cutting line are highlighted by the EF mounting material and thus represent damage. Automated Otsu thresholding<sup>15</sup> is then used within Matlab to yield a binary image of damaged areas as seen in Figure 3(c). Further Matlab calculations provide a novel damage metric which presents a pixel count/actual area (when used with

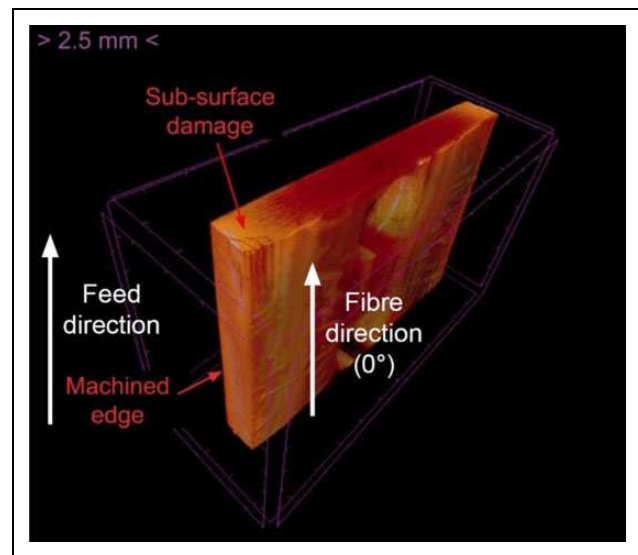
**Figure 4.** 3D XCT scan of UD fibres oriented at 0° to the cutting edge made from 1879 planar .tiff images to allow comparison to EF method. XCT: X-ray computed tomography; UD: unidirectional.

Post-processing of the images was completed using “CTvox v3.0 (Bruker)”, a free to download software to produce images that are shown in Figure 4. The 3D image is made of up to 1879 single planar slice .tiff images that can be used for direct comparison to EF images such as that

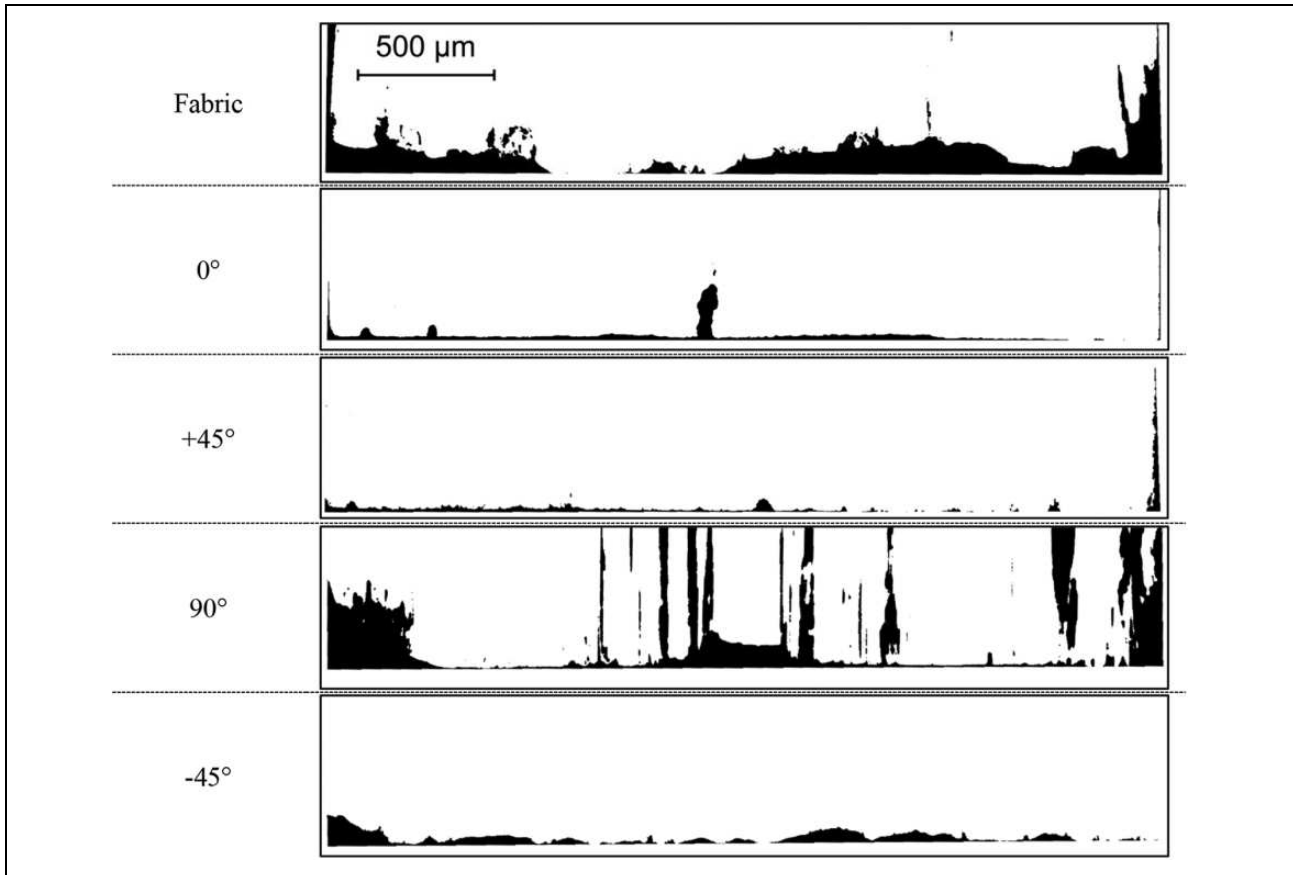
**Figure 5.** Binary images denoting damage obtained through novel metric calculations.

Figure 5 shows the binary images created through the use of the novel damage metric for the various fibre orientations used within this study. By applying the thresholding method described in the second section, the total amount of damage compared to the theoretically straight cut can be calculated. The amount of damage is shown in Figure 6, where error bars represent repeatability error of the novel process.

It can be seen that machining  $90^\circ$  fibres forms the greatest level of damage. Figure 5 shows large-scale damage along the length of the fibres/fibre–matrix interface. The damage occurring during machining of  $90^\circ$  is described by Wang et al.,<sup>19</sup> with the cutting force causing shear of the fibres and the force also causing a mode I type opening along the fibre–matrix interface. Various authors<sup>20,21</sup> described the cutting process of this fibre orientation as a

Figure 5 shows that subsurface defects have occurred for fabric,  $0^\circ$  and  $90^\circ$  fibres which would not have been captured with methods such as focus variation. While images show subsurface damage, it is noted that a larger population of sectioned material is required to draw full conclusions of cutting modes of differing fibre orientations.

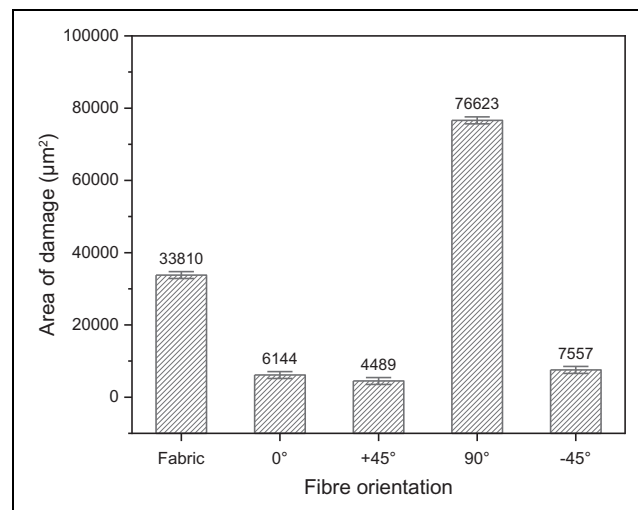
**Figure 6.** Novel metric damage results for differing fibre orientations to the cutting edge.

type I delamination where the failure mode propagates into the trimmed edge by some unspecified distance. Fibres at  $+45^\circ$  to the cutting edge exhibit the least amount of damage when using the novel metric even compared to  $0^\circ$  fibres which typically exhibit the least amount of surface damage according to the literature.<sup>3,21</sup> However, the subsurface

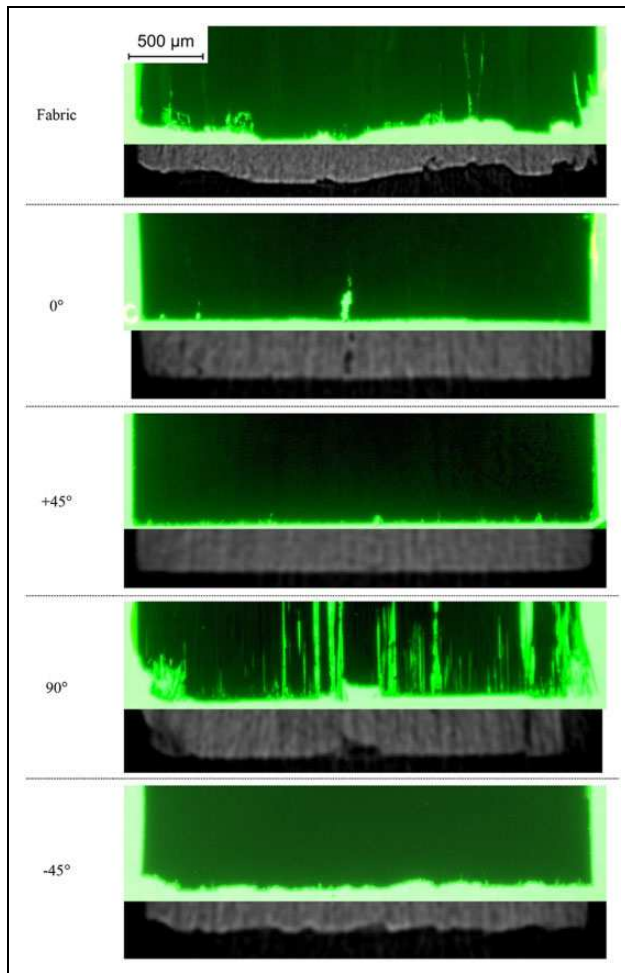
**Figure 7.** Verification of epifluorescent method by comparison with single-planar slice XCT. XCT: X-ray computed tomography.

Figure 7 shows the verification results when the EF method is compared to XCT images. While the resolution of the XCT is limited by relatively high distance between scan sections compared to fibre diameter, artefacts and ghosting, all of which do not allow individual fibres to be imaged, it can be seen that major areas of damage on the machined edge seen through XCT is replicated in the EF images. Importantly, the EF images do not exhibit further damage from the processing method. The machined edge shown for the  $-45^\circ$  XCT sample does not match the EF closely which may be due to the distance between individual images taken by the XCT equipment; however, the contrast available shows some light greyscale areas which can be interpreted to allow a match with the EF image.

Visible transverse cracks for  $90^\circ$  fibres can be seen in the EF image in Figure 7 and are observed to a less visible extent in the XCT image. This is due to power limitations in the XCT equipment which does not allow resolution to individual fibre level in addition to the production of artefacts which mask areas of no material.

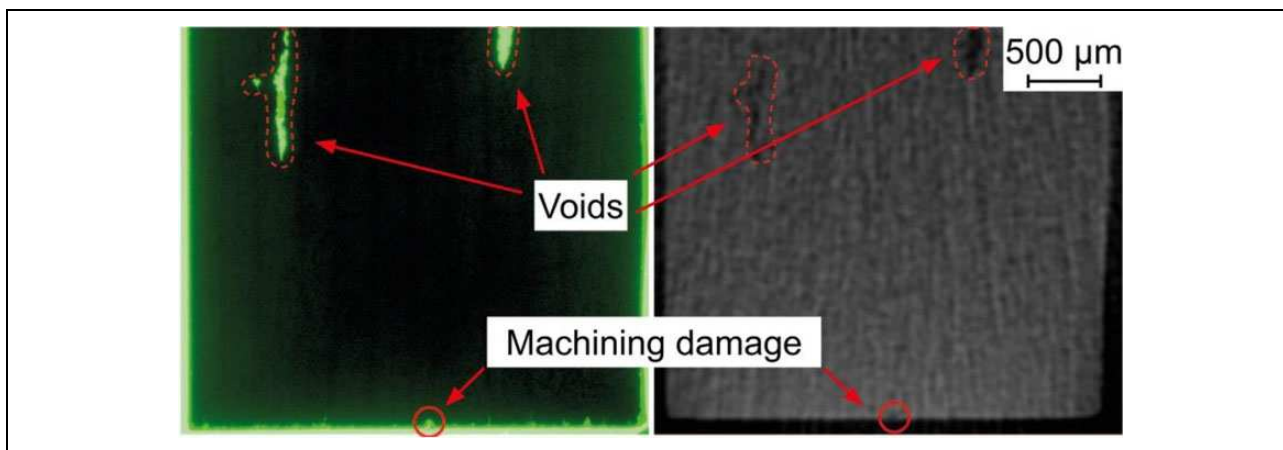
**Figure 8.** Further verification of damage to  $+45^\circ$  fibres.

the resolution limit of the XCT equipment used. However, Figure 8 shows validation through inspection of a deeper surface which shows that voids are seen alongside a small amount of edge damage which can be seen in the XCT image.
