Bearing damage identification in oxide/oxide ceramic matrix composite with a new test design

In this paper, the mechanisms of damage of an oxide/oxide ceramic matrix composite bearing are studied with a new experimental setup, the balanced quarter hole device (BQH). This test was designed to allow direct observation of the damage development on a material subjected to bearing failure. In a standard bearing experiment, real time monitoring is extremely difficult to set up, and post mortem observations of the bearing plane can be biased by the cutting operation. High speed cameras were used to take pictures of the bearing plane so that the damage development could be studied and a damage chronology established. The validity of the setup was verified by comparing the results obtained with those of a standard bearing test. Two different stacking sequences were studied, and the influence of the material microstructure and composite machining was investigated. It was shown that the first critical damage, matrix cracks, appeared before the load drop, and then led to delamination and kink bands, causing the final failure of the material.

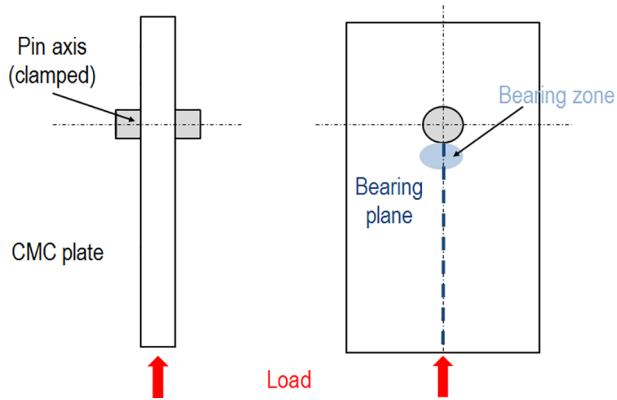
Fig. 1. Modified bearing sample based on ASTM D5961 [22]

Consequently, a new experimental procedure needed to be designed to allow direct observation of the bearing plane during the tests (Fig. 1). Schilling et al. [23] performed tests on a full bearing specimen with in situ tomography but this solution was expensive and required a complex test setup. Aldebert et al. [24] and Catché et al. [25] studied the damage chronology on the slice of a rectangular composite plate, with an adjusted axis producing a compressive load on the slice. While this setup allowed for the monitoring of the bearing zone, it did not consider the drilling effects (surface roughness, local damage) or the stress intensity factor due to the hole, and the contact area between the axis and the plies was not representative of a bolted joint.

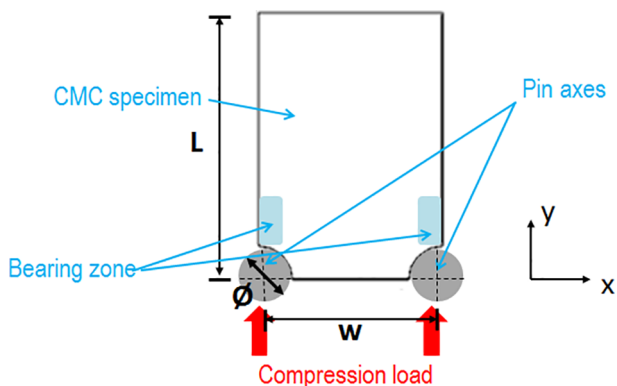
Fig. 2. Sample geometry.

In this paper, the geometry was therefore adapted so as to obtain a contact zone that was more representative of a bearing test (Fig. 2). The setup was designed with two drillings in order to be symmetric. This improved the stability of the specimen, prevented sliding during the test and ensured a quasi-simultaneous failure of the two partial holes. Even when simultaneity was not achieved, the setup still had the interest of allowing access to a history of the bearing damage. This symmetric behavior was monitored thanks to digital image correlation monitoring, by checking that the vertical displacement of the specimen was equivalent on both sides. Moreover, the geometry of the specimen, particularly its free length, ensured that the failure would be a bearing one.

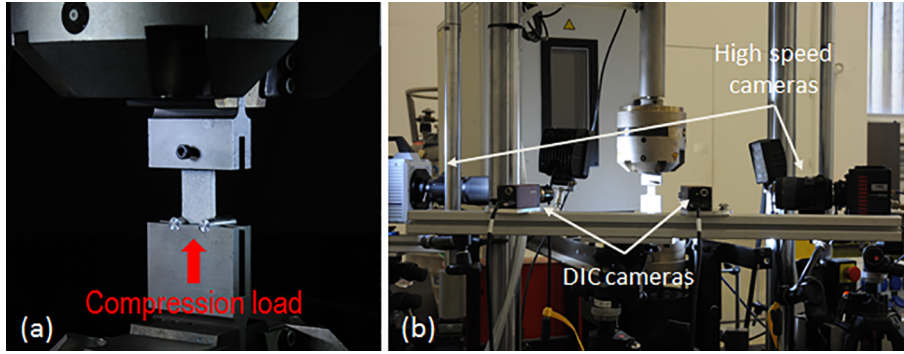
Fig. 3. Experimental design (a) test setup and (b) instrumentation.

The sample was held at its top by an adjustment system that allowed it to be rebalanced at the beginning of the tests. The bearing contact was achieved with two axes made of steel, to which a compression load was applied (Fig. 3.a). Monotonic tests were performed on an Instron 100 kN with controlled displacement. The specimens were loaded at a rate of 0.1 mm/min, at room temperature. The damage development on both slices was monitored in real time with two high speed cameras (Photron FASTCAM SA5 and MINI AX200) taking 100 000 frames per second. This rate of acquisition was chosen before the tests to be sure to record enough data during the load drop phase (about 5 ms). An analysis of the results showed that it could be lowered to 20,000 frames per second without loss of information. The two high speed cameras were synchronized, and the load was recorded in order to be correlated with the pictures taken by the devices. In addition, a digital image correlation setup (VIC 3D) was used to measure displacement and strain on the front face of the specimen. The test configuration is presented in Fig. 3.b.

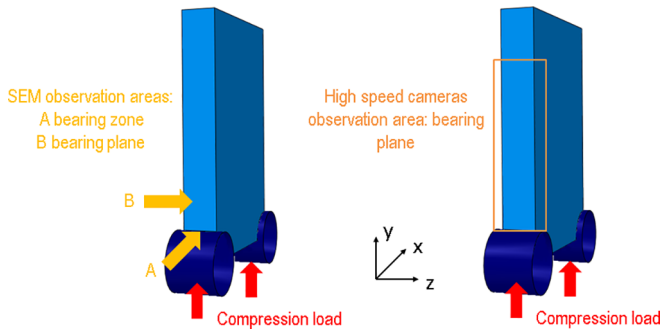
Fig. 4. Areas observed with the experimental instrumentation of the BQH test.

After the tests, an SEM was used to obtain a final cartography of bearing damage inside the holes (area A) and on the slices (area B). Fig. 4 is a schematic representation of the areas observed with the high speed cameras and studied with the SEM.

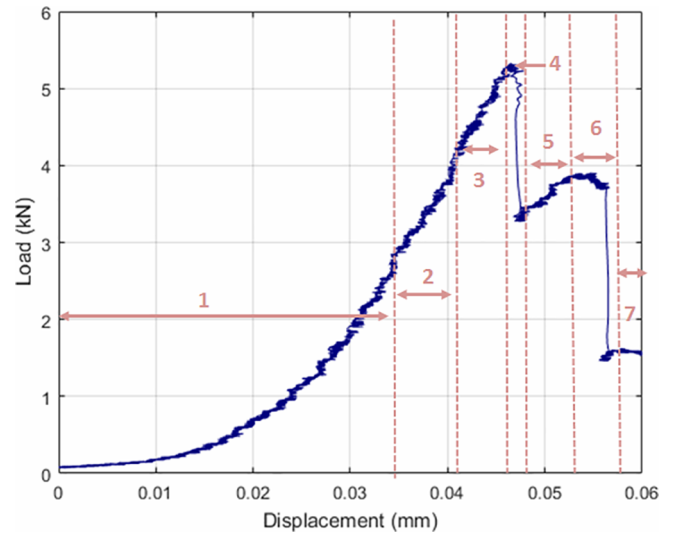
Fig. 6. Phases of the BQH experimental behavior (BQH22).

Fig. 5. Four tests were performed for each lay-up. Fig. 5.a corresponds to the $[0]_{10}$ stacking sequence (BQH₁₁, BQH₁₂, BQH₁₃ and BQH₁₄) and Fig. 5.b to the $[0/45/0/45/0]_s$ one (BQH₂₁, BQH₂₂, BQH₃₂ and BQH₃₃). The mean maximum load was similar for both stacking sequences but the dispersion of the results was greater for the $[0/45/0/45/0]_s$ specimens. The curves can be decomposed into several stages, presented on one typical curve in Fig. 6.

1. Adjustment of the specimen in the test setup (due to clearances)
2. Elastic linear behavior
3. Nonlinear behavior
4. First bearing peak and load drop
5. Load recovery

6. Second bearing peak and load drop
7. Residual load

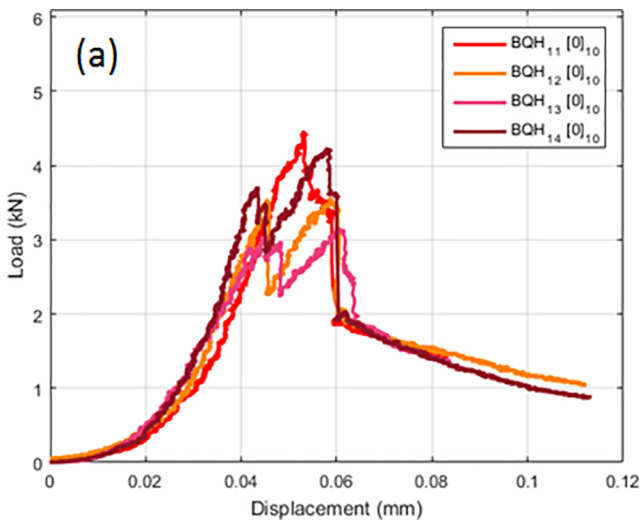
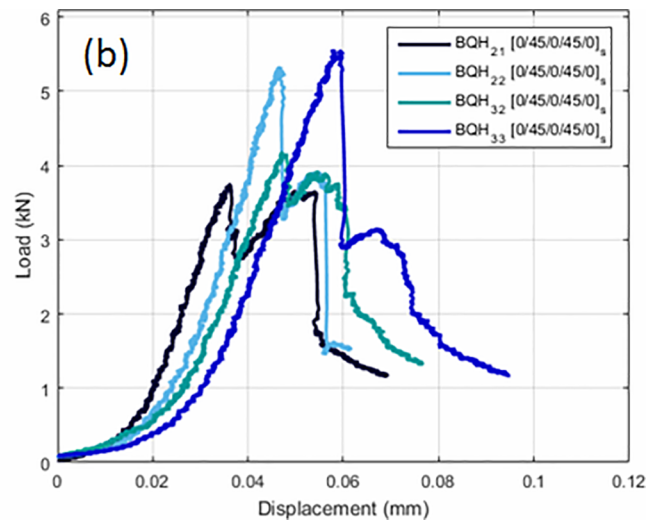
Fig. 5. Experimental curves for the BQH tests. (a) stacking sequence $[0]_{10}$ and (b) stacking sequence $[0/45/0/45/0]_s$.

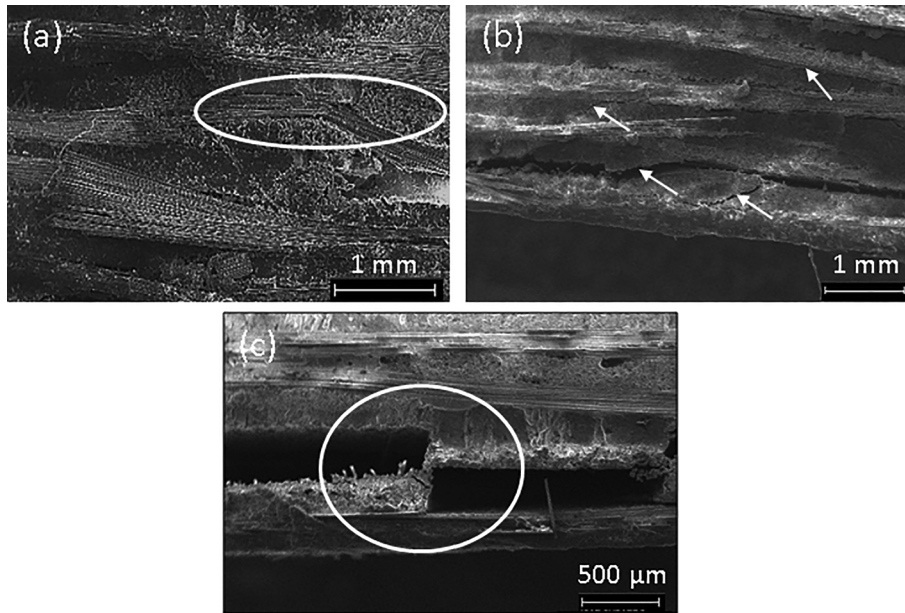
Fig. 7. SEM images (area B) of damage in the oxide/oxide CMC ([0]₁₀ specimen): (a) kink bands due to fiber buckling, (b) matrix cracks and (c) delamination between plies.

The main damage observed was comparable to that existing in a classical bearing test [10,20,21]: fiber micro-buckling and kink bands, matrix cracking and delamination between adjacent plies (Fig. 7).

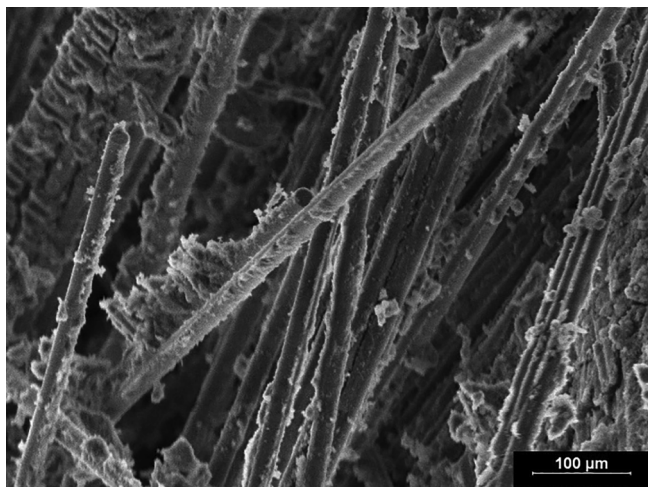
Fig. 8. SEM image (area A) of fiber pull-out in a [0/45/0/45/0]_s specimen.

Fiber pull-outs were noticeable, proving the efficiency of the weak matrix concept (Fig. 8). Some fibers were also extracted from the slice (Fig. 9). Unlike a standard specimen, the BQH did not have a closed bearing plane (free edge configuration), so there was no material to

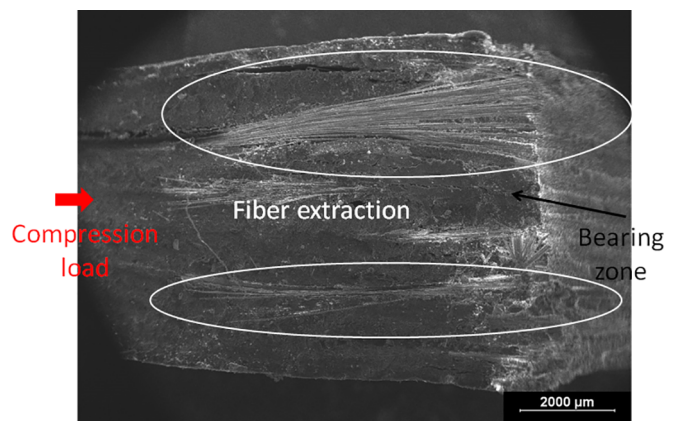
Fig. 9. SEM image (area B) of fiber extraction from the slice of a [0/45/0/45/0]_s specimen.

retain the fibers in the composite. This fiber extraction constituted additional damage that was not representative of the bearing chronology, and it will not be included in the damage chronology.

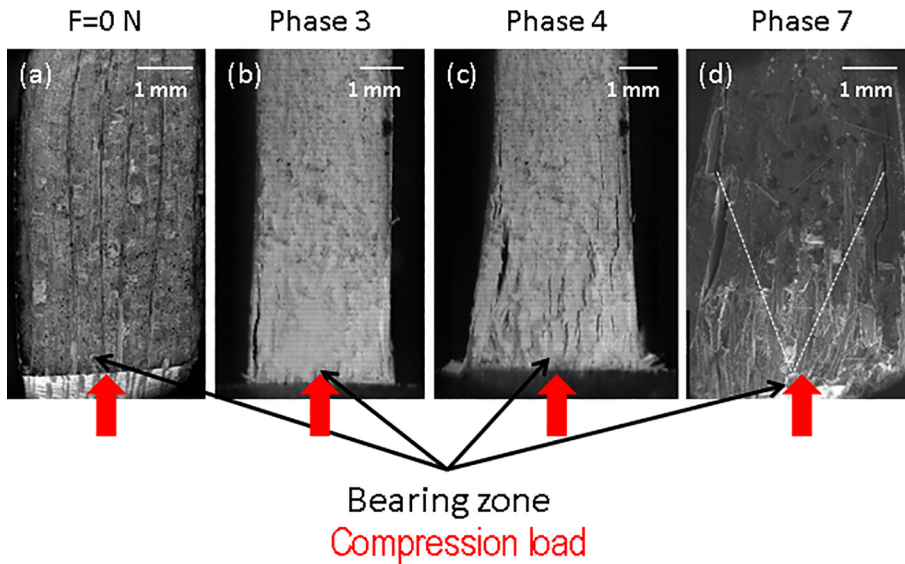
Fig. 11. Damage chronology for the $[0/45/0/45/0]_s$ specimens: (a) before testing (SEM image), (b) first matrix cracks (phase 3, high speed camera image), (c) propagation of matrix cracks and delamination at the $0^\circ/45^\circ$ interfaces (phase 4, high speed camera image) and (d) specimen after the bearing failure (phase 7, SEM image).

The damage evolution on the slice of the specimens is presented in Figs. 10 and 11. Each image, taken with either the high speed camera or the SEM, shows the damage cartography at a bearing stage. It can be noted that the damage is localized on the external plies of the structure, regardless of the stacking sequence. This can be explained by the fact that the internal plies are contained by the external ones, so the damage evolution is restrained inside the composite.

The damage chronology is quite similar for both stacking sequences. During phase 1 and phase 2, no damage is observed. The first degradation is seen in phase 3, which is consistent with the loss of linearity in the load-displacement curve. The first damage is fiber buckling in the 0° plies (Figs. 10.b and 11.b). It can appear on either the internal or external plies, but always close to the contact area between the specimen and the steel axis. This damage is not easily detectable because of the camera resolution, but it seems to exist in several specimens.

The load drop (phase 4) corresponds to the swelling of the structure induced by the development of new matrix cracks and the propagation of the former one. The damage during this phase is described more precisely in the next section. The weakening of the structure then leads to the appearance of ply buckling, delamination and kink bands, causing the final failure. In several specimens, delaminations are not distributed throughout the thickness but appear first on the external plies of the composite. Then they propagate through the thickness towards the internal plies by following the shape of the fiber tows (Fig. 11.c). On the SEM image taken after the tests, it can be seen that the extent of the delamination is greater in the external plies than in the internal ones, and that the final degradation is V shaped (Fig. 11.d).

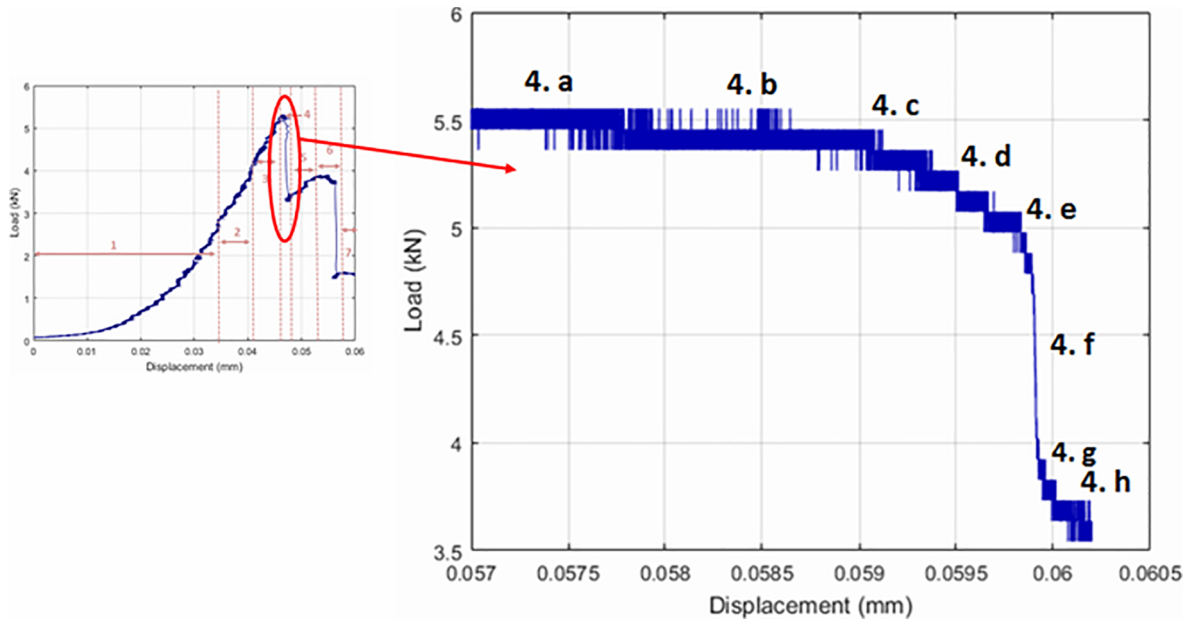
Fig. 12. Load displacement curve of BQH₂₂ during phase 4.

The damage development during stage 4 of the BQH test was precisely studied with the images taken by the high speed cameras. The load displacement curves of two $[0/45/0/45/0]_s$ specimens can be seen on Figs. 12 and 13. Figs. 14 and 15 show the mechanical behavior of two specimens exhibiting different degradation patterns.

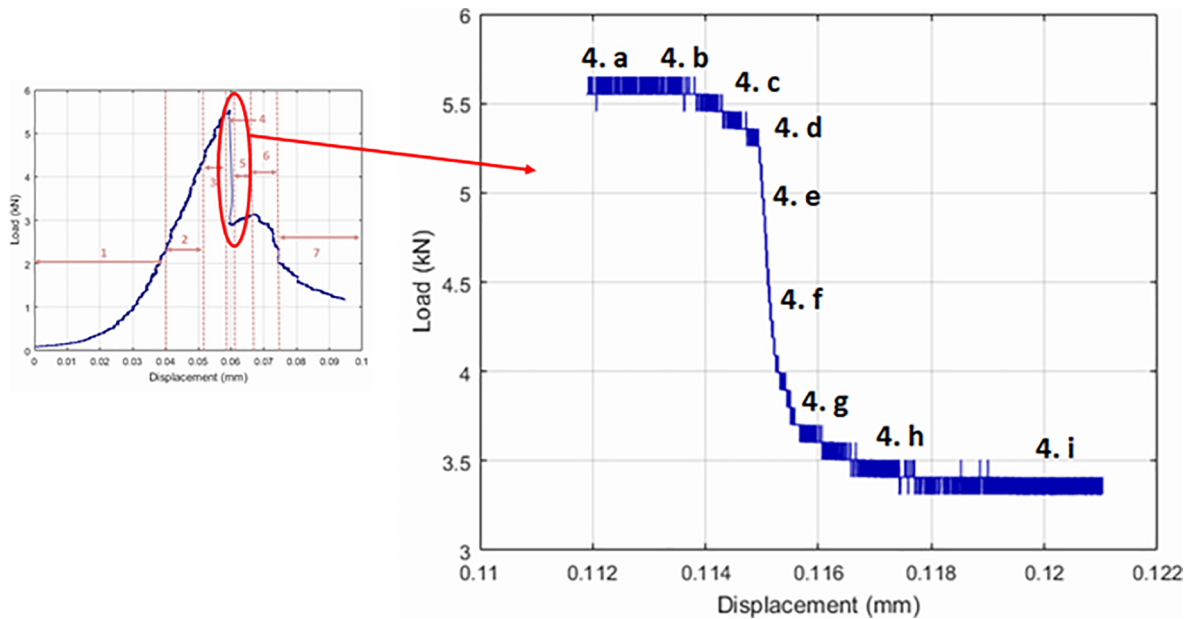
Fig. 13. Load displacement curve of BQH₃₃ during phase 4.

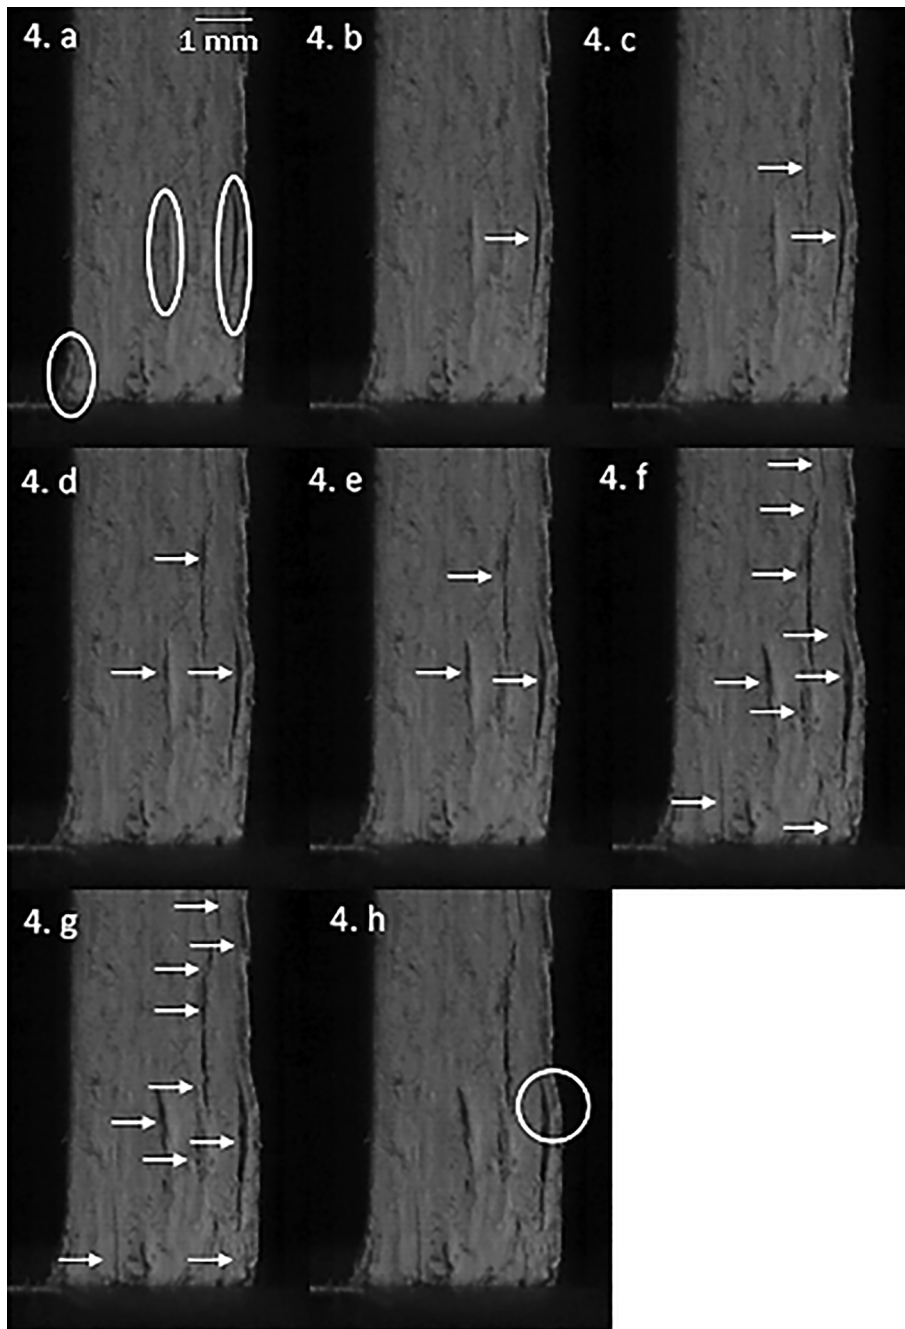
Fig. 14. High speed camera images of damage kinematics (delamination propagation) during the load drop stage (BQH₂₂).

On Fig. 14, the two first images of the BQH₂₂ load drop phase show that some damage (matrix cracks and delamination of an external ply) existed before this stage. During the falling of the load, the delamination extends, new matrix cracks and delamination appear and the existing ones propagate along the composite (images 4.c to 4.f). It can also be observed that the swelling of the slice occurs during this phase (between images 4.e and 4.f). Finally, at the end of this sequence, the initial delamination leads to the buckling of the external ply of the specimen.

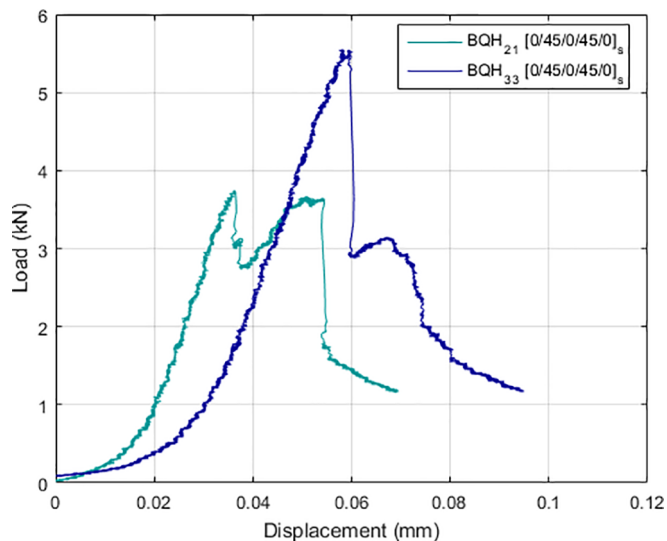
Fig. 16. Experimental curves for the BQH₂₁ and BQH₃₃.

behavior. In this section, two specimens presenting the same stacking sequence ([0/45/0/45/0]_s) are studied. BQH₂₁ has a higher stiffness before breakage than BQH₃₃ but a lower bearing peak load (Fig. 16).

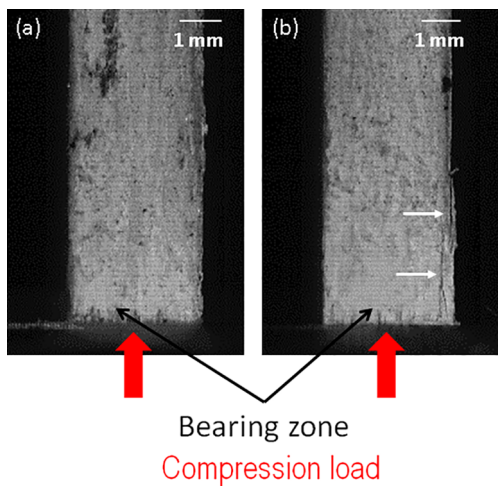
Fig. 17. High speed camera images of the specimens at the beginning of phase 2: (a) BQH₂₁ and (b) BQH₃₃.

The pictures from the high speed cameras indicate that BQH₃₃ shows cracks almost at the beginning of phase 2, whereas BQH₂₁ exhibits its first damage later (Fig. 17). The stiffness degradation being linked with the composite damage, the former specimen maintains its initial stiffness longer than BQH₃₃. The images at the bearing point also show differences between the two specimens (Fig. 18). Both samples exhibit several delaminations but, on the BQH₂₁, their extent is greater. The damage must have propagated faster and more easily on this

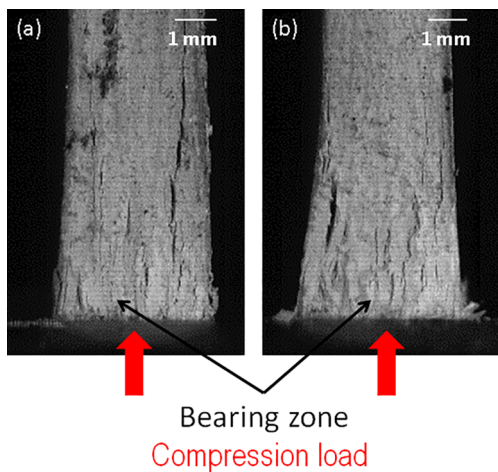
Fig. 18. High speed camera images of the specimens at the first bearing peak (phase 4): (a) BQH₂₁ and (b) BQH₃₃.

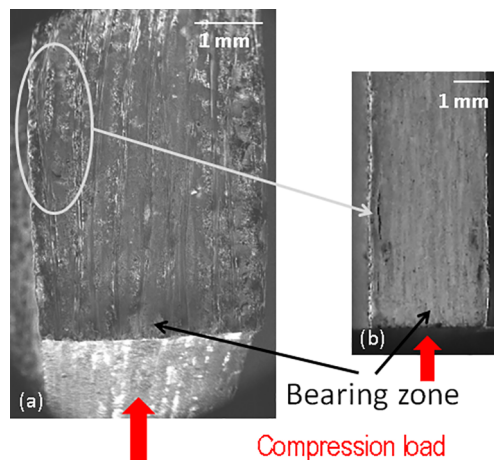
Fig. 19. Damage appearance related to the microstructure: (a) before testing, location of the highest matrix fraction (SEM, area B) and (b) during the test, location of the first matrix crack (high speed camera).

propagation was found on some specimens. These zones corresponded to locations where the fiber waviness and therefore the matrix fraction were the most marked. On Fig. 19, it is noticeable that the first matrix cracks occur at a place where the fiber waviness induces a surplus of matrix and, on Fig. 20, the delamination of the composite propagates over a similar area.

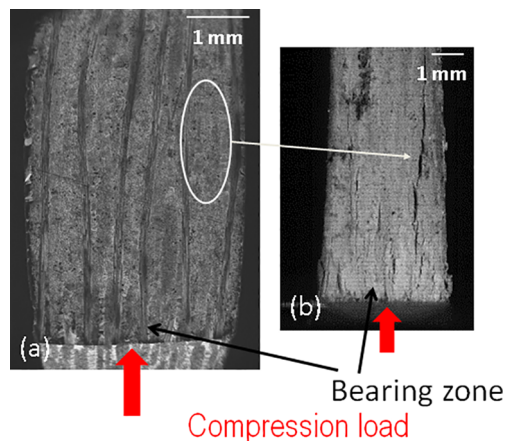
Fig. 20. Damage appearance related to the microstructure: (a) before testing, location of the highest matrix fraction (SEM, area B) and (b), during the test, propagation of a delamination (high speed camera).

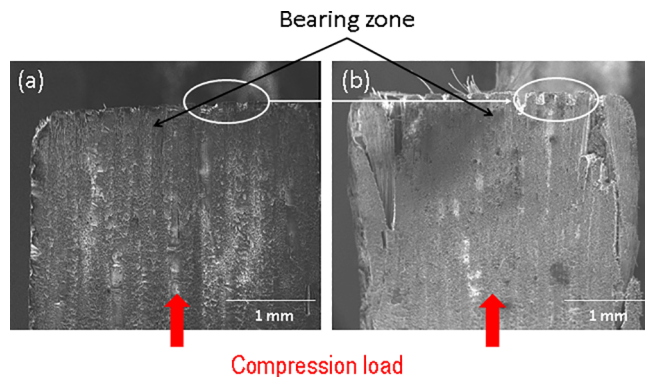
Fig. 21. SEM images (area A) of BQH specimens, the machining defects induce tow breakage (a) image before testing and (b) image after the experiment.

The location of the bearing damage can also be influenced by the machining of a composite, which can cause defects such as fiber extraction or matrix breakage, and these can initiate the first damage when the specimen is subjected to a bearing load [26–28]. Fig. 21 shows an example of such a phenomenon. The post mortem SEM picture shows that some 0° tows were broken on the bearing contact area. A comparison with the pre-test SEM image reveals that the location of

such breakage corresponds to the place where the fibers were damaged by the drilling. On Fig. 22, the first matrix crack seems to coincide with fiber degradation due to the cutting operation.

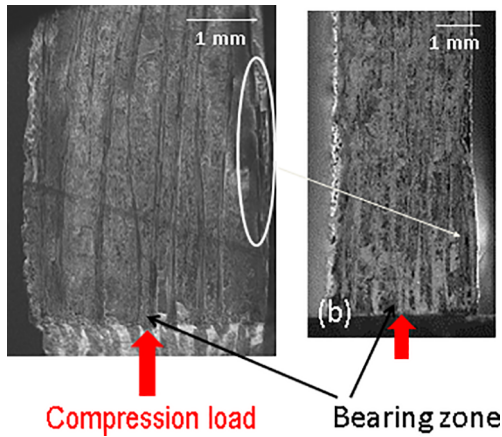
Fig. 22. Images of BQH specimens; the machining defects induce cracks (a) Image before testing (SEM, area B) and (b) image during the experiment (high speed camera).

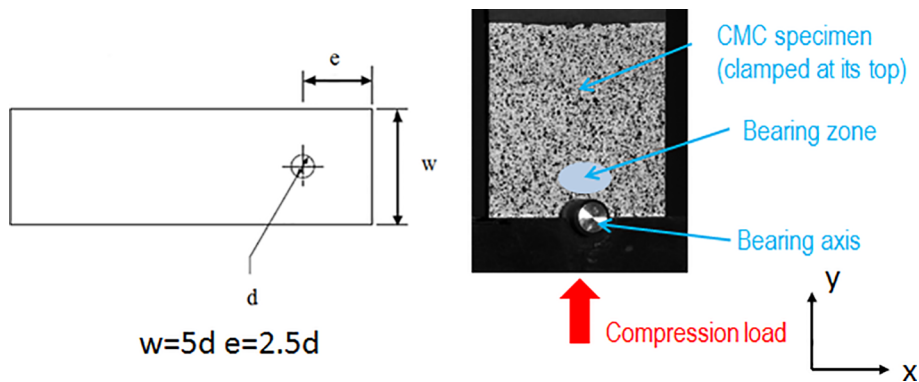
Fig. 23. Bearing specimen geometry and loading conditions (DIC image).

The results obtained were compared to those of standard bearing tests in order to assess the relevance of our experimental design. The comparison was made for [0/45/0/45/0]_s specimens, as the available bearing tests were performed with this stacking sequence. Fig. 23 shows the bearing specimen geometry and loading conditions. The width of

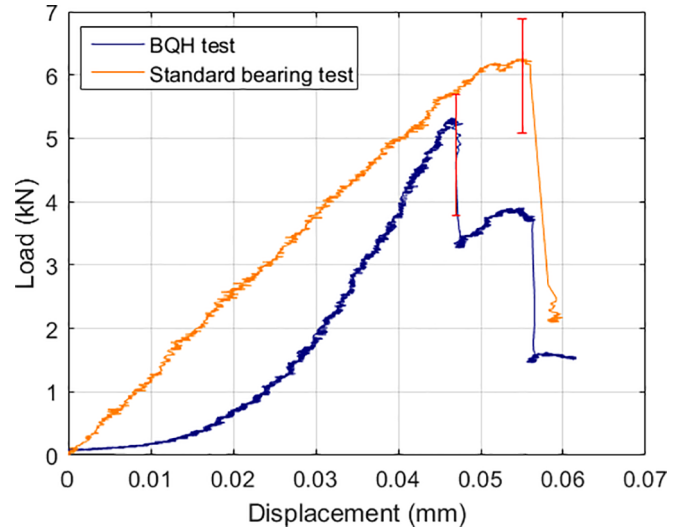
Fig. 24. Experimental load displacement curves for standard bearing and BQH tests.

standard bearing and BQH experiments are plotted in Fig. 24. The maximum load is 25% higher on average for the standard test. This can be explained by the fact that the contact zone is smaller with the quarter hole device, the axis only pushing on a partial bearing zone. Moreover, the geometry of the specimens is not the same and this parameter can influence the ultimate load in a bolted joint [8,29,30]. Unlike the standard bearing one, the BQH specimen also presents a free edge; hence the damage is not confined and can develop more easily. For the standard test, the stress at peak can be deduced from the relation $\sigma = (F/d t)$, where F is the load, t the thickness of the composite plate, and d the hole diameter. However, due to the specimen geometry, this relation is no longer applicable for the BQH device, and the bearing stress cannot be obtained from this test.

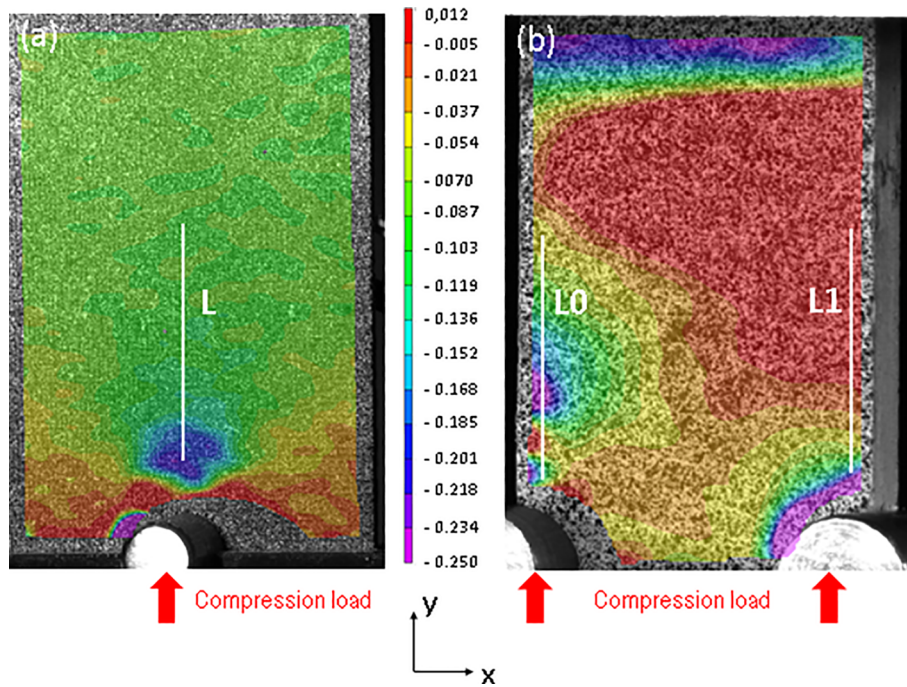
Fig. 25. Longitudinal strain cartography (%) at the first bearing point: (a) standard bearing test, (b) BQH test.

The digital image correlation data were also compared, and the longitudinal strain cartographies at the first bearing point are presented in Fig. 25. It can be seen that the cartographies are qualitatively similar: the digital image correlation shows that there is a strain location from the start of the nonlinear phase. This higher strain certainly indicates the appearance of damage in the composite. It is located near the bearing contact zone, over a distance nearly corresponding to the drilling diameter.

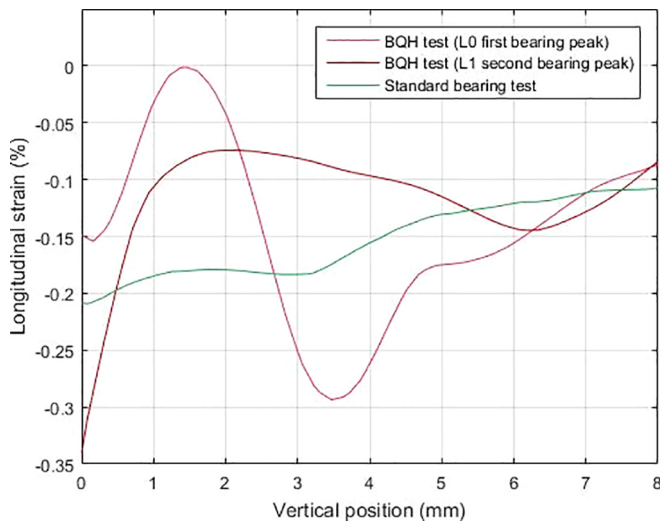
Fig. 26. Longitudinal strain as a function of the vertical position.

Moreover, the value of the longitudinal strain can be compared for both experiments along a vertical line located on the bearing plane (Fig. 26). For the standard test, the curve is the one obtained at the bearing peak. For the BQH test, the cartographies of both bearing peaks are presented. The line L0 corresponds to the first bearing peak (for the left hole) and the line L1 to the second one (right hole). For both configurations the vertical position $y = 0$ is taken next to the hole.

At the bearing location ($y = 0$), all configurations show the same behavior, with a negative strain due to the compressive damage. The value of the strain for the standard bearing is included between those for the BQH test. It can be observed that the strain variation is different for the two bearing peaks of the BQH, but this can be explained by the different behaviors of the two holes. For L0, the study of the out of plane displacement indicates that the specimen is subjected to a local buckling on the external ply at the first bearing point (Fig. 27). This may explain the fact that the longitudinal strain oscillates along the bearing plane and that its value is higher for $y = 2$ than for $y = 4$. In contrast, on the bearing plane L1, there is no buckling but only a swelling of the material on the bearing zone (Fig. 28). These observations are confirmed by the camera images, with buckling appearing on

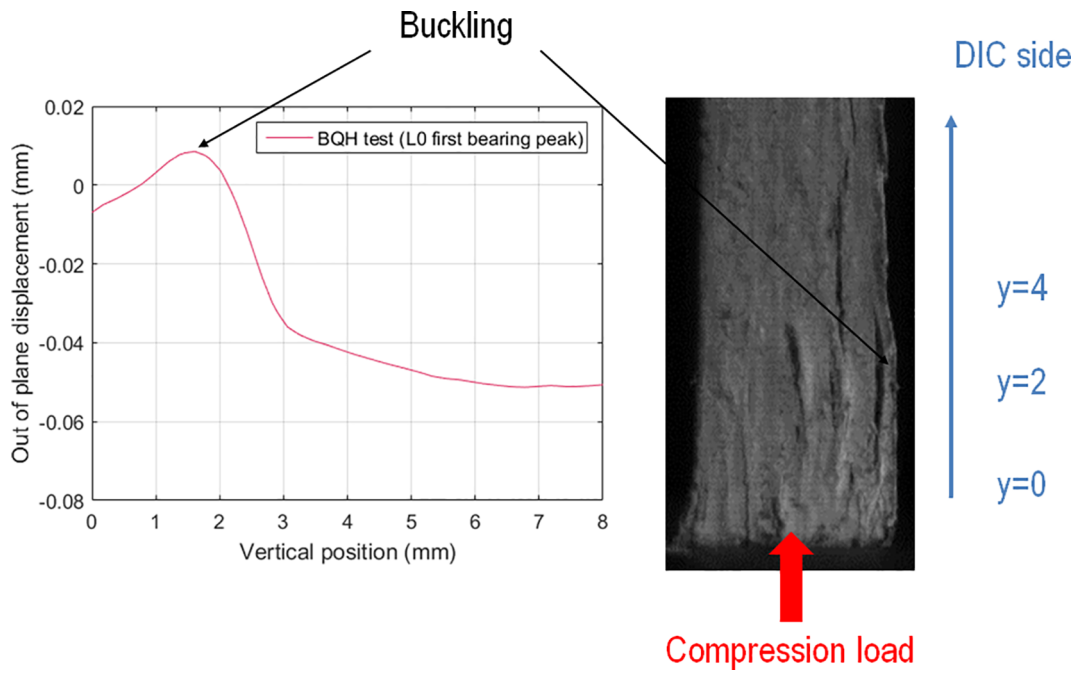
Fig. 27. Out of plane displacement at the first bearing peak (BQH₂₂, L0).

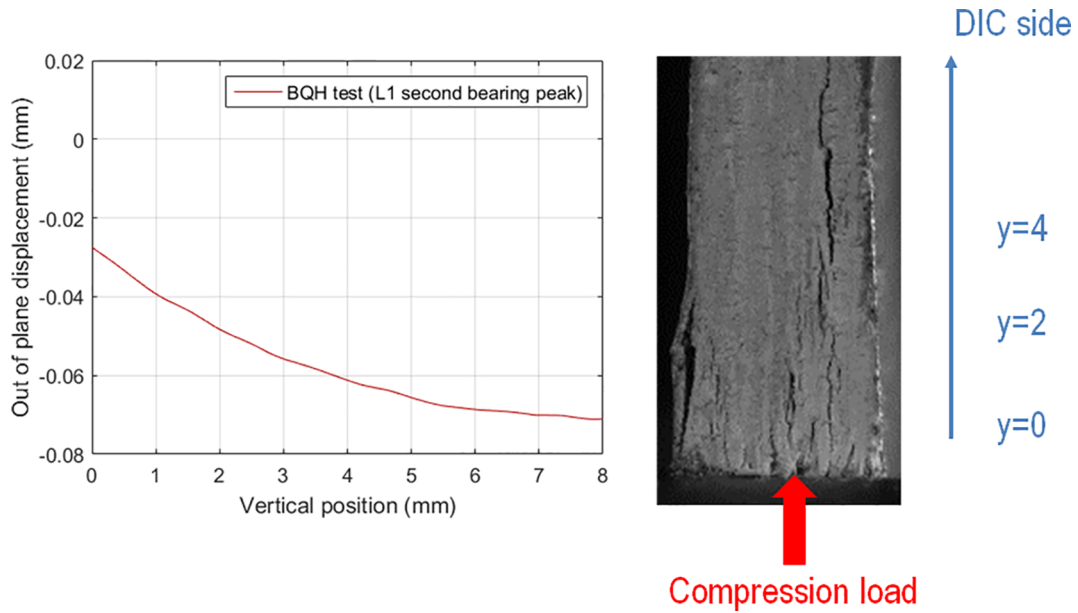
Fig. 28. Out of plane displacement at the second bearing peak (BQH₂₂, L1).

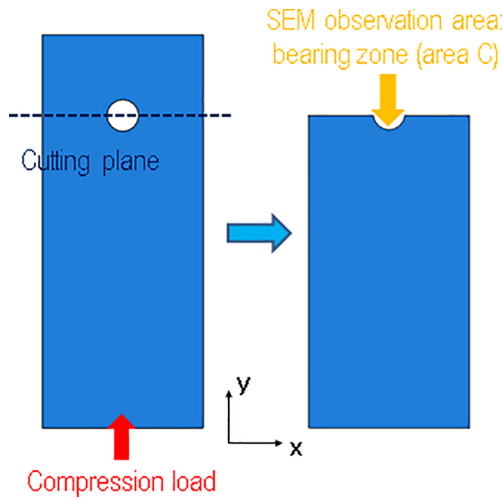
Fig. 29. First SEM observation area (inside the hole).

For both configurations, bearing damage was studied. Post mortem observations were achieved using an SEM, with images taken inside the hole (Fig. 29, area C) and on the bearing plane (after cutting the specimen for the standard bearing tests, Fig. 30, area D).

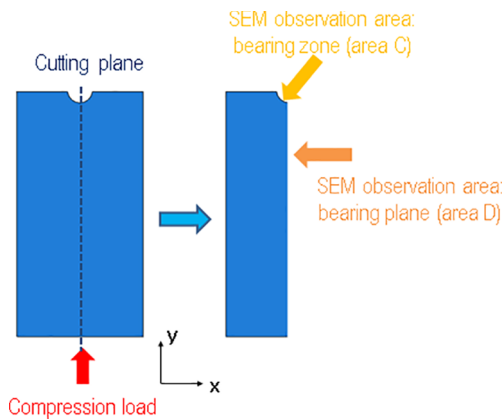
Fig. 30. Second SEM observation area (on the bearing plane/bearing zone).

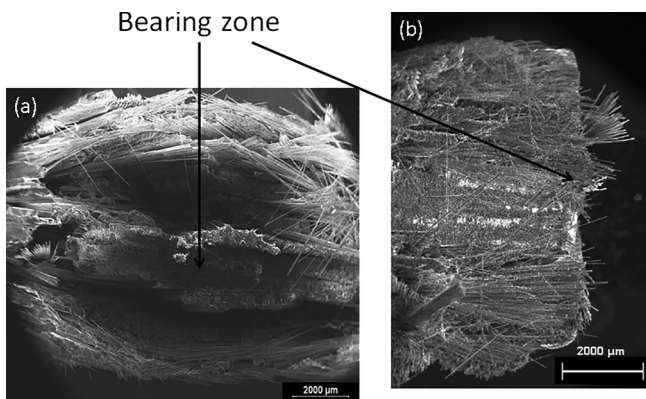
Fig. 31. SEM images of the specimen after the tests, showing the external plies more damaged than the internal ones: (a) on a standard bearing test (area C) and (b) on a BQH test (area A).

- The location of the main damage: on both configurations, the external plies were more damaged than the internal ones (Fig. 31). Moreover, on some specimens, the external plies (0° plies) were broken due to a compression failure (Fig. 32).
- On the SEM images, it can be seen that the edges of some 0° rows are missing, due to the buckling of the plies near the bearing contact (Fig. 33)
- There are fiber kink bands near the contact zone, on the bearing plane of the composite (Fig. 34).
- The same V-shaped damage can be observed through the thickness of the composite, on the bearing plane (Fig. 35).

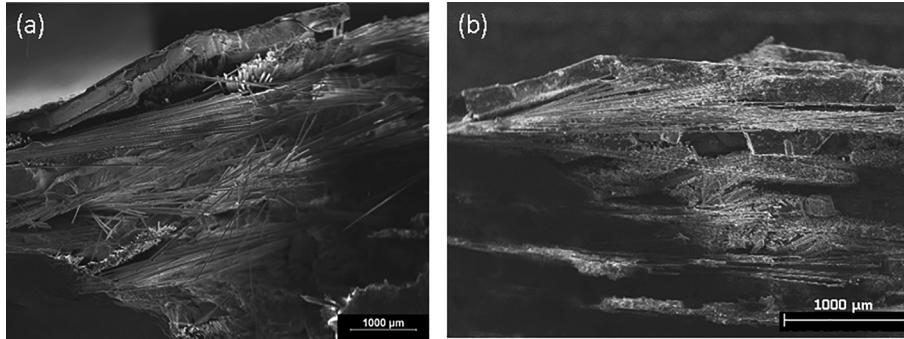
Fig. 32. SEM images of the breakage of the external plies: (a) on a standard bearing test (area D) and (b) on a BQH test (area B).

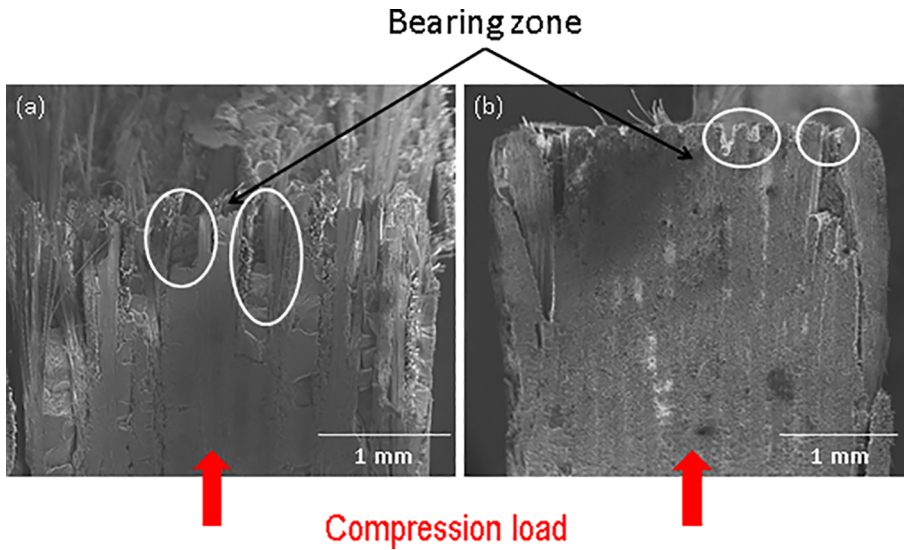
Fig. 33. SEM images of tow breakage: (a) on a standard bearing test (area D) and (b) on a BQH test (area A).

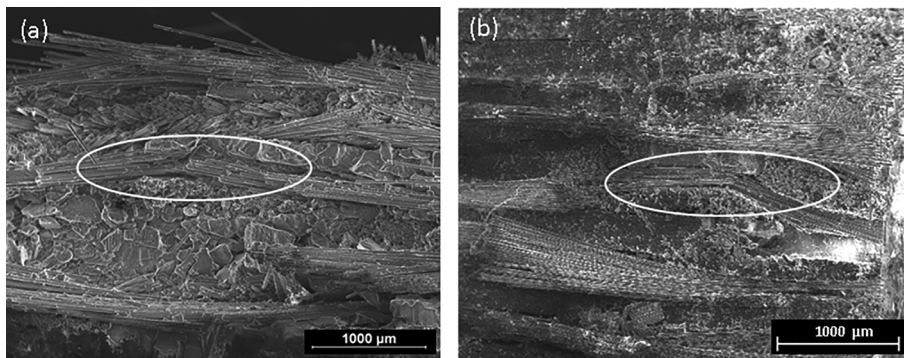
Fig. 34. SEM images of kinking due to the bearing failure: (a) on a standard bearing test (area D) and (b) on a BQH test (area B).

The bearing failure is due to an accumulation of multiple degradations including kink bands, matrix cracks and delamination. The first significant damage seems to be matrix cracking. The microstructure of the material plays an important role in the damage initiation as the cracks tend to appear on the zones with the highest matrix fraction, which are weaker than the rest of the structure.

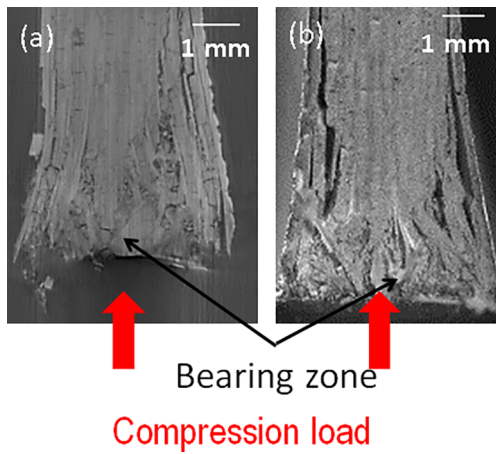
Fig. 35. Damage after failure on the slice of the specimen: (a) tomography of the bearing plane on a standard bearing test and (b) high speed camera image on a BQH test.

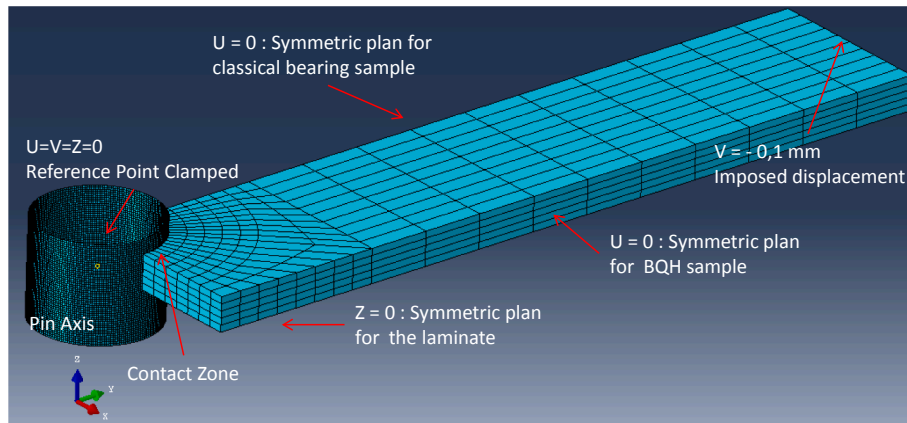
Fig. 36. Numerical model of the configurations.

The CMC specimen was meshed at ply level, with twenty quadratic C3D8 elements (Abaqus reference) per ply (brick elements with eight Gauss point and three DoF per nodes) and represents the half of the test specimen (Fig. 36). For this computation, the CMC behavior was

The boundary conditions are representative of the two configurations. For each sample, pin axis was clamped and an imposed displacement equal to -0.1 mm was applied to the opposite face (Fig. 36).

The same model was used for the bearing and BQH samples, only the symmetric conditions on the x direction change.

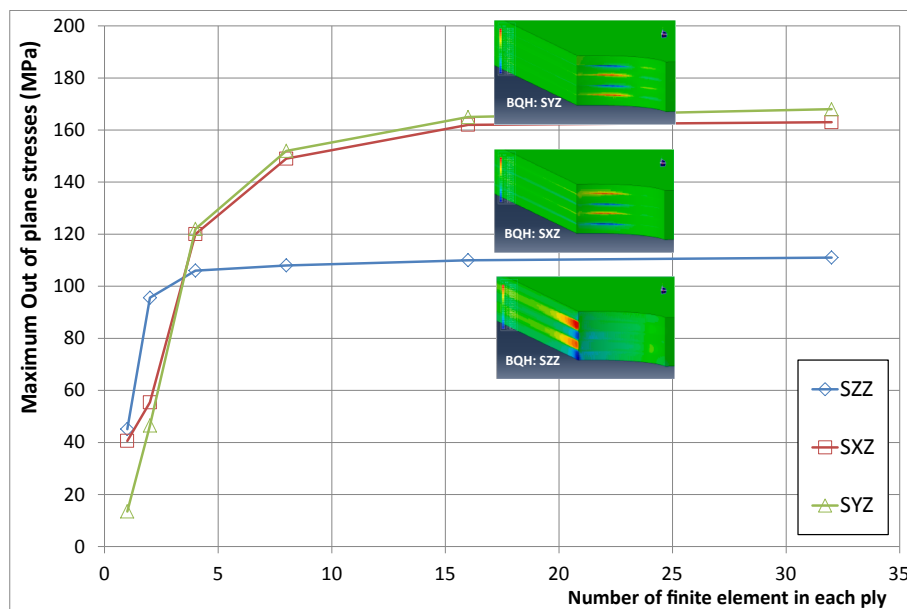
Fig. 37. Mesh convergence study for BQH FE model.

A convergence study was performed in order to validate the FE model. The mesh density according to the thickness direction varies between one and thirty two elements. The results show for BHQ sample model and for out of plane stresses distribution (Fig. 37), that convergence is obtained for twenty elements in the ply thickness. We used the same mesh for bearing sample model.

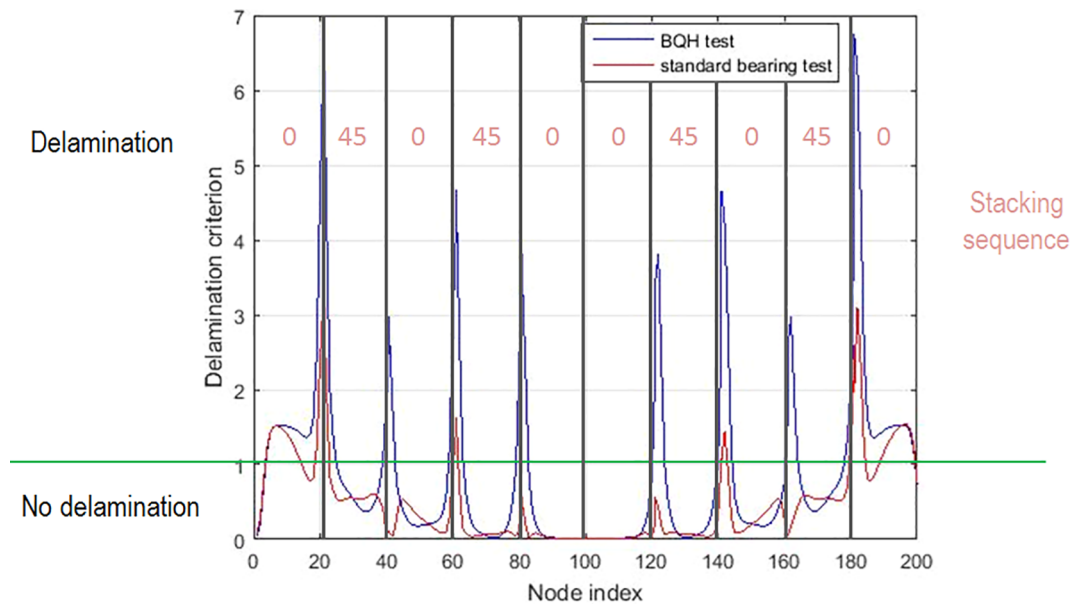
Fig. 38. Delamination criterion of both configurations for $[0/45/0/45/0]_s$ stacking sequence.

The material delaminates when f exceeds the value 1. The values of σ_{zz}^R , σ_{xz}^R and σ_{yz}^R were obtained through a previous experimental campaign aimed at obtaining the mechanical parameters of the oxide/oxide CMC by testing it with tension, compression, or shearing tests. The results of the delamination criterion for a displacement corresponding to the bearing displacement are presented in Fig. 38.

The results are consistent with the experimental observations; in particular, delamination occurs at the same locations as predicted by the criterion. For both tests, the CMC tends to delaminate at the $0^\circ/45^\circ$ interfaces, and the delamination is greater on the external plies due to the free boundary conditions.

It can be noted that the BQH criterion is quantitatively higher than the standard bearing one. This confirms that the free edge in the BQH test could enhance delamination depending on the layup. In some other configurations to be determined, delamination could become preponderant and such a BQH test could not be compared to standard bearing test. In contrast, some layups could exhibit no difference in terms of delamination criterion, as can be seen in Fig. 39 for the $[0]_{10}$ stacking sequence. For this layup, the BQH setup does not enhance delamination, it even tends to reduce it on the external plies. However, even if there is no delamination, some intra ply debonding can be seen in the composite. Performing finite element simulations gave an insight into the order of magnitude of delamination differences due to the BQH test configuration.

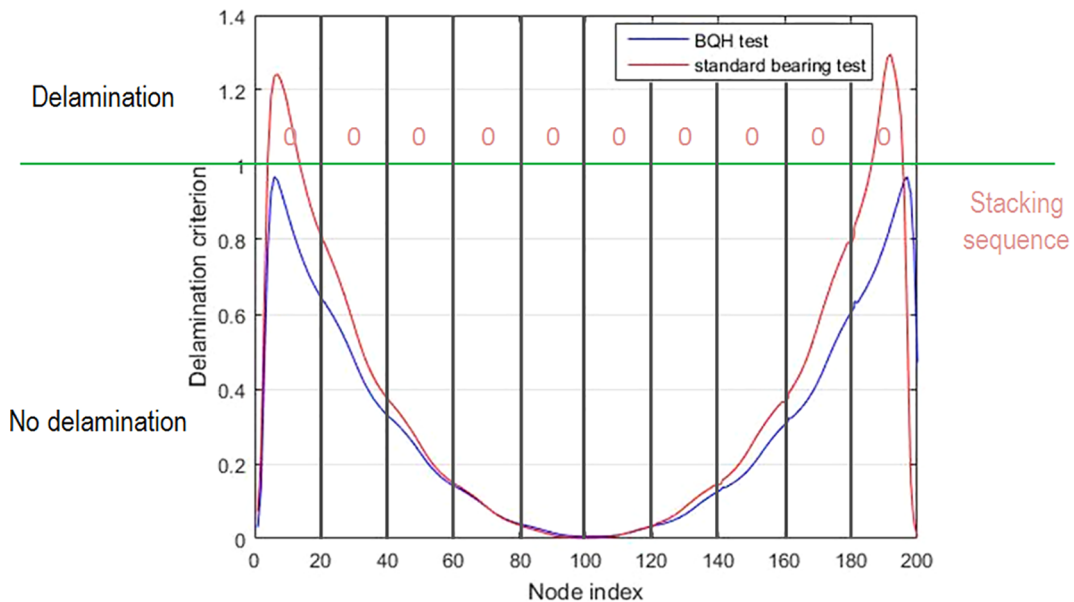
Fig. 39. Delamination criterion of both configurations for $[0]_{10}$ stacking sequence.
