Cite this article: Mol L, Gomez-Heras M, Brassey C, Green O, Blenkinsop T. 2017 The benefit of a tough skin: bullet holes, weathering and the preservation of heritage. *R. Soc. open sci.* **4**: 160335. http://dx.doi.org/10.1098/rsos.160335

The benefit of a tough skin: bullet holes, weathering and the preservation of heritage

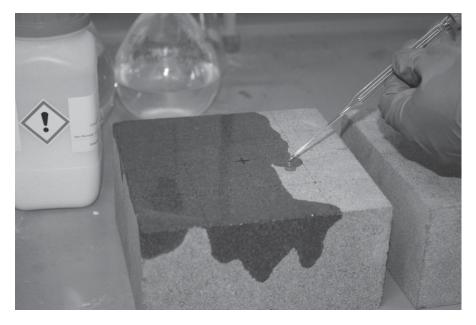
Figure 2. Application of Wacker OH 100 treatment.

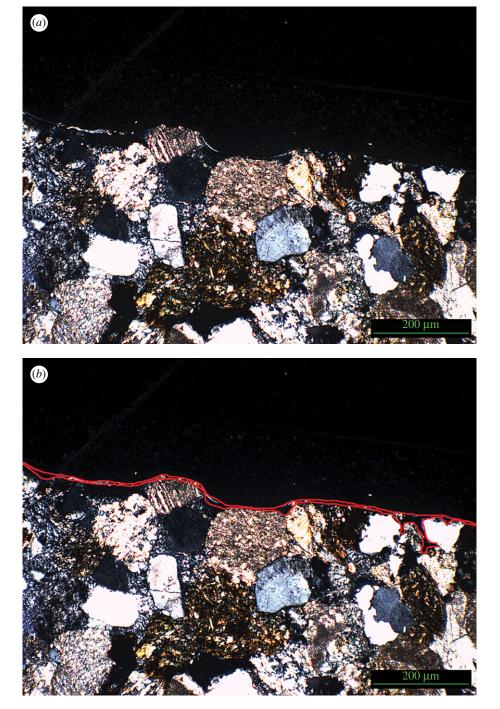
Figure 3. (a) Wacker OH 100 gel layer in original image. (b) Wacker OH 100 gel layer with accentuated observation of gel deposition.

Cementation of the surface, referred to as 'case hardening' and manifested as a surface crust, often develops after freshly cut building stone is exposed to environmental factors such as precipitation and temperature fluctuations [19,20]. This cementation can consist of multiple phases such as carbonate, calcite or iron oxide crusts, and while stabilizing the top surface can also enhance deterioration of the stone matrix owing to subsurface moisture accumulation and subsequent dissolution of the cement matrix as well as increasing pressure on the surface [21–23]. To address this change in surface hardness and porosity, half the samples were treated with Wacker SILRES BS OH 100, an ethyl silicate-based consolidant which forms a silica-based gel upon contact with moisture in the stone pores, and subsequently dries within the pore system [24], by pipetting the substance onto the surface (figure 2). This consolidant is also used in conservation of stone artefacts to increase hydrophobicity and decrease bioinfestation potential [25–27]. One layer was applied to mimic surface consolidation, as it is used here as an analogy for natural case hardening, rather than multiple applications which might have resulted in consolidation of the majority of the sample [28]. After curing, a thin layer of consolidant was observed at the surface of the block but, as anticipated, this layer was mostly restricted to the surface and immediate subsurface (figure 3a,b). Case hardening under natural circumstances results in the deposition of a

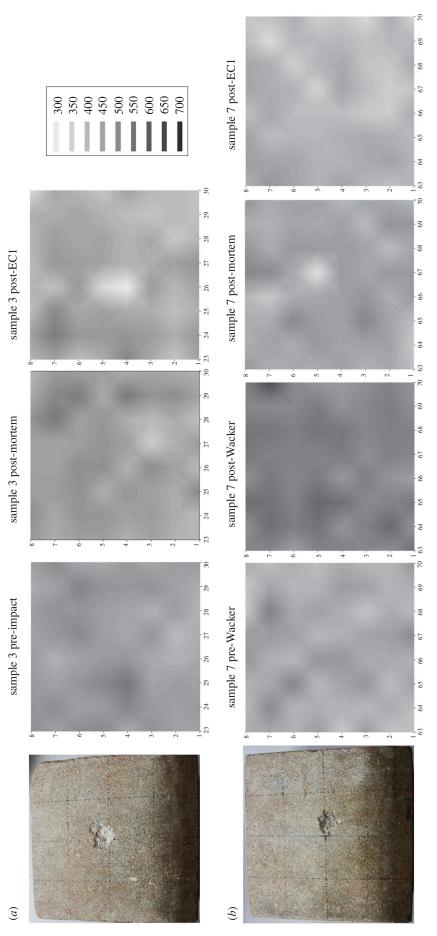
Figure 7. Piccolo data from samples 3 (a, sample not treated with Wacker OH 100) and 7 (b, sample treated with Wacker OH 100 and shot) in Leeb value. Values were interpolated using SigmaPlot area plot.

However, mean values cannot adequately describe spatial variations in elastic properties. Therefore, the Piccolo data from samples 3 and 7 measured across the surface of the block have been plotted in figure 7 to show change during the various stages of the experiment. Here, two interesting trends emerge. Firstly, sample 3, which was not treated with Wacker OH 100, does not show weakening directly corresponding to the impact area, although damage is apparent elsewhere. This follows the trend of the absorption of the impact by the more elastic nature of the surface (compared with the Wacker OH 100 treated surface). However, after the environmental cabinet treatment there is a clear weakening of the impact area, as represented by the lighter coloured area and relatively stable measurements around the impact area. This trend is reversed in sample 7 where initially the impact area is clearly identifiable post-impact (the very light grey area that corresponds with the location of the impact), accompanied by a general deterioration of the surface strength across the surface of the block. This impact area is much less visible after the environmental cabinet treatment. Instead there appears to be a general but less severe deterioration of the surface.

As can be seen in figures 6 and 7, all samples were negatively affected by the environmental cabinet treatment. However, the extent to which the samples were affected by the treatment appeared to be strongly related to the nature of fracture network developed at the time of impact, as based on the research set out by Momber [34]: The rigid, Wacker OH 100 treated, fractured surface appears to be more vulnerable to temperature changes overall, whereas the untreated and more plastic surface appears to cope far better with the thermal stresses placed upon the samples in the environmental cabinet but suffered noticeable degradation of the impact area, leaving it vulnerable to potential cavernous weathering. The pre-impact condition of the surface is therefore instrumental in determining the impact of a projectile, such as a bullet, and projecting future deterioration patterns.

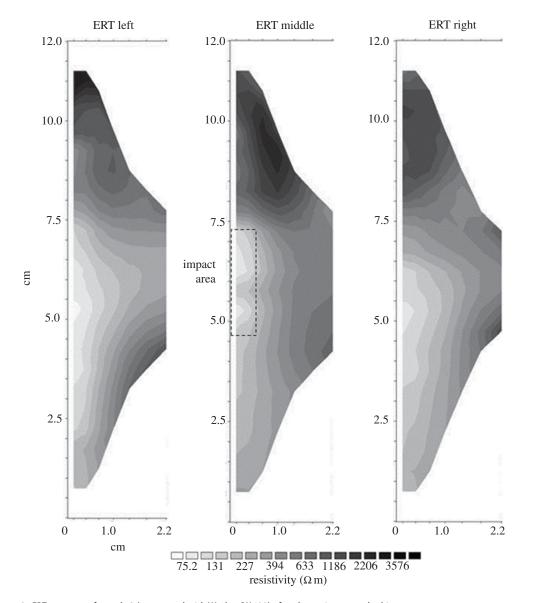
Figure 8. ERT transects of sample 3 (not treated with Wacker OH 100) after the environmental cabinet treatment.

Resistivity measurements were taken along three transects across the stone sample (for sampling strategy, see figure 4). The middle transect covers the impact area and it was expected that the most noticeable changes would be seen in this area. Figure 8 shows the distribution of moisture in sample 3 after the environmental cabinet treatment. This sample was not treated with Wacker OH 100. The areas of low resistivity (light greys and whites) are assumed to indicate higher moisture content, whereas the

dark grey and black areas indicate high resistivity, are assumed to be lower moisture contents. Capillary rise facilitates the upward movement of moisture until it reaches the impact area where it moves towards the surface and evaporates. An accumulation of moisture within the subsurface impact area can also be distinguished, forming a wedge shape of low resistivity into the stone body and saturating the inter-grain spaces in the fracture network. At the middle transect, the direct impact area shows a higher moisture content than in the surrounding area, suggesting that the evaporation is indeed concentrated in this area, as previously suggested.

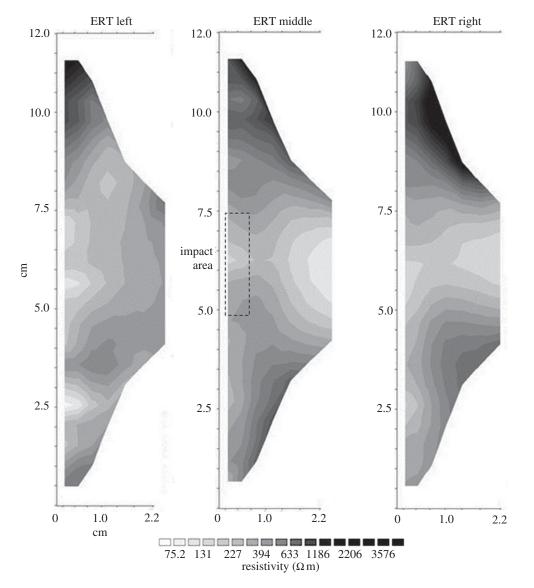
Figure 9. ERT transects of sample 7 (Wacker OH 100 treated) after the environmental cabinet treatment.

Sample 7 (figure 9) shows a very different pattern; moisture is drawn throughout the face of the stone, rather that drawn up towards the impact area. The impact area, while visible, is less clearly defined. However, the area behind the surface impact area clearly draws moisture in to a much greater degree than that seen in sample 3. Towards the foot of the block the moisture appears to be drawn up rather than into the block, as visible in sample 3, indicating more rapid capillary rise along the surface.

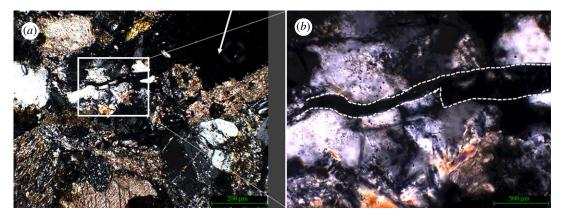
Figure 11. (a) Part of the impact area of sample 2 (not Wacker OH 100 treated); arrow indicates direction of impact. (b) Close-up of the fragmented and separated quartz found in the impact zone of sample 2, and white dashed lines clarify the position of the separation.

Quartz in the direct impact zone showed noticeable fracturing along the impact area. Figure 11a illustrates the fractures observed in the impact zone of sample 2 which was not treated with a consolidant. The absence of this surface support has resulted in the separation of the quartz fragment along the fracture line. Figure 11b shows a close-up of the area.

The bullet impacted in the area directly to the right of the fractured quartz, therefore, the conclusion could be drawn that the fracture and subsequent separation of the crystal is the result of the shockwaves generated at impact travelling sideways through the near-surface of the stone sample. The absence of a consolidant, and therefore a higher relative elasticity of the surface, facilitates sideways movement of the crystals. This type of separation was not observed in the samples treated with consolidant. This observation supports the notion that the nature of a micro-fracture network created upon impact is as dependent on the state of the material pre-impact as it is on the type of impact. As figure 12*a* illustrates, sample 3 exhibits this type of fracture network in the area directly adjacent to the impact. Figure 12*b*,*c* illustrates the geometric nature of the fracture network.

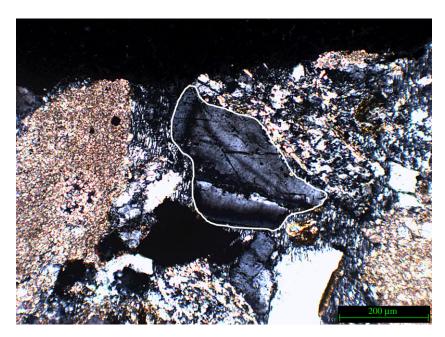
Figure 14. Sample 6 showing fractures, similar to those found in the non-consolidated samples. The mineral specifically referred to is outlined in white.

The above examples are observed in non-consolidated material. In consolidated material (samples 5–8) similar fractures were observed, implying that even though impact area development may differ the effects of the impact on mineral grains immediately surrounding the impact area are very similar. Figure 14 shows fractures found on the edge of the direct impact area in a Wacker OH 100 treated block (sample 6).

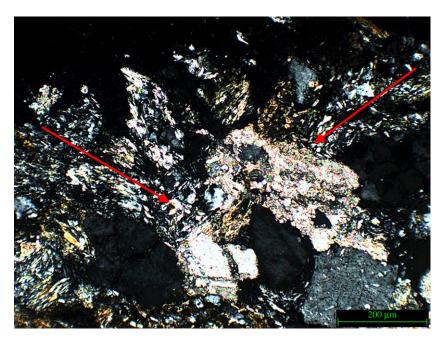
Figure 15. Sample 4, with arrows indicating clay matrix movement. This sample was not treated with Wacker OH 100.

Deformation of the clay (muscovite/kaolinite) cementation indicates a realignment of the general matrix in response to the shock generated on impact. Figure 15 illustrates this realignment in relation to the centre of the bullet impact which is in the area between the two arrows. The arrows indicate the new direction of the clay minerals, an alignment which is not visible in the non-impacted samples

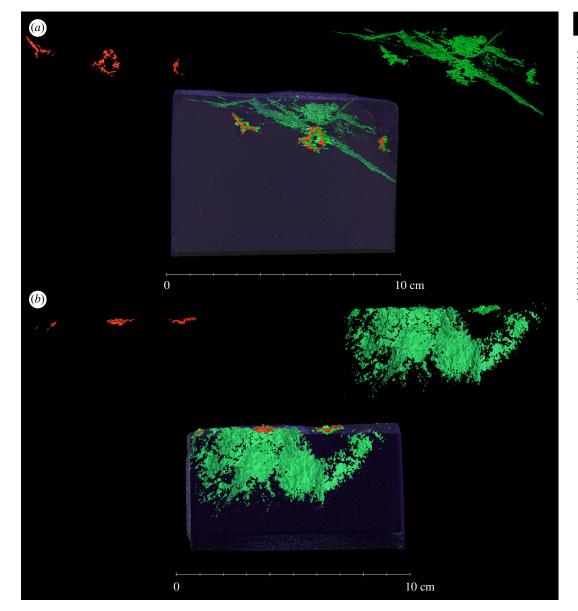
Figure 16. X-ray of impact areas, green demarcates areas of low density (fractured), whereas red indicates areas of higher density, likely to be lead deposits from the bullet encasing. (a) Frontal view (line of sight parallel to travel of bullet) and (b) top-down view. This sample was not treated with Wacker OH 100.

As all previous tests indicated both deformation of minerals around the impact zone as well as consolidation of the clay, a sample was scanned using X-ray tomography to map out compaction and fracture zones. These results are shown in figure 16, where the impacts coincide with compacted areas, whereas the fractured area extends onto the surface, radiating out from underneath the impact zones. The damage appears to have been caused by stress travelling into the block as the bullet hit, towards the

edges of the block while following a bedding plane within the stone sample. This exploitation of a preexisting weakness is a commonly observed mechanism in stone under environmental stress [36]. These results also confirm the creation of compaction areas at the site of impact, which in turn affects impact site response to environmental stress and potential for long-term deterioration.
