# Characterization of plastic deformation induced by machining in a Ni-based superalloy

Ding, Rengen; Knaggs, Craig; Li, Hangyue; Li, Yue Gang; Bowen, Paul

Ding, R, Knaggs, C, Li, H, Li, YG & Bowen, P 2020, 'Characterization of plastic deformation induced by machining in a Ni-based superalloy', *Materials Science and Engineering A*, vol. 778, 139104, pp. 1-13. <https://doi.org/10.1016/j.msea.2020.139104>

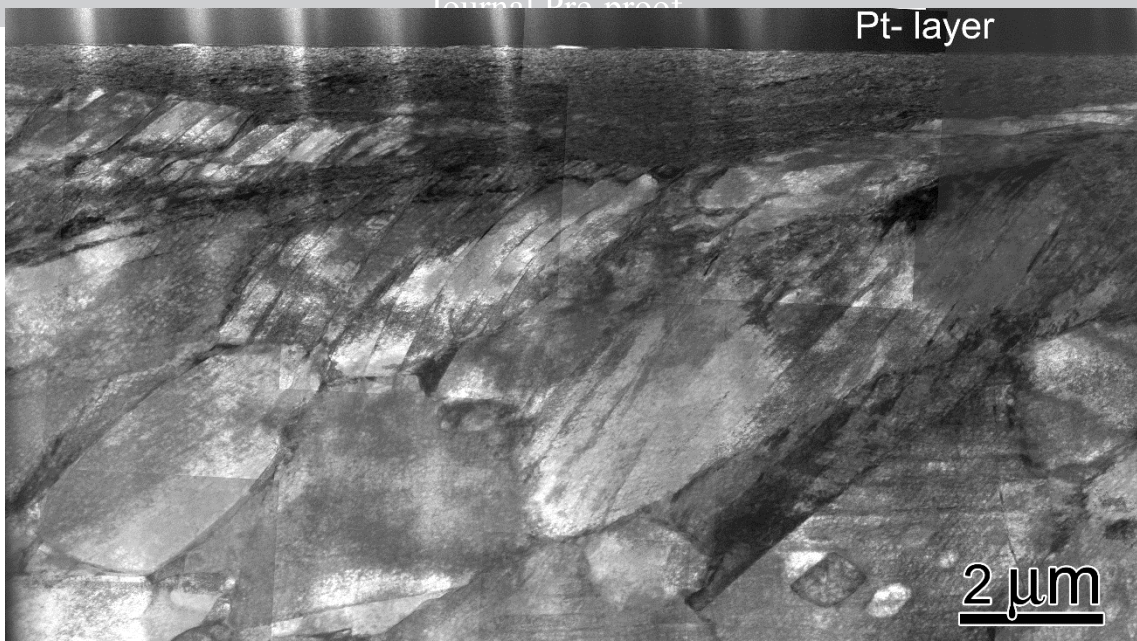
Figure 8 (a) A montage of BF-STEM images taken from the slight damage specimen, (b) A TEM image taken from the top surface of fig. 8a, and (c) an SAD pattern taken from fig. 8b.

Microhardness testing did not reveal any work-hardening of the slightly damaged sample, which could be related to widely spaced indents ( $\sim 50 \mu\text{m}$ ) and/or a narrow work-hardening zone (Fig. 8a). However, nanoindents showed that the hardness revealed by the first indent ( $\sim 4 \mu\text{m}$  away from the surface) is slightly higher than the baseline value, which is supported by the microstructure at the centre of Fig. 8a ( $\sim 4 \mu\text{m}$  away from the surface) exhibiting a high density of dislocations and slip bands. In the damaged sample, moreover, the hardness values from both the microindents (Fig. 6b) and nanoindents (Fig. 6c) reach 140% of the baseline value and are strongly localized within 20  $\mu\text{m}$  of the surface. This finding is associated with high strain, e.g. heavy deformed  $\gamma'$  observed as in the SEM image (Fig. 4c). High strain also led to poor indexing in EBSD (Fig. 5). The increase in hardness was reflected by the microstructure. For example, in Fig. 10a, the microstructure within 10  $\mu\text{m}$  of the surface consists of nc grains and a high density of dislocations and slip bands. Here, it should be noted that, although in the slightly damaged sample a very fine microstructure (i.e. nc grains combined with a high density of dislocations) was also observed in the region beginning at the surface and ending between 300-800 nm away (Fig. 8), the nanoindenter did not measure

this region. The hardness values of the first indent ( $\sim 4 \mu\text{m}$  away from the surface) are from large grains with a high density of dislocations and slip bands for the slightly damaged sample (as seen in Fig. 8a) and nc grains with a high density of dislocations for the damaged sample (Fig. 10a). Thus, the observed hardness value of the first indent for the damaged sample is much higher than that for the slightly damaged sample (Fig. 6). Messé et al. [20] observed that the hardness of the surface of shot-peened RR1000 reaches 180% of the baseline value but there was no evidence of recrystallization. The surface hardness of the drilled 720Li is 120% of the baseline value but there was recrystallization [22]. Child et al. [12] found that shot-peening makes the surface hardness increase by 30% for 720Li. These discrepancies are attributed to different deformation microstructures.

The TKD and TEM observations can be used to assert the mechanism of grain refinement of the machined layer. In 720Li alloy no twinning was observed in the deformed region. Clearly, the grain refinement induced via machining was achieved by dislocation slip, as revealed in Fig. 8a. In the region (e.g. the centre bottom of Fig. 8a) with relatively low strain, multiple slip systems are activated and a high density of dislocations is found while the original grain is not obviously deformed. With increasing strain and strain rate induced by machining, a higher density of dislocations is produced, which develops into dislocation tangles and walls, leading to storage of the system energy in form of crystalline defects (Fig. 8a), and which results in the formation of elongated grain via rotational mechanism. Then, the elongated grains can be subdivided into dislocations cells via those dislocation tangles and dislocation walls (Fig. 8a). At the same time, the massive dislocations could bow around  $\gamma'$  precipitates or cut them with coupled dislocations, leading to heavy plastic deformation of those  $\gamma'$  particles (Figs. 4 and 9). With the further increase of strain and strain rate with closing to the machining surface, a density of dislocations is further improved. In order to reduce the stored energy, the dislocation cells will absorb the dislocations and evolve into subgrains with low misorientation (Fig. 11c), thus still keeping a strong texture (Figs. 10e and 11d). In this stage, dynamic recovery dominates the grain development. In superficial layer, cutting temperature reaches the highest value, which causes tertiary  $\gamma'$  particles fully dissolved (Figs. 9, 12, and 14). At the meantime, higher cutting temperature accelerates atomic diffusion of  $\gamma'/\gamma$  constituent elements, thus promoting that the subgrains absorb the dislocations and the grain boundary angles increases. This process brings about the annihilation and rearrangement of dislocations and the growth of recrystallised grains, thus leading to the formation of more grains with low density of dislocations and high misorientation. Eventually, the texture of the superficial layer becomes more random, as evident in Figs. 10c, 11b, and 13d. It is thus considered that in superficial layer dynamic recrystallisation dominates grain structure evolution. To better describe the microstructural evolution of alloy 720Li during machining, a schematic diagram summarising the major aspects of the deformation microstructures formed in different regions (subsurface and surface) during machining is given in figure 15.

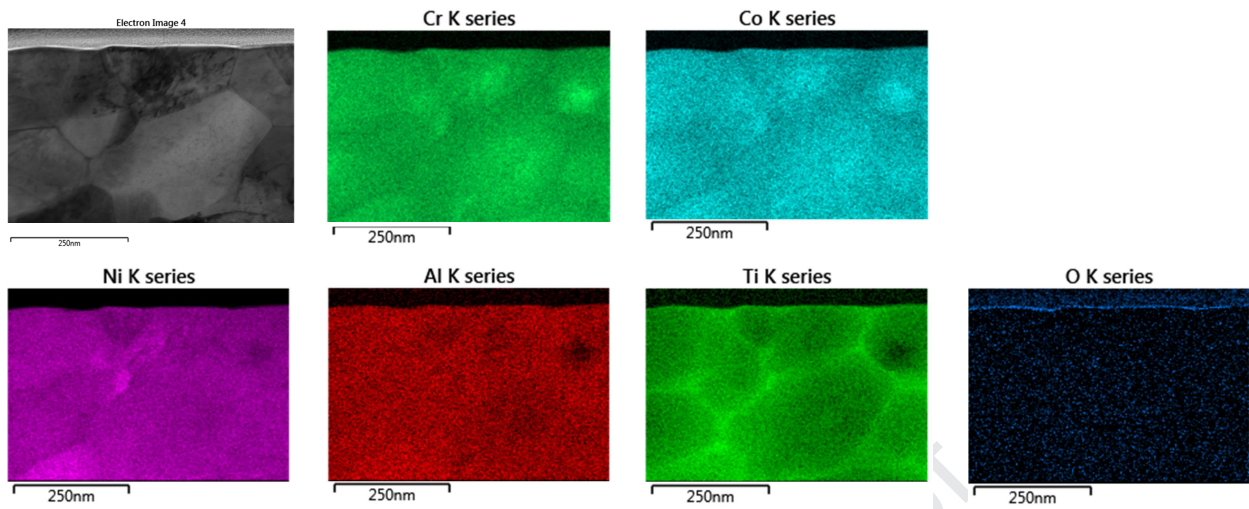
Figure 14 EDS maps for the surface of the ramp in the damage specimen, showing Ti enrichment at grain boundaries.

Figure 14 shows an electron image and the corresponding EDS maps through the surface of the ramp. Clear grains and grain boundaries are visible in the electron image of Fig. 14. EDS maps show there is no evidence of  $\gamma'$  while Cr and Co are rich in the grain interiors. An interesting observation is Ti enrichment at the grain boundaries (Fig. 14). Partitioning of Cr,

Co and Ti indicates that the immediate subsurface of the ramp has stayed for a certain time at a high temperature. From the electron images of the surfaces (Fig. 13) and the corresponding EDS maps (Fig. 14), there is a region where the tertiary  $\gamma'$  is not observable and in which nc is also visible. The surface layer has no tertiary  $\gamma'$  and coarser nc grains, which suggests that the surface is soft compared to the subsurface.

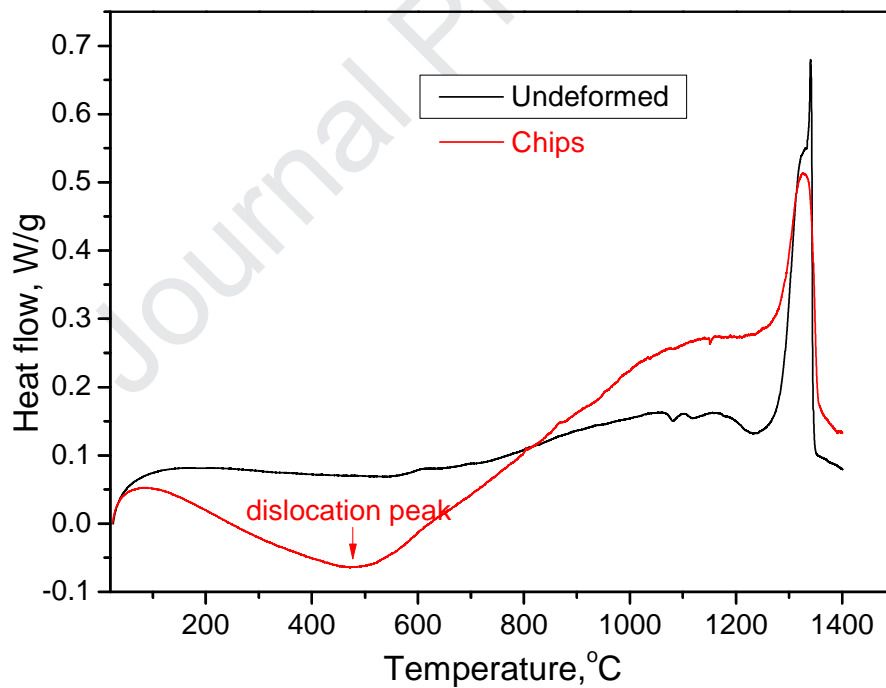
Figure 15 Differential scanning calorimetry curves with a heating rate of 10°C/min for chips and undeformed material.
