Bednarczyk, Klaus; Heeling, Anne; Schaller, Detlef; Vierfuss, Ulrich Coastal Protection at the North and Baltic Sea: Helgoland Island

Coastal Protection at the North and Baltic Sea: Helgoland Island

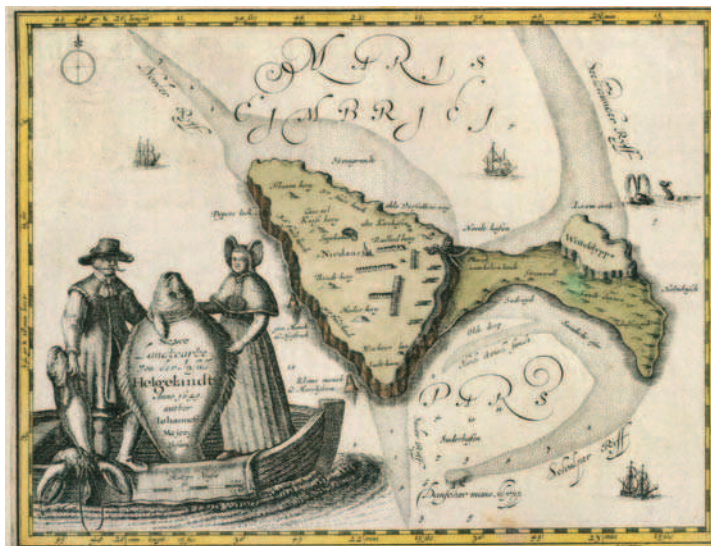
Fig. 3: The island of Helgoland with the 'Wittekliff' and 'Woal' in the 17th century (map by Johannes Mejer, 1694)

During this time, the main island was connected with the ‘Wittekliff’ by a sand spit, the ‘Woal’ (Fig. 3). Since medieval times, shell-limestone and gypsum had been mined on this cliff. This exploitation contributed to its rapid destruction up to a point of instability; it collapsed during the storm surge of 1711. Shortly afterwards, the ‘Woal’ disappeared as well. On top of the remaining cliff, the present Düne developed. The sand island is important for today’s beach activities.

In 1721, the history of Düne being an independent island begins by its separation from the main island. The breaching of the sand spit 'Woal' (Fig. 3) triggered the generation of a gully which became deeper and wider. The size of the main body of Düne decreased during the course of the centuries, and it assumed a spindle shape (Fig. 6). At its eastern end, a long-stretched flat sand and rubble spit developed. This so-called 'Aade' was continuously modified by waves and currents.

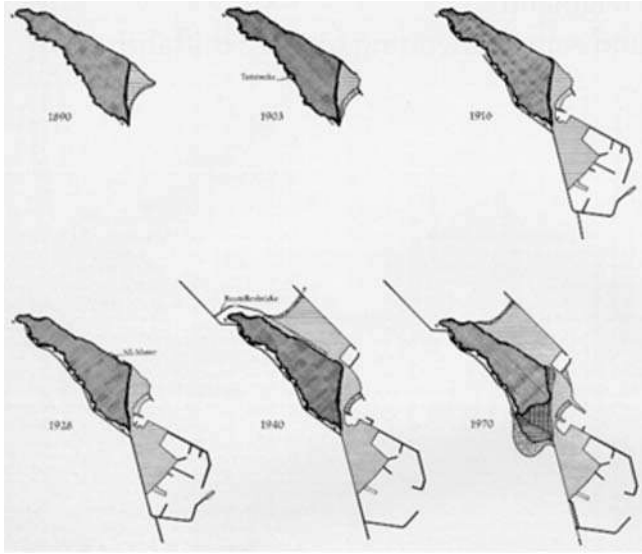
Fig. 4: Development of Helgoland (main island) since 1890 (after KRUMBEIN, 1975)

In 1890 Great Britain relinquished the ownership of the island to the German Empire in exchange of rights in Africa (so-called Helgoland–Zanzibar–Treaty). The emperor Wilhelm II had Helgoland turned into a navy base. Now, shore protection measures at the western part of the island were accelerated since in many places the unsecured rock cliffs threatened to collapse onto the gun emplacements, underground shelters and bunkers. Consequently, in 1903, the construction of the protective south-west beach wall began with the last gap closed in 1927. South of the rock island, the naval port with new harbour facilities and large jetties was established (Fig. 4).

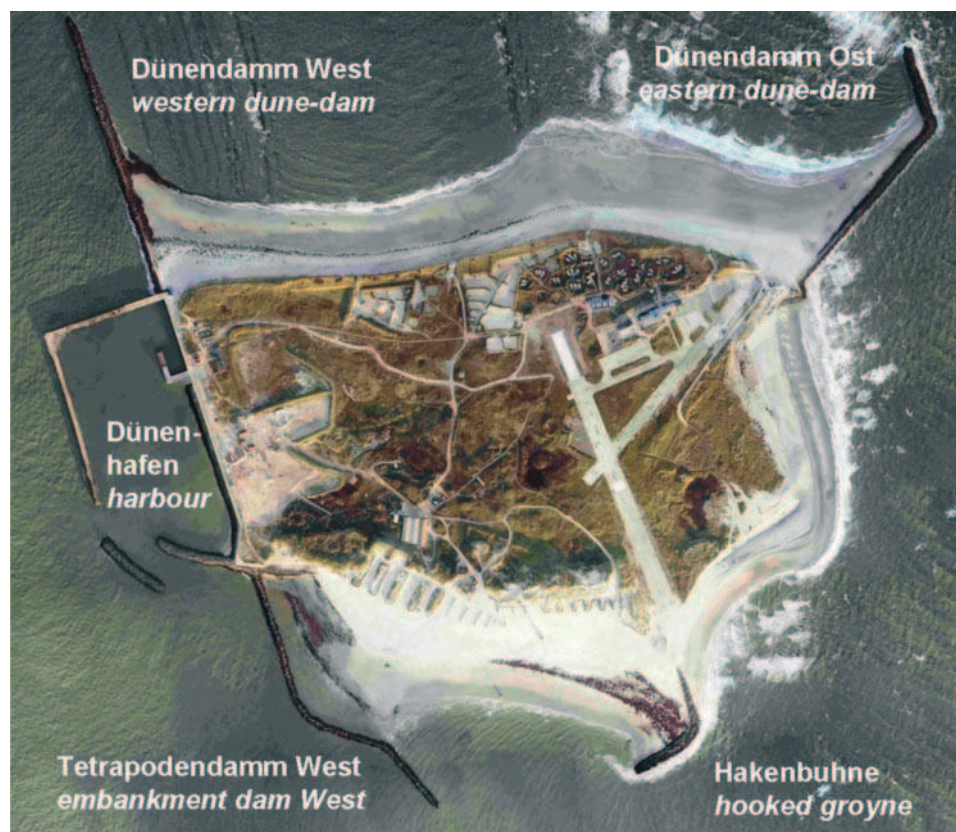
Fig. 7: The Düne of Helgoland (aerial photograph of Nov. 14, 2007)

In 1979, with the receding beach front at the eastern part of the southern beach, the HW-line moved to the immediate vicinity of the runway of the little airport, resulting in a scour at the runway head. Among others, this led to a concept for the protection of the southern side of Düne and the runway. For this purpose, a 60 m Tetrapode groyne was built in early 1983 and extended to 234 m in 1987. This hooked groyne was the counterpart to the embankment dam mentioned above. The result was an increased sand deposition and the evolution of a bay ideal for swimming. This bay has been stable until now (Fig. 7).

The counterparts of these structures at the southern side are the Tetrapode dam (1965–1974) and the hooked groyne (1983–1987; cf. Fig. 7). Finally, the dune harbour was protected by a new southern jetty and an offshore breakwater against wave impact. Moreover, these structures are to prevent the penetration of sediment. The harbour is an integral part of the protection of Düne.

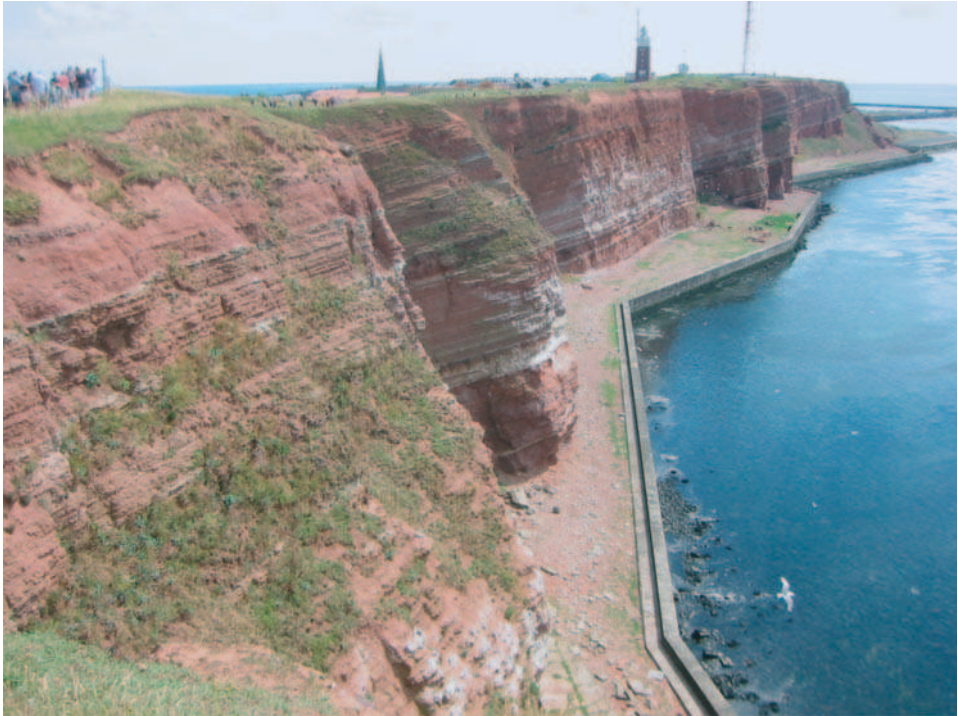
Fig. 8: View of the cliff coast and a part of the south-western sea wall
(Photo: H. J. Bennöhr, 2005, Wikipedia Commons)

The sea wall was erected using a combination of concrete blocks, poured concrete and a covering of natural stone blocks between 1903 and 1913 and between 1926 and 1927. It was substantially damaged by bombs during and after WWII and reconstructed in concrete between 1960 and 1963. The average crown elevation is at approx. HW + 3.50 m, and the toe of the rock slope in front of the wall is close to LW. Towards the North, the south-western sea wall merges into the northern jetty. South of the 'Kringel', which was generated by the blasting in 1947, it continues to cross over into the shore protection and jetty structures of the secure protective harbour.
